# National Transportation Safety Board

WPR22LA093

## **FACTUAL EXAM REPORT**

Location: Chemehuevi Valley, California  
Date: February 7, 2022  
Airplane: Cessna 152 (N6496L)

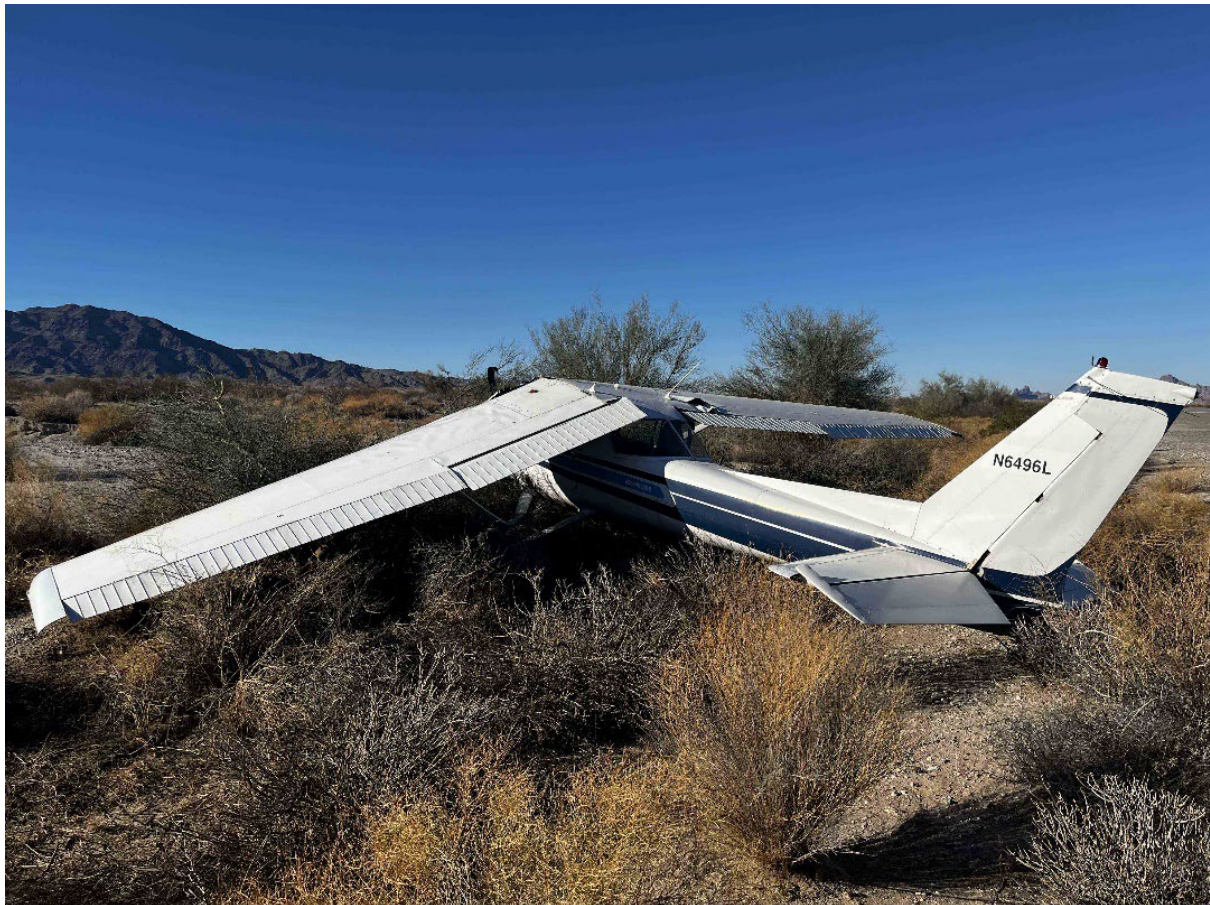
**Figure 1- Airplane at the accident site**

The airframe damage was limited to the left wing, which had folded down at the root (figure 1), and the nosewheel which had bent aft and remained partially attached to the firewall at the lower mount points (figure 2).

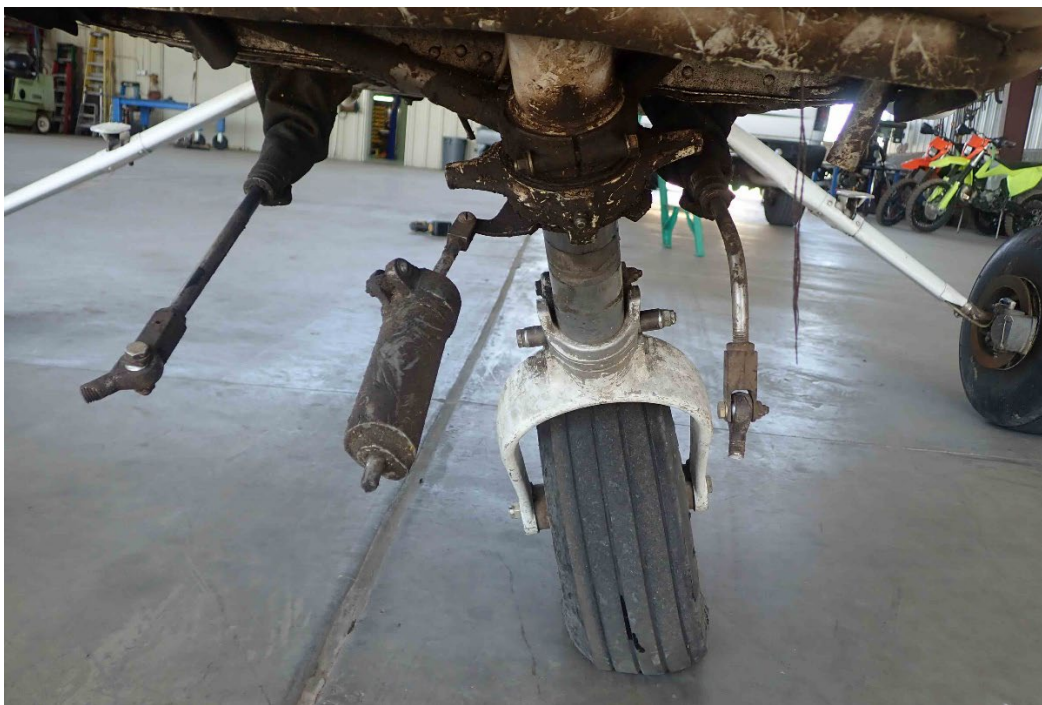
**Figure 2 - Nosegear**

The left steering control rod was bent, and the eyebolts for both rods had broken away from the trunnion; the fracture surfaces of the eyebolts exhibited crystalline surface features and bending to their edges consistent with overload. The control rods were continuous from the eyebolts through to the foot pedals, and movement of the rudder pedals resulted in movement of the control rods.

The shimmy damper remained attached to its steering arm and had broken away from the trunnion. Its mounting bolt was intact, and broken lugs from the trunnion were still attached. The lug separation surfaces exhibited crystalline features consistent with overload.

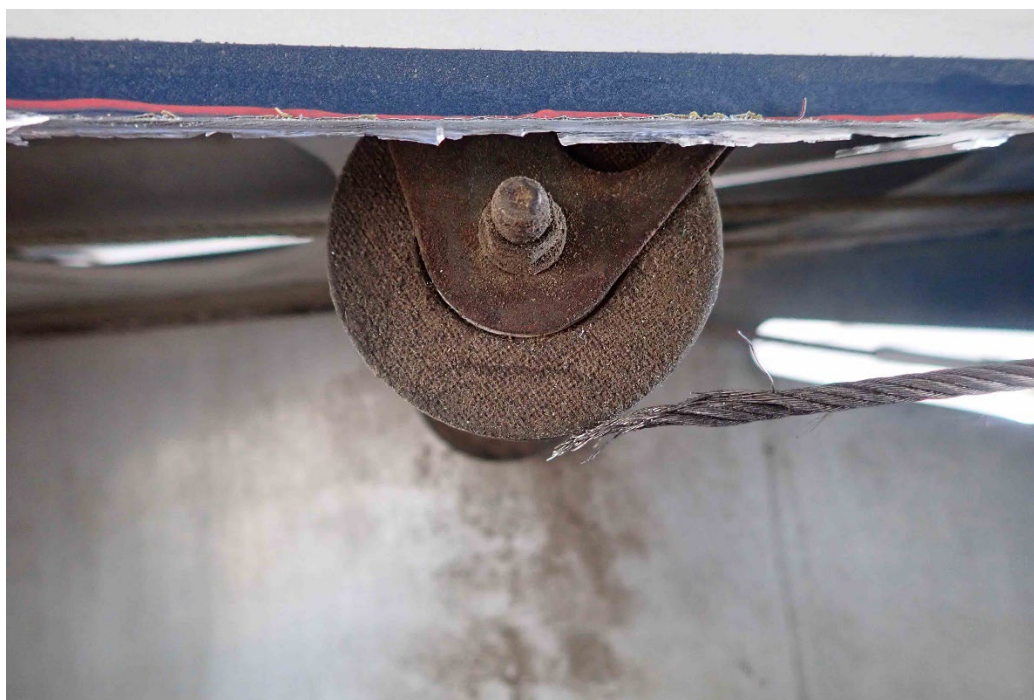
**Figure 3 - Left aft rudder pulley and cable**

The right rudder cable was continuous from the foot pedals to the rudder horn. The cable exhibited evidence of wear at the aft pulley. The wear included polishing, flattening, and broken wires (figure 3). The pulley was free and could be spun easily by hand.

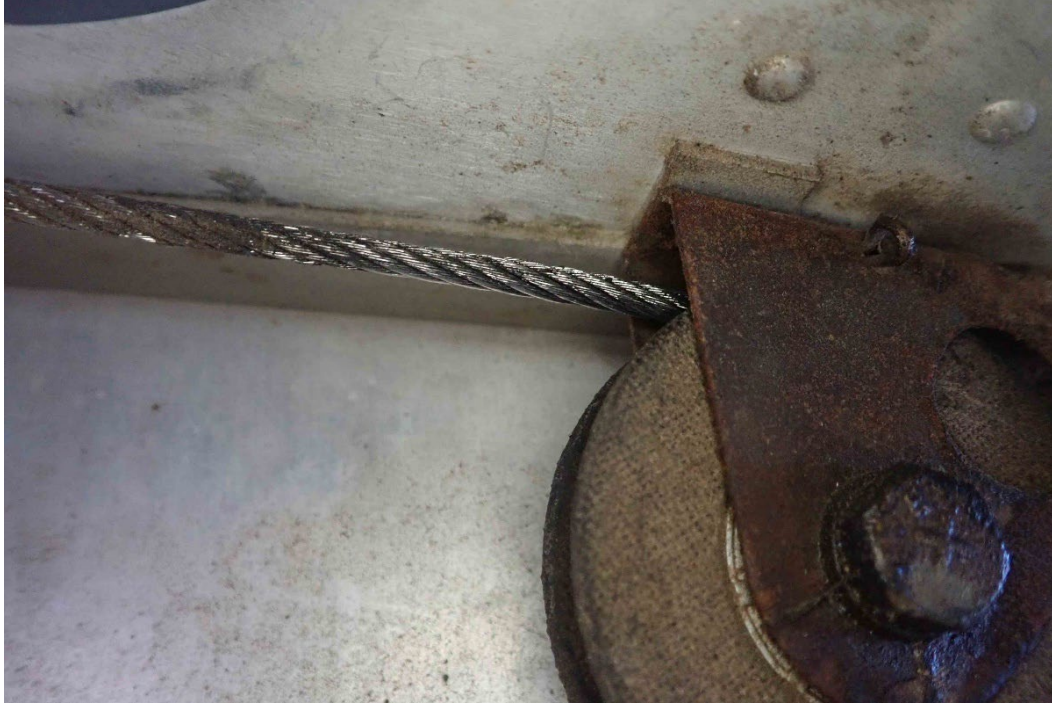
**Figure 4 - Right aft rudder pulley and cable**

The left rudder cable had snapped at the aft pulley in the tailcone (figure 4). Aft of the failure, the remaining cable segment was still attached to the rudder horn, and forward of the failure the cable remained attached to the foot pedal assembly. The wires at the failure area exhibited similar wear signatures to the right cable, all in the area of the pulley, which was free and could be spun easily.

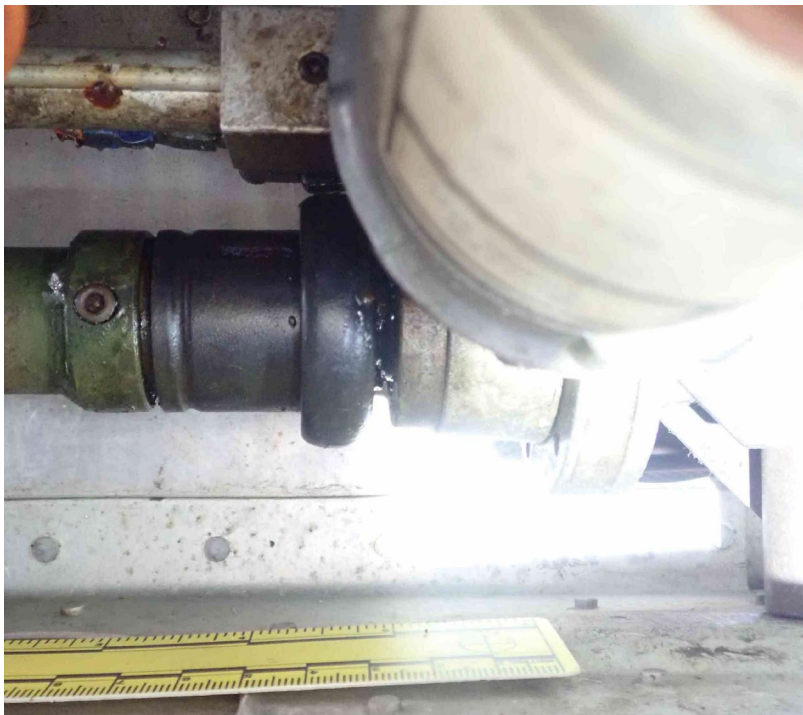
**Figure 5 - Flap actuator**

The right flap was in the retracted position, and due to the damage to the left wing, the left flap was hanging free. The flap control lever was in the 0° flaps position, and the flap indicator was in the 10° position. The flap drive actuator was in the fully retracted position, which was consistent with the flaps set to 0° (figure 5).
