# **WPR22LA114**

## **Hartzell Propeller Air Safety Investigator Field Notes** **Rev. A March 4, 2024**

NTSB File No.: WPR22LA114  
Accident Date: February 24, 2022  
Location: Oceanside, CA  
Aircraft: Cessna C-208B  
Aircraft Registration: N10JA  
Aircraft Total Time: Recorded A/C TT on 2/22/2022 was 9580.6  
Propeller TSN: Approximately 1415.9+ Hours

### **Propeller Examination**

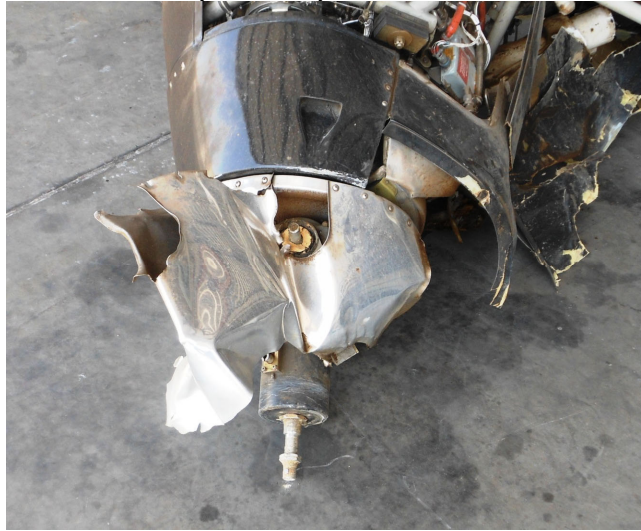
Photo #1 – Propeller as-presented for examination

The propeller was presented for examination at Air Transport on February 25, 2022 as shown in Photo #1. The propeller remained attached to the engine propeller shaft flange with all four blades fracture-separated at the shank. There were no apparent oil leaks emanating from the propeller or mounting flange. Three blades were recovered in their entirety and only a tip fragment of the fourth blade was recovered near the main wreckage. All eight mounting nuts were present, secure and lockwired. The spinner dome exhibited spiral scoring, was crushed and torn with the majority still attached to the spinner bulkhead. There were no discernable counterweight impressions in the dome that could provide blade angle information. The spinner bulkhead mounting screws sheared opposite rotation and the bulkhead separated from the hub with rotational scoring marks on both forward and aft sides. The blades were numbered #1 through #4 clockwise (in sequence of rotation) as viewed from the aft side. The start lock pins could be actuated by finger force indicating the propeller was not resting on the start locks.

The Blade #3 and Blade #4 counterweights were forcefully rotated over-center towards low pitch, indicating fractured or dislodged pitch change components. The Blade #3 counterweight

was preventing the Blade #2 counterweight from actuating toward feather so #3 counterweight was removed from the shank during this examination. When the propeller was actuated toward the feather stop, Blades #1 and #2 moved smoothly and freely, Blades #3 and #4 did not actuate.

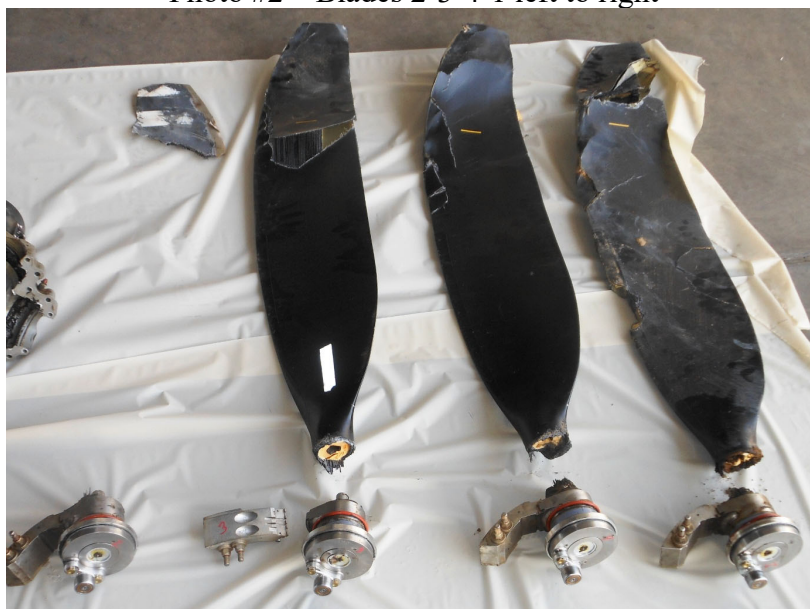
Photo #2 – Blades 2-3-4-1 left to right

The fractured blade segments were paired with their respective shanks by matching the fiber fracture patterns as shown in Photo #2. The #2 blade tip fracture-separated and was the only portion of the blade recovered near the main wreckage; it is unknown how much effort was given to searching the area for the remainder of Blade #2? Blades #3 and #4 were recovered mostly intact with chordwise/rotational scoring on the camber side and fracture patterns consistent with bending aft and twisting to low pitch. Leading edge erosion shield damage indicated impact forces were concentrated in the lead-to-trail direction indicating rotation under some power. The tip on Blade #1 was fracture-separated and recovered at the scene. Blade #1 exhibited chordwise/rotational scoring on the majority of the camber side. There were no remarkable chordwise/rotational scoring marks on the face side of any blades.

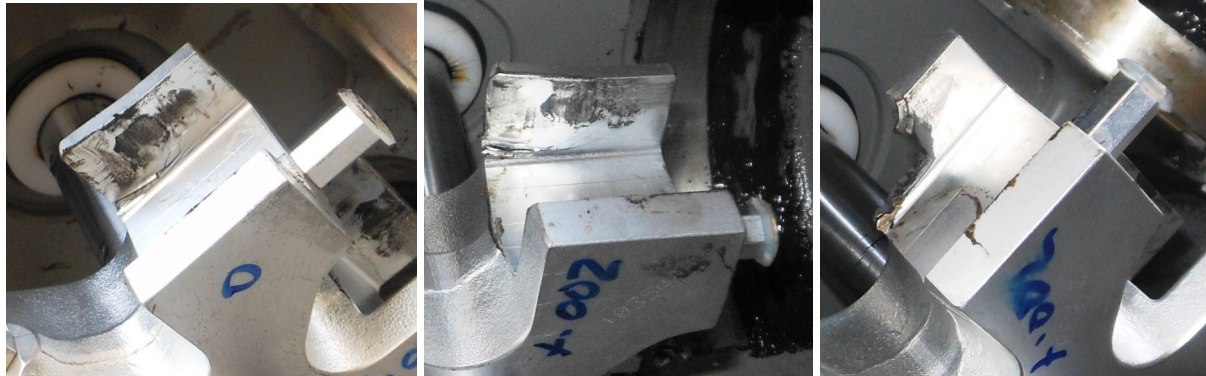
Photo montage #3 – Fractured fork tangs montage

Two forward tangs on the fork were fractured/cracked/bent toward low pitch. One tang was fracture-separated (Photo #3). The Blade #3 and Blade #4 pitch change knobs were found on the forward side/underneath the pitch change fork due to forceful rotation to low pitch. There were knob/bracket contact marks on the forward hub wall from these two blades. All four pitch change knob assemblies remained intact and secured on the blade butt (seen in Photo #2).

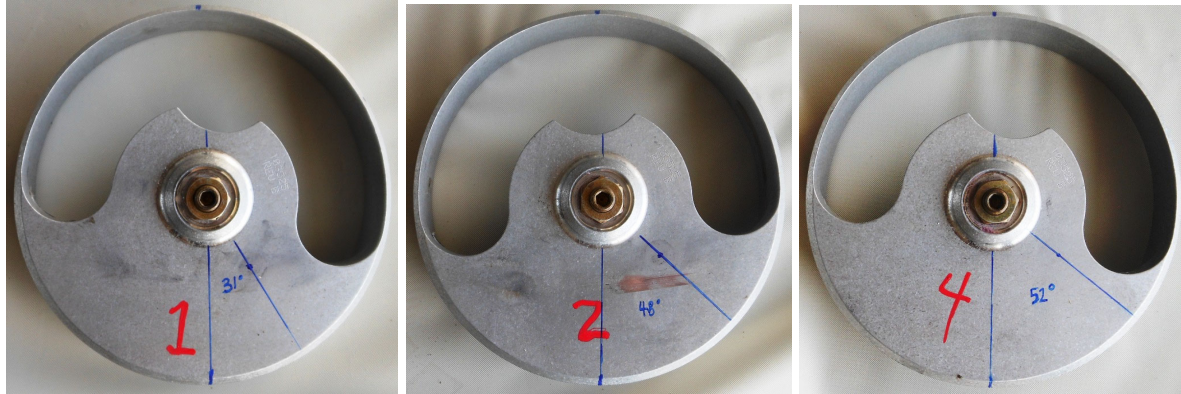
Photo #4 – Preload plates with fork bumper marks

Preload plates #1, #2 and #4 had discernable fork bumper impact marks in the low blade angle range (Photo #4).

The fork bumper impact mark measurements shown in Photo #4 translated to the following approximate blade angles:

Preload Plate #1 bumper mark at 31 degrees = ~10.9 degree blade angle

Preload Plate #2 bumper mark at 48 degrees = ~ -17 degree blade angle

Preload Plate #4 bumper mark at 52 degrees = ~ -33 degree blade angle

The average of these three marks is approximately -13° which coincides with the reverse stop angle.

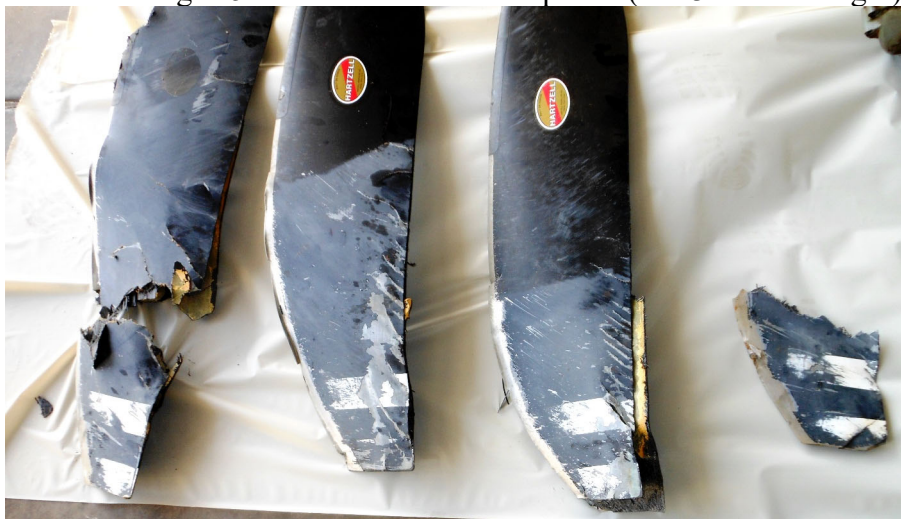
Photo montage #5 – Camber side blade tip area (1-4-3-2 left-to-right)

All four blades fractured at the blade-shank interface. Chordwise/rotational scoring was evident on the camber side of all four blades (Photo #5), moving progressively to a lower radius in the sequence of rotation. Blade #1 was fractured approximately 10-11" from the tip. Blade #2 was also fractured approximately 11" from the tip. All four blades exhibited leading edge nicks, gouging and some chunking. All four blades also exhibited trailing edge compression delamination.

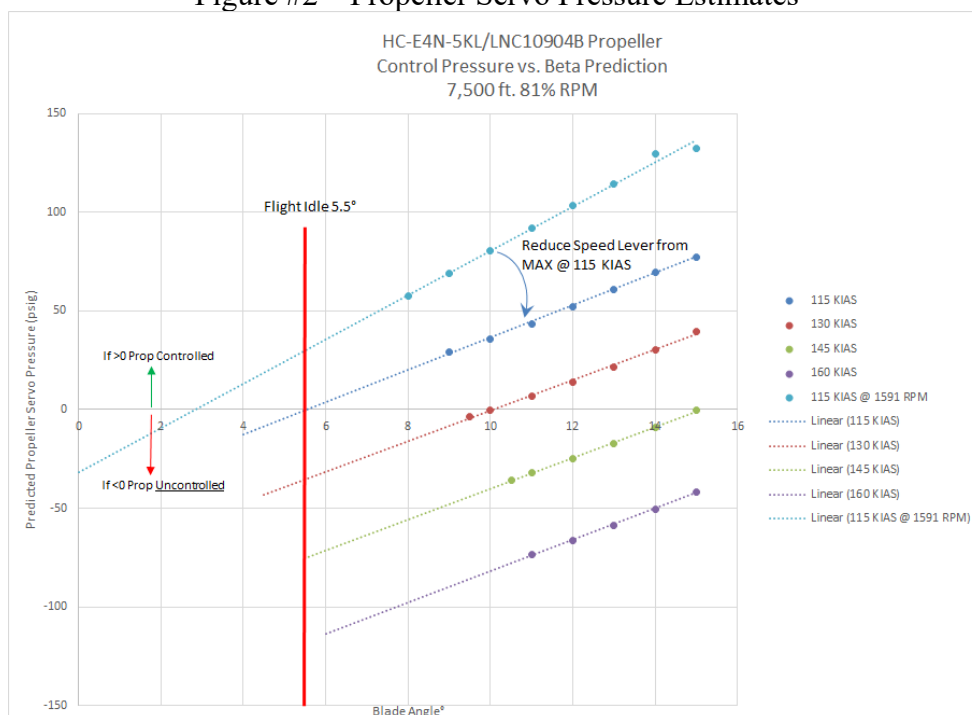
Figure #2 – Propeller Servo Pressure Estimates

An estimate of propeller servo pressure was conducted across a range of decreasing blade angles using Hartzell's PROP Code<sup>1</sup> and at a flight condition representative of the accident descent. The analysis suggests the propeller could become uncontrolled (servo pressure < 0 psi) if the engine speed lever is moved to the LOW position and the power lever is moved below the Flight Idle gate. Figure #2 shows servo pressure estimates as a function of blade angle and RPM.
