National Transportation Safety Board

WPR22LA114

**INVESTIGATIVE SUPPLEMENTAL MATERIAL**

Location: Oceanside, California  
Date: February 24, 2022  
Time: 1245 Pacific daylight time  
Airplane: Cessna C208B Supervan 900

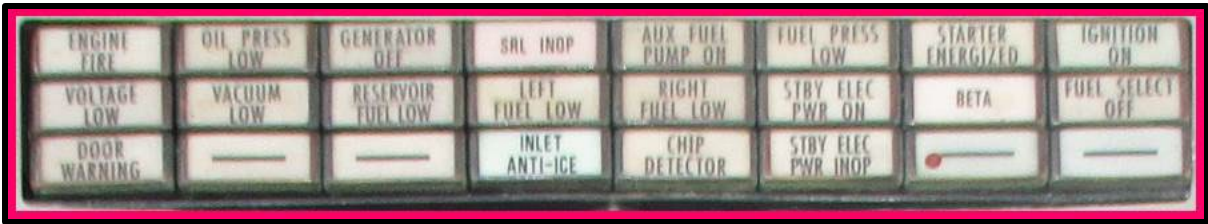
Figure 5: Annunciator Panel

An annunciator panel from the accident aircraft was submitted to the Materials Laboratory for examination. The panel contained twenty-four (24) individual annunciators. Each annunciator contained two (2) bulbs. The panel was intact and visually appeared to have had limited impact-related damage. The individual annunciator lights were removed from the panel and x-rayed to determine the status of the filaments inside each of the bulbs. The status of each light is listed in the chart below.
