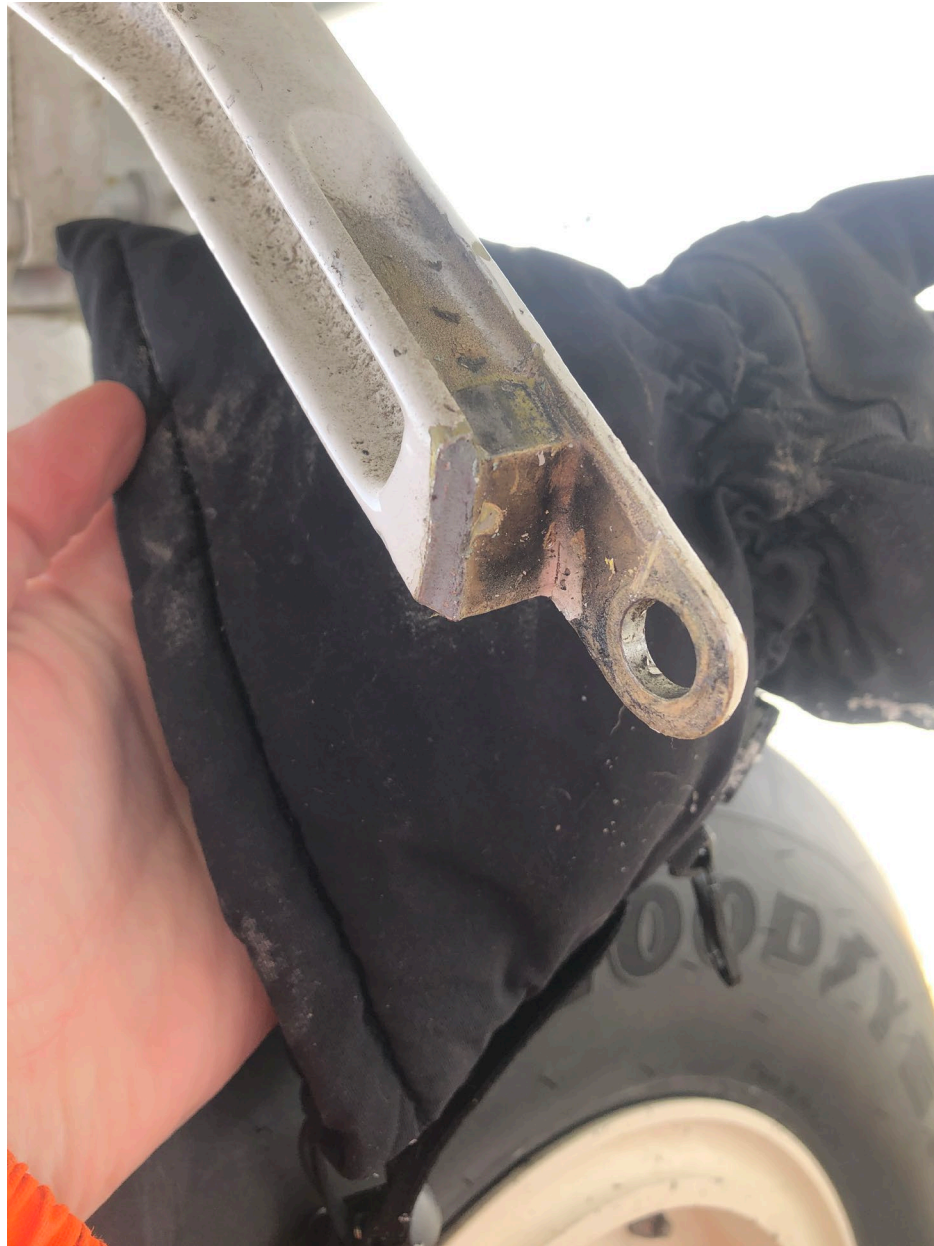
**Photo 1 – Bellcrank lower arm fork (courtesy of local mechanic)**

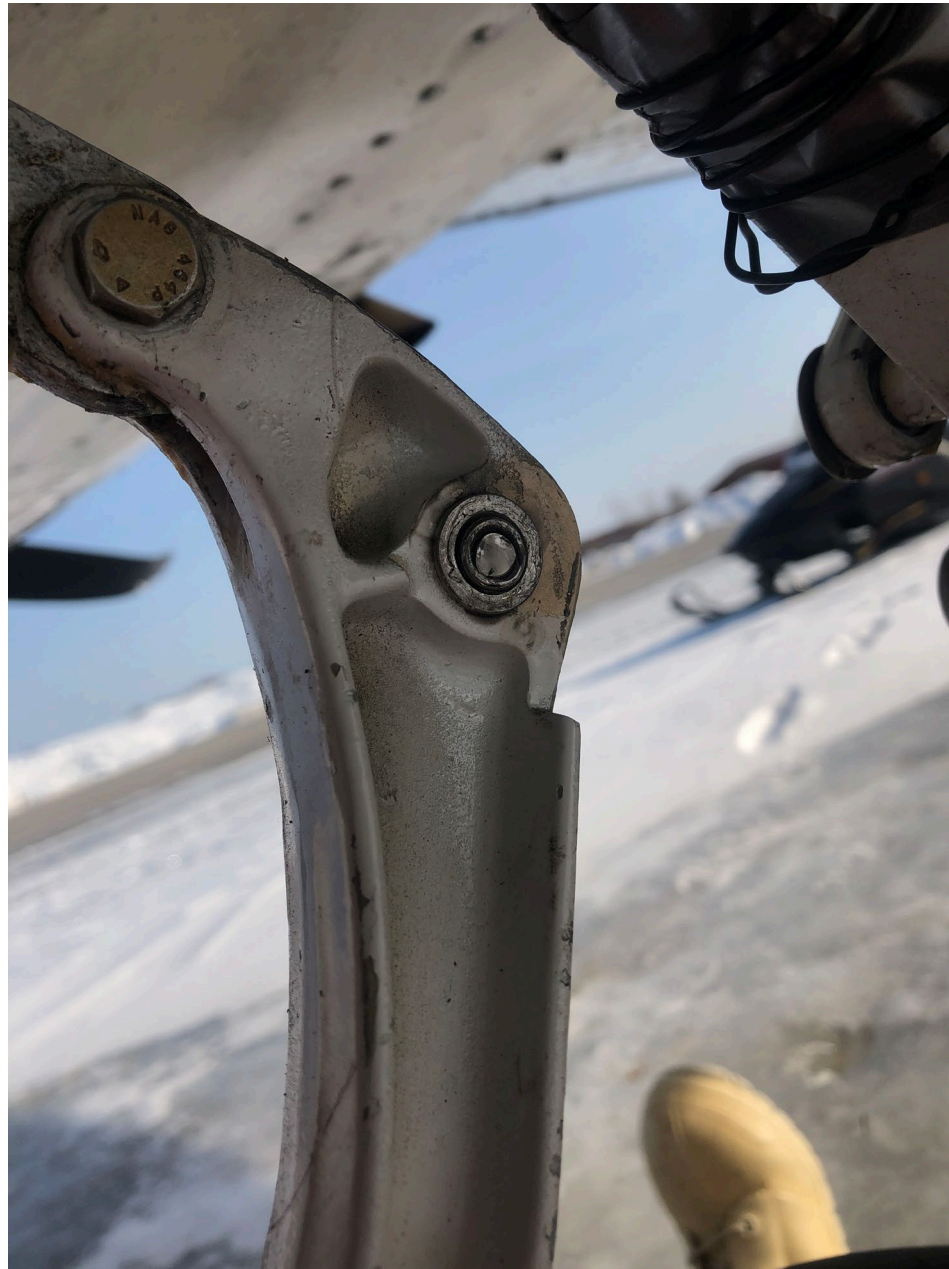
**Photo 2 – Bellcrank pivot bolt (courtesy of local mechanic)**

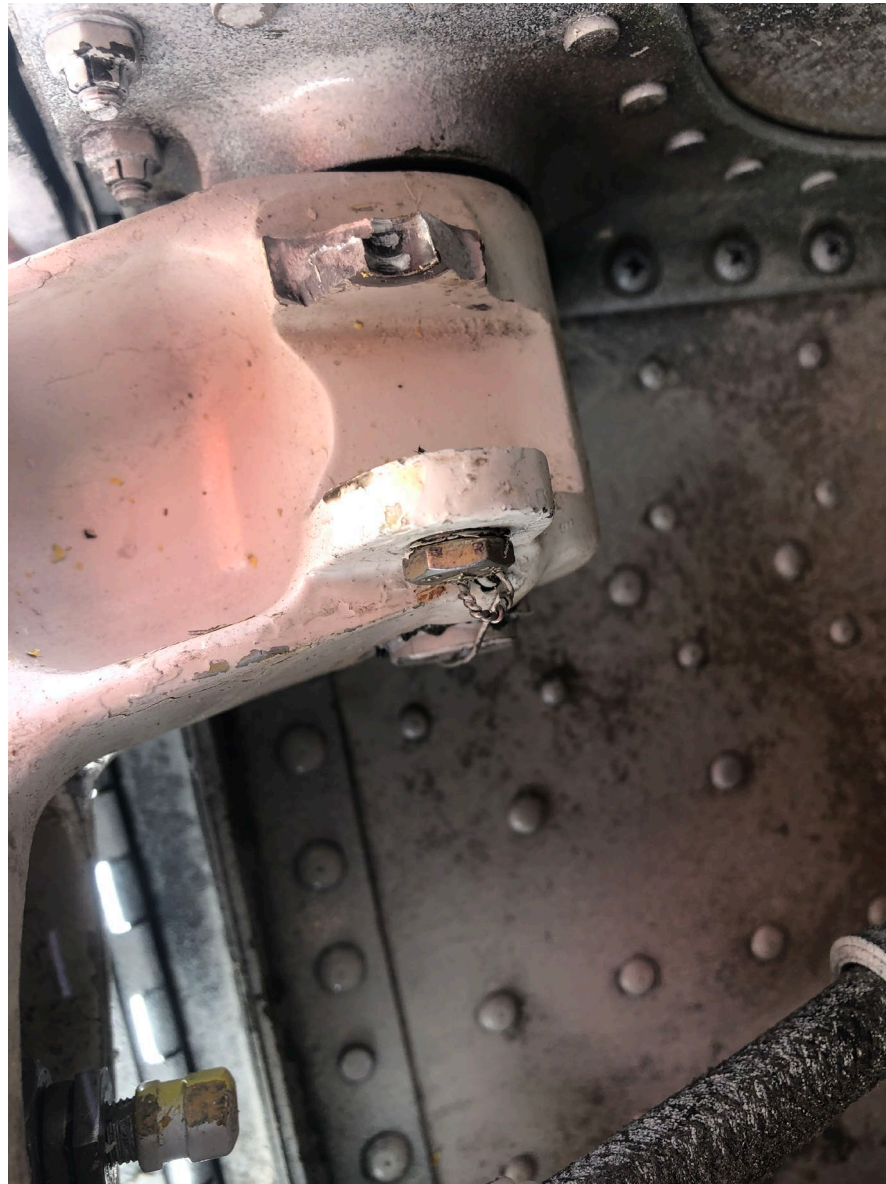
**Photo 3 – Trunnion clevis off landing gear strut (courtesy of local mechanic)**

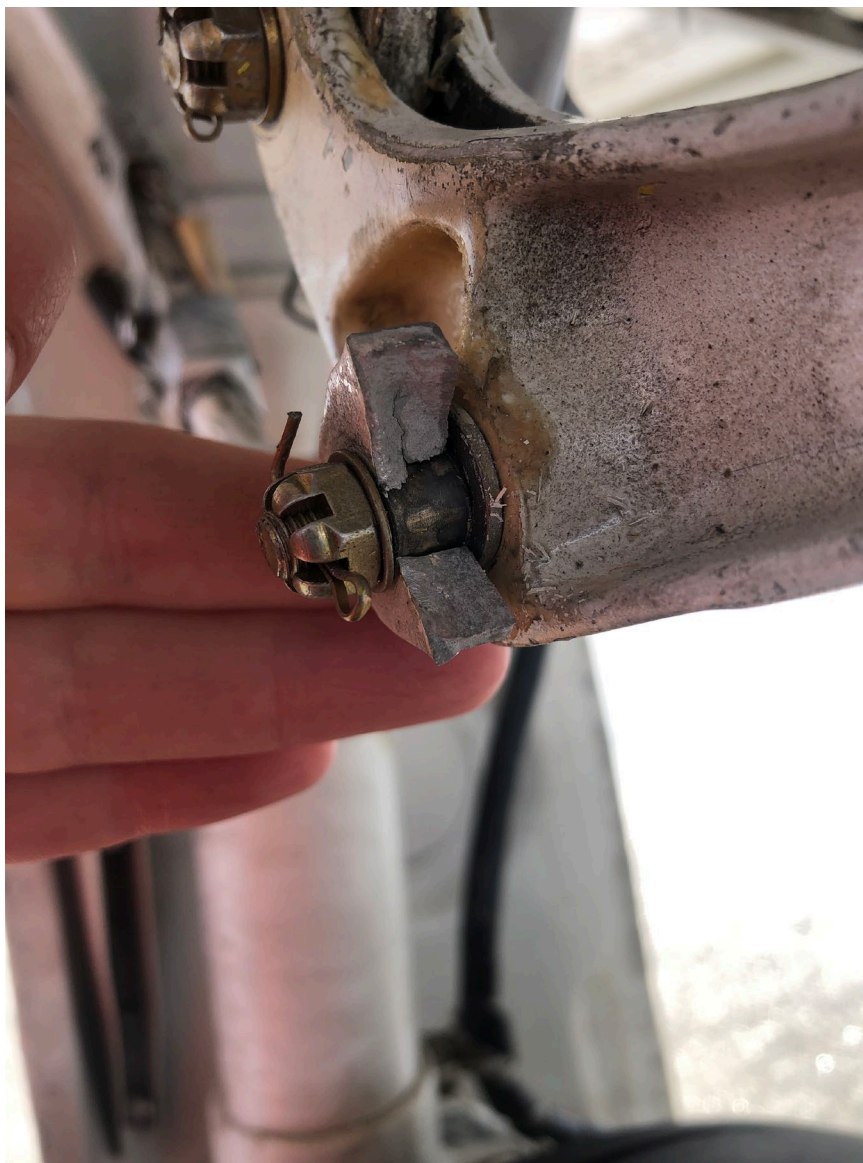
**Photo 4 – Trunnion clevis at right main landing gear bellcrank assembly (Courtesy of Continental Motors)**

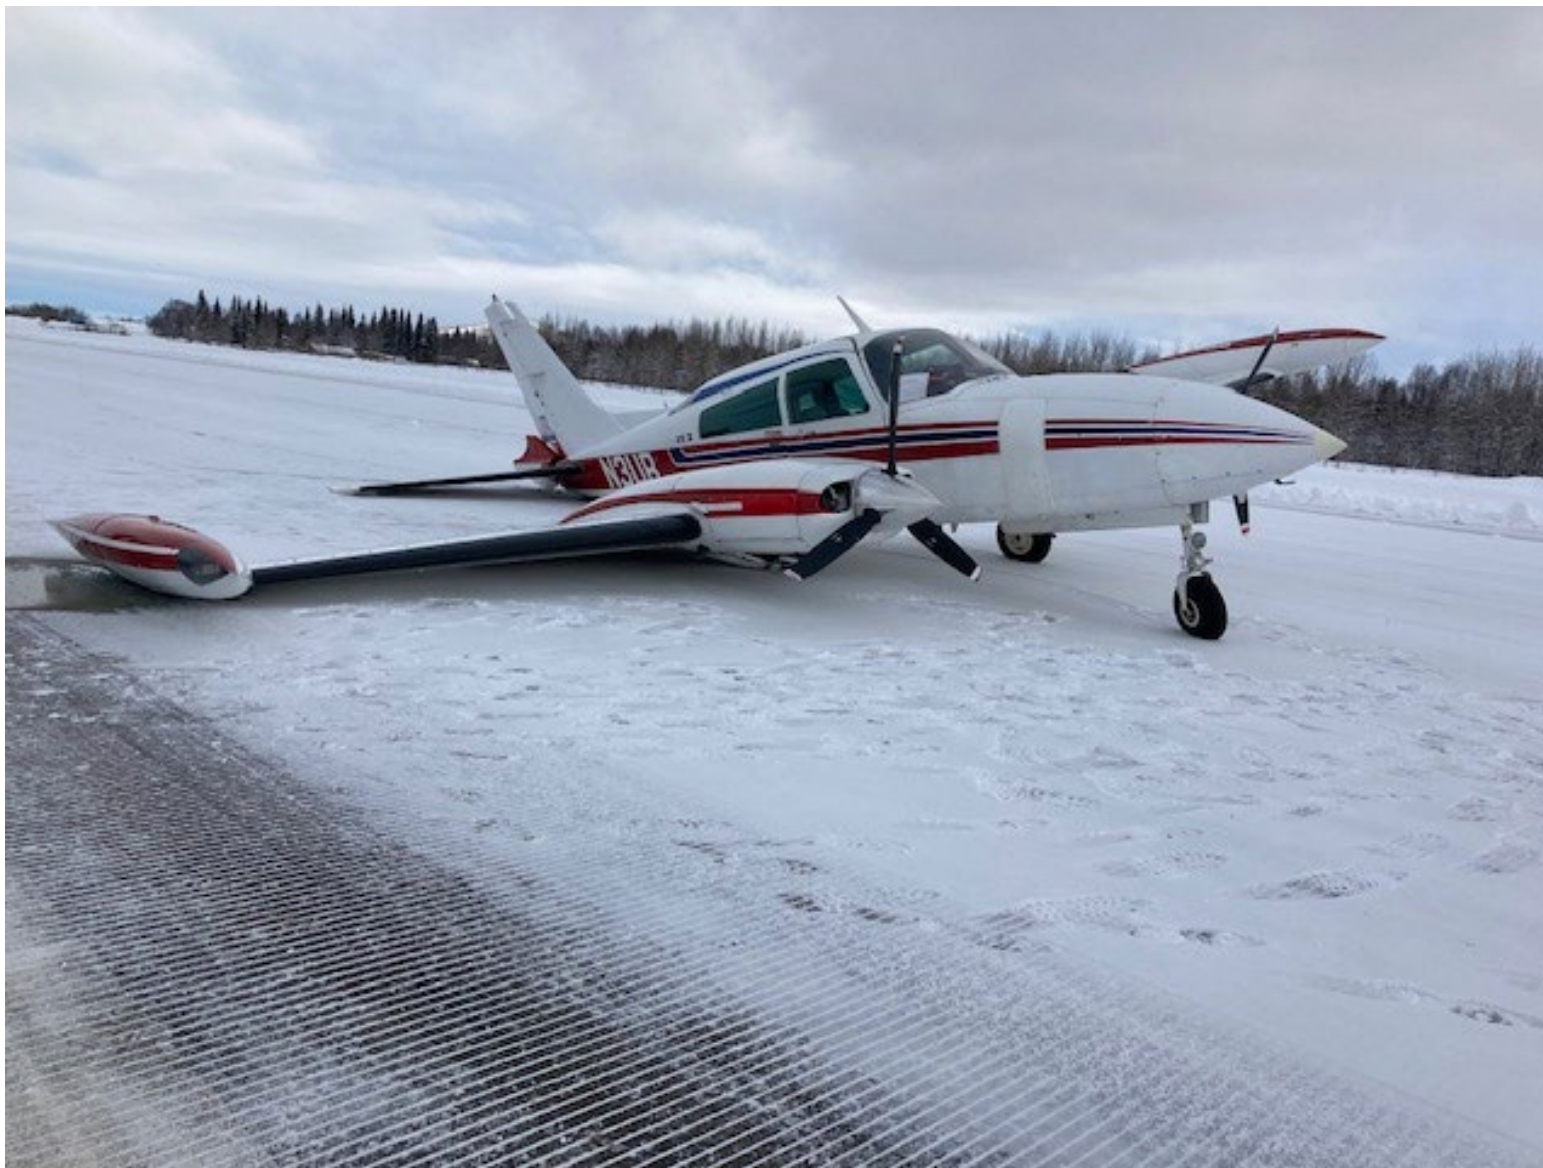
**Photo 5 – Airplane at accident site (courtesy of accident pilot)**
