## **NATIONAL TRANSPORTATION SAFETY BOARD**

# **WRECKAGE EXAMINATION SUMMARY REPORT**

**WPR22LA127**

Location: St George, Utah  
Date: March 24, 2022  
Aircraft: N111NW  
NTSB IIC: Andrew Swick

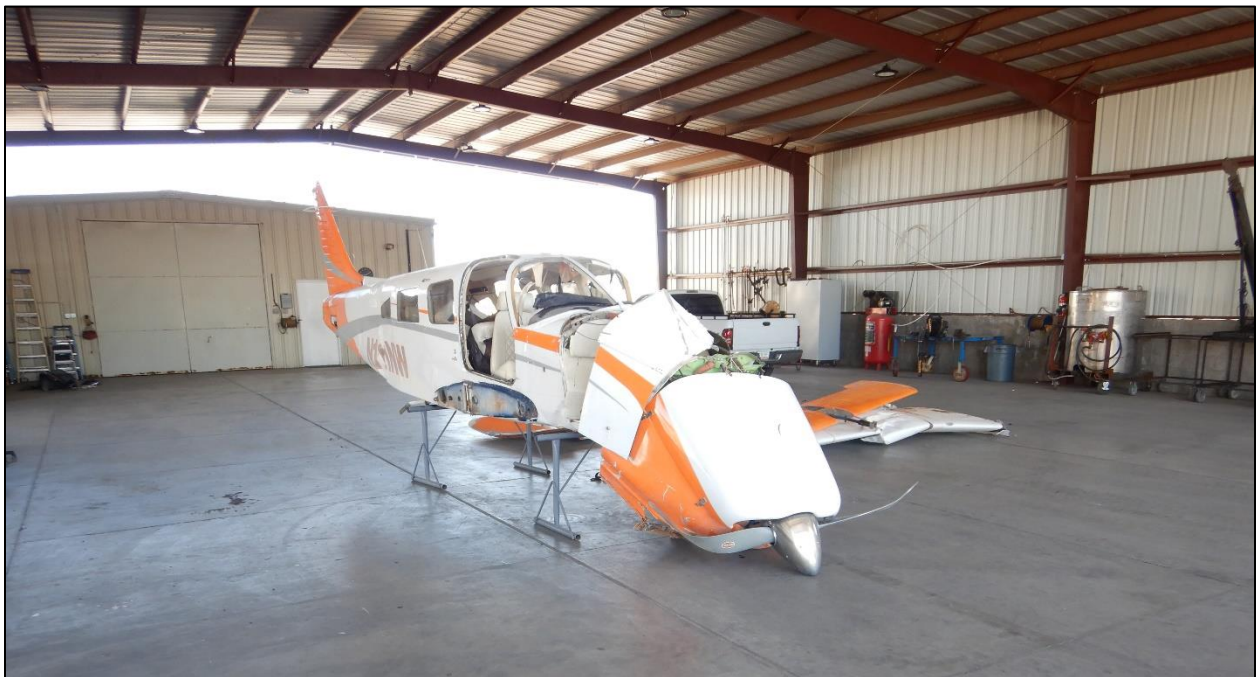
## C. SUMMARY

Figure 1-Main wreckage during the follow-up examination.

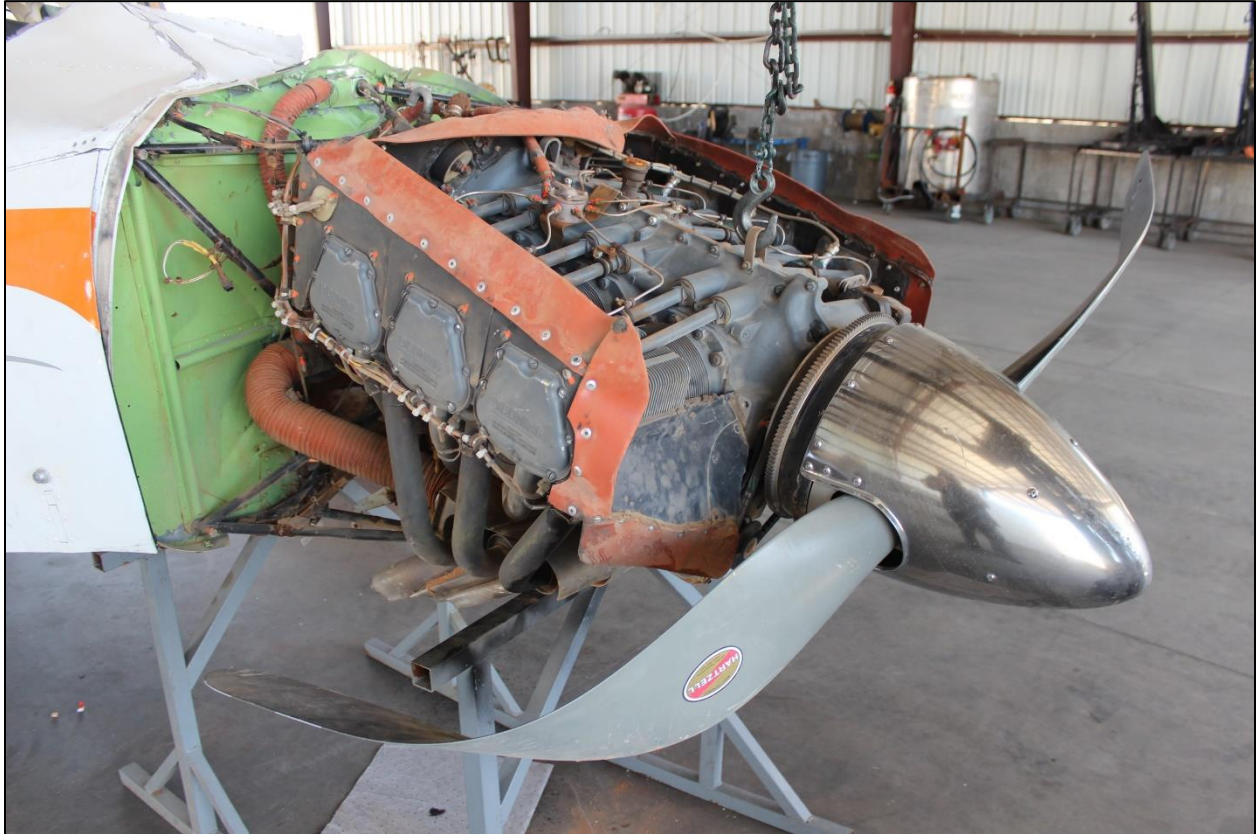
The engine was examined and was found to be undamaged. The propeller assembly remained attached to the crankshaft propeller flange and both blades had aft bending. Engine control continuity was established from the cabin. Fuel lines were found intact and secure to their respective fuel system component. The fuel lines were also free of internal obstructions to flow when teste. Fuel system components were examined and found to be unremarkable. Fuel was present during multiple fuel system component examinations. Water detection paste was used and was negative for water contamination.

Figure 2-Right forward view of the engine and propeller assembly.

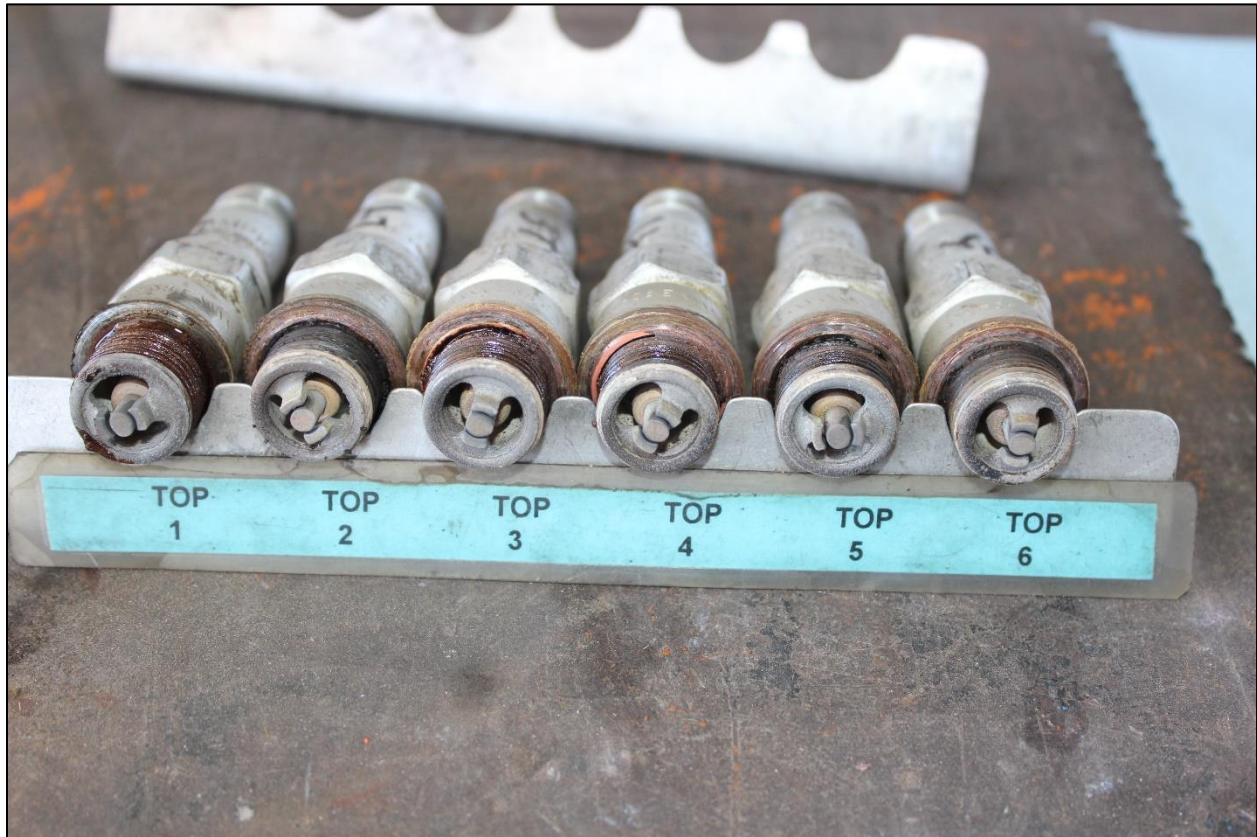
The upper spark plugs were removed and examined. The spark plug electrodes were undamaged. The electrode areas revealed combustion deposits consistent with normal operation.

Figure 3-Upper spark plug electrodes.

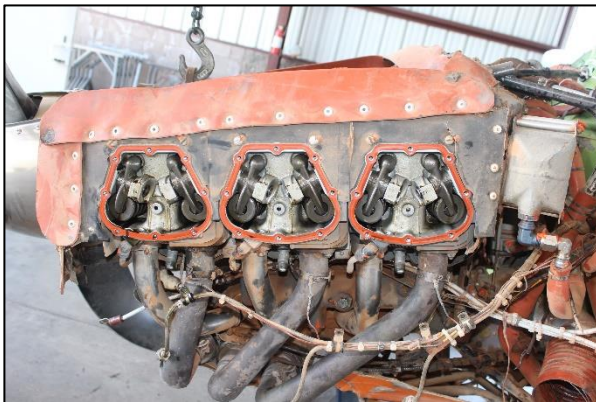
The crankshaft was rotated by hand easily with the propeller assembly. Cylinder compression was established at each cylinder in proper order. The cylinder overhead components moved normally during the crankshaft rotation and were lubricated and undamaged. Internal gear continuity was also established throughout the engine and accessory section. The cylinders were boroscoped revealing normal combustion deposits and undamaged combustion chambers.

Figure 4-Left cylinder overhead components.

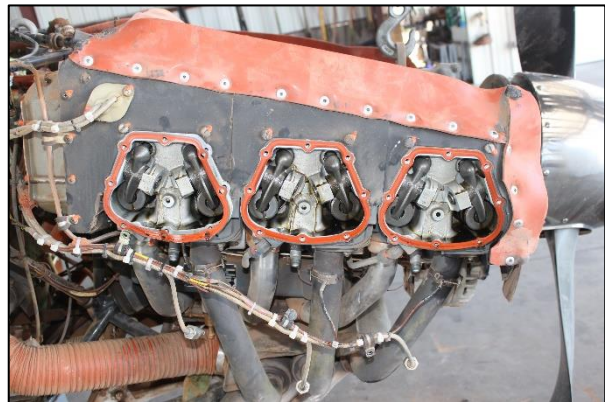
Figure 5-Right cylinder overhead components.

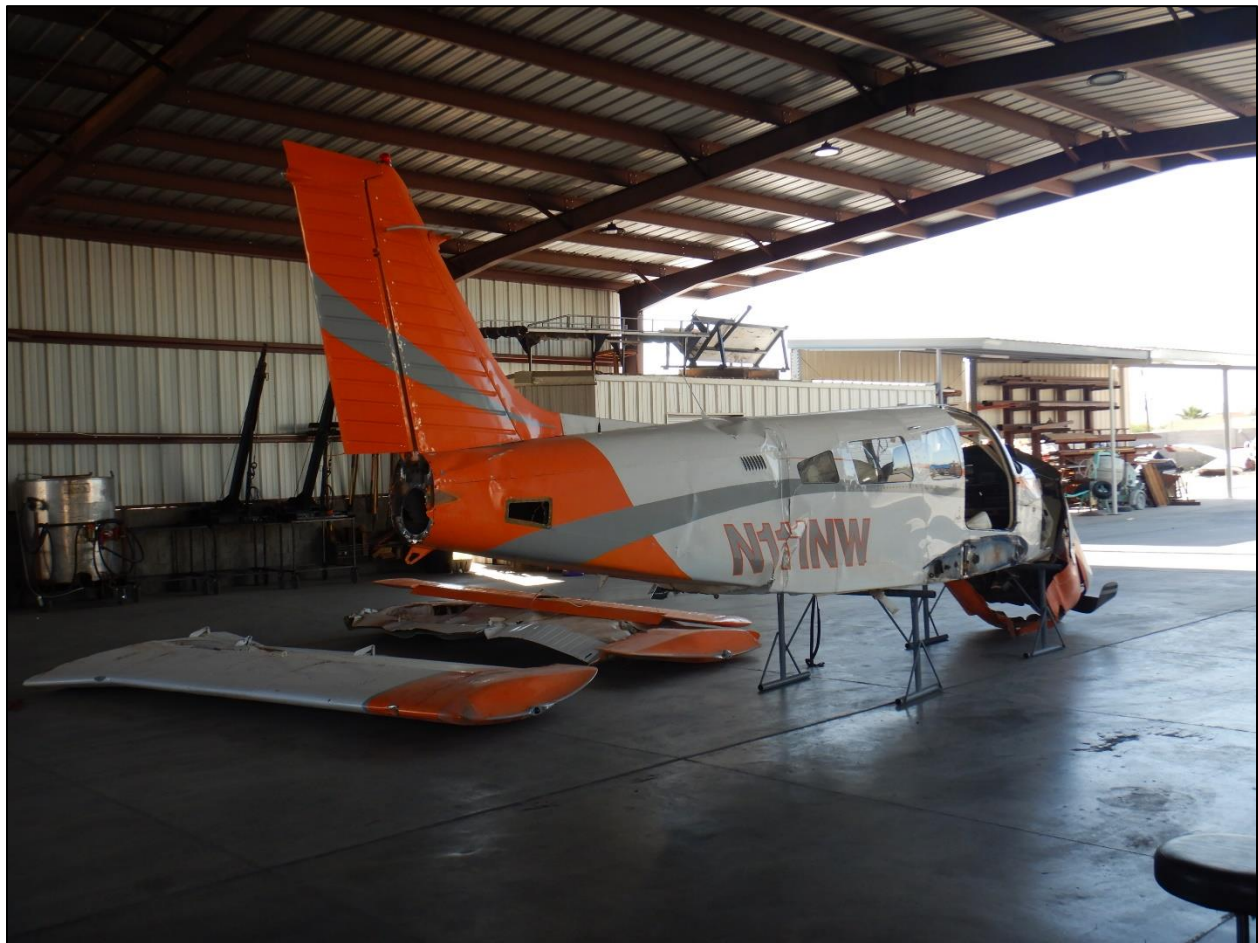
The fuselage was buckled and bent in multiple locations. The cabin area structure was buckled and the instrument panel was deformed. The instruments were undamaged and two instruments were removed for further inspection and download of internal flight data. The structure area surrounding the fuel selector handle was deformed and the fuel selector valve was undamaged and found in the right tank position. During the fuel selector valve disassembly, fuel was found in the bowl and the screen was free of contamination. The fuel selector valve tested normally. The fuel boost pump was activated and operated normally. The airframe fuel lines were tested normally with exception to the fuel line connecting the electric boost pump and the firewall which had impact damage.

All flight control cable continuity was established. The flap lever was found in the 40-degree position and flap control was established.

Figure 6-Fuselage and wings during the examination.

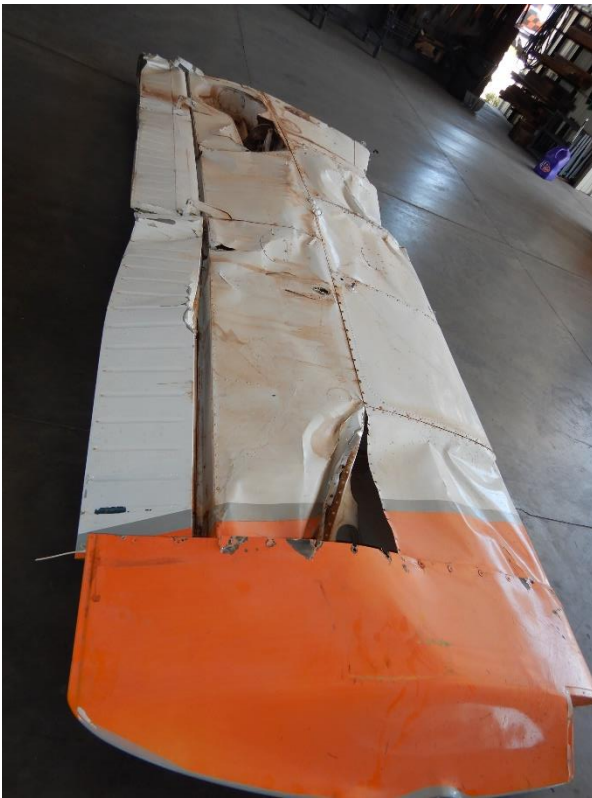
The left wing had impact damage throughout its length and the main spar fractured near the wing root area. The main landing gear separated from the wing. The left wing fuel tanks remained attached to the wing. The outboard wing fuel tank was undamaged and the fuel tank cap remained attached to the filler neck. The inboard wing fuel tank had impact damage. The fuel tank vent was tested and operated normally. No blockages were noted in the left wing tank fuel lines.

Figure 7-Left wing lower surface.

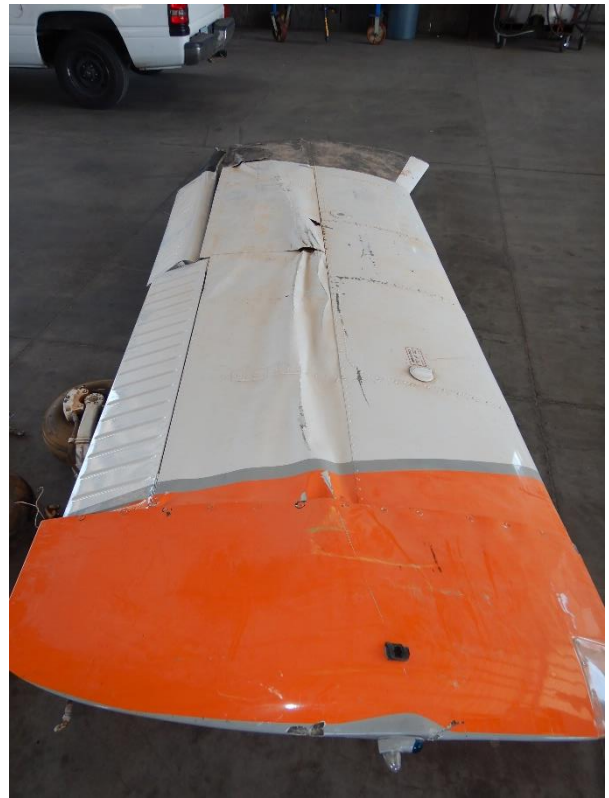
The right wing had impact damage and the main landing gear separated. The wing fuel tanks remained intact and the fuel tank cap remained attached to the filler neck. The fuel tank vent was tested and operated normally. No blockages were noted in the right wing tank fuel lines.

Figure 8-Right wing upper surface.
