## SUMMARY OF FINDINGS

**Date: May 20, 2022**  
**Person Contacted: Christopher K. French (A&P)**  
**NTSB Accident Number: WPR22LA133**

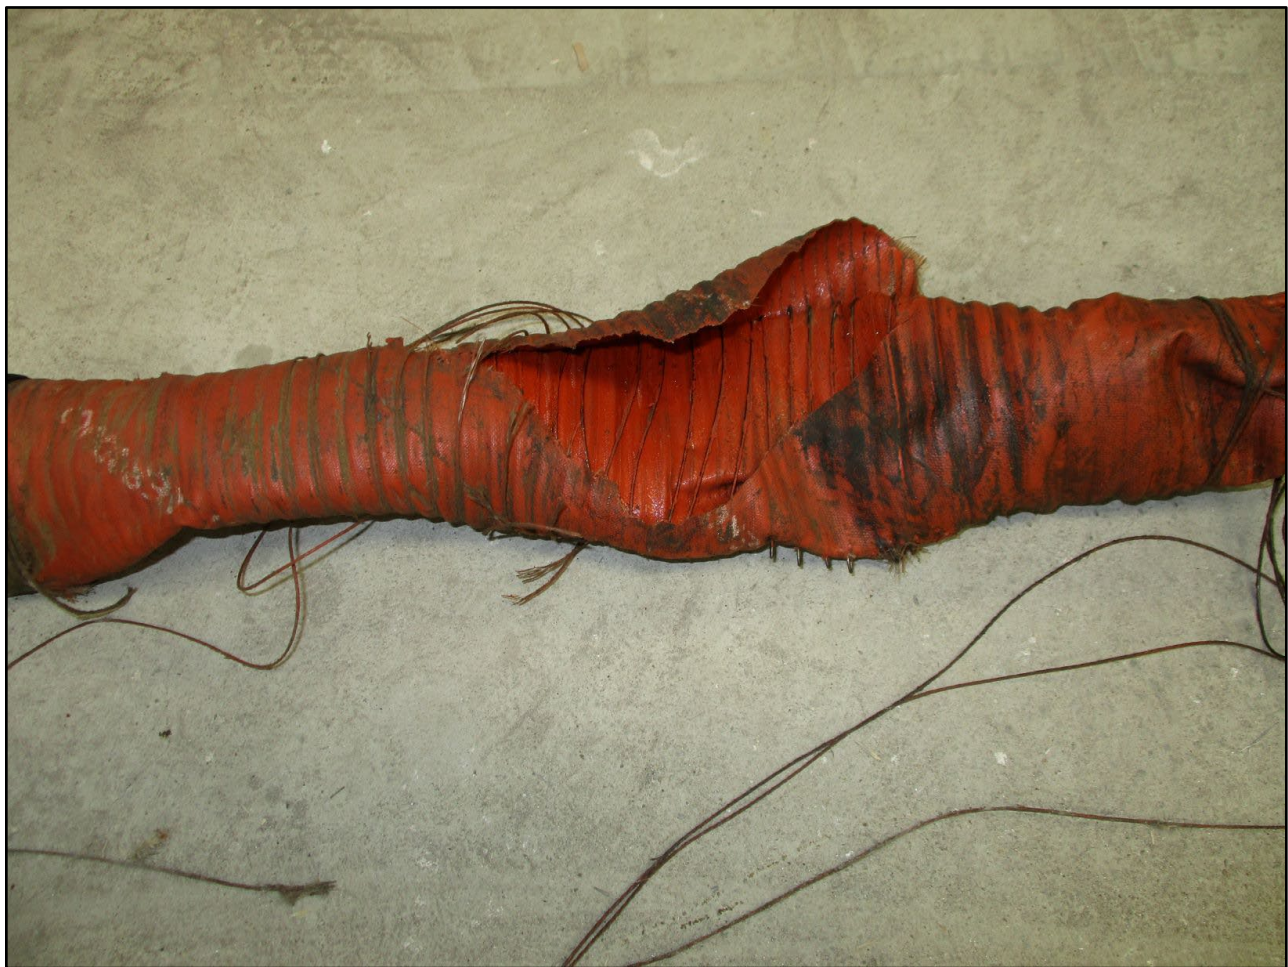
Induction: Air filter was present, and any dirt or debris could be easily attributed to the crash. Carb heat ducting was intact and appeared airworthy. The air duct between the air filter box and the carburetor was damaged significantly during the crash and pulled mostly free of the aircraft. The ducting seems to have been of the SCEET variety, approximately 2 in. diameter, with both an inner and outer silicone-impregnated cloth with wire coil sandwiched between. Careful disassembly showed significant disbonding of the inner and outer layer, but further investigation showed areas where oil and debris that did not seem to be associate with the crash were present between the disbonding. It appears the inner layer may have had some areas unsupported during a negative pressure flow, which would have been during engine operation.

*Figure 1: View induction duct (photo courtesy of A&P)*

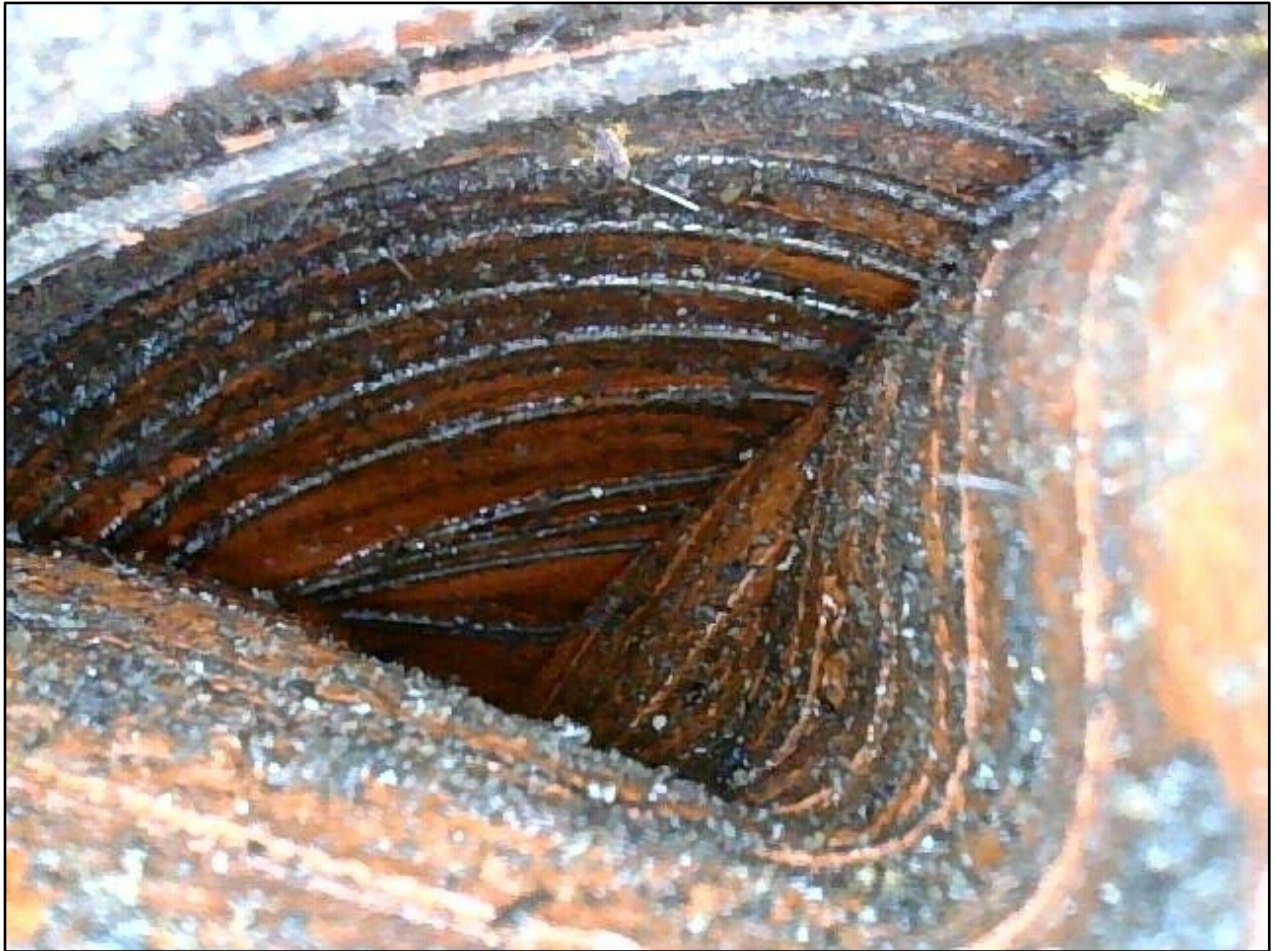
Attached are two photos: One shows the borescoped interior of a disbonded region of the SCEET induction duct, and the other shows a cylinder borescope image showing some shiny particles near the cylinder valves (suspected lead deposits).

*Figure 2: View of borescope induction duct (photo courtesy of A&P)*

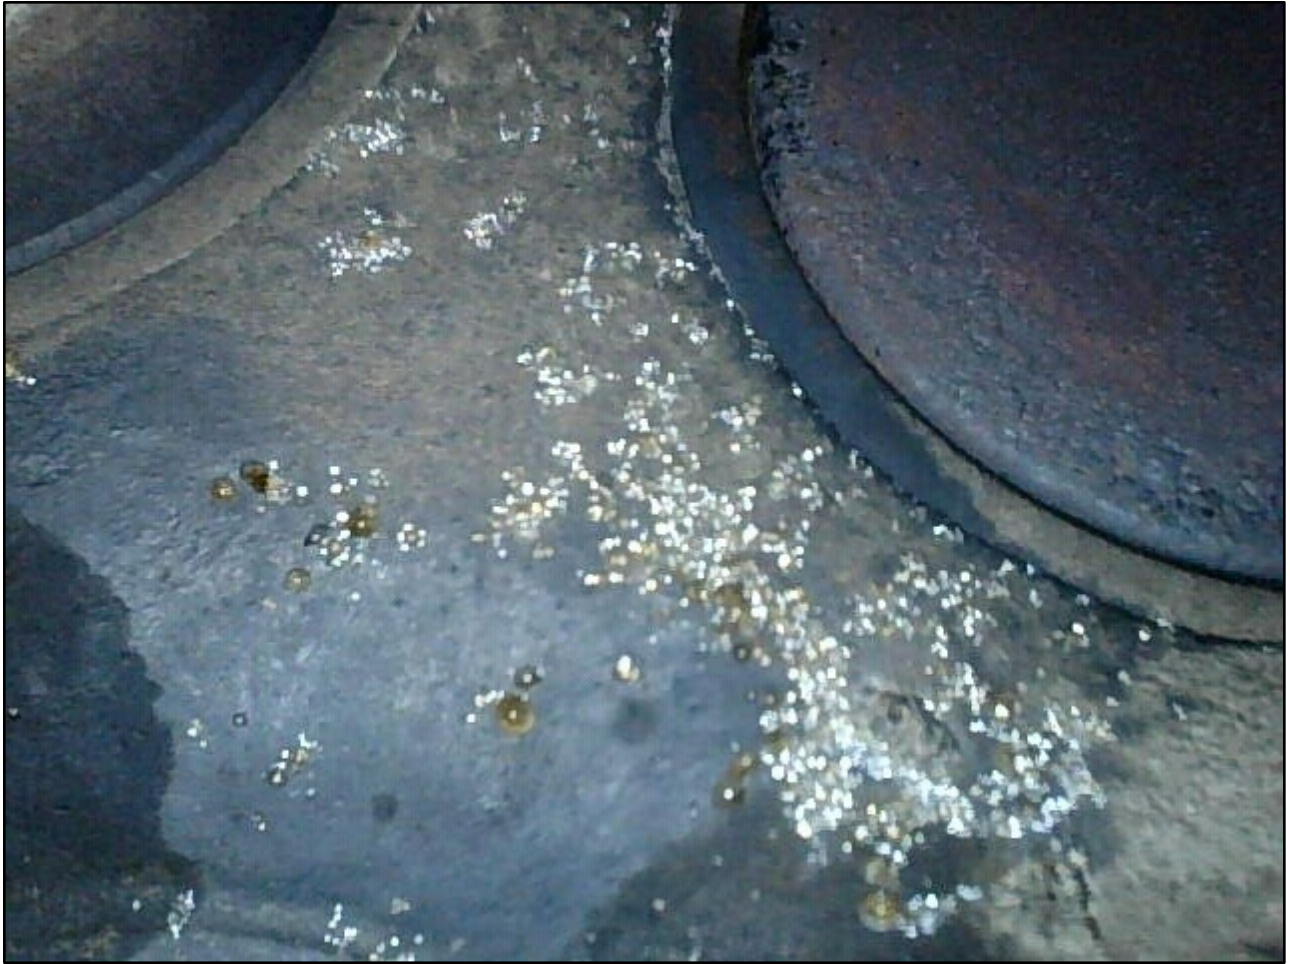
*Figure 3: View of cylinder borescope (photo curtesy of A&P)*
