## **NATIONAL TRANSPORTATION SAFETY BOARD**

# **AIRFRAME AND ENGINE EXAMINATION**

**WPR22LA138**

Location: Tucson, AZ  
Date: March 30, 2022  
Aircraft: Cozy Mark IV, N294MV  
Serial 0394  
NTSB IIC: Albert Nixon

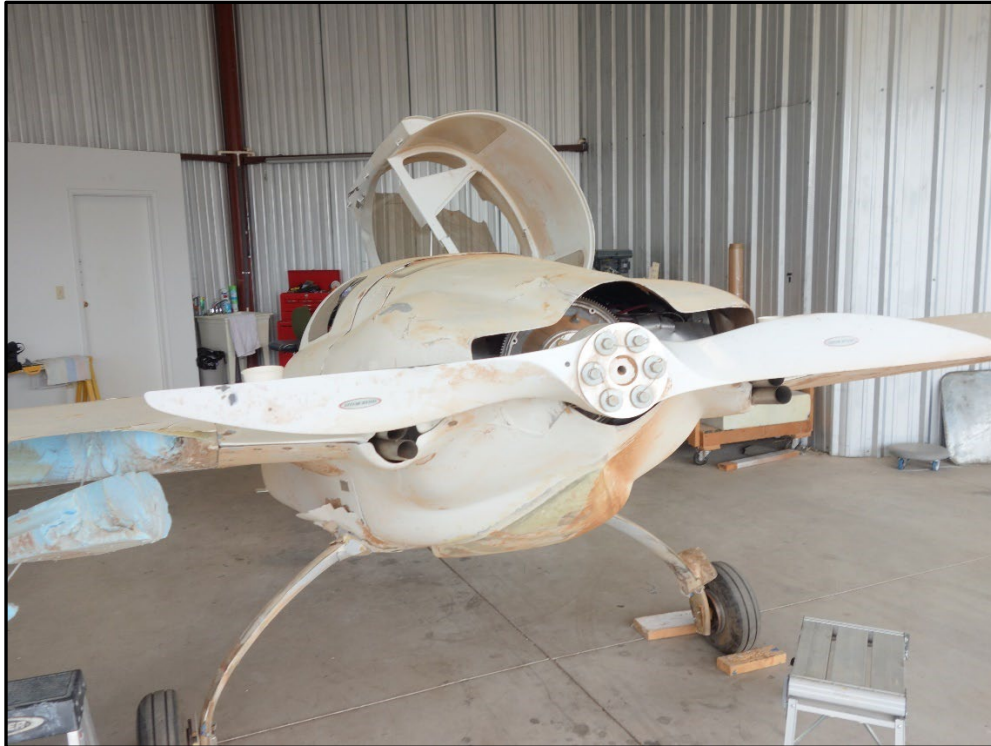
The left wing was separated about mid-span. The right winglet and rudder top portions were damaged. Both ailerons were attached.

**Figure 1: View of the airplane as viewed from the left side rear.**

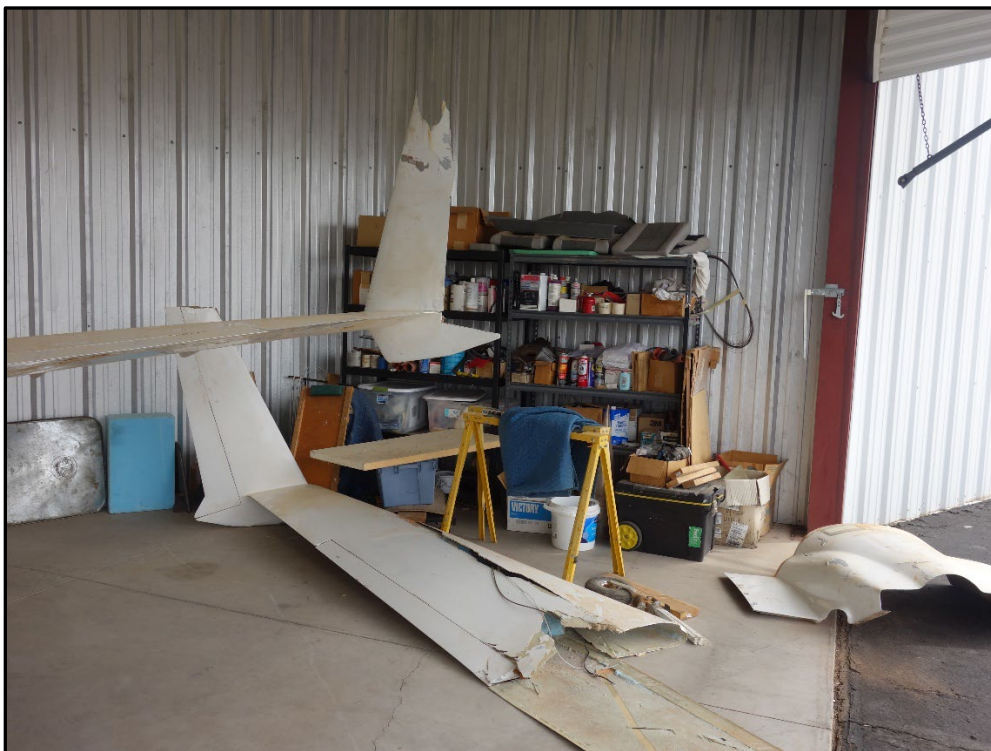
**Figure 2: View of the portion of the left wing that separated.**

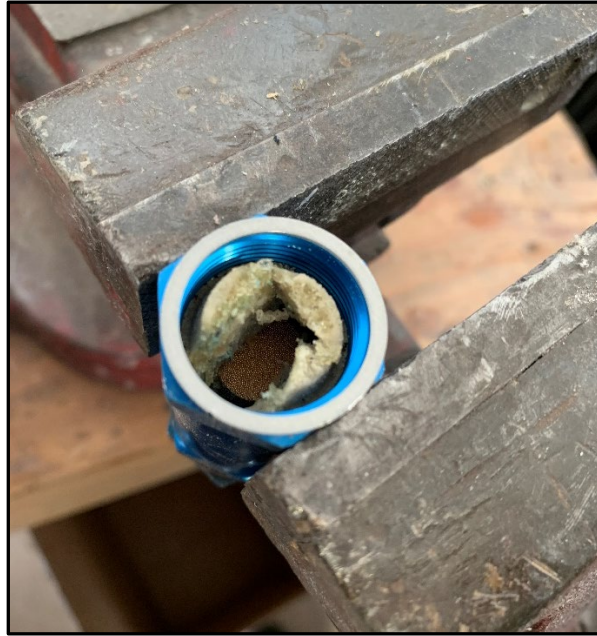
All fuel lines were secured. Examination of the right fuel line filter revealed that it was partially clogged with a grey colored material. Examination of the left fuel line filter revealed that it was clogged with the grey colored material.

Figure 3: Material that clogged and surrounded the left fuel filter.

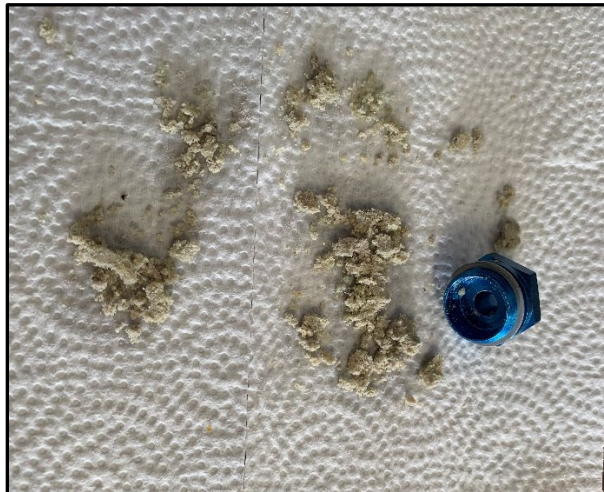
Figure 4: Material found inside the left fuel filter cover as viewed from the top.
