## INVESTIGATION SUPPLEMENTAL INFORMATION

On April 03, 2022, at 1310 Pacific daylight time, a Soneria IIL, N333BM, sustained substantial damage when it was involved in an accident near Jean, Nevada. The pilot sustained serious injuries. The airplane was operated as a Title 14 Code of Federal Regulations(CFR) Part 91 personal flight.

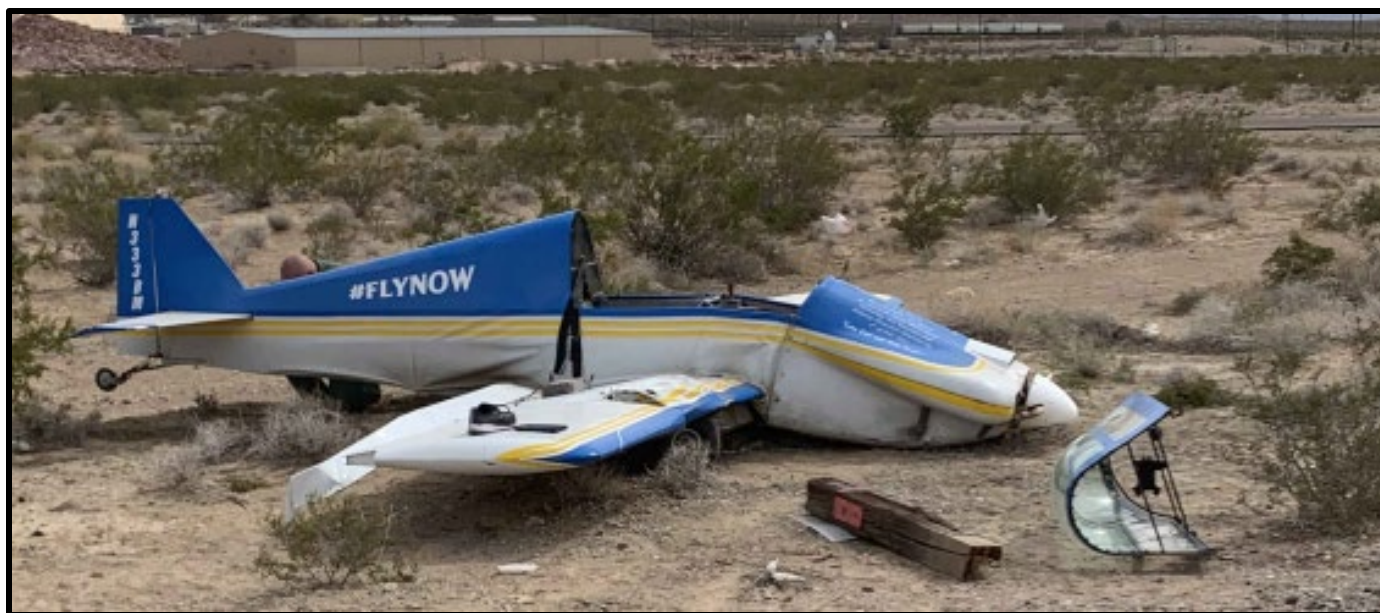
The pilot stated that he departed from Kingman, Arizona with the intention of landing at his home airport in North Las Vegas, Nevada. Prior to the flight, he added 3.8 gallons of fuel, but did not know the total amount of fuel on board at the time of departure. While en route, the pilot opted to divert to Jean, Nevada because of the gusty wind conditions in Kingman. During the flight, he noted that there were strong headwinds but thought he had adequate fuel onboard. When arriving in the proximity of Jean, the pilot made a low pass over the airport in an effort to evaluate the wind conditions. While maneuvering to land on runway 20, the engine experienced a loss of power. The pilot was unable to maintain level altitude and collided with the desert terrain about 0.5 miles north of the approach end of the runway.

The Clark County Fire Department responded to the accident site. Fire personnel stated that a visual examination of the fuel quantity indicator showed the fuel tank was empty. This was confirmed by opening the fuel cap, visually examining the inside of the tank, and then inserting a dipstick.

Figure 1: Airplane Wreckage at Accident Site (photo provided by Las Vegas Police Department)

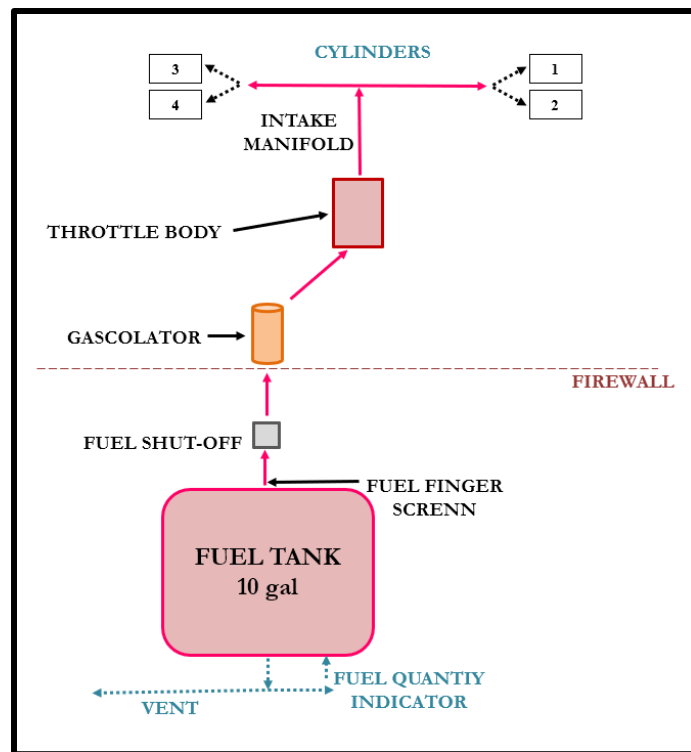
Figure 2: Fuel System Diagram

The airplane's fuel system was a gravity-fed design where fuel flowed from an aluminum 10-gallon tank mounted in front of the instrument panel. Inside the tank there was a finger screen at the outlet and at the top of the tank was a vent output port. The port connected to a T-fitting where one clear plastic tube was routed to the instrument panel and back to the bottom of the tank. On the tube there was a series of different colored tie-raps that served a fuel quantity indicator for the pilot. The other tube on the T-fitting was routed to the bottom of the airplane and functioned as a vent. From the fuel tanks, the fuel was routed to a fuel shutoff valve and then through several fittings through the firewall to a gascolator (mounted on the engine-side of the firewall). The fuel would then continue to a fuel injector unit, an AeroInjector 35, where it was routed from the inlet through an orifice to the air inlet. From the inlet, the fuel-air mixture continued into the intake manifold and into each cylinder. A majority of the fuel pipe fittings had Teflon tape on the threads.

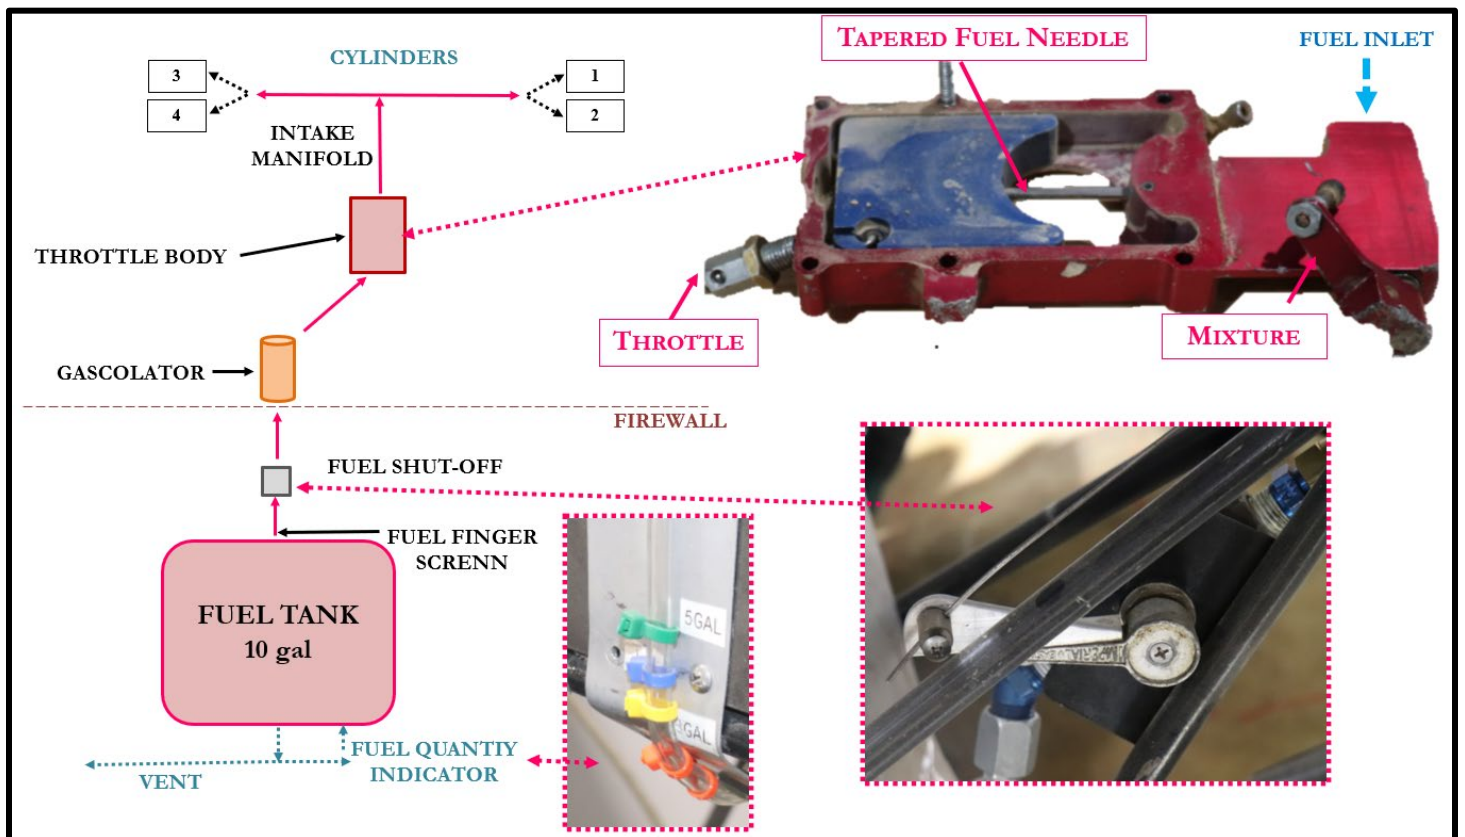
Figure 3: Fuel System (as found)

A post-accident examination revealed that there was no fuel onboard the airplane. The entire system remained unbreached except where the gascolator drain was compromised (pushed upward in the open position). The gascolator was clean and no debris was in the screen. The fuel throttle body was impact damaged and there was debris inside the slide cavity. The tapered fuel needle remained in the fuel orifice and the throttle slide was in a

**Important. Never use teflon tape on any fuel system connections as it may block fuel flow.**

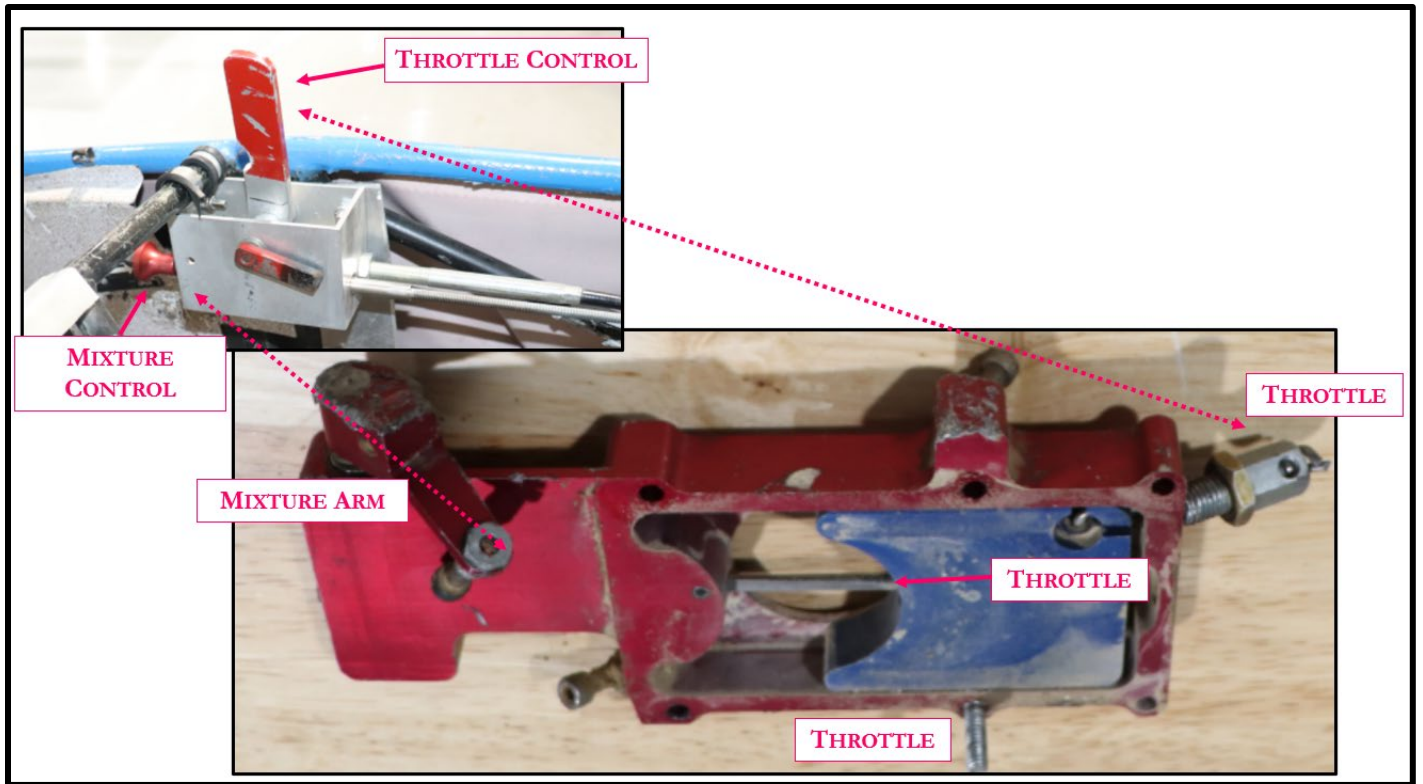
*Figure 4: Throttle Body*

partially open position, consistent with near full throttle. The air filter was not located and presumed to be left at the accident site.

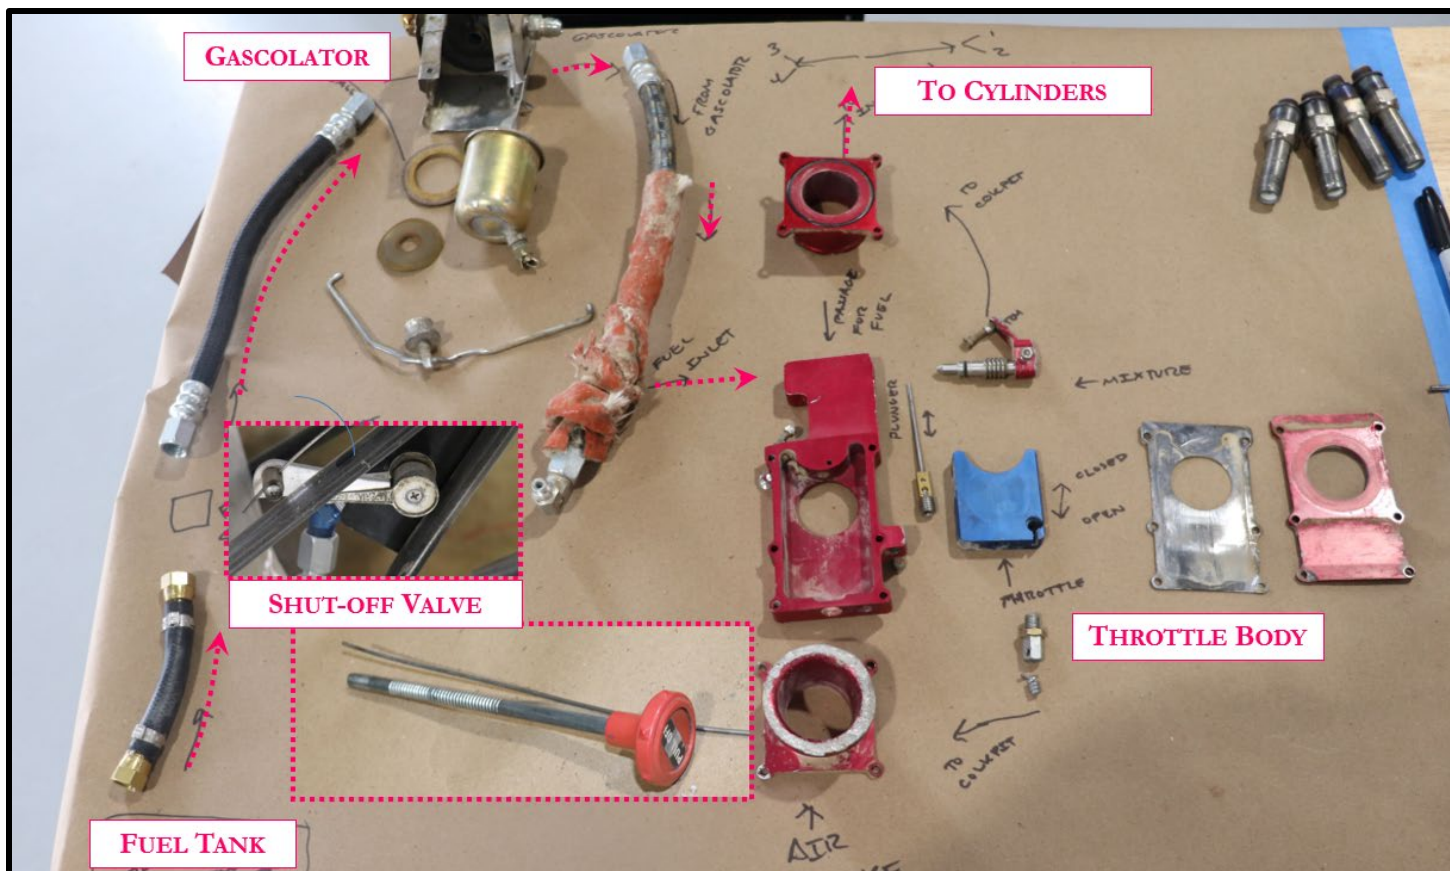
The fuel shutoff valve was in between the off and on position. Investigators applied air pressure to the inlet which resulted in air pressure to partially escape to the outlet. The push-pull control to the valve was disconnected from its respective cable. It could not be confirmed if the damage to the control or position of the valve was changed during impact because fuselage structure was bent and compromised the cable.

Figure 5: Fuel System Examination (showing fuel shut-off handle disconnected)

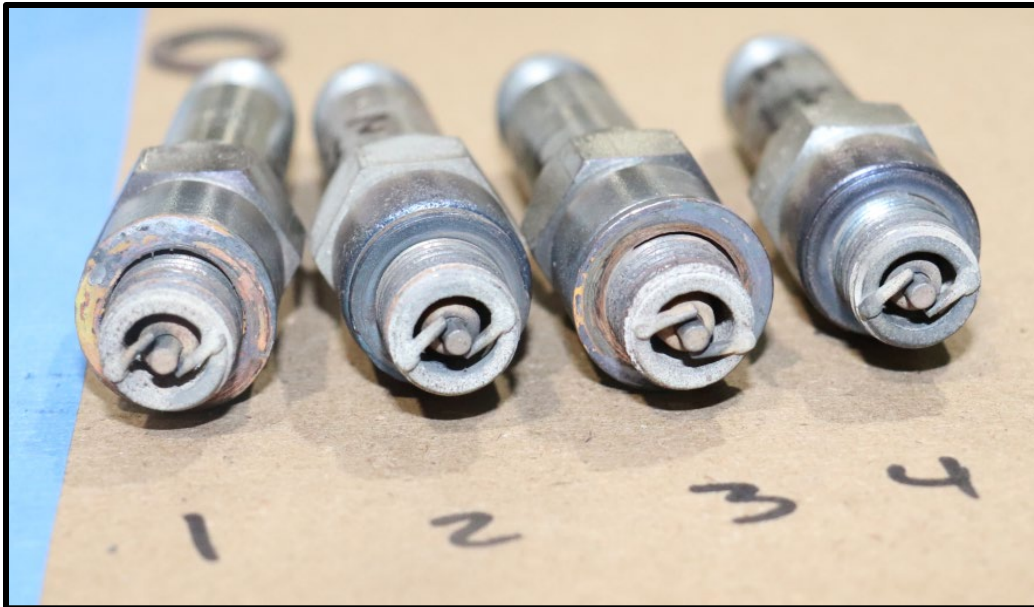
*Figure 6: Spark Plugs*

During a post-accident examination, investigators achieved manual rotation of the crankshaft by rotation of the remaining propeller blades. Valve train continuity was observed, with equal lift action at each rocker assembly; oil was found in the rocker box areas on all cylinders. Investigators removed the upper spark plugs of all cylinders; they were light gray/white in color, consistent to lean to normal engine operation. A borescope examination of the cylinders revealed no foreign object damage, no evidence of detonation, and no indication of excessive oil consumption. The exhaust manifold pipes should white residue consistent with a lean mixture. The magneto timing was consistent with normal operation.

The upper spark plugs were reattached to their respective lead and rotation of the crankshaft resulted in a visible spark at each plug; the impulse coupling was audible during rotations.
