# National Transportation Safety Board

WPR22LA163

## **MATERIALS LABORATORY**

Factual Report 22-086

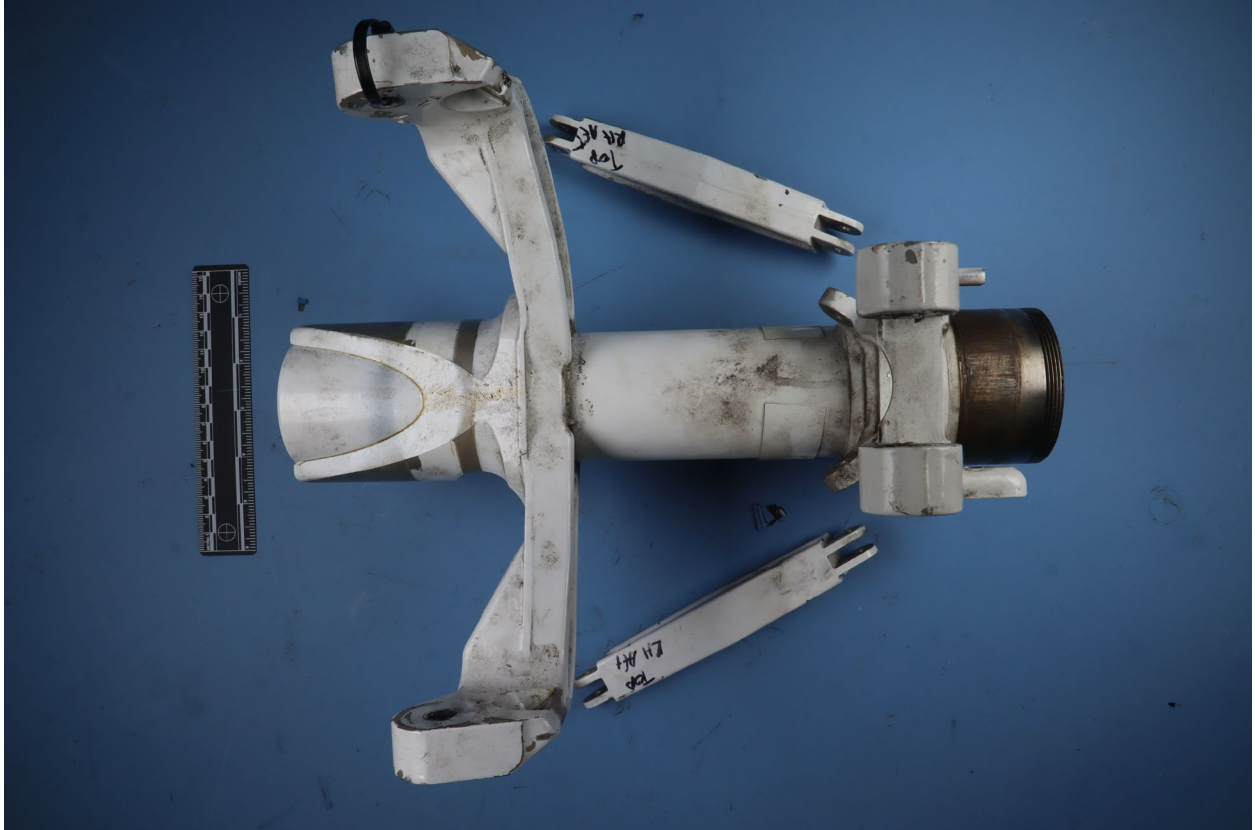
Nosewheel landing gear trunnion (Figure 1)

**Figure 1.** Upper nose gear shock strut with upper and lower trunnions and braces as received.

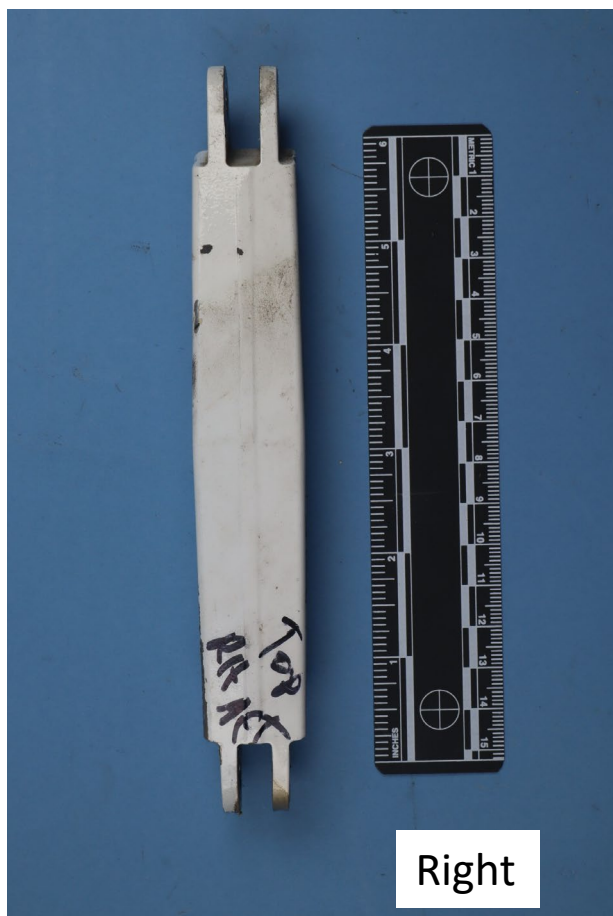
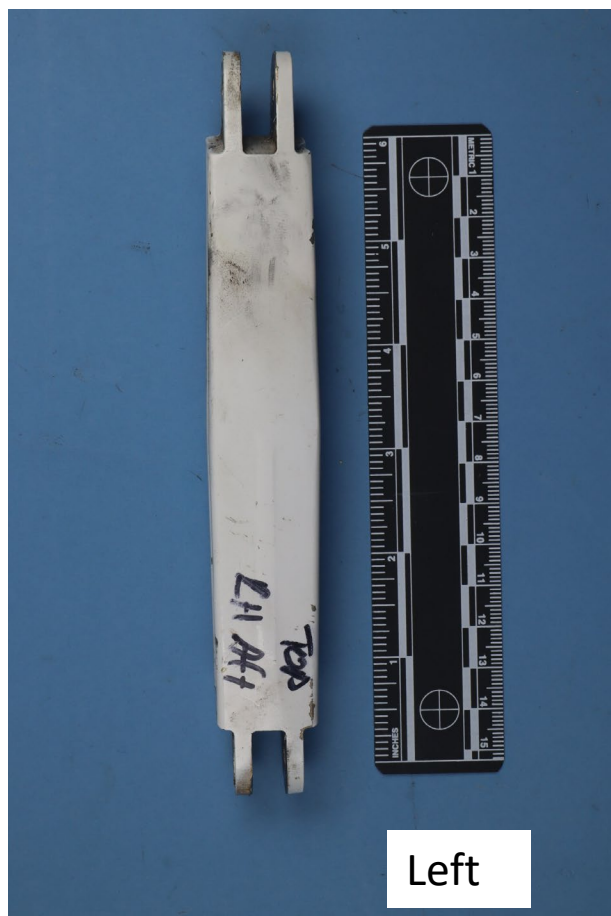
The upper portion of the nose gear shock strut containing the upper and lower trunnions was examined. The braces that link the upper trunnion to the lower trunnion were disconnected and included with their connecting hardware for the examination. Both the left-hand and right-hand braces (Figure 2) did not exhibit any anomalies or signs of deformation. The connecting hardware for these braces was not marked to identify which side the hardware belonged to. Two bolts (Figure 3) exhibited signs of gross plastic deformation consistent with shear overload. The other two bolts exhibited a slight bend (Figure 4).

**Figure 2.** Left and right braces.

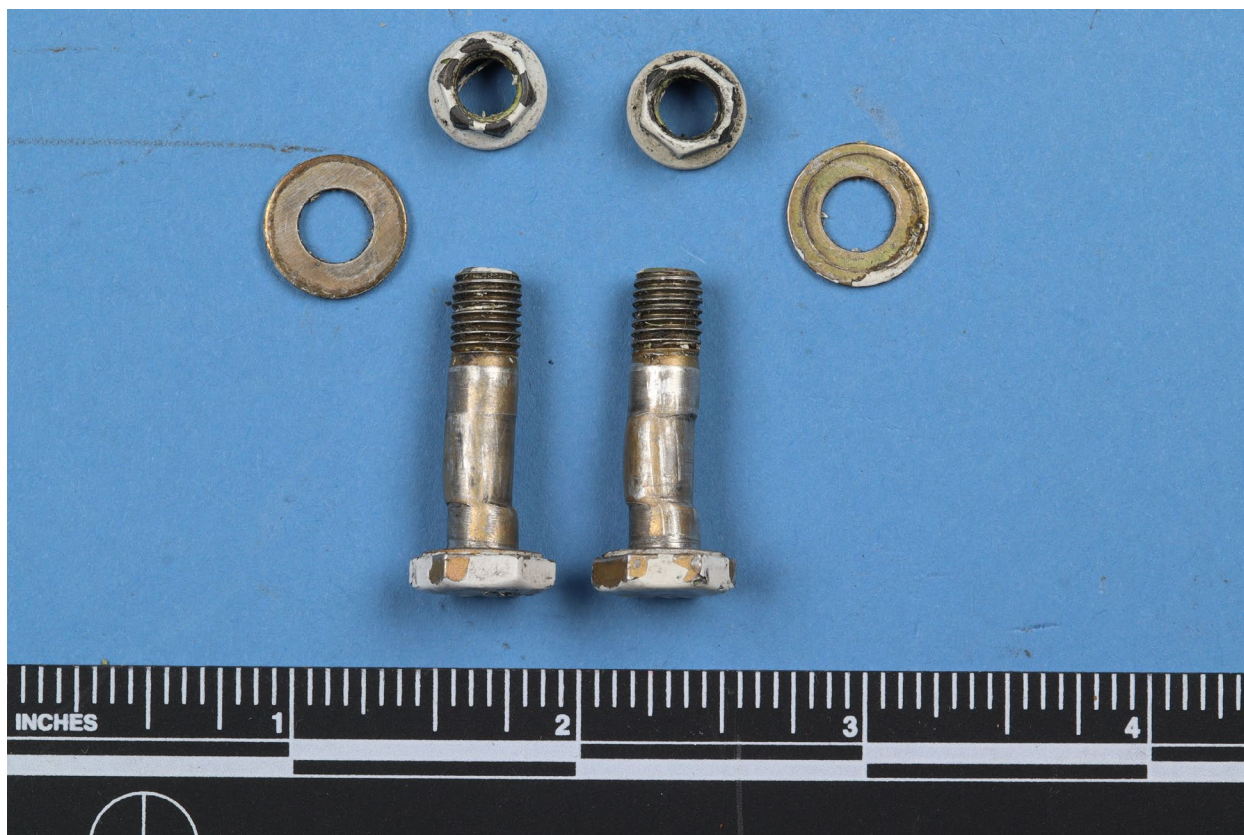
**Figure 3.** Brace attachment hardware exhibiting gross plastic deformation.

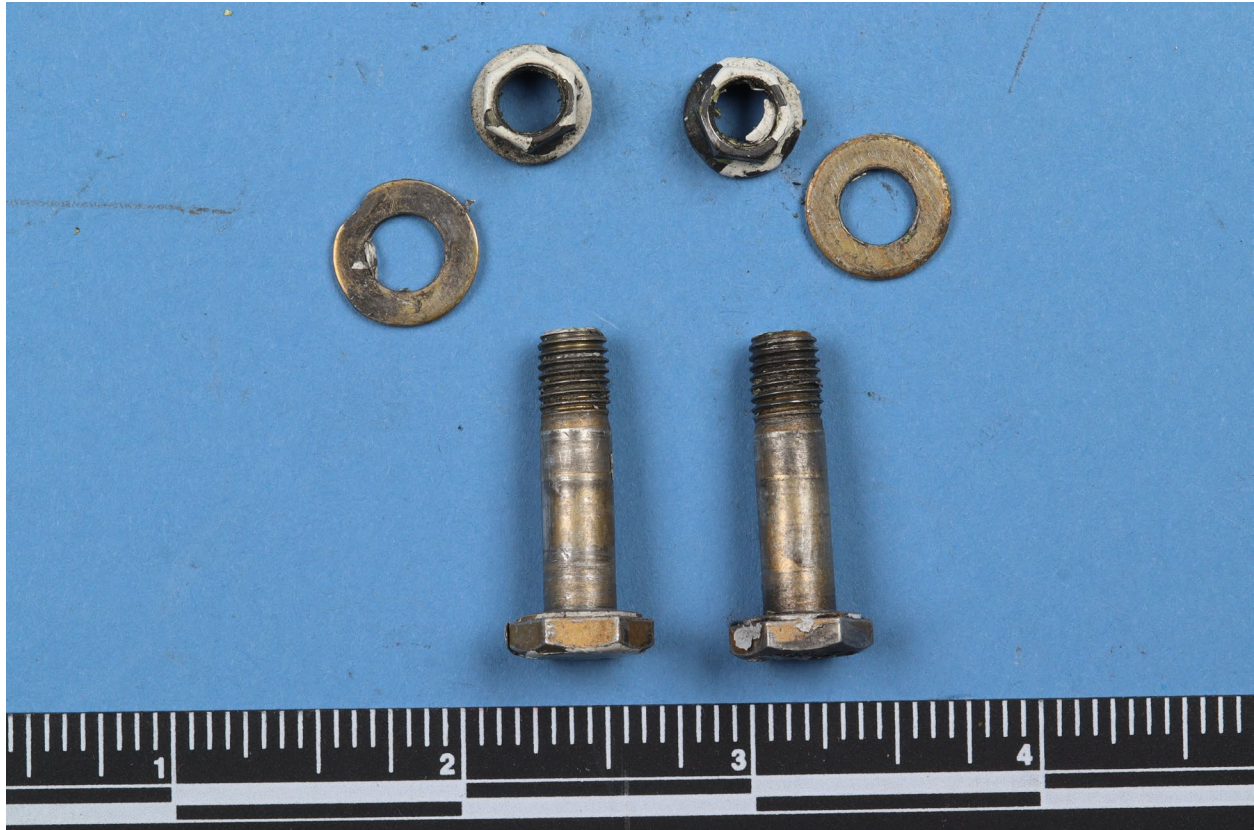
**Figure 4.** Brace attachment hardware exhibiting a slight bend.

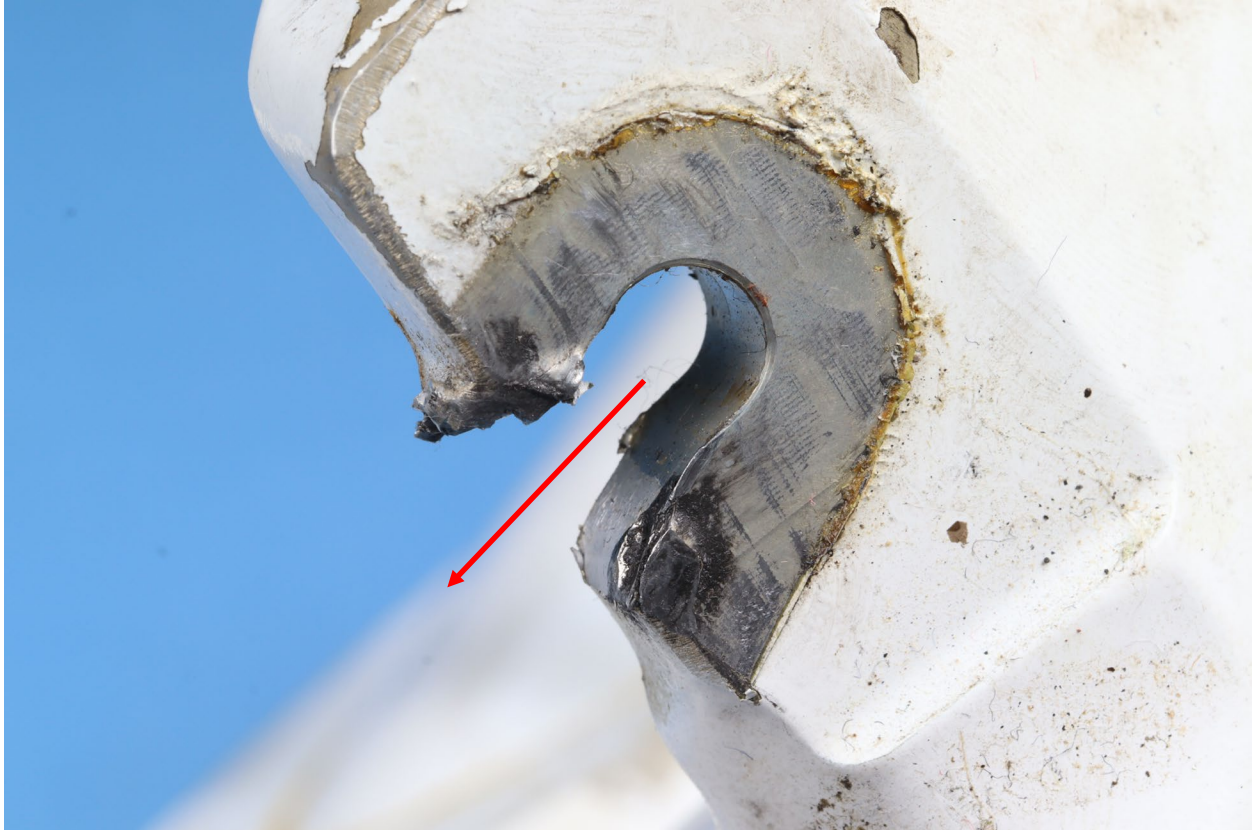
The upper trunnion exhibited a damaged bolt hole where the right brace would be attached (Figure 5). The damage consisted of deformation and missing material consistent with shear tear out of the attachment bolt in a direction coincident with the long dimension of the brace. The fracture surface was smeared and did not yield any fractographic information. The deformation of the material was consistent with an overstress fracture.

**Figure 5.** Tear out of bolt hole. Red arrow depicts direction of force.

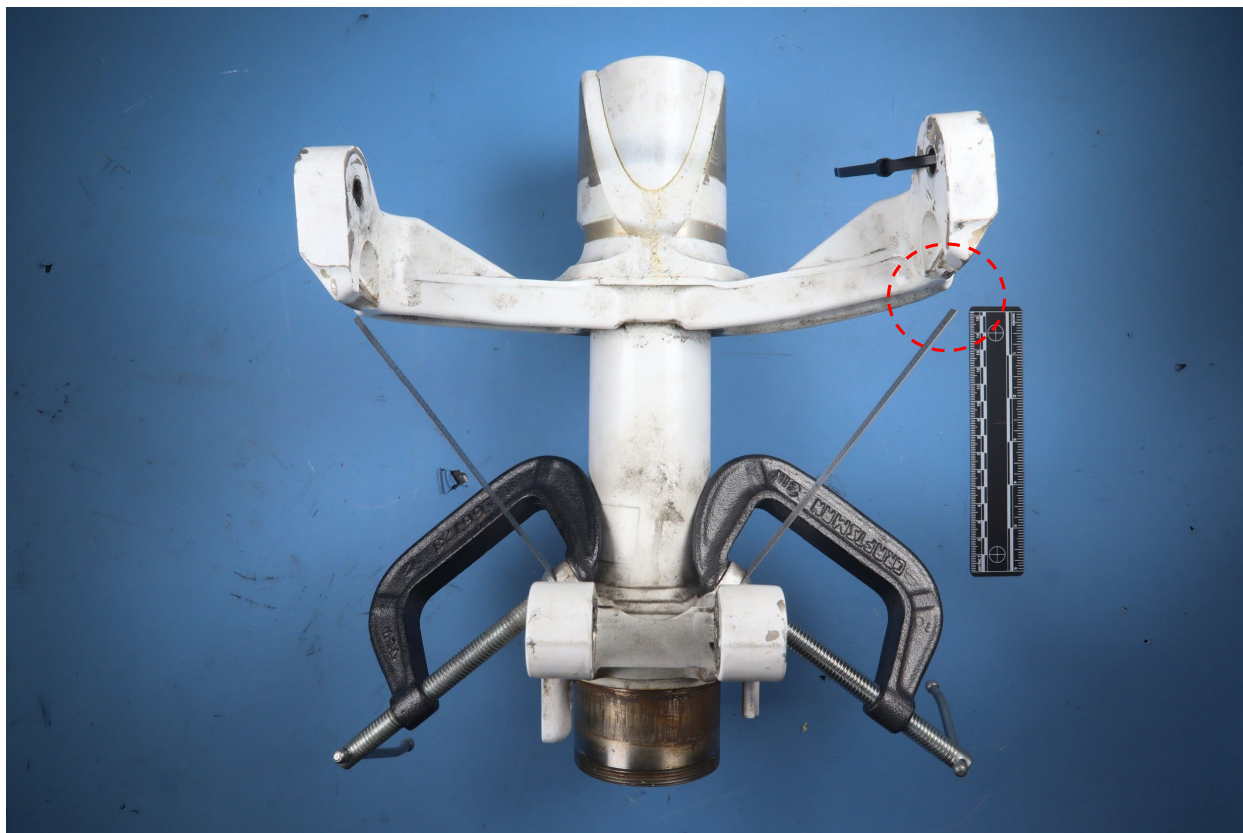
Straight edge scales clamped to the lower trunnion at the brace attachment points revealed plastic deformation of the upper trunnion (Figure 6). The upper portion of the nose gear shock strut was scanned using a Keyence VL 3D scanner to perform alignment and distance measurements between the upper and lower trunnion brace attachment points. The measurements revealed that the angle between the planes of the brace attachment points of the left-hand side was approximately 178 degrees while the angle between the planes of the attachment points of the right-hand side was approximately 173 degrees (Figure 7). The

**Figure 6.** Deformation of upper trunnion.

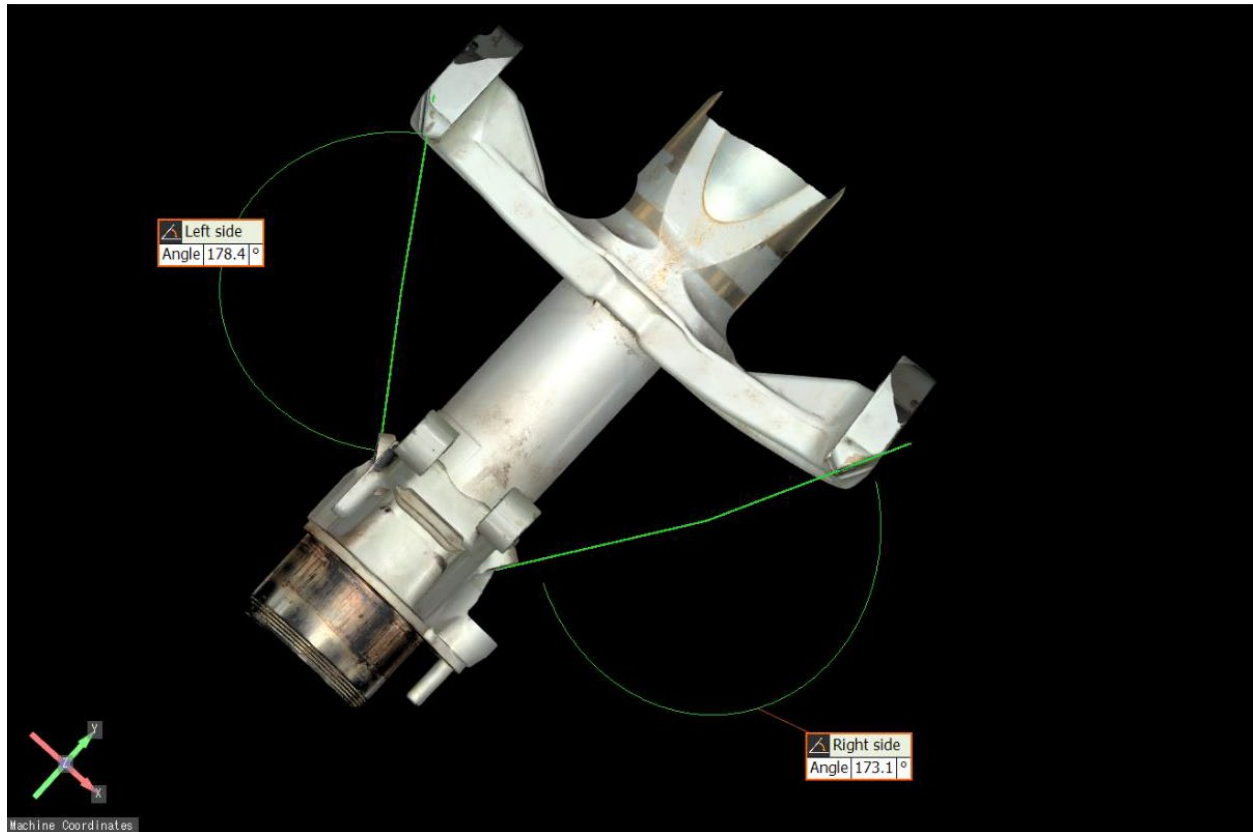
**Figure 7.** Angle between the planes of the brace attachment points.

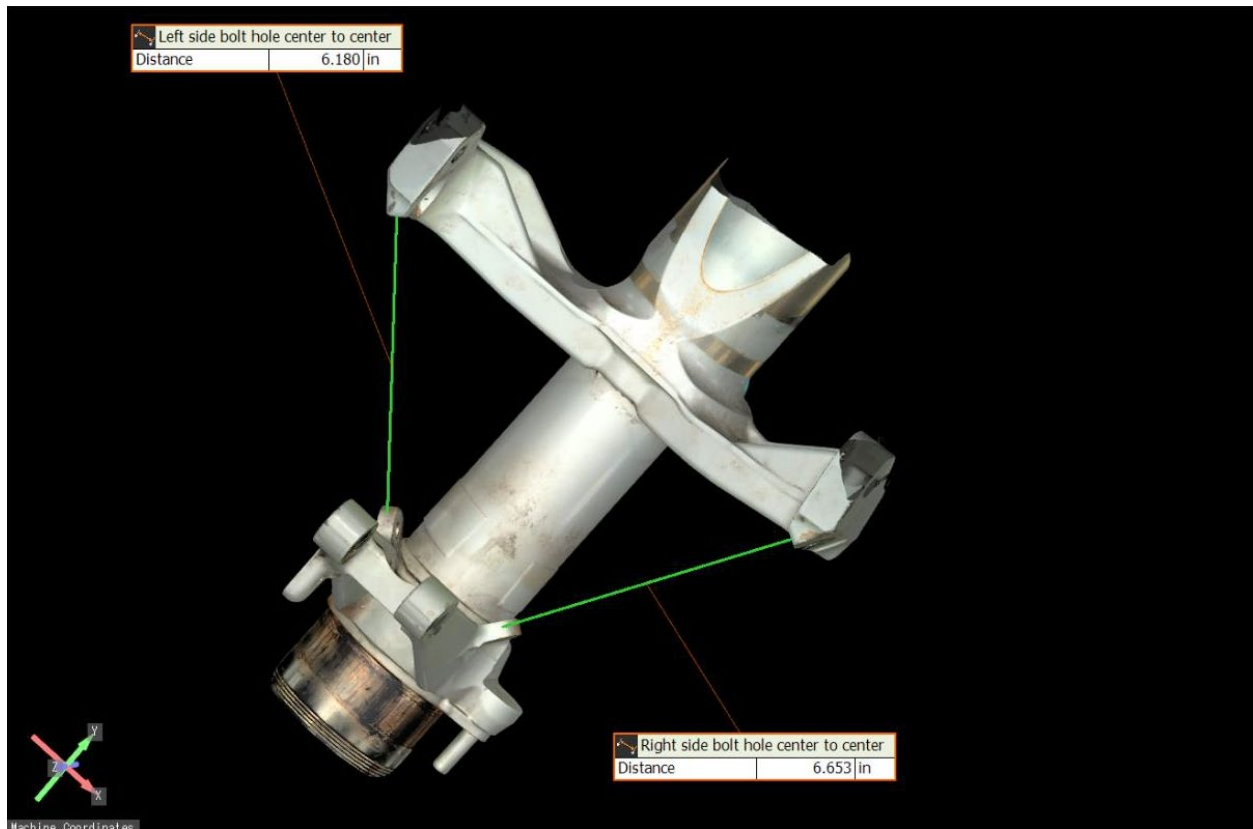
measurements also revealed that the distance between the bolt hole centers for the left-hand brace attachment points was approximately 6.2 inches while the center-to-center bolt hole distances for the right-hand brace attachment points was approximately 6.5 inches (Figure 8). This deformation to the upper trunnion is consistent with bending overstress.

**Figure 8.** Distance between bolt hole centers.
