# National Transportation Safety Board

WPR22LA166

## **POST-ACCIDENT ENGINE EXAMINATION SUMMARY**

Location: Ravensdale, Washington  
Date: April 23, 2022  
Time: 1820 Pacific daylight time  
0120 coordinated universal time  
Airplane: N4398B Cessna 170B

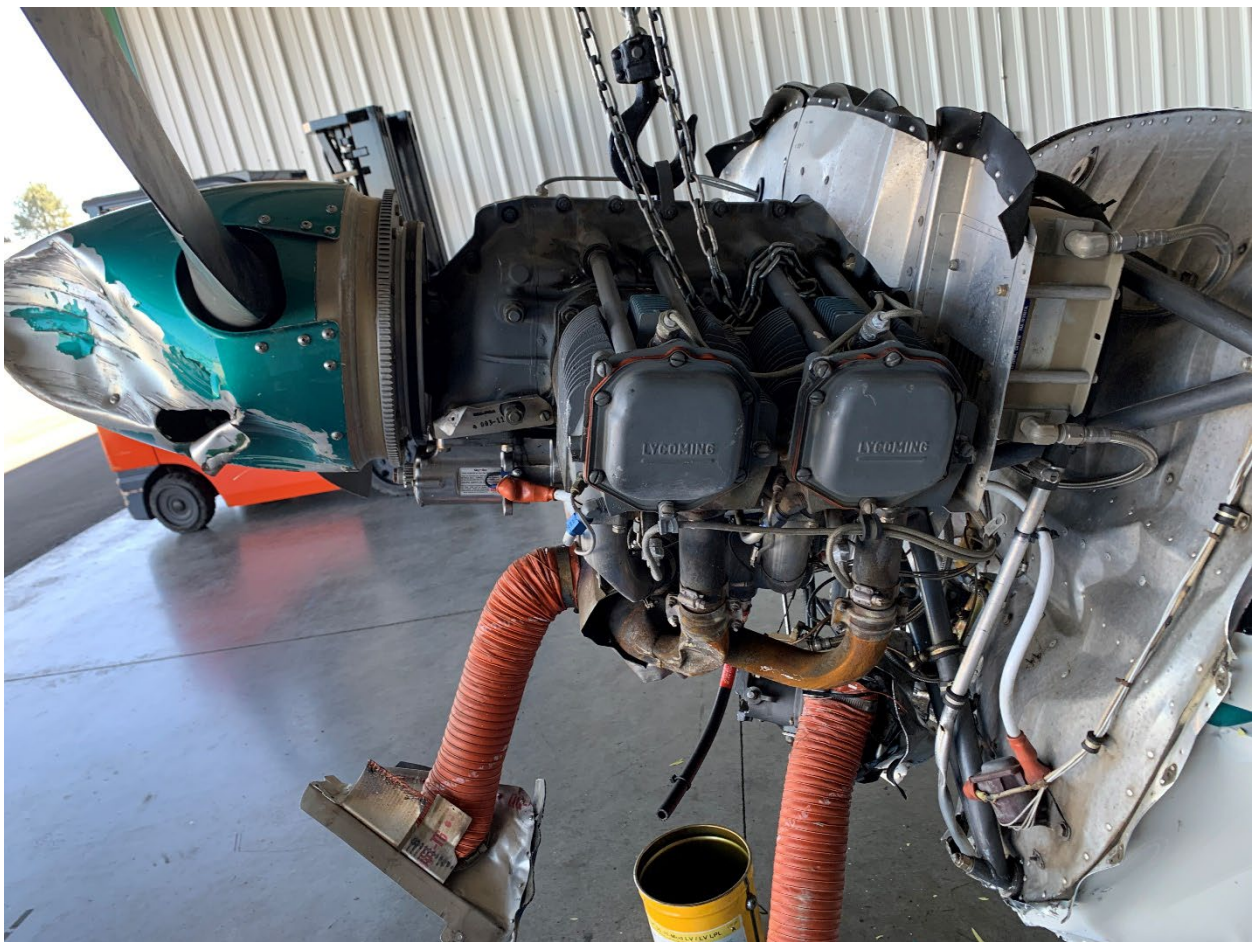
**Figure 1. View of accident engine**

The airplane was equipped with a Lycoming O-360-A1A (figure 1), engine serial no. RL-34474-36E. The engine examination took place on August 17, 2022 at Avtech Services, LLC.

The engine remained attached to its engine mounts, which were connected to the engine firewall. All four cylinders and the accessories and accessory case were unremarkable. The intake and exhaust tubes sustained impact damage. The engine oil case remained intact and secured and had 6 quarts of oil.

The rocker box covers were removed. The intake and exhaust rocker arms were intact, and oil coated residue was seen in all cylinders. All intake and exhaust valve springs were in place and visually appeared to be undamaged. The upper spark plugs were removed, and the examination of the cylinders combustion chamber interior components using a lighted borescope revealed normal piston face and valve signatures, and no indications of catastrophic engine failure. A normal amount of combustion deposits was observed within the combustion dome of each cylinder and piston face. All of the intake and exhaust valves were unremarkable.

Mechanical continuity was established throughout the rotating group, valve train and accessory section as the crankshaft was manually rotated at the propeller by hand. Thumb compression was achieved at all four cylinders and the valves displayed normal lift when the crankshaft was rotated. The magneto to engine timing was 25° before top dead center cylinder number one for both the right and left magneto. The top engine spark plugs were removed from the engine, and they were the massive electrode type. The sparkplugs exhibited black deposits within the electrode area. All of spark plugs exhibited signatures consistent with NORMAL when compared to the Champion Check-A-Plug comparison chart.

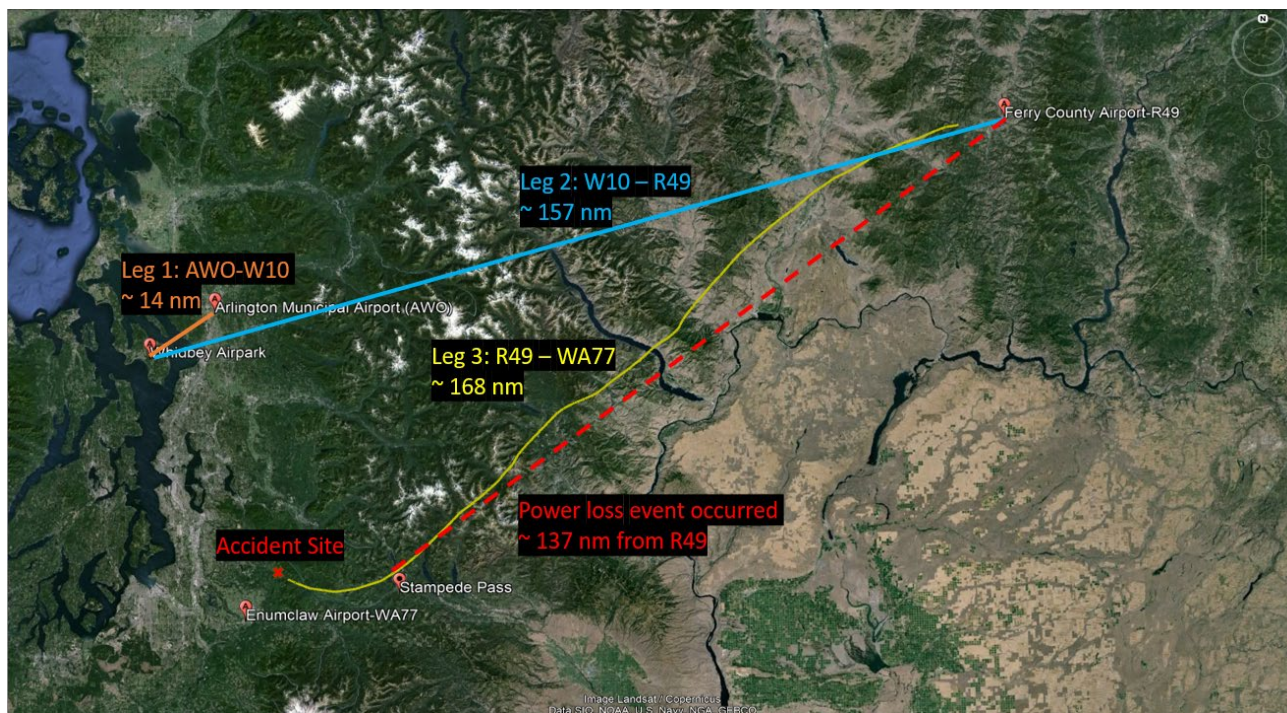
**Figure 2. Google Earth map depicting flight route of accident airplane.**

Each leg was calculated using direct course headings (figure 2). The pilot reported that he fueled the airplane with about 34-36 gallons and believed that he had about 3 hours of flight time, as the engine burned about 12 gallons of 100 LL per hour. The accident airplane was equipped with 2-20 gallon wing fuel tanks.

8 knots. After the passenger was picked up, the same station reported winds at 9,000 ft msl were 240° at 7 knots. At the time of departure from R49, the winds aloft reported winds were 230° at 7 knots. The fuel calculations revealed that at the time of the engine power loss event, the airplane was flying for a total of about 2.8 hours and would have consumed about 42 gallons of fuel. The pilot was requested to provide his fuel calculations, but it was not provided to the investigator. The accident airplane was not refueled at R49.
