WPR22LA166

## INVESTIGATION PHOTOGRAPHS

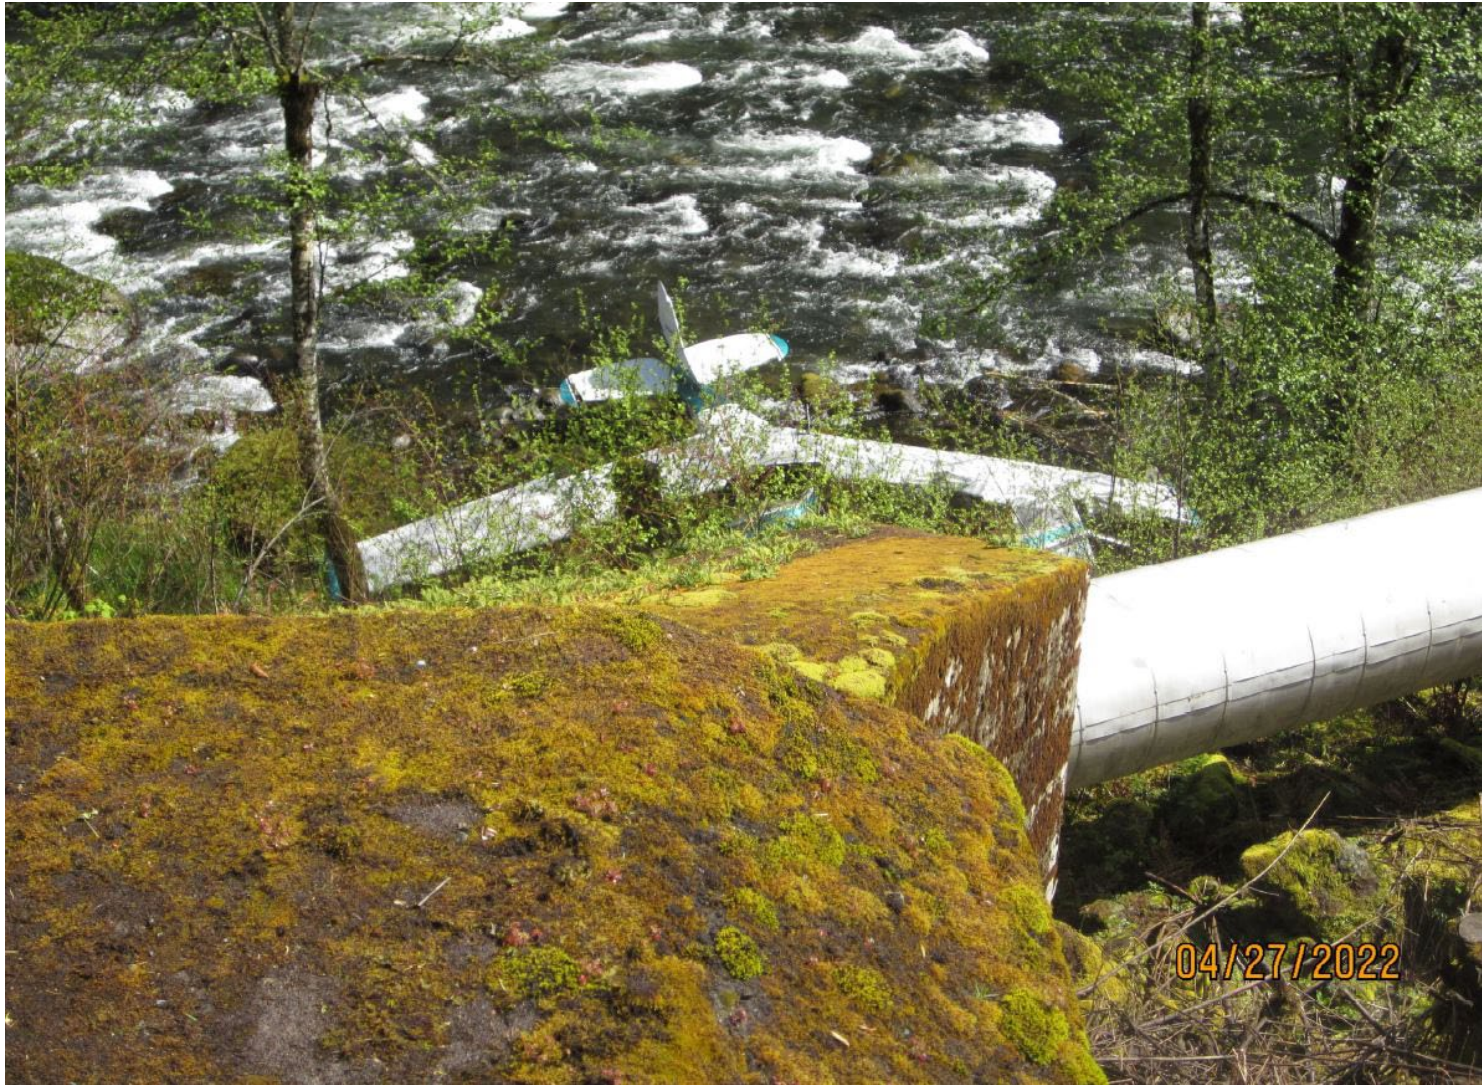
**Photograph 1 - Accident airplane upright in riverbank (Courtesy of recovery company)**

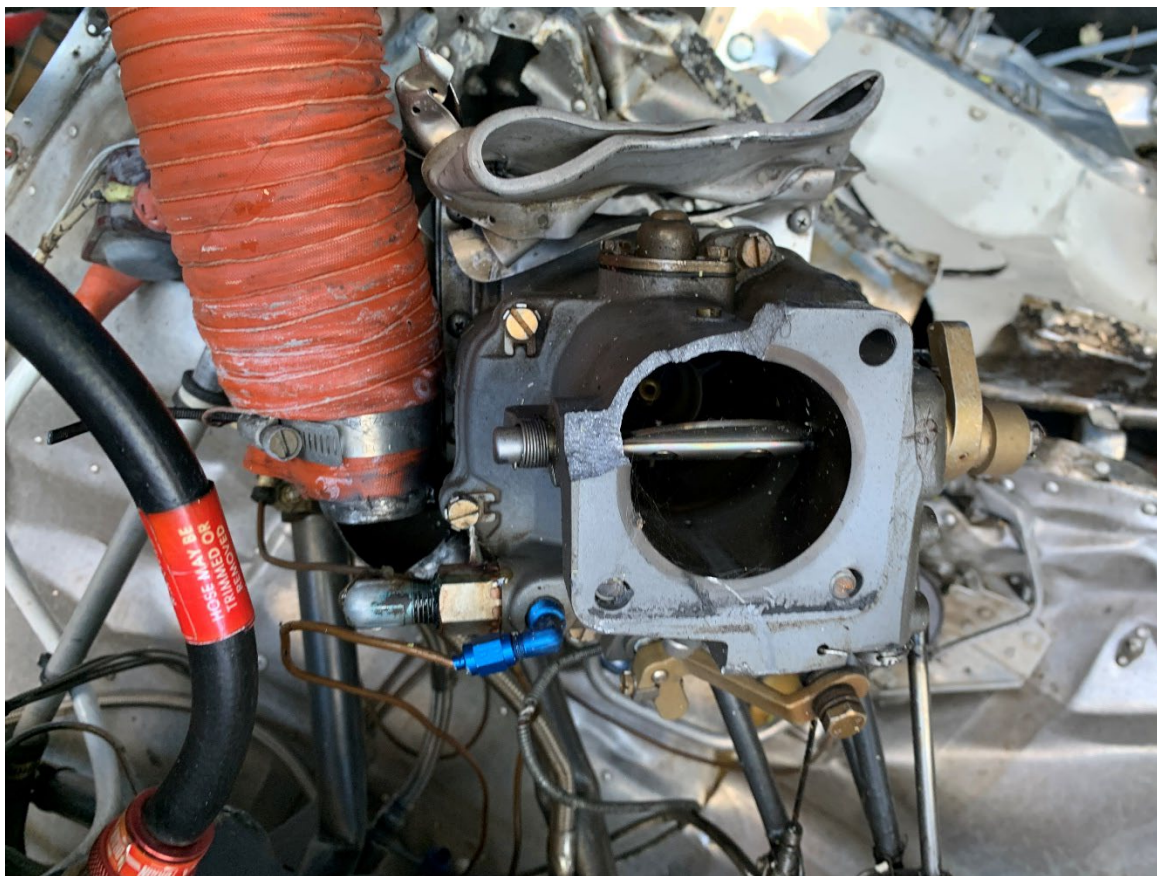
**Photograph 3 - View of separated carburetor from impact damage**

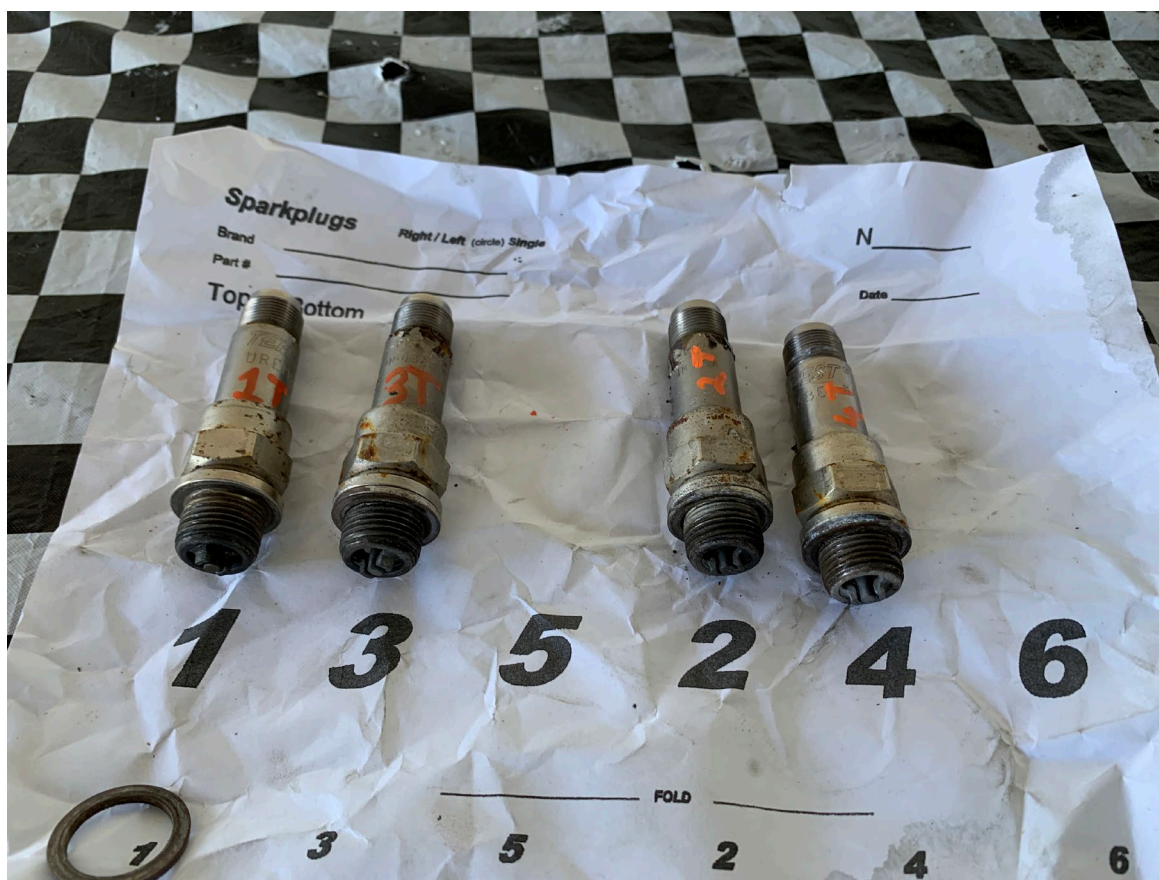
**Photograph 4 - View of removed top spark plugs**

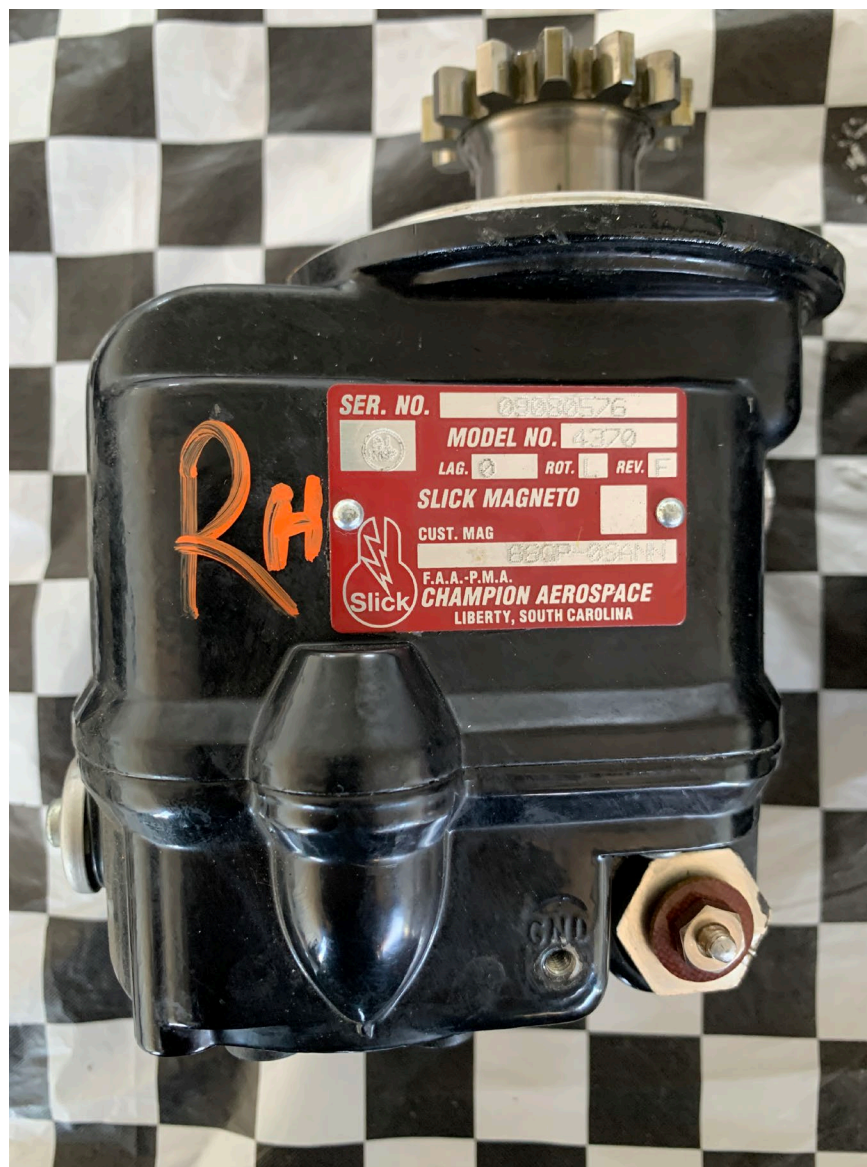
**Photograph 5 - View of removed right hand magneto**

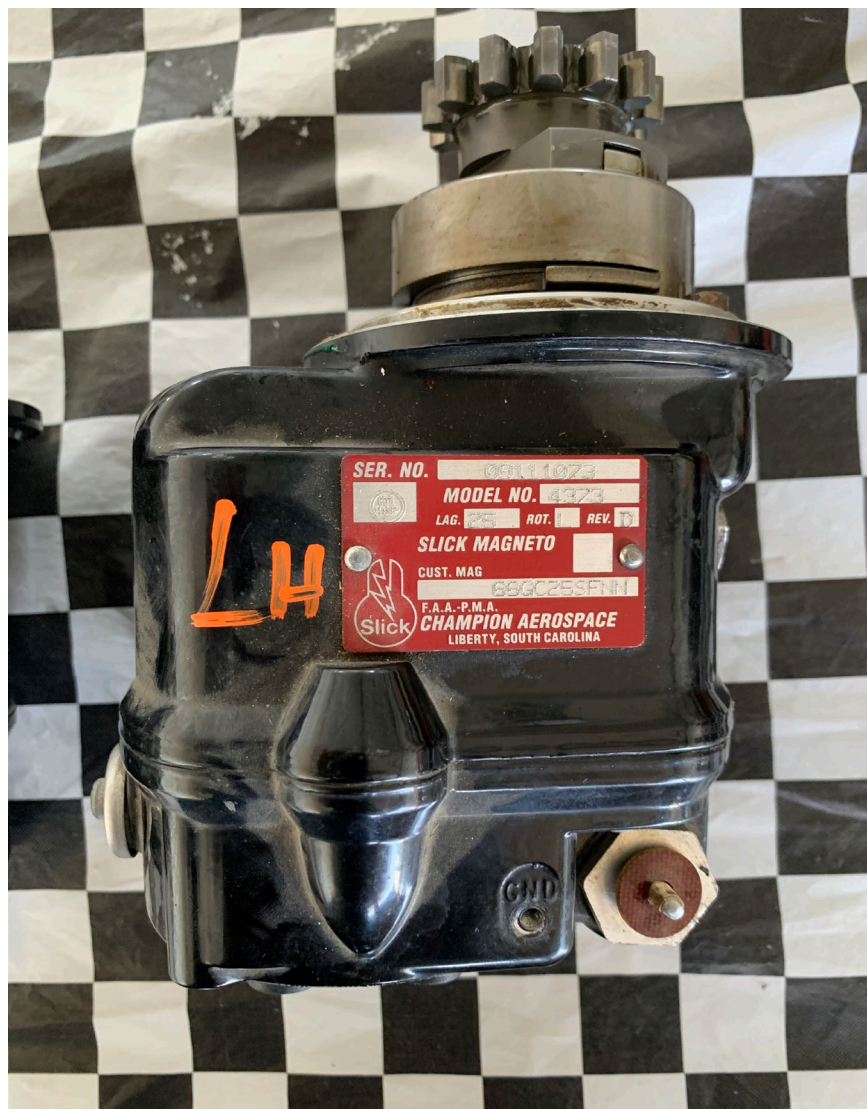
**Photograph 6 - View of removed left hand magneto**
