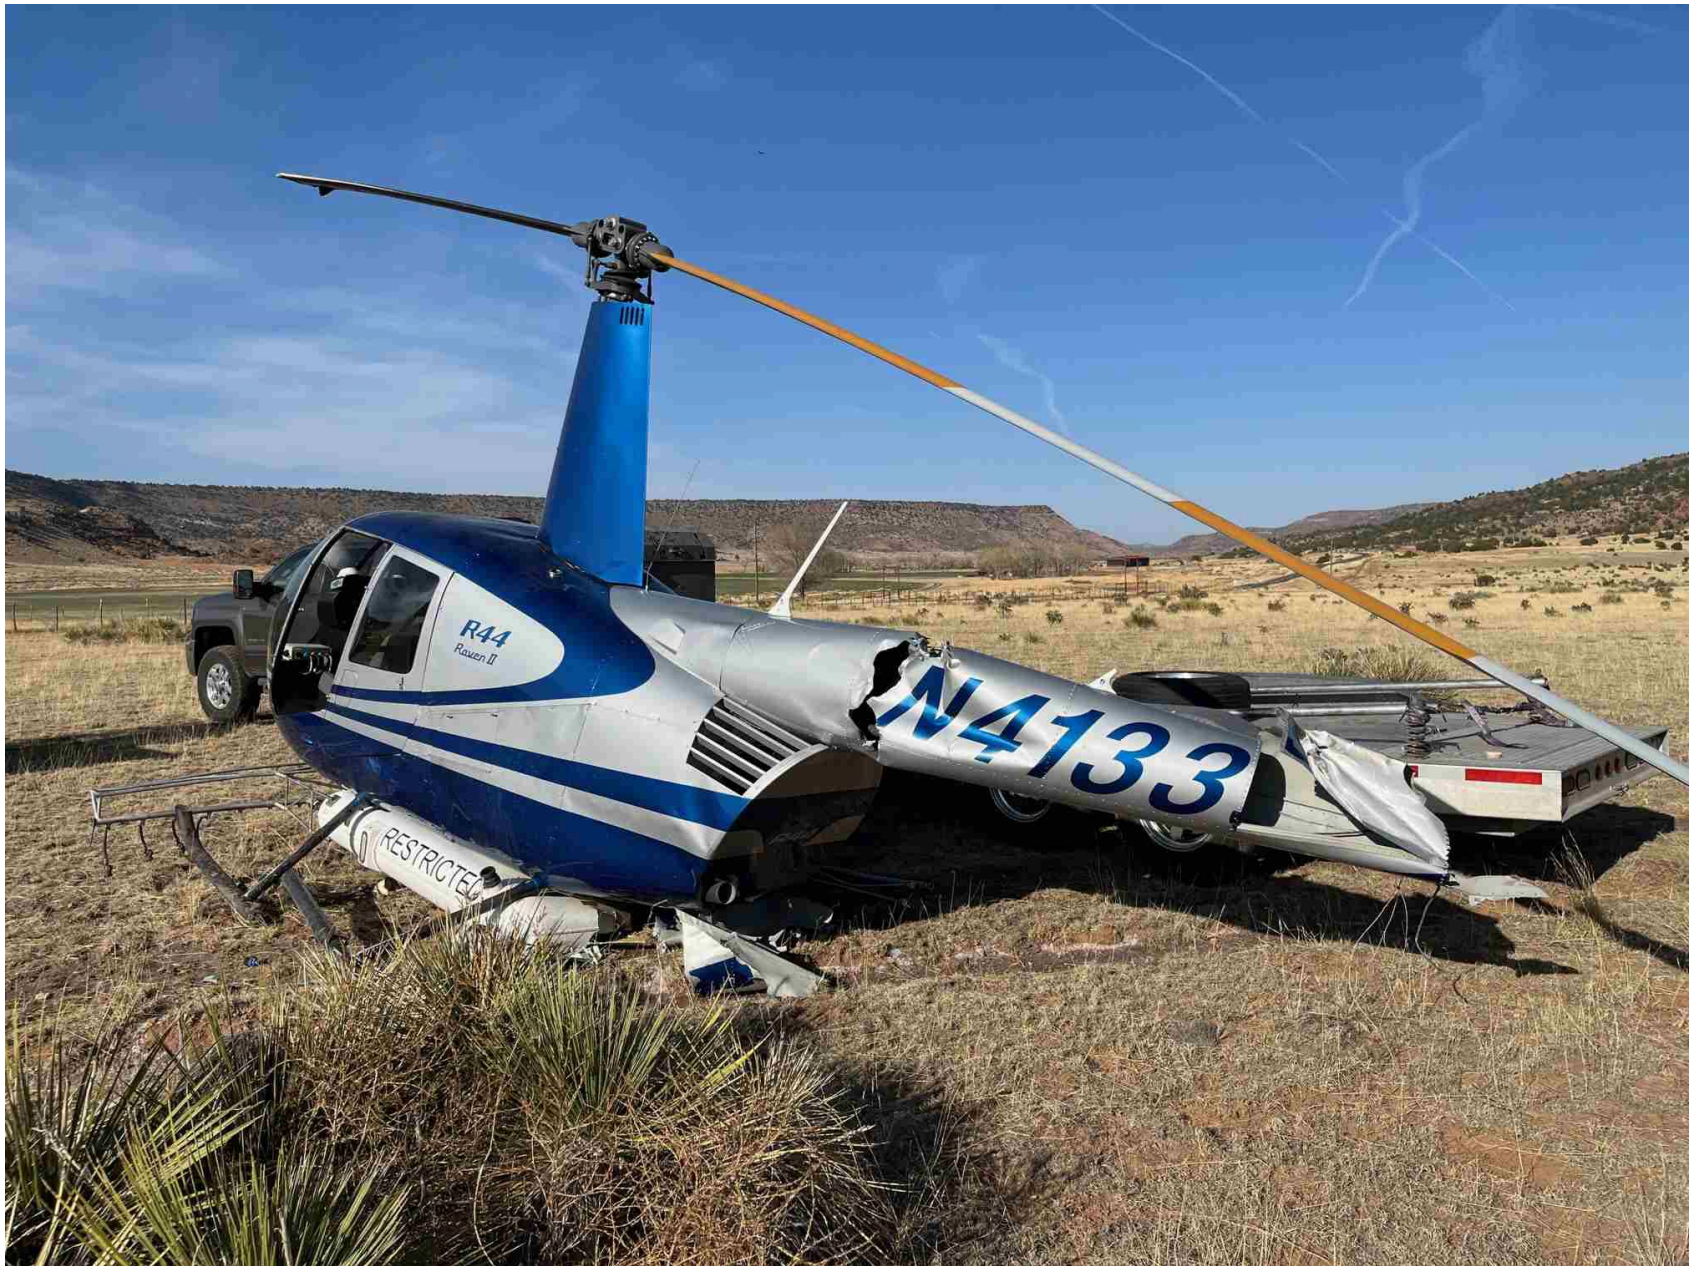
**Photo 1 – View of tailboom damage (photo courtesy of the operator)**
