## **Memorandum of Record**

**Subject: WPR22LA180, N8493P Wreckage Examination Notes**

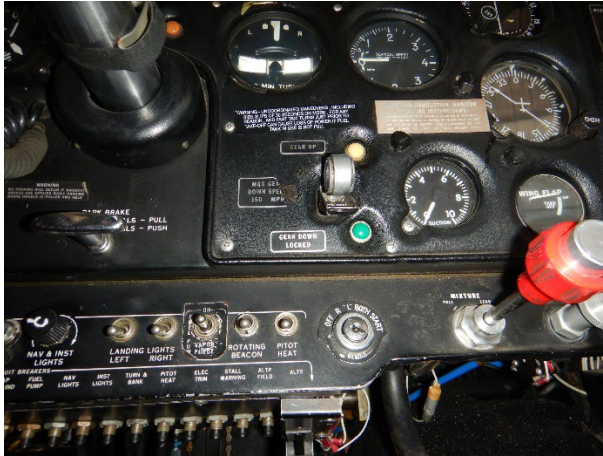
The landing gear switch was in the down position and the “Gear – Motor” circuit breaker was in the out/popped position (figures 1 and 2). The cover to the emergency landing gear disconnect was removed and the disconnect was activated.

*Figure 1 – Landing gear switch position*

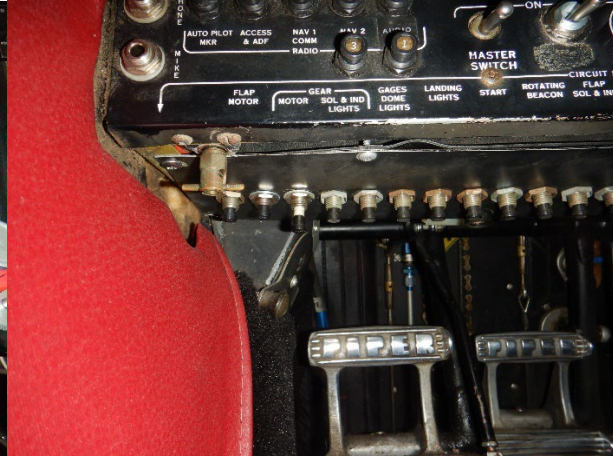
*Figure 2 - Popped LG Motor Circuit Breaker*

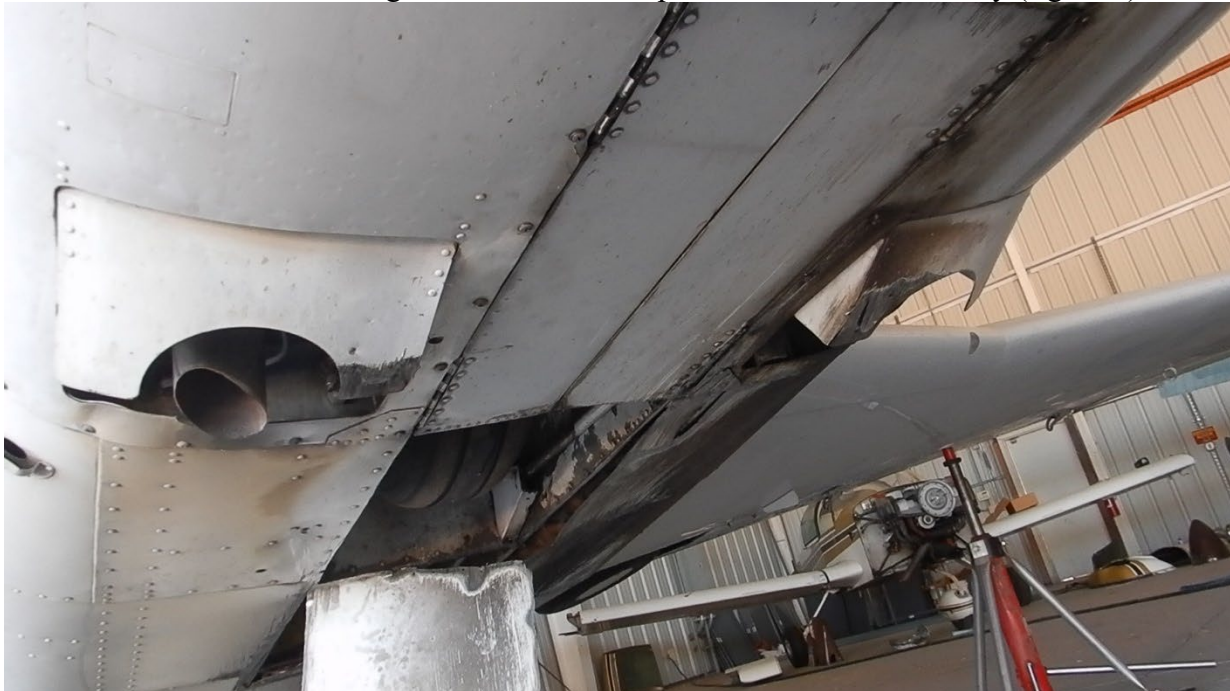
The underside of the airplane was examined, to include all LG doors and gear. The underside of the fuselage was scraped and worn where the airplane had contacted the runway. No wear or scraping was observed on either MLG door or wheel. No abrasion damage was noted to the nose gear or wheel. Scraping and abrasion damage was noted to the face of both nose gear doors consistent with the doors being closed when the airplane contacted the runway (figure 3).

*Figure 3 – Nose Landing Gear Doors Closed*

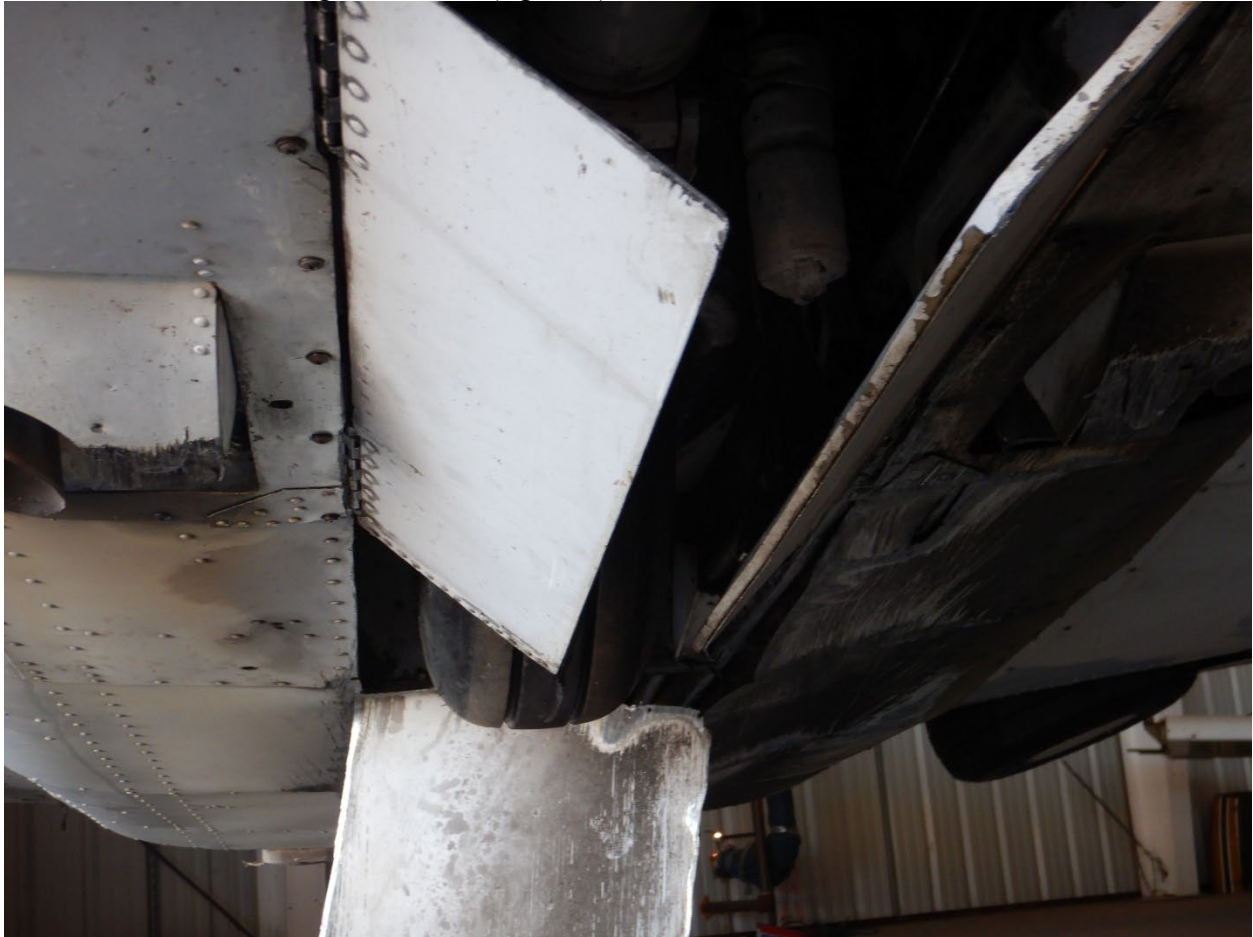
During an extension cycle of the landing gear, power was interrupted as the LG lowered to stop the LG in the approximate position the MLG were observed in when the airplane was found on the runway. With the gear in that partially down configuration the nose gear extended about 5 inches below the fuselage and the NG doors opened about 45° and extended about the same amount below the fuselage as the tire (figure 4).

*Figure 4 – Landing Gear Partially Extended*
