## **NATIONAL TRANSPORTATION SAFETY BOARD**

# **AIRFRAME AND ENGINE EXAMINATION**

**WPR22LA186**

Location: Prescott, AZ  
Date: May 22, 2022  
Aircraft: Cessna P172D, N8540X  
Serial P17257140  
NTSB IIC: Albert Nixon

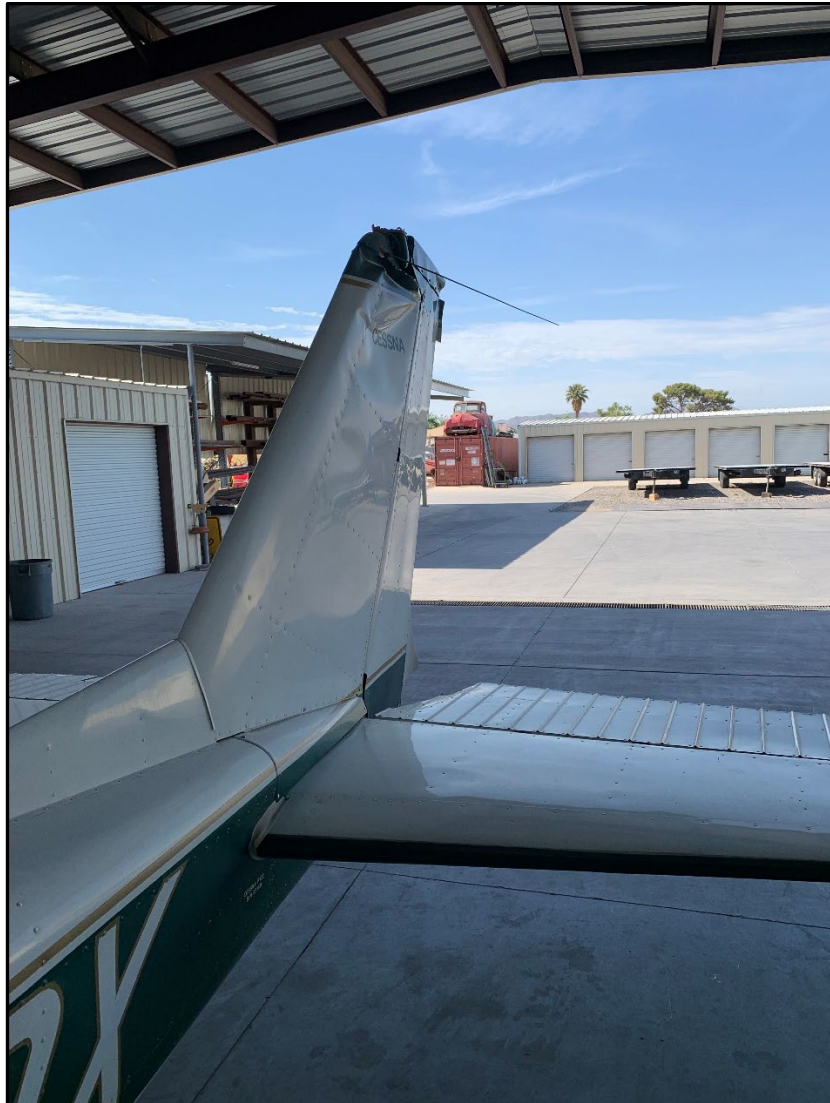
Figure 1: View of the vertical stabilizer and rudder.

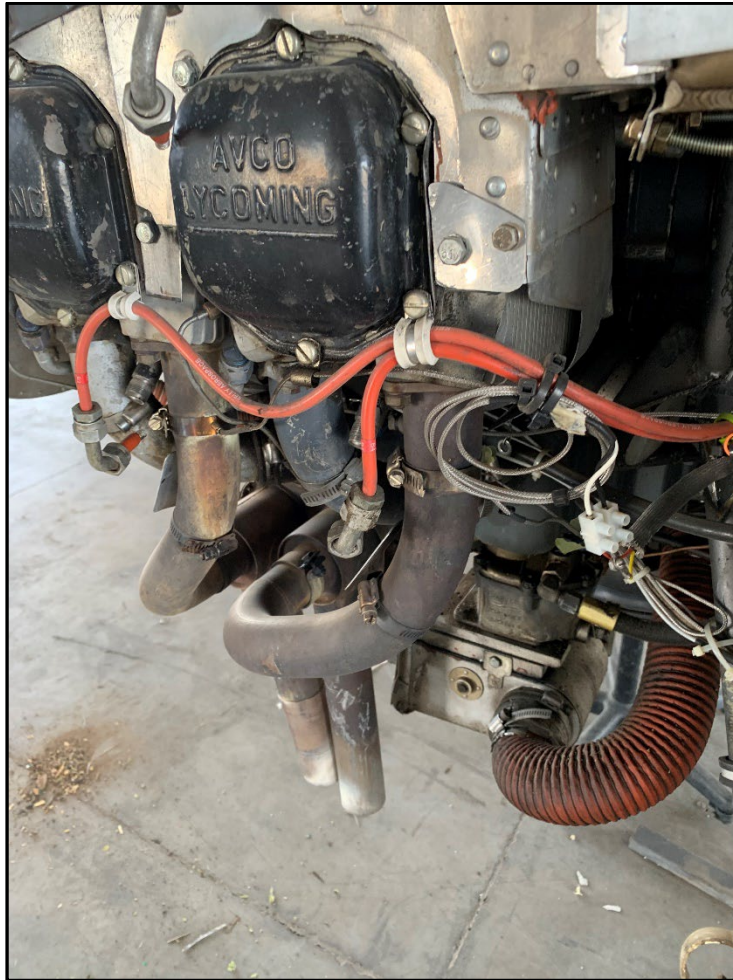
Figure 2: Engine as viewed from the left side.

The engine was observed partially attached to the fuselage and one of the engine mounts was separated. The bottom portion of the engine was observed to sustain impact damage. The carburetor screen was examined and was clear of contamination.
