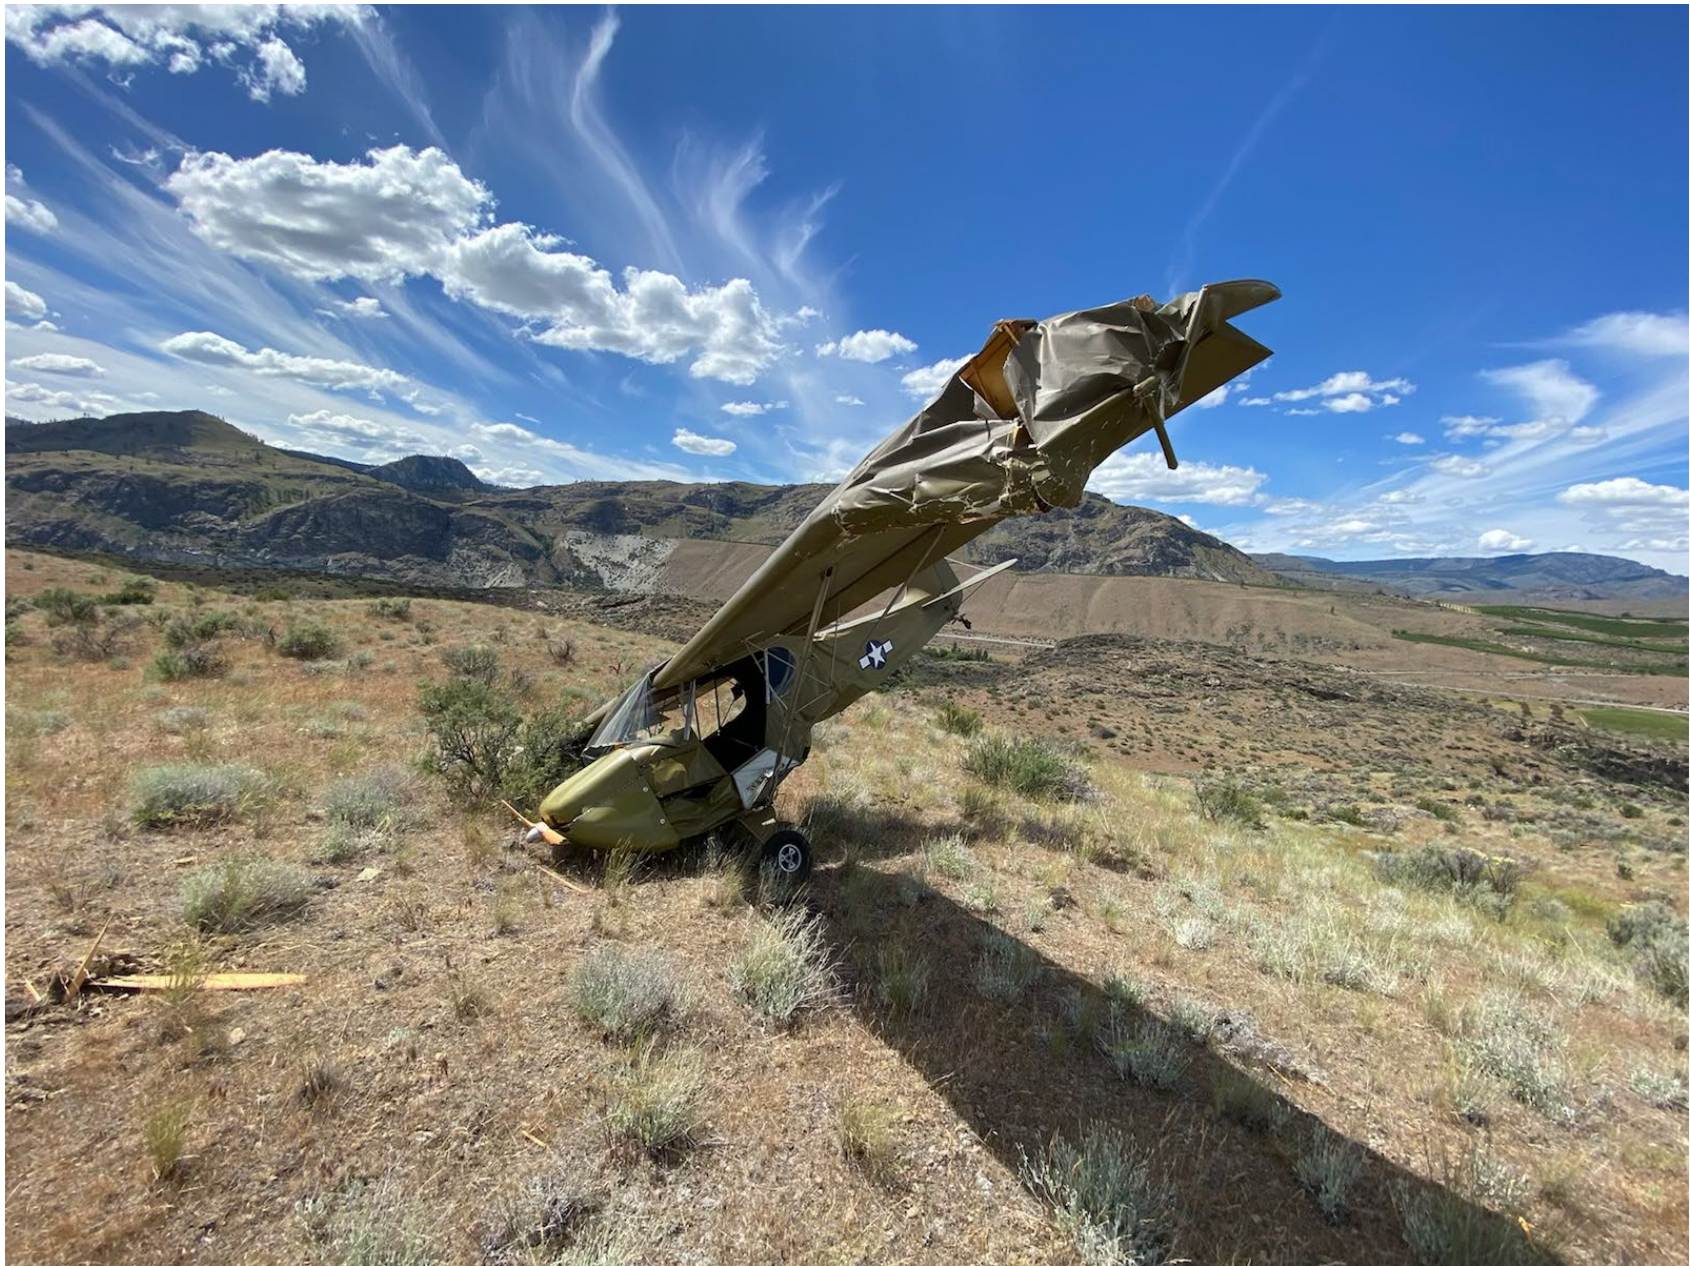
**Photo 1 –N15MF, showing substantial damage to the left wing and fuselage. Photo courtesy of the pilot.**

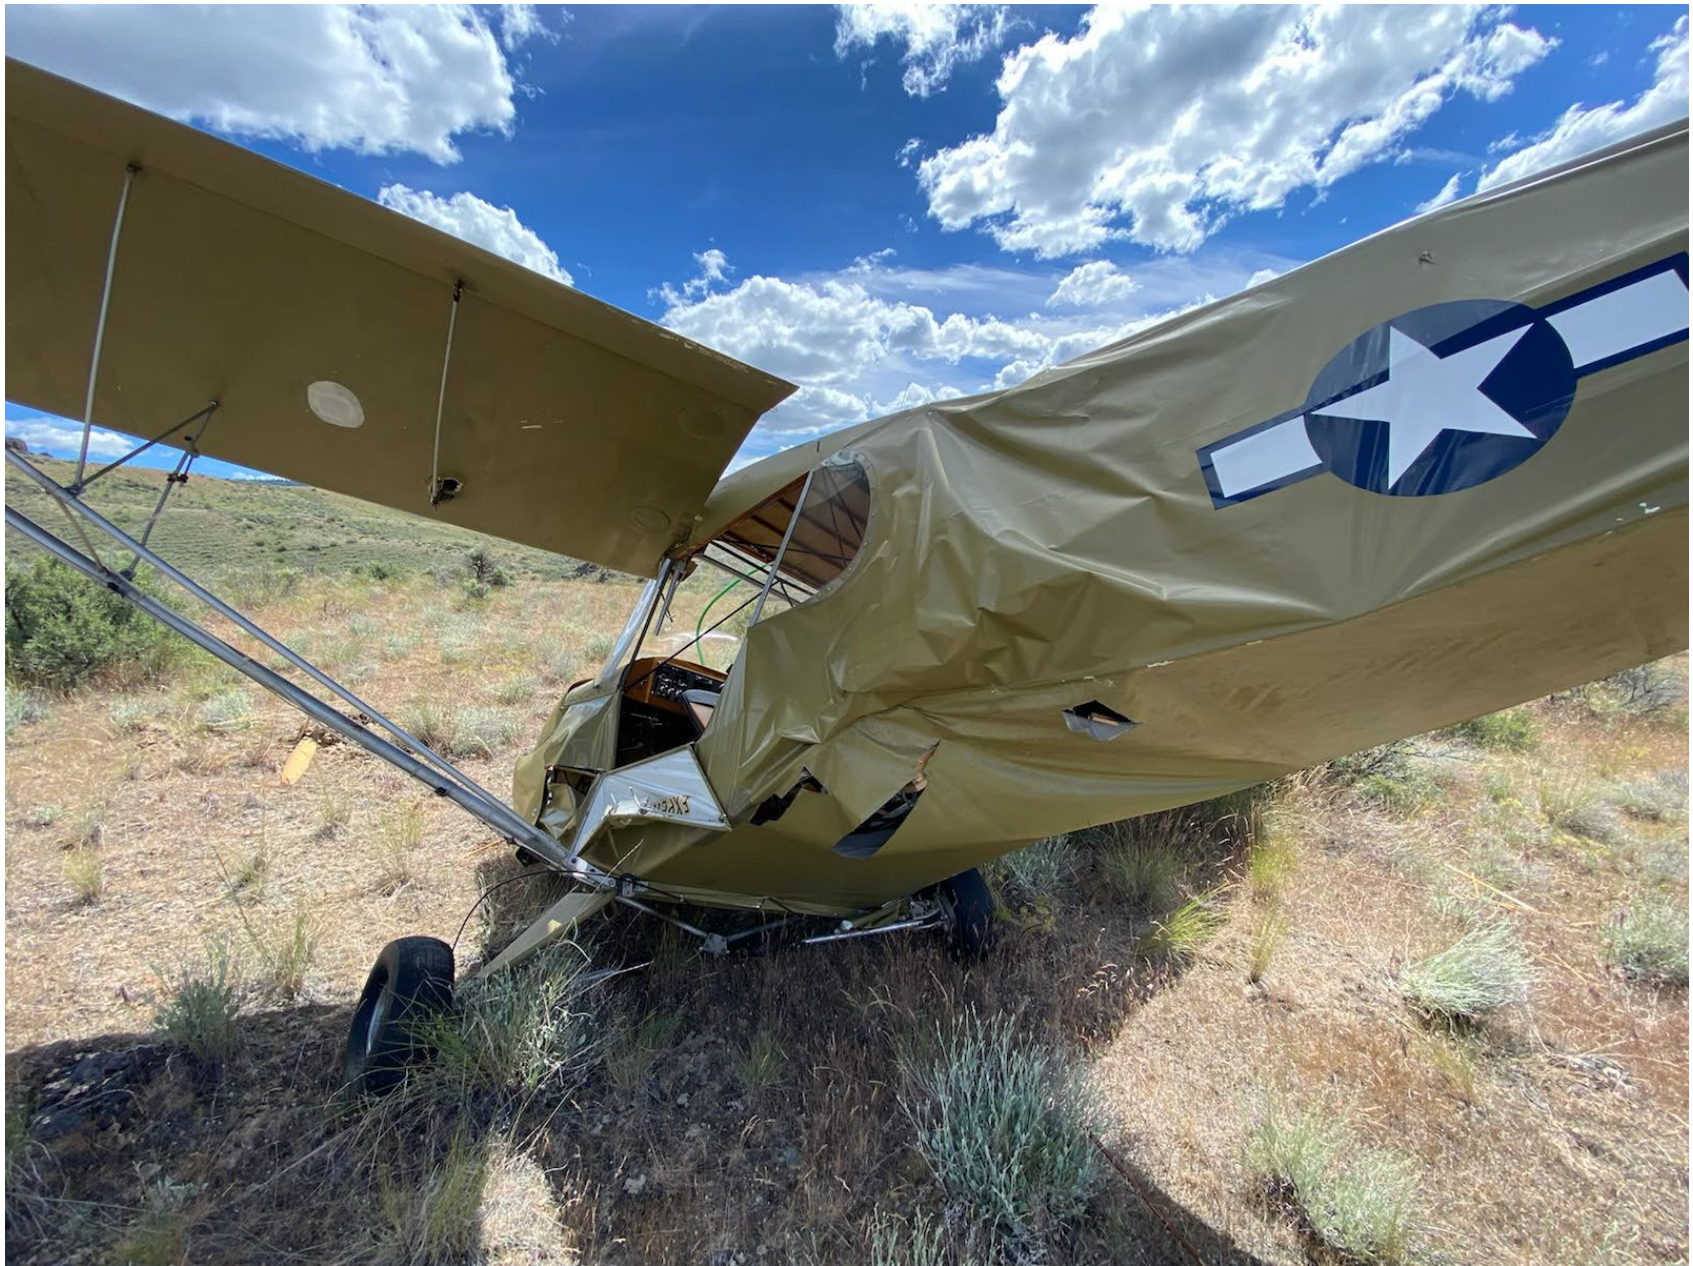
**Photo 2 – N15MF, showing substantial damage to the fuselage. Photo courtesy of the pilot.**
