# National Transportation Safety Board

WPR22LA202

## **AIRFRAME AND ENGINE EXAMINATION REPORT**

Location: Chelan, Washington  
Date: 6/5/2022  
Time: 1300 Pacific Daylight Time  
Airplane: N15MF / Super Koala

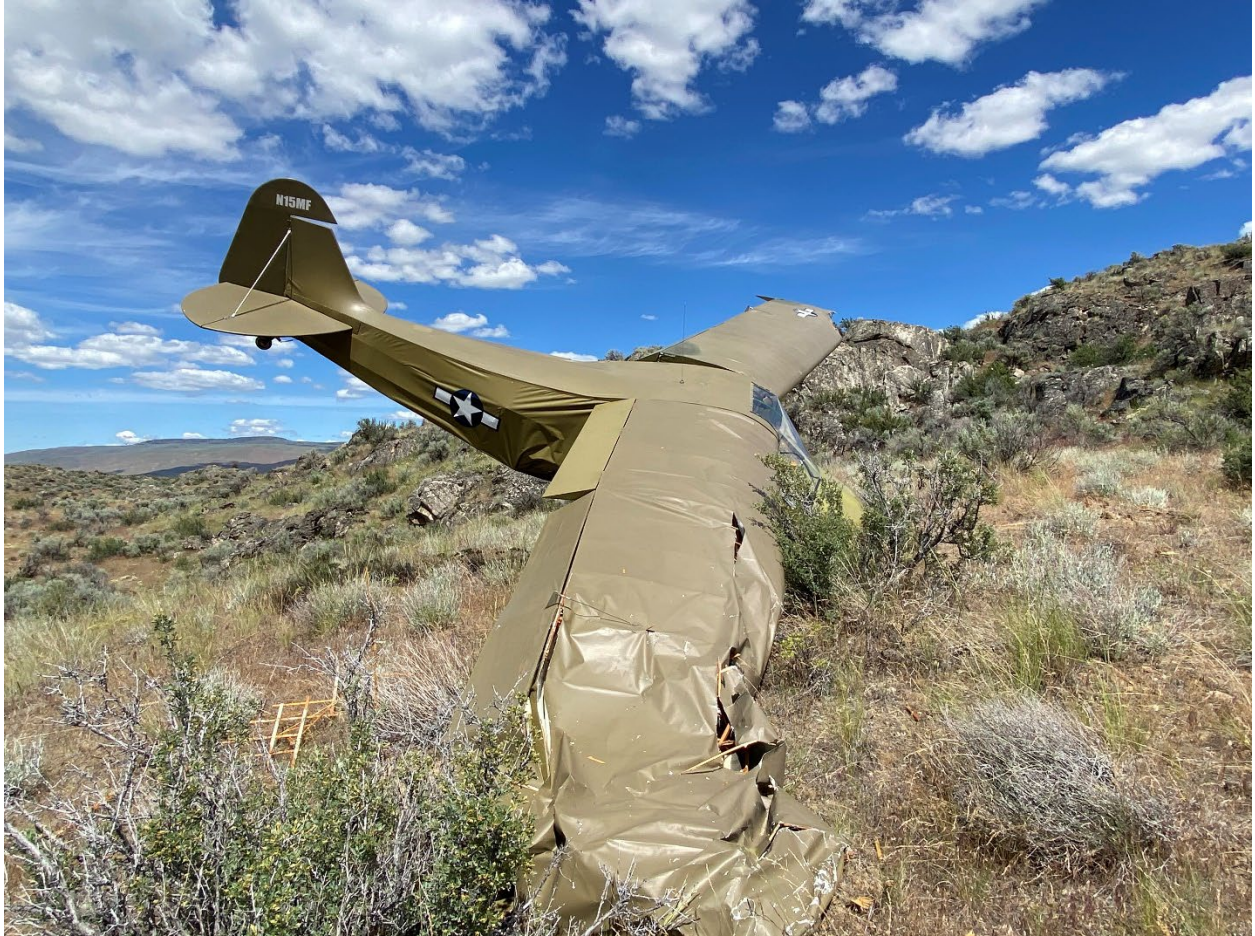
**Figure 1. N15MF, Right-side view (Photo courtesy of the pilot)**

The fuselage was constructed of wood and fabric and was substantially damaged. The mid-section of the fuselage was fractured and partially separated. The fabric covering was torn and the wooden structure was fractured in several locations.

The wings were not available for examination; however, a review of photos, provided by the pilot after the accident, revealed that the left wing partially separated from the fuselage at the root. The left-wing tip, inboard to about 24 inches was crushed aft. The aileron remained attached to the wing and exhibited minor damage. The left-wing flap remained attached to the wing and exhibited minor damage.

The right wing remained attached to the fuselage and exhibited substantial damage to the wing inboard of the tip to about mid span. The right-wing aileron was bent chordwise. The right-wing flap remained attached to the wing and exhibited minor damage.

The right-side main landing gear was fractured and buckled. The left-side main landing gear remained attached to the fuselage and exhibited minor damage. The brake assemblies remained attached to the respective wheels. The tail wheel remained attached to the fuselage and exhibited minor damage.

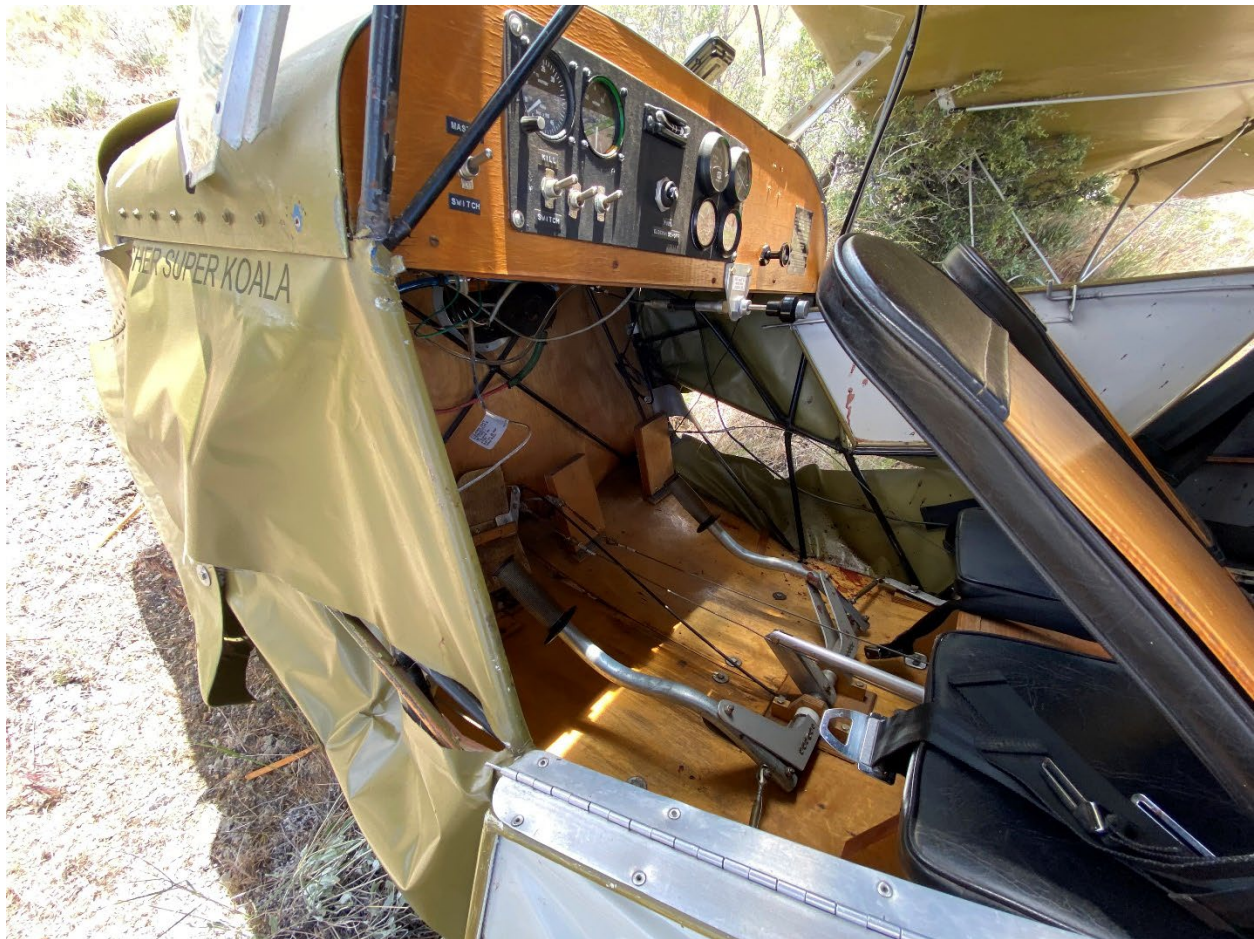
**Figure 3. Cabin area**

The cockpit exhibited minor damage and retained its integrity. The instrument panel exhibited minor damage. All instruments and switches remained attached. The throttle remained attached to the instrument panel.

The fuselage and cabin area retained its shape. There was no postaccident fire.

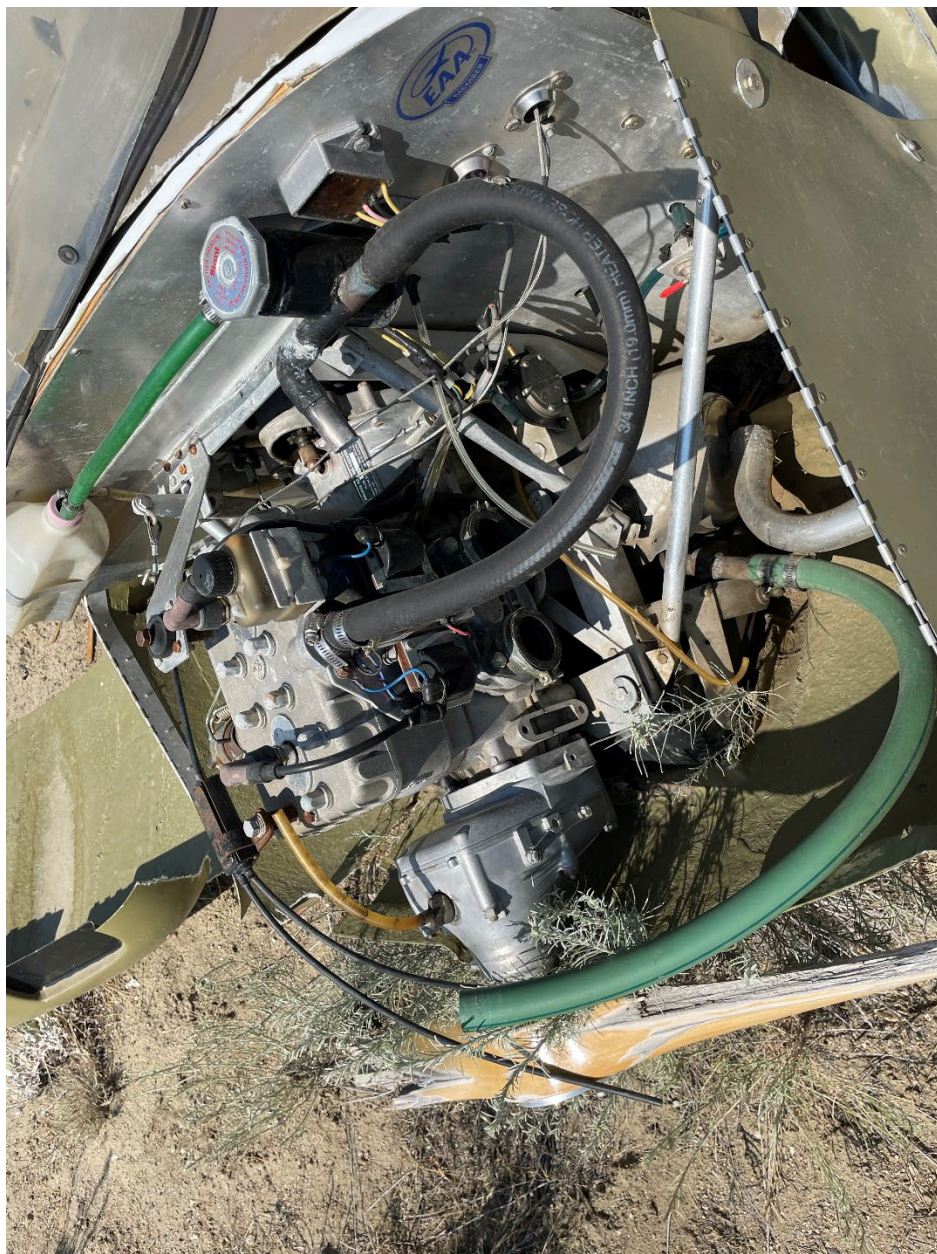
**Figure 4. Engine**

The engine remained attached to the engine mount and the engine mount remained attached to the firewall. The engine could only be rotated about 30 to 40 degrees due to the airframe being placed on the ground. There was not method available to raise the airframe off the ground and rotated the engine further. The engine rotated about 30 to 40 degrees, freely and did not exhibit any signs of seizure or resistance to rotate. The two cylinders had thumb force compression.

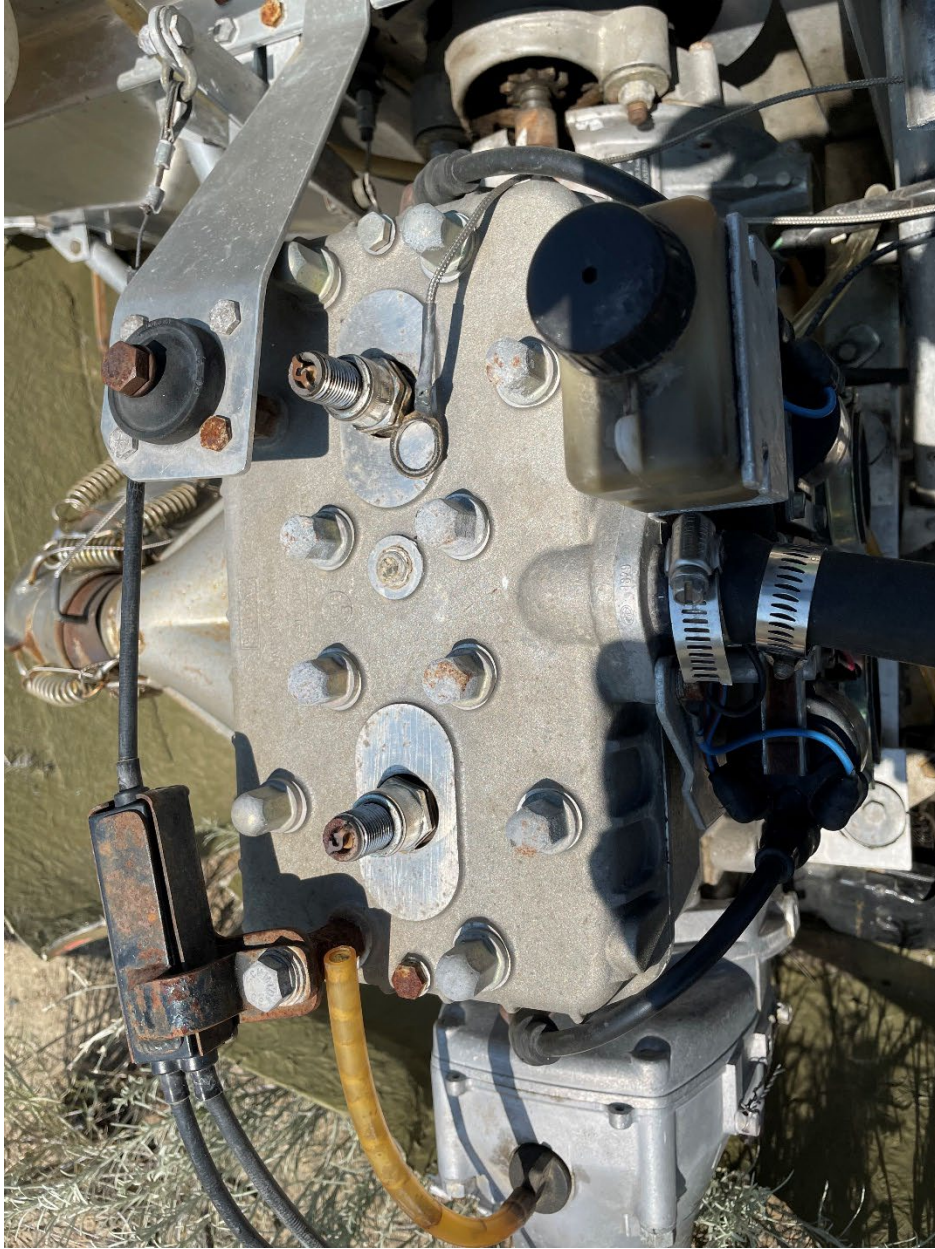
**Figure 5. Spark plugs**

The spark plugs exhibited a dark tan appearance at the electrodes. The spark plug leads remained attached to the coils and the spark plugs and exhibited a good appearance with no signs of embrittlement. The coils remained attached to the engine and exhibited a secure, clean condition. When the engine was rotated about 30 to 40 degrees, there was no spark produced.

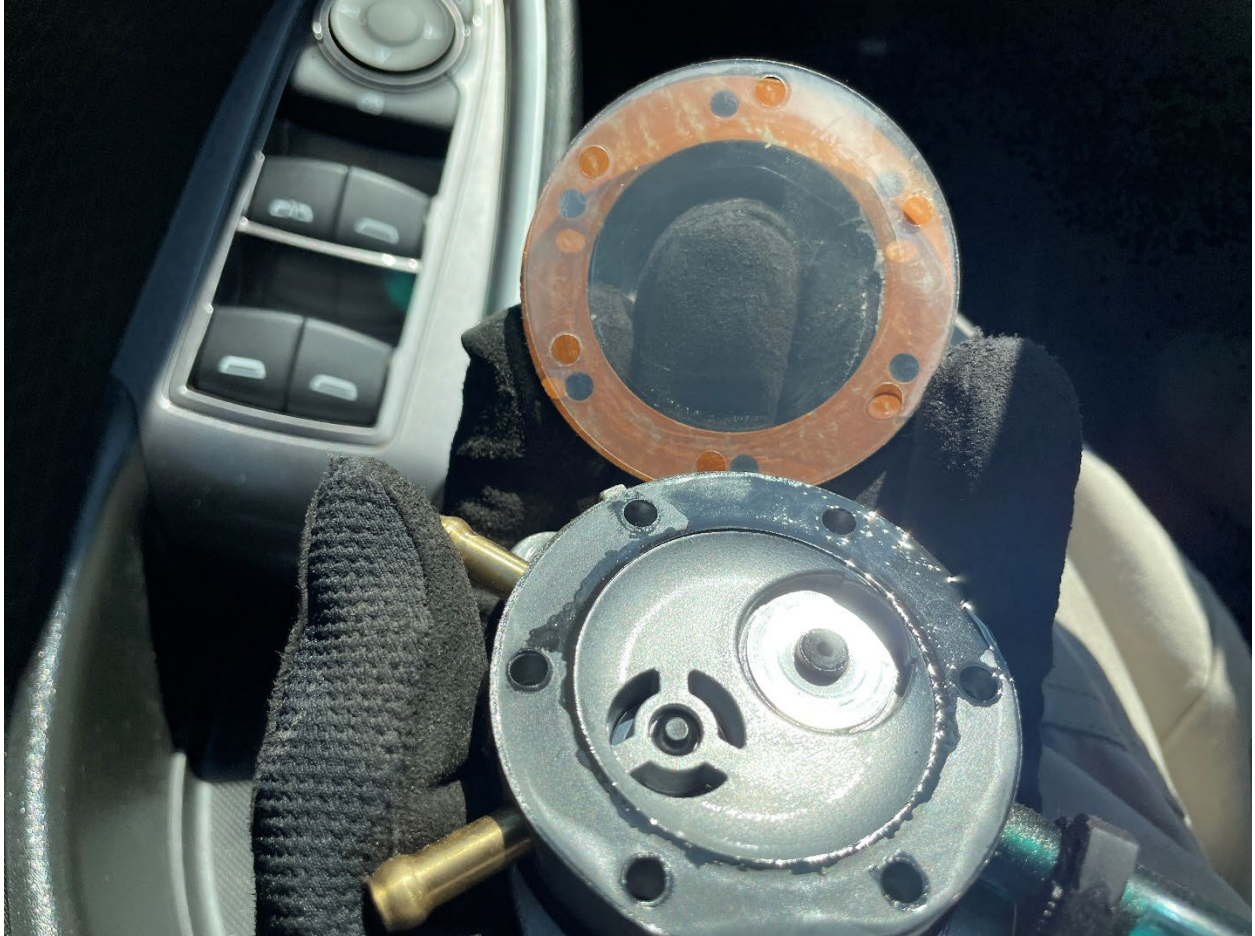
**Figure 6. Diaphragm fuel pump**

The fuel tank was not available for examination. The fuel lines ran from a fuel shutoff valve to the diaphragm pump, to the carburetors. The lines were new in appearance and did not exhibit any breaches or cracks. The diaphragm pump was examined and did not exhibit any anomalies that would preclude normal operation.

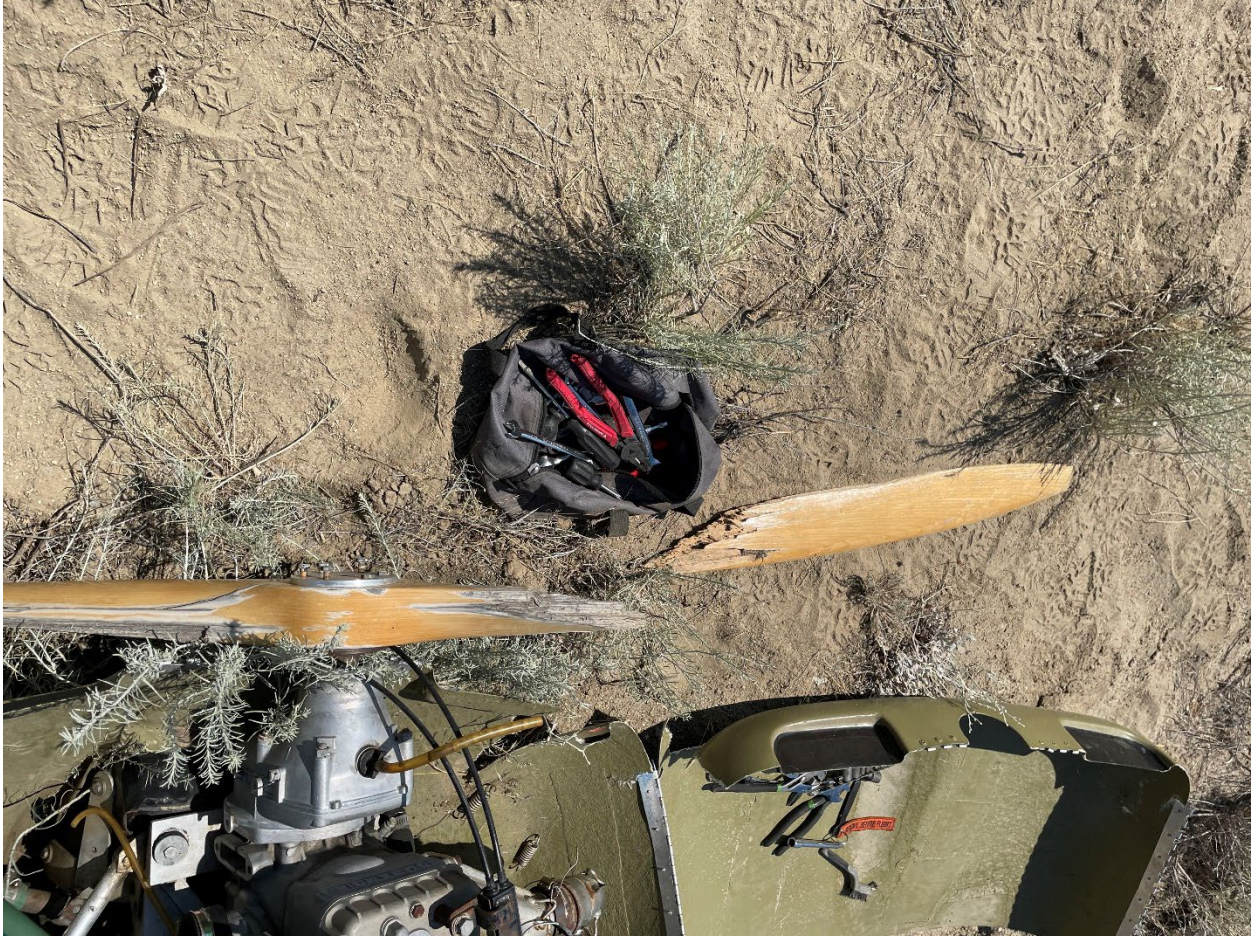
**Figure 9. Propeller**

The two-bladed, wooden propeller fractured and liberated sections of both blades. The hub remained attached to the propeller flange.
