# National Transportation Safety Board

WPR22LA202

## **ACCIDENT SITE SURVEY**

Location: Chelan, Washington  
Date: June 5, 2022  
Time: 1300 Pacific daylight time  
Airplane: N15MF / Super Koala

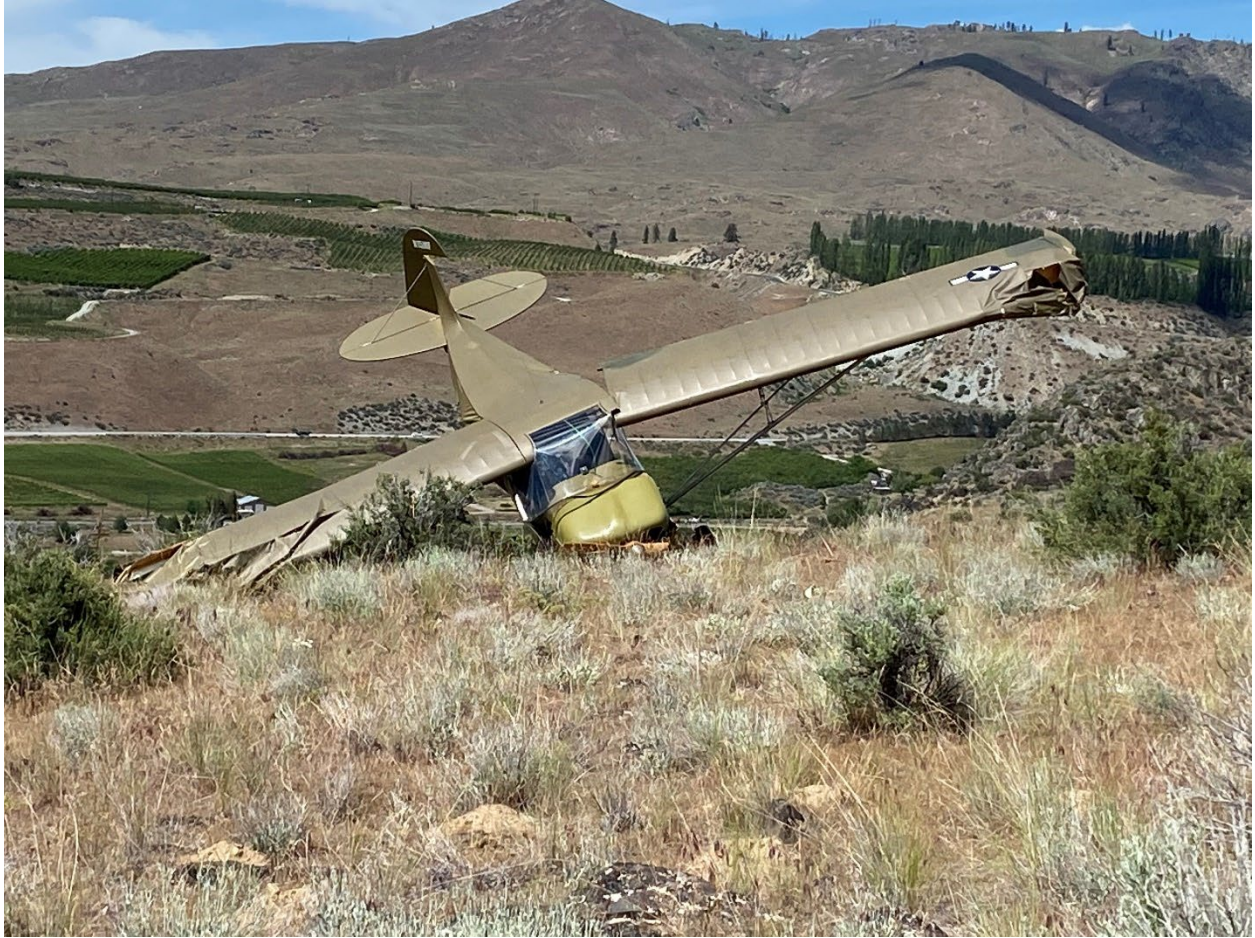
Figure 2. N15MF at the accident site. Photo courtesy of the pilot.

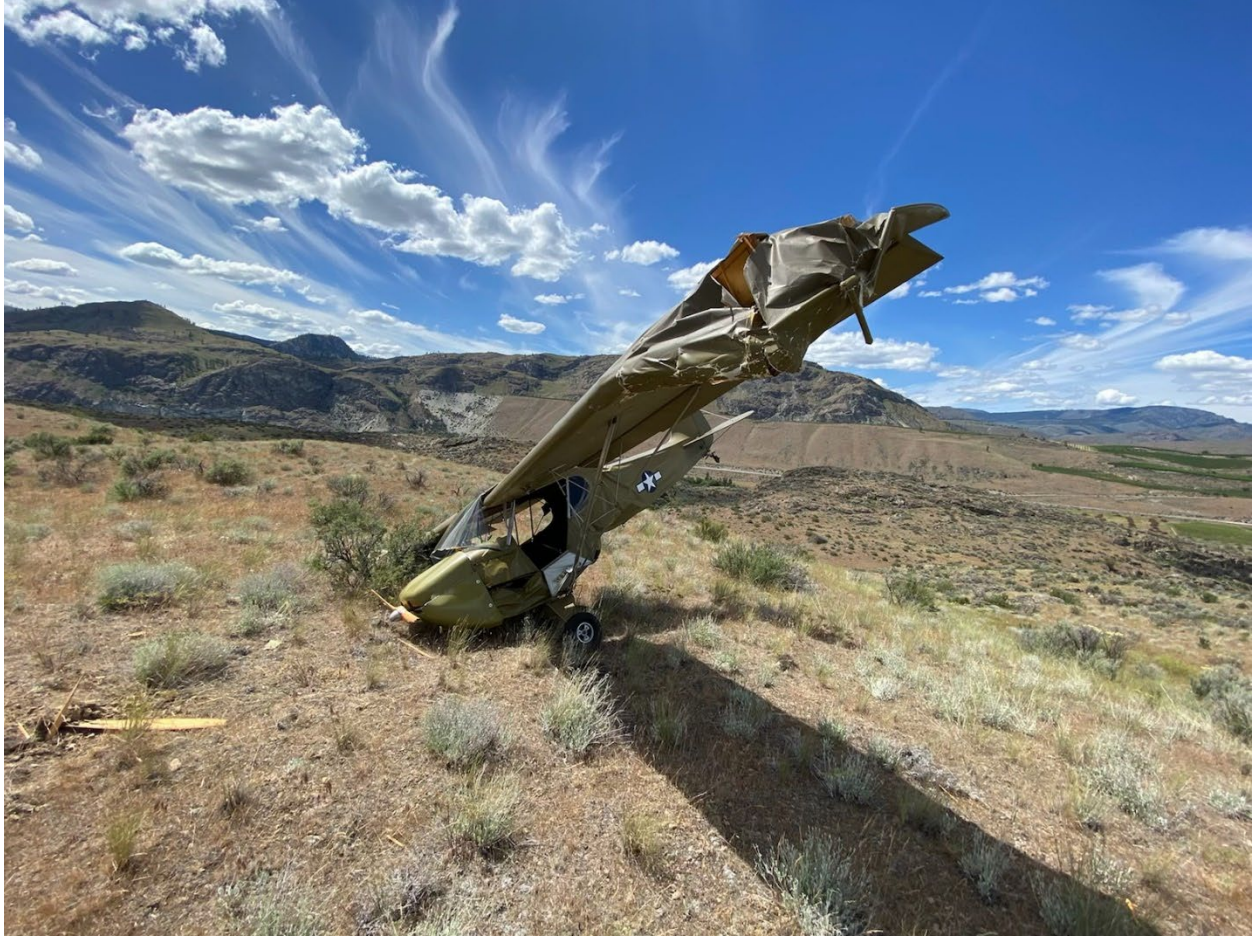
Figure 3. Side view of N15MF at the accident site. Photo courtesy of the pilot.

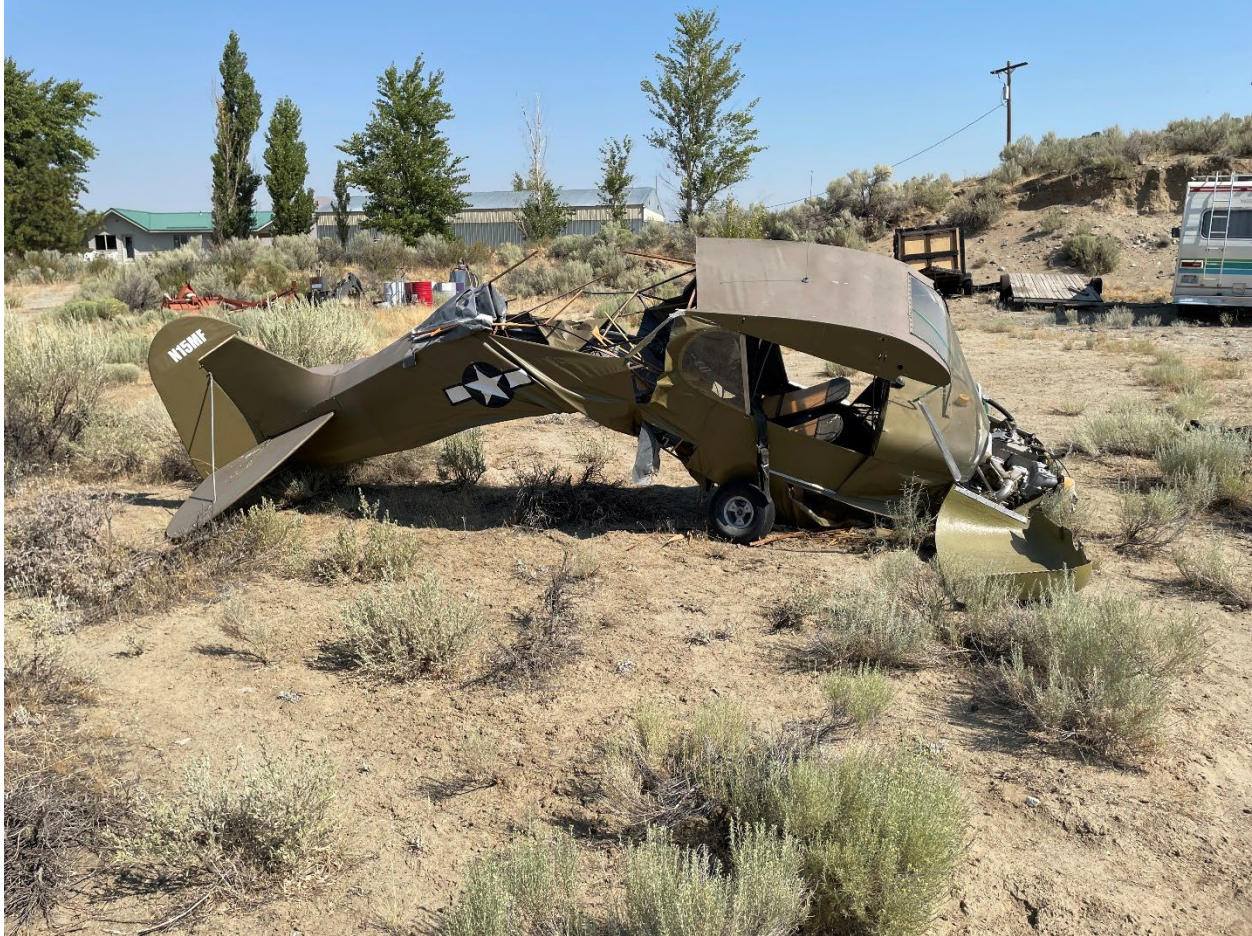
lived on the airport property. He pointed to an open area where the airplane was located. The wings and the fuel tank were not present. Despite multiple attempts to reach the pilot, he was unavailable to answer questions about the wings and fuel tank.

Figure 4. N15MF, as found at the airport, prior to the airframe and engine examination.
