## **NATIONAL TRANSPORTATION SAFETY BOARD**

### **ENGINE EXAMINATION SUMMARY**

**WPR22LA211**

Location: Fairfield, Utah  
Date: June 9, 2022  
Aircraft: N46JH; Rans S-21

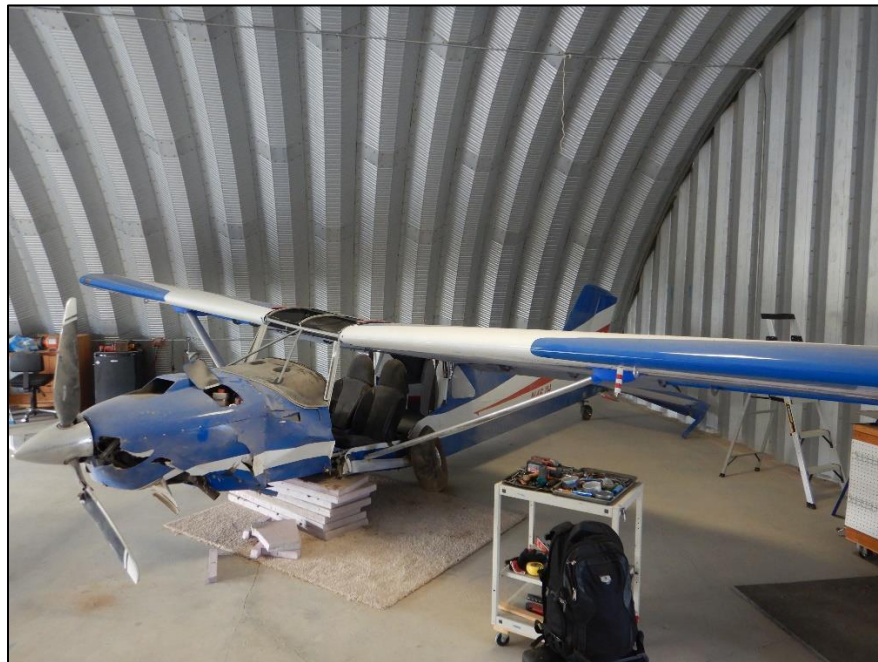
**Figure 1-Main wreckage, view of the forward left side.**

The airplane was positioned in the owner's hangar for the examination. The main gear had impact damage and was pushed aft from its original position. The fuselage had impact damage and had deformation to the cabin area. The engine cowling and propeller assembly had impact damage and remained partially attached.

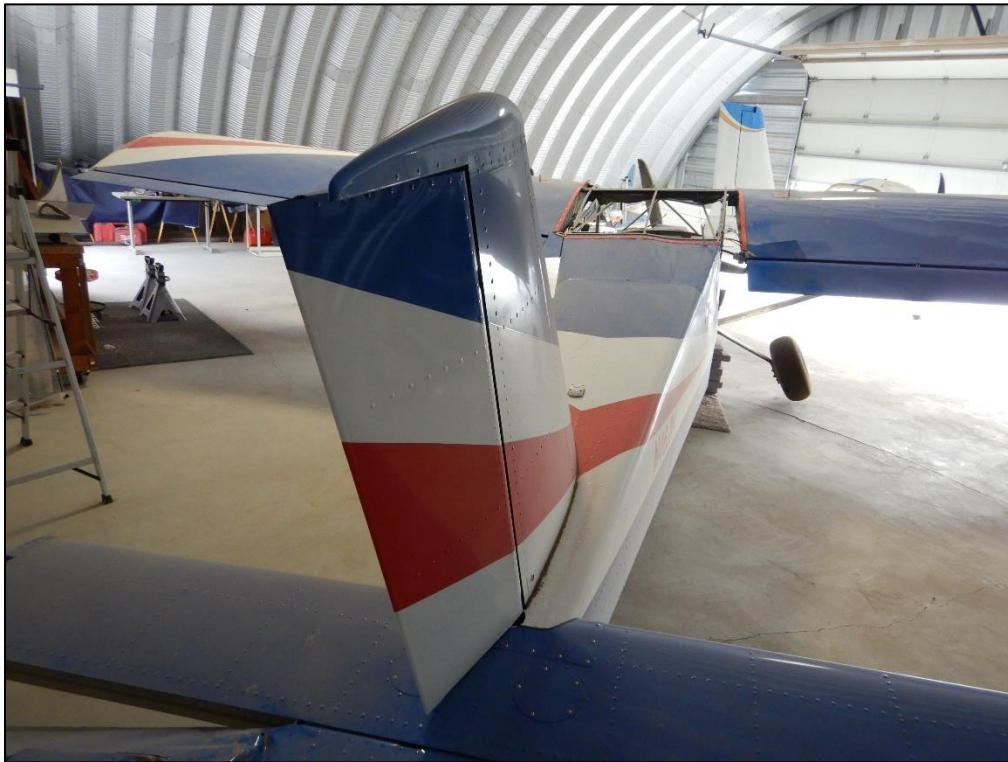
**Figure 2-Main wreckage, view from the aft.**

The wings had minor damage and the right wing was partially attached to the fuselage. The elevator had impact damage and separated from the left outboard attachment.

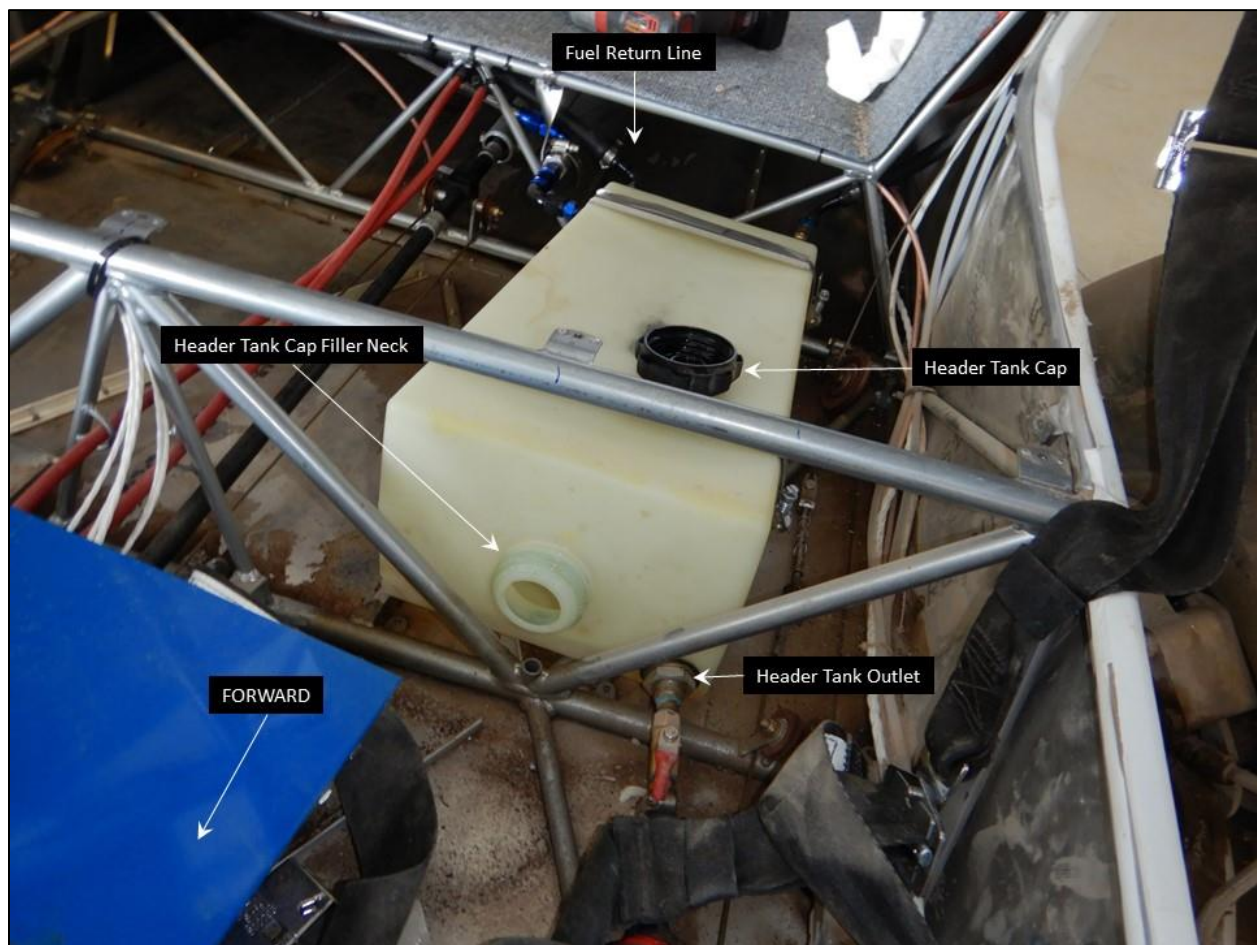
Figure 4-Header tank.

The wing tanks remained intact, and the fuel caps were secure and unremarkable. The wing tank supply lines were undamaged and remained attached to the header tank located on the aft cabin floor. The supply lines had shutoff valves attached at (pilot) head level and were found in the open position. The header tank is about 5 gallons in capacity and positioned sideways with its filler cap halfway down the front side of the tank. (See Figure 4.) The fuel return line from the engine was attached and secured to the aft right side of the tank.

The header tank did not have a venting line and the header tank cap was not a vented type. According to the Rotax Installation Manual, the venting line from the header tank to the wing tank should generally be on an incline to avoid trapping bubbles. The venting line must have an inner diameter of at least 12 mm (0.05 in).

The outlet line and a shutoff valve were secured to the lower forward side of the header tank.

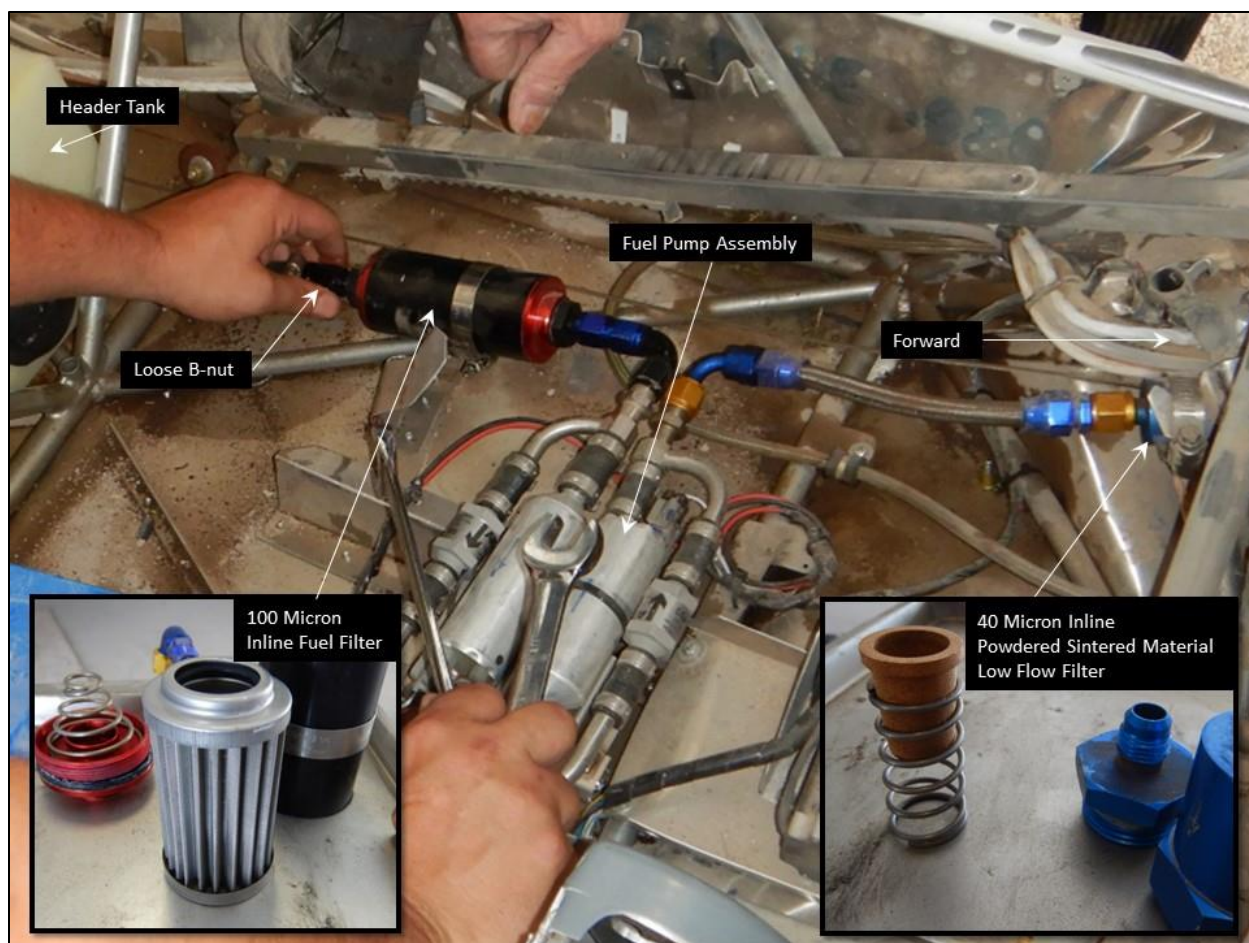
**Figure 5-Airframe fuel system, cabin area.**

A 100-micron inline fuel filter was attached to the outlet line from the header tank. The inlet b-nut fitting to the filter assembly was finger loose. Fuel dripped from the fitting during the initial turns of the fitting. The filter was disassembled, and the screen was clear of debris. A sealant was noted on the O-ring and cap. The fuel pump assembly was attached to the floor with plastic zip ties. One of the zip ties separated. The pump operated normally when initiated from the instrument panel. A 40-micron inline low flow fuel filter was attached to the high-pressure side of the fuel system after the fuel pump. The filter was removed and disassembled. Small amounts of contaminants, consistent with the O-ring sealant was noted in the filter cavity. Airflow was restricted when blown air was applied to the powdered sintered material filter. A shutoff valve on the high pressure supply line was located near the pilot's knee area.

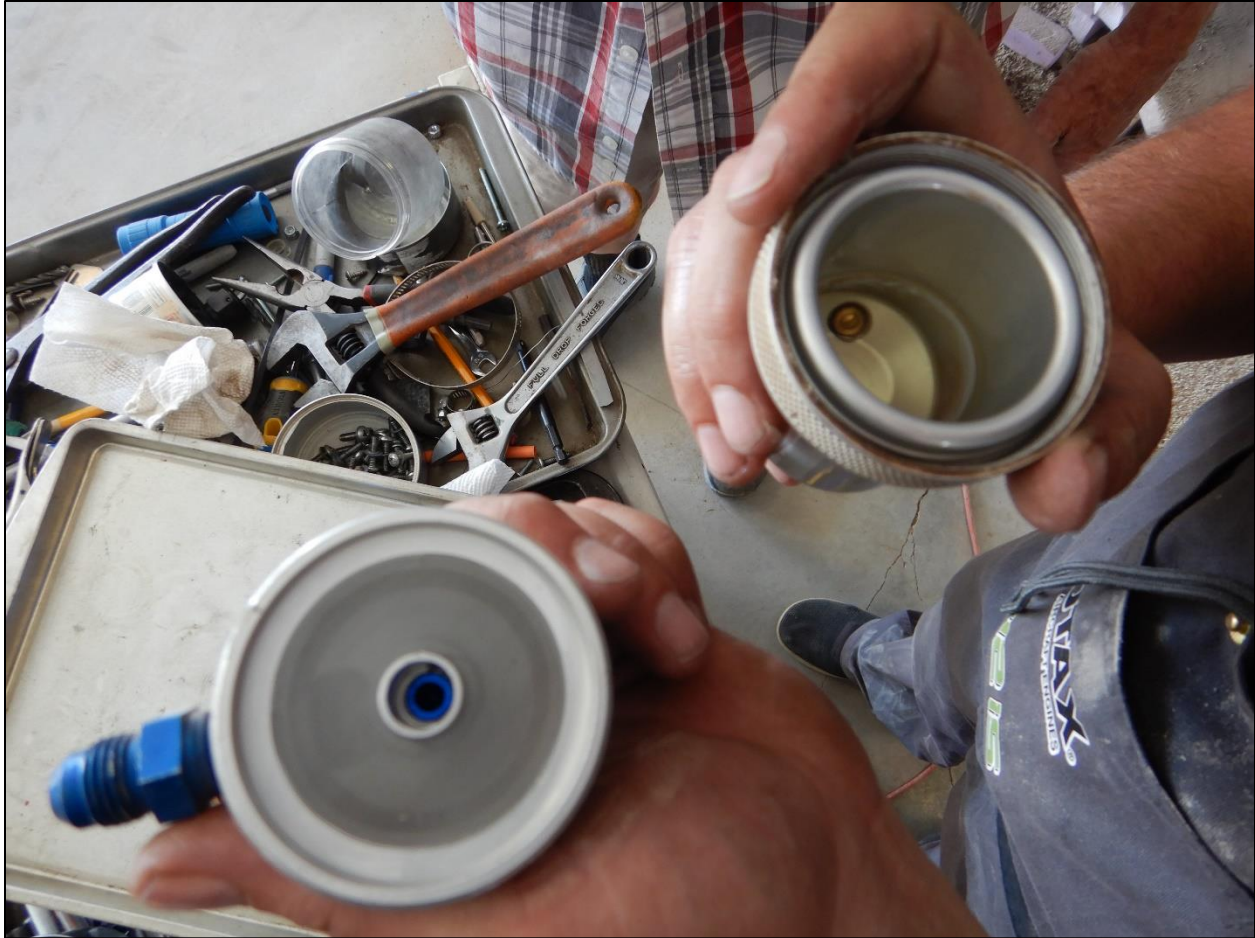
**Figure 6-Gascolator, disassembled.**

The gascolator was removed from the wreckage and the inlet fitting had impact damage. The internal screen was undamaged and clear, and the cavity bowl contained automotive type fuel and was free of contamination.

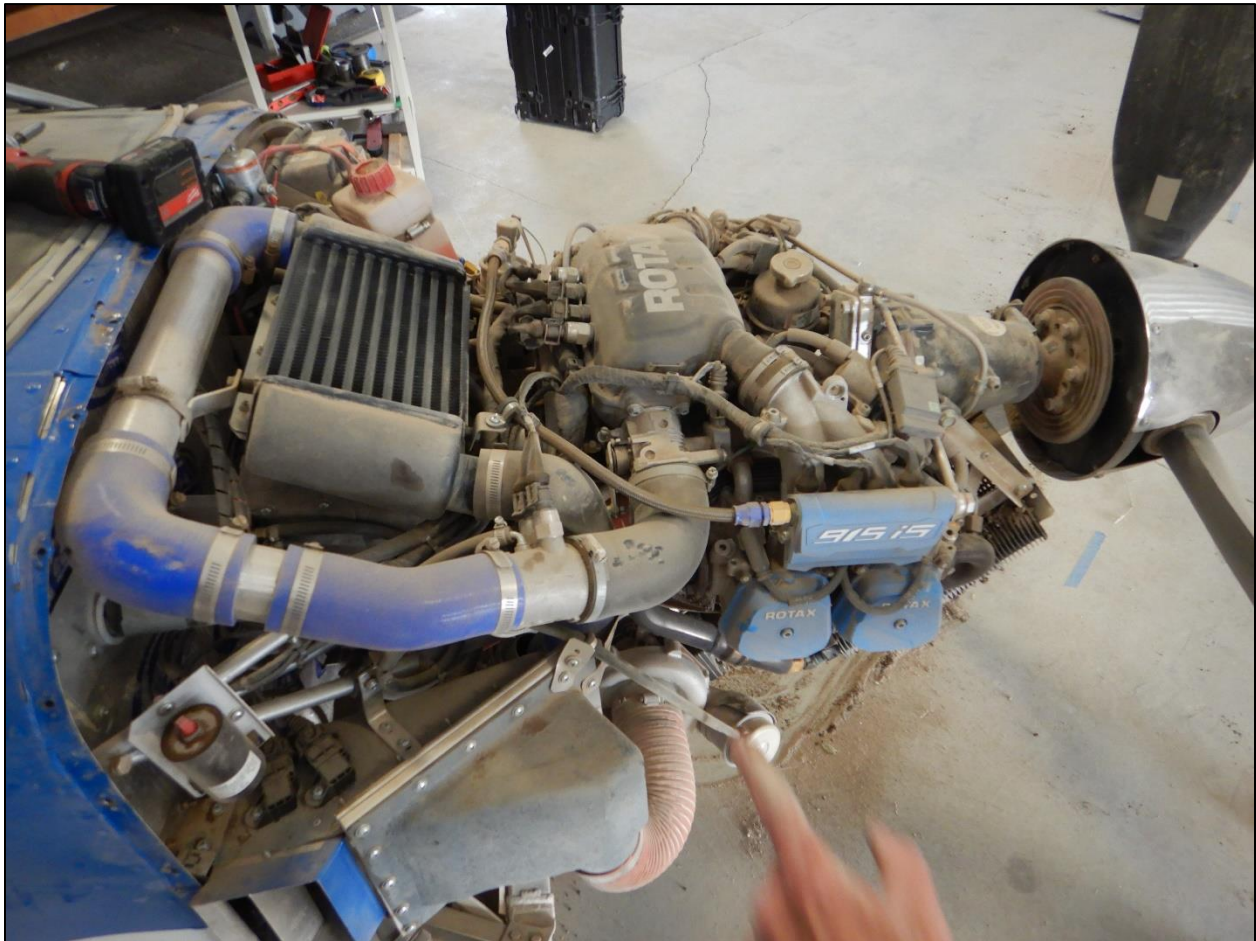
Figure 7-Engine and propeller assembly, right side view.

The engine remained attached to the fuselage and was mostly intact. The propeller assembly remained attached to the engine. Each of the three blades had impact damage to their midsections. The upper and lower engine cowlings had impact damage and remained partially attached to each other and the fuselage attachments. The cowling was removed, and the engine was covered in a layer of dust and dirt. The induction tubes from the turbocharger to the intercooler separated at their attachments. The lower engine coolant cooler had impact damage and was pushed upwards in the center. The flexible induction tubes were removed, and the engine intake was boroscoped. No foreign objects were found in any of the intake tubes. The induction tube near the turbocharger shows some thermal damage in a small section. The tubes internal surfaces were undamaged.

A restricted bypass line between the inlet (pressure side of the fuel pump) and the return line was not installed on the engine. This bypass line allows venting of the fuel system after a potential inclusion of air.

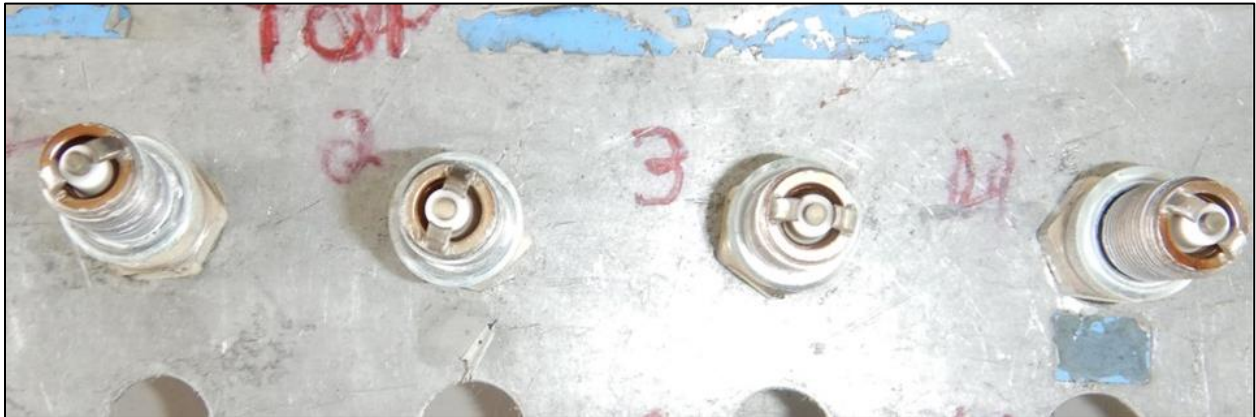
**Figure 8-Upper spark plugs.**

The upper spark plugs were removed and showed normal operating signatures.

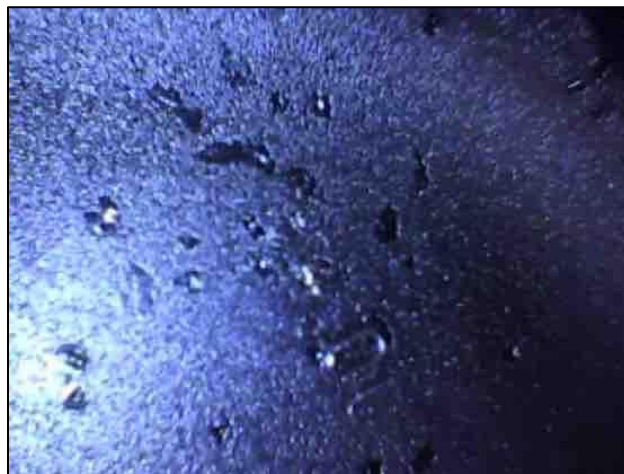
**Figure 9-Piston marks, position unknown.**

The cylinders were boroscoped and the combustion chambers showed damage consistent with detonation. No other damage or anomalies were noted during the boroscope examination.

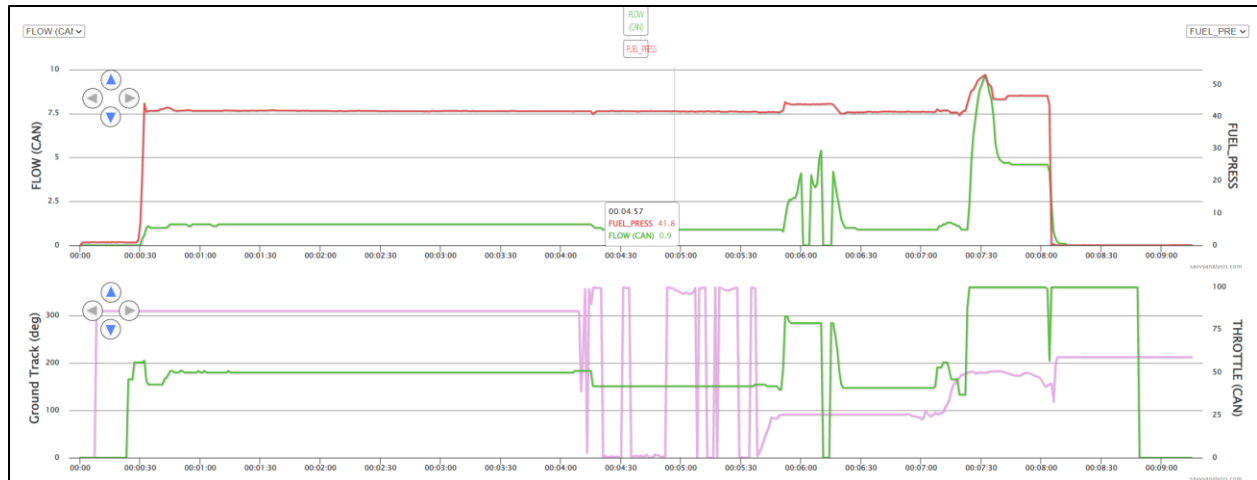
Figure 11-Dynon data.

The downloaded data was uploaded to a program to complete a readout of the data. The data reveals a fuel flow that is not consistent with the fuel pressure during throttle movement.
