# National Transportation Safety Board

WPR22LA213

## **AIRFRAME & ENGINE EXAMINATION SUMMARY**

Location: Auburn, Washington  
Date: June 11, 2022  
Time: 1836 Pacific standard time  
Airplane: Piper PA-24-250, N7482P

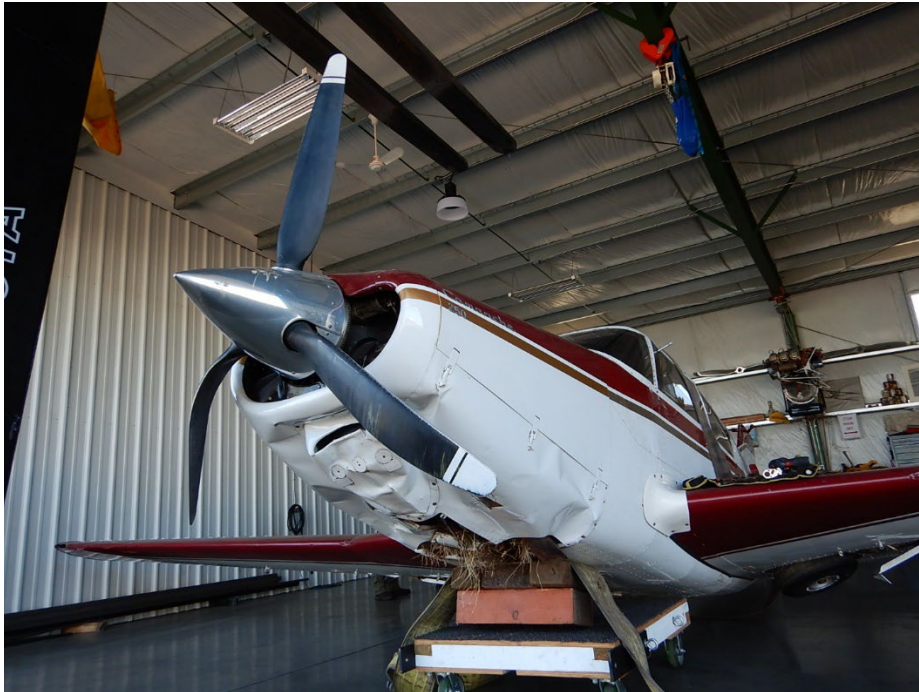
The wreckage examination (figure 1) was performed at Avtech Services LLC in Auburn, WA. Examination of the airframe revealed that the right wing was substantially damaged. Flight control continuity was established throughout the airframe from the cockpit to all primary flight controls surfaces. The right main fuel tank, left auxiliary,

and right auxiliary had fuel and appeared to be all full. The left main tank had about a gallon of fuel. The throttle, mixture, carburetor heat, and propeller governor lever in the cockpit and on the engine were found intact and maintained continuity.

**Figure 1. View of airplane wreckage at examination**

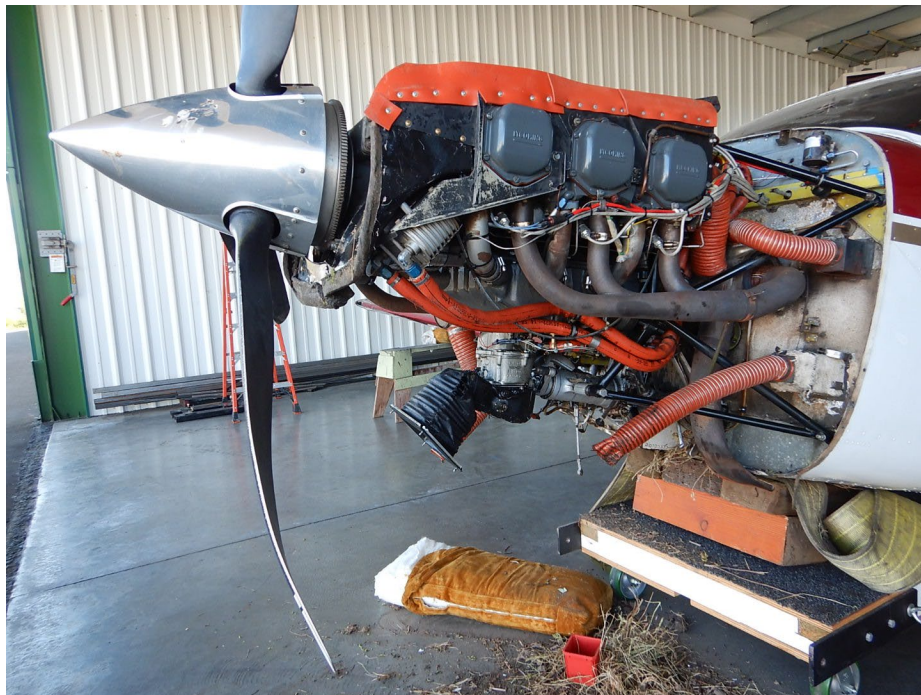
**Figure 2. View of engine at engine examination**

Examination of the recovered engine revealed that the engine remained intact with no signs of visible impact damage. The engine stayed secure in the engine compartment throughout the examination. The engine, to include the mounts and engine truss, had no visible impact damage to the cylinders or crankcase. The attached engine its accessories were found intact and secured to its corresponding mount pad.
