# National Transportation Safety Board

WPR22LA217

## **MATERIALS LABORATORY**

Factual Report 22-078

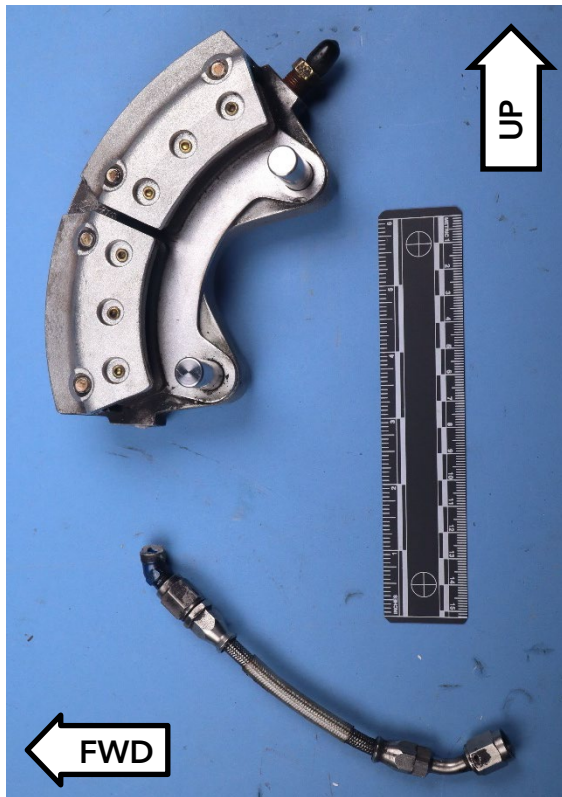
An overall view of the submitted brake caliper and brake line components from the left main landing gear are shown in figure 1. The brake line 45-degree fitting at the lower side of the caliper was fractured. The fracture surfaces had a uniform matte gray appearance as shown in figure 2, and the fracture intersected the surfaces at slant angles, features consistent with ductile overstress fracture.

**Figure 1.** Outboard side of the brake caliper and brake line showing the fractured 45-degree fitting.

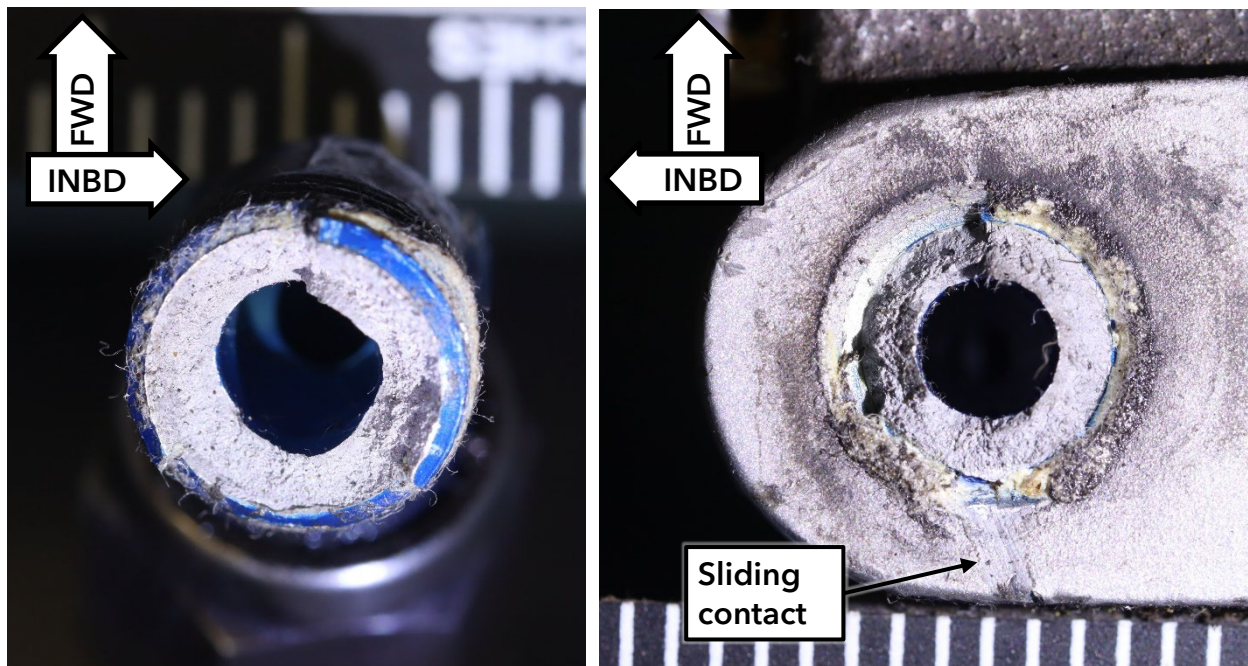
**Figure 2.** Upper (right image) and lower (left image) mating fracture surfaces of the 45-degree fitting.

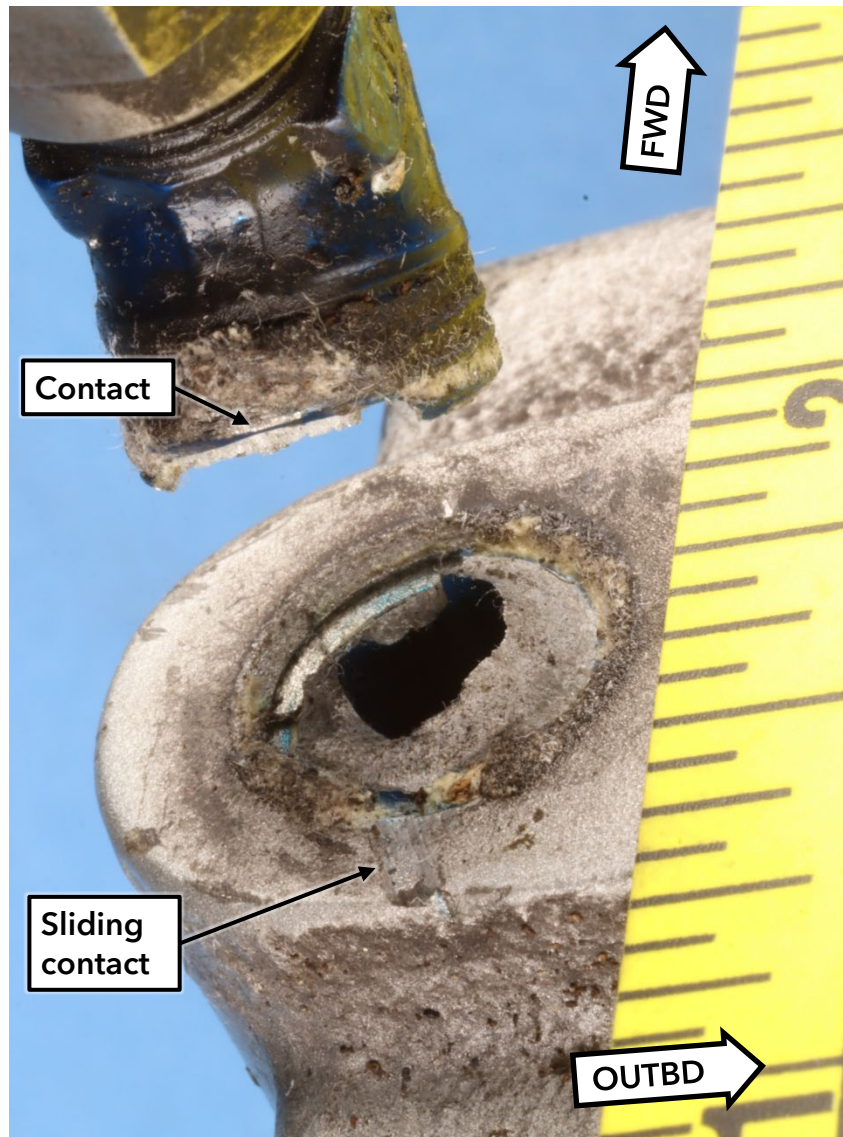
A sliding contact mark was observed on the lower surface of the caliper aft of the fitting as indicated in figure 2. The surface within the contact mark was smeared showing a deformation pattern consistent with contacting an object moving forward relative to the brake caliper. A contact mark was also observed on the aft side of the fitting adjacent to the sliding contact mark on the caliper as shown in figure 3.

**Figure 3.** Lower surface of the brake caliper showing a sliding contact mark on the caliper surface and a contact mark on the adjacent surface on the aft side of the fractured fitting.
