## **NATIONAL TRANSPORTATION SAFETY BOARD**

# **AIRFRAME AND ENGINE EXAMINATION**

**WPR22LA219**

| Aircraft: | Cessna, TR182, N756EG |

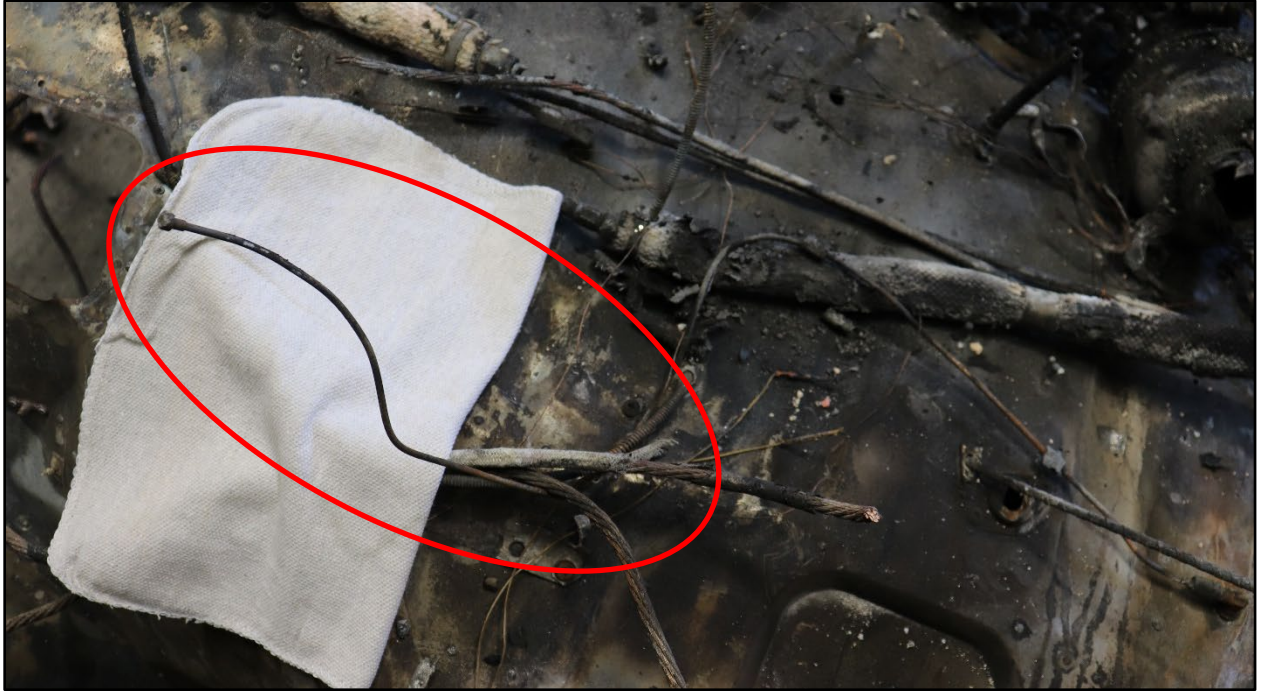
The fuel primer line was separated from the airframe fuel strainer assembly and exhibited thermal and impact damage. The airframe fuel strainer assembly was separated from the firewall and was thermal and impact damaged. Safety wire was observed from the bottom of the fuel filter to a threaded fuel fitting.

Figure 1: View of primer fuel line.

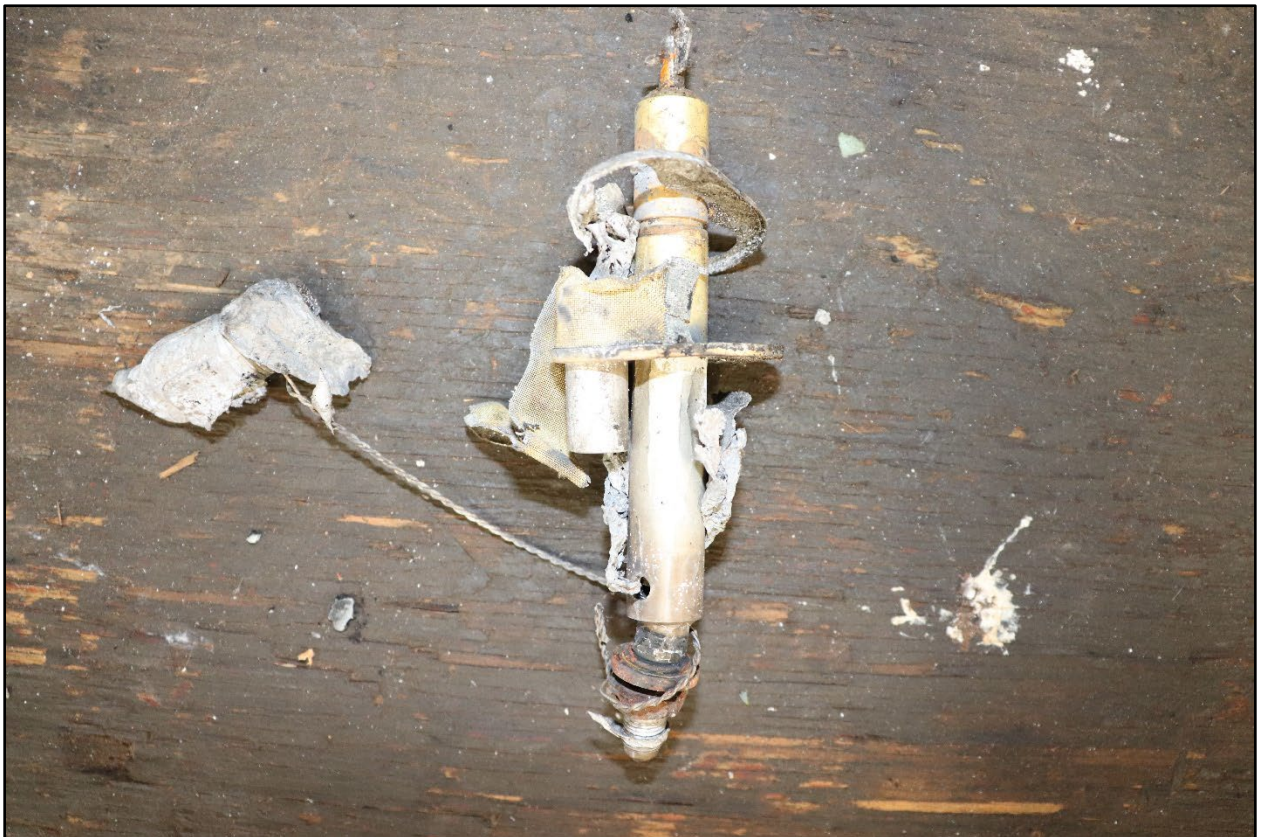
Figure 2: View of airframe fuel strainer assembly damage.

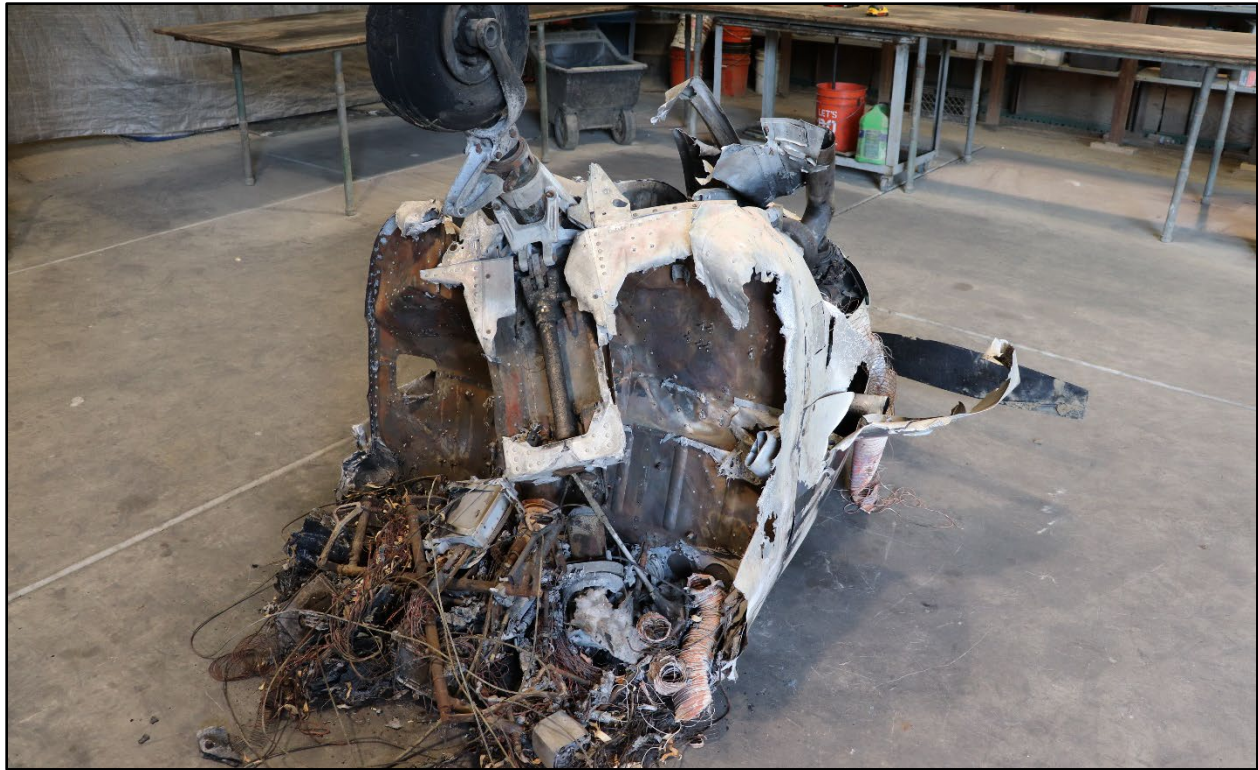
Examination of the recovered wreckage revealed that the cockpit and fuselage structure was mostly destroyed by thermal and impact damage. The firewall separated from the fuselage structure, the engine, engine mount and nose landing gear remained attached to the firewall and exhibited thermal and impact damage throughout. The main landing gear and instrument panel were separated, exhibited thermal and impact damage throughout. Multiple instruments were separated from the instrument panel and exhibited thermal and impact damage.

**Figure 3: View firewall thermal and impact damage.**

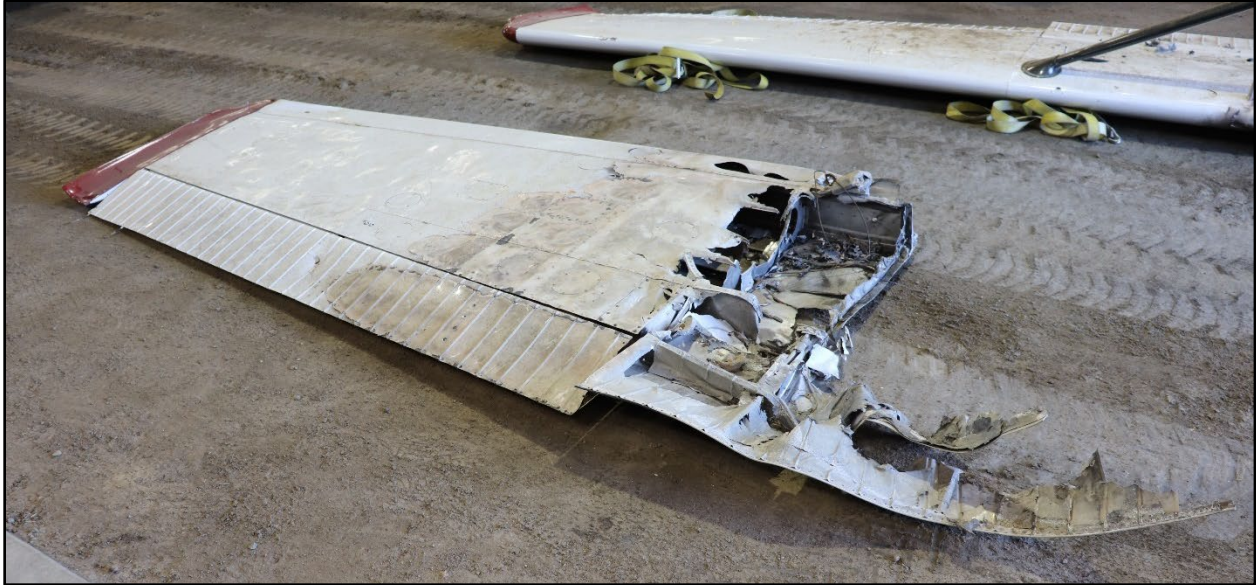
The right wing from the wing root to about midspan was destroyed by fire. The right wing aileron remained attached to the wing attachment points. The outboard wing flap remained attached to the outboard wing attachment points and the inboard wing flap was thermal and impact damaged. The right main landing gear separated from the fuselage and was thermal damaged.

**Figure 4: View of right wing thermal damage.**

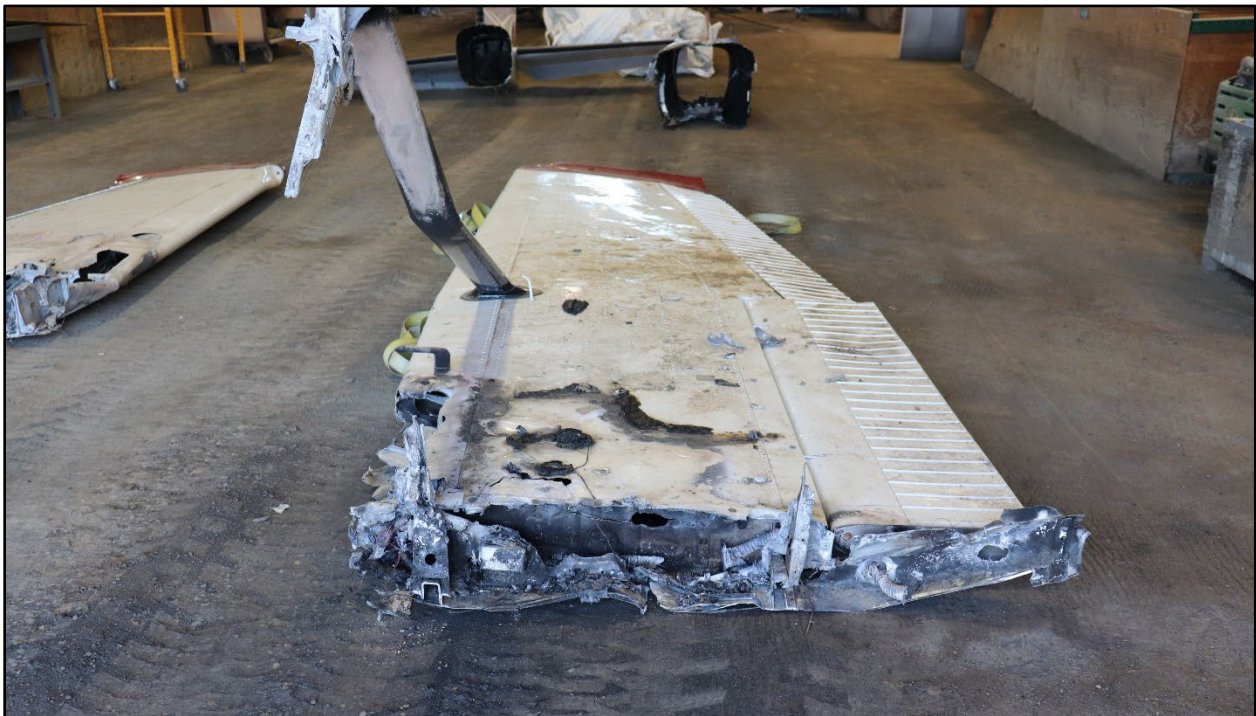
The left wing was separated from the fuselage at the wing root and was thermal damaged. The left aileron and flap remained attached to the wing via the wing attachment points. The left main landing gear separated from the fuselage and was thermal damaged.

**Figure 5: View of left wing thermal damage.**

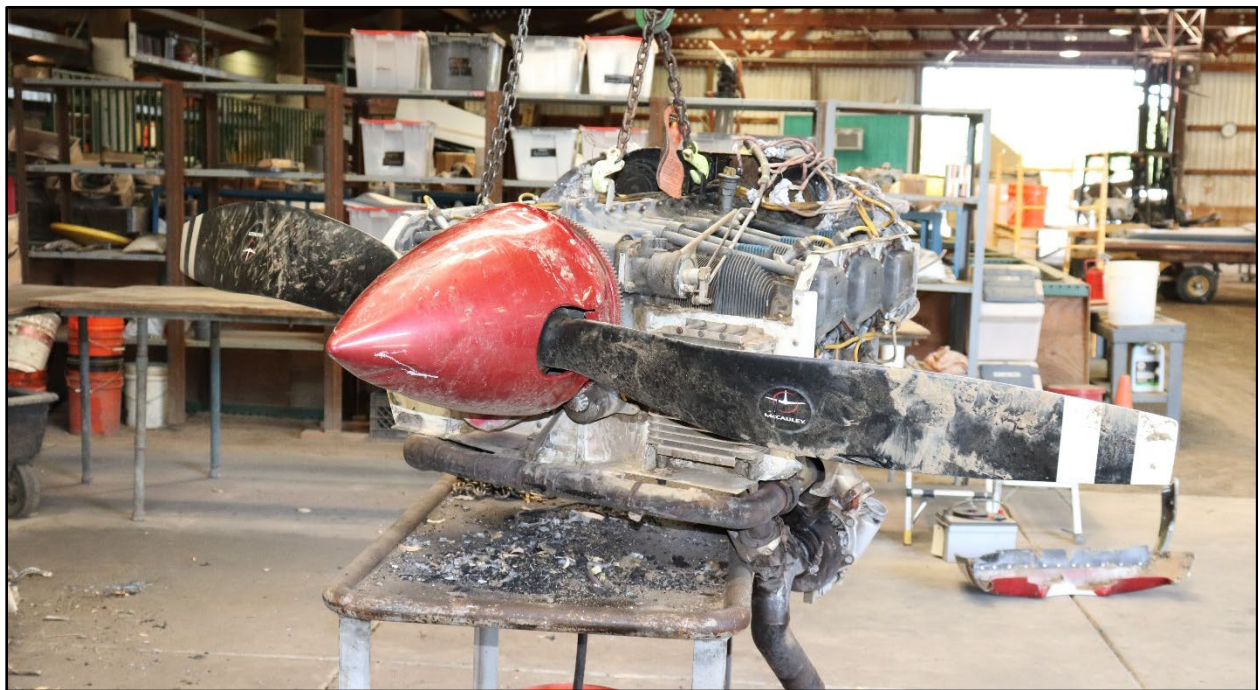
Examination of the recovered engine revealed that the engine remained attached to the engine mounts, impact and thermal damage was observed. Impact damage was observed to the number 3 & 5 cylinder rocker box covers. No evidence of any mechanical damage was observed to the engine crankcase. All six cylinders and engine accessories remained attached. Extensive thermal damage was observed to the engine accessories case. The carburetor exhibited bulging, consistent with thermal damage. The engine driven fuel pump remained attached to the engine and was thermal damaged. All fuel lines near the engine's accessories case were thermal damaged and various fuel lines were loose.

The intake and exhaust system remained secure to the cylinders, bending and crushing was observed.

Figure 6: Front view of engine.

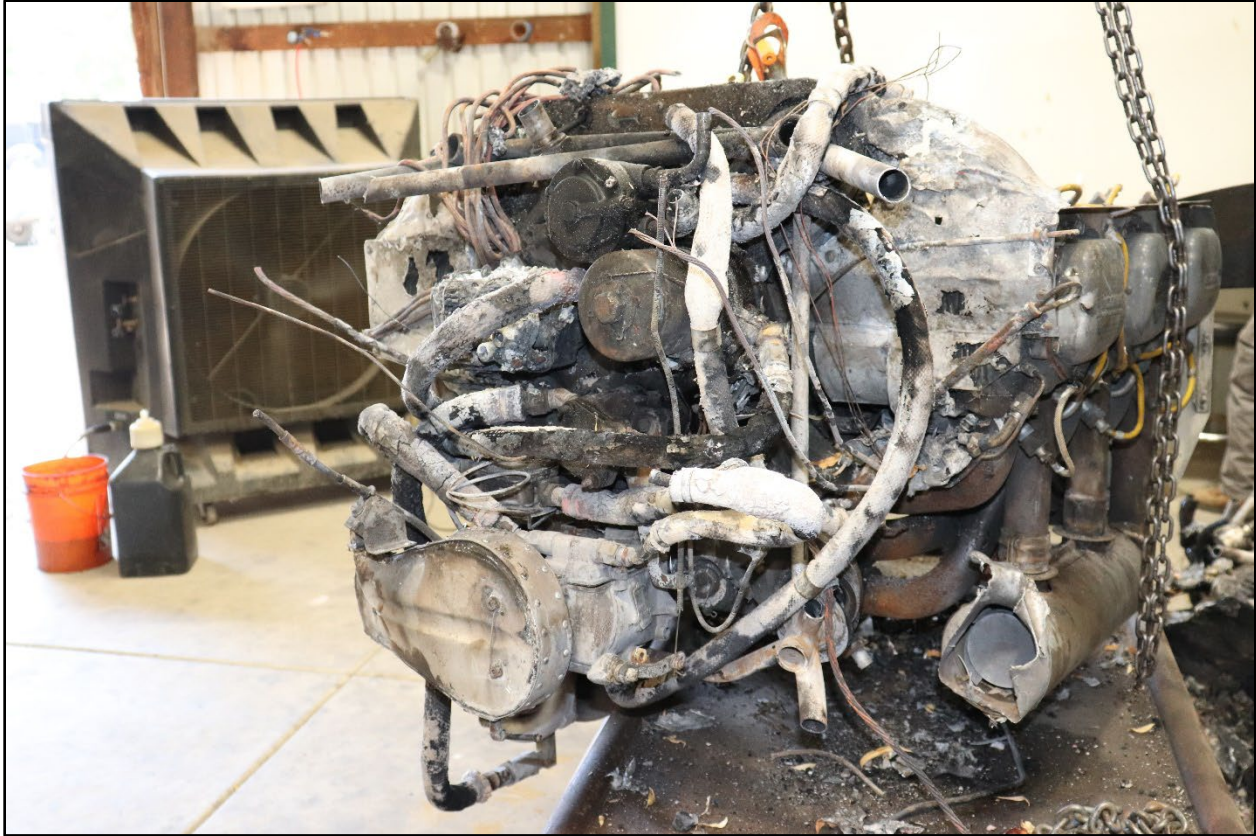
The single drive, dual magneto remained attached to the engine accessory case, extensive damage thermal damaged was observed. Due to extensive thermal damage, a functional test could not be performed.

**Figure 7: Rear view of engine thermal damage.**

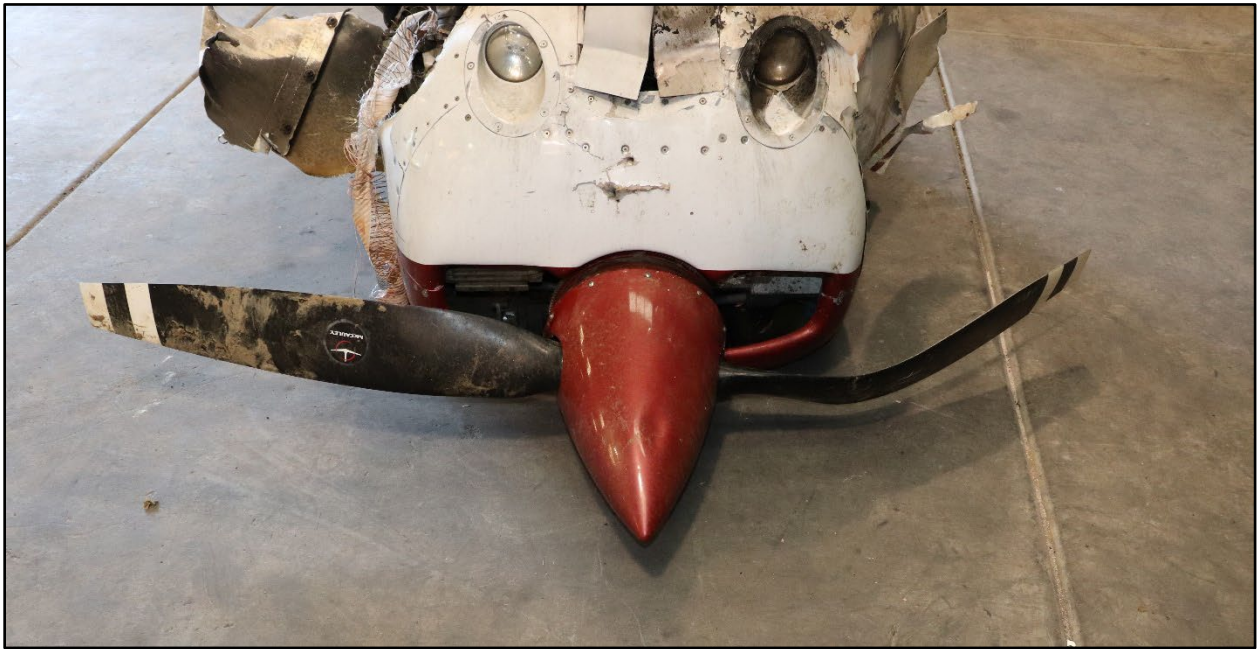
The airplane was equipped with a two blade McCauley propeller. The propeller and propeller hub remained attached to the engine at the crankshaft. Both propeller blades remained attached to the propeller hub. Propeller blade A exhibited polishing along the leading edge with unidirectional striations on the cambered side of the blade. Propeller blade B exhibited bending aft about mid with unidirectional striations on the cambered side of the blade.

Figure 8: View of propeller.
