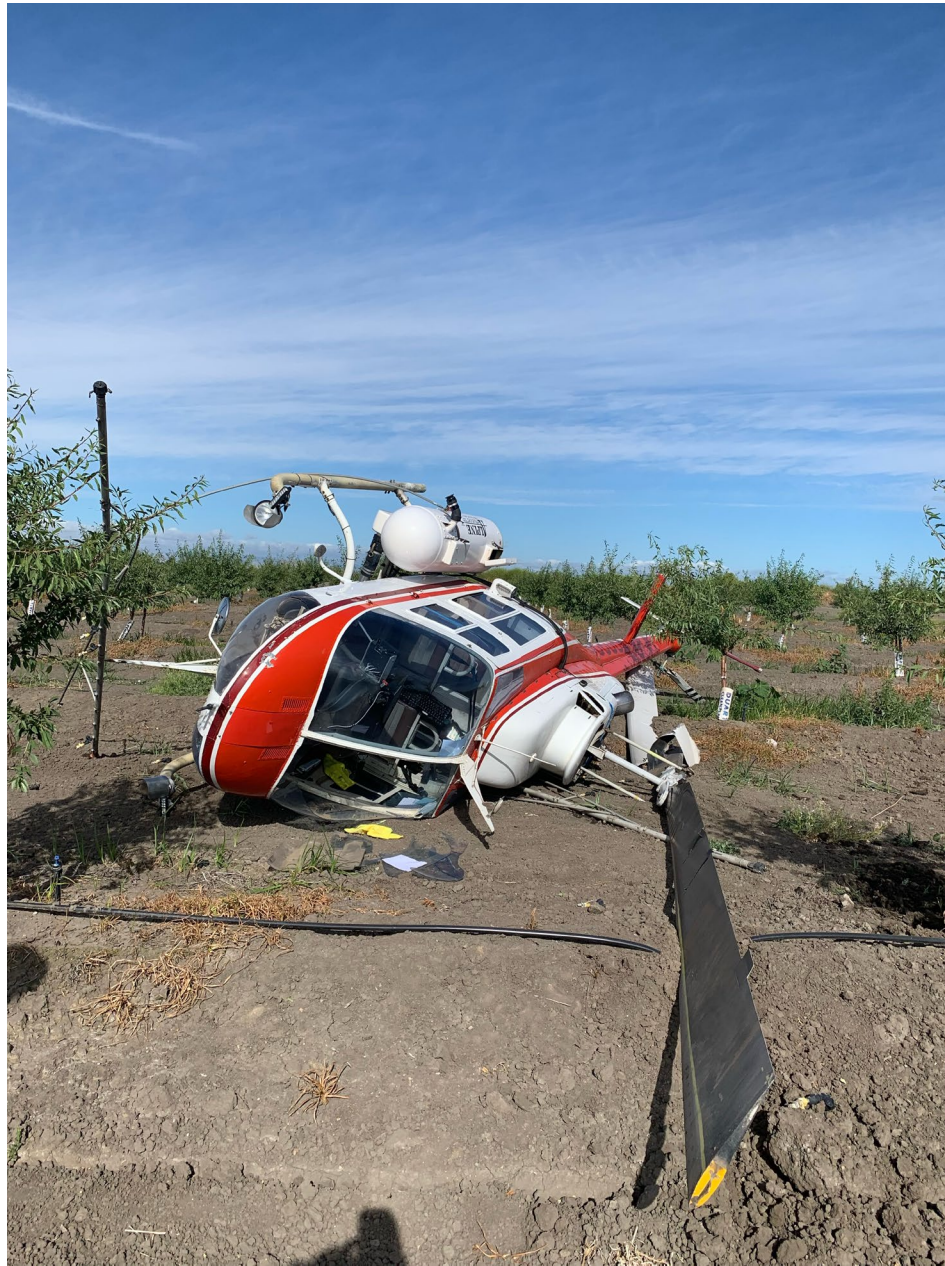
**Photo 1 – N90326 at the accident location. Photo courtesy of the operator.**

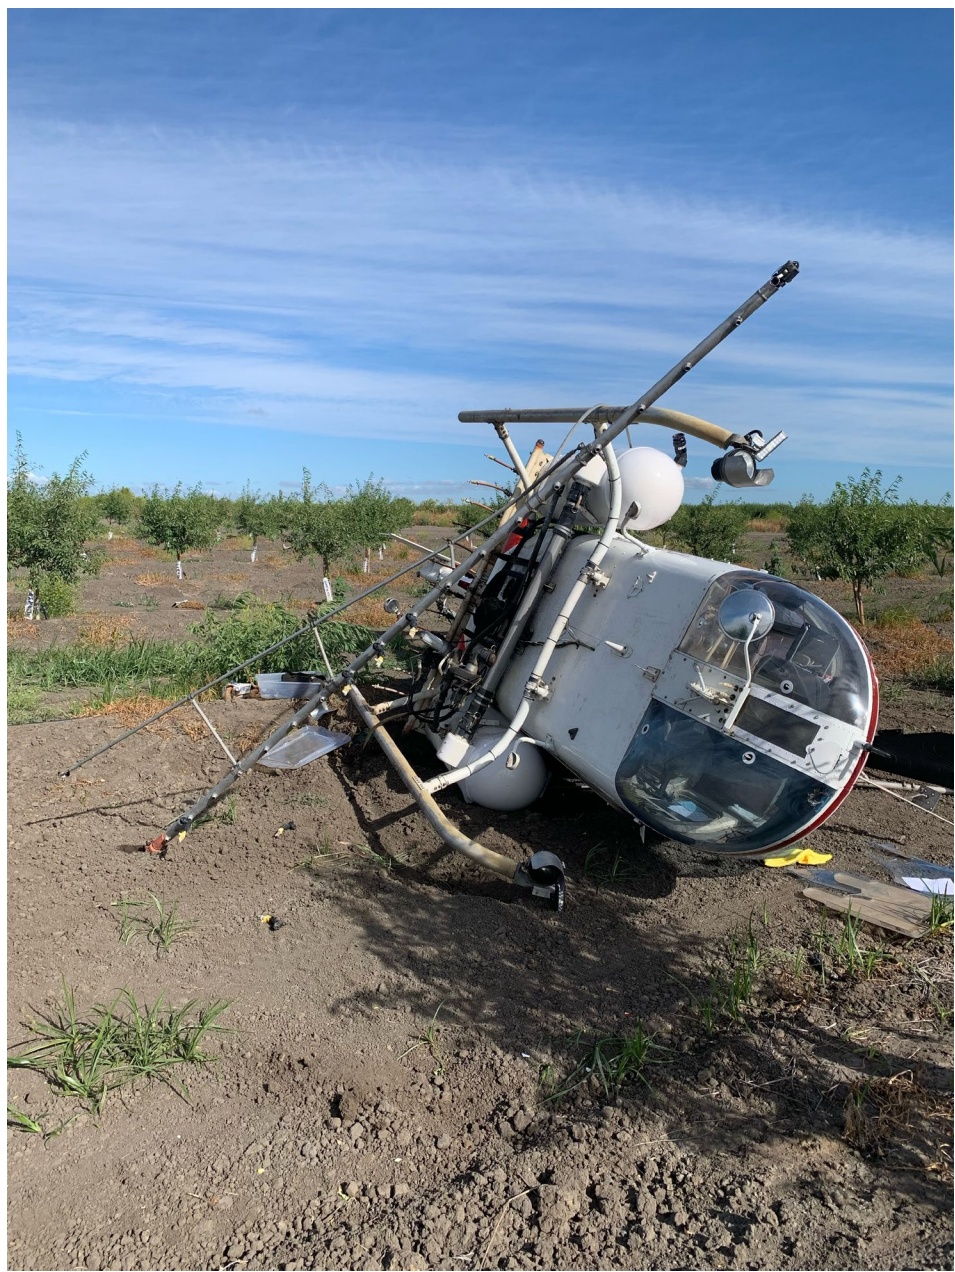
**Photo 2 – Front, underside view. Photo courtesy of the operator.**

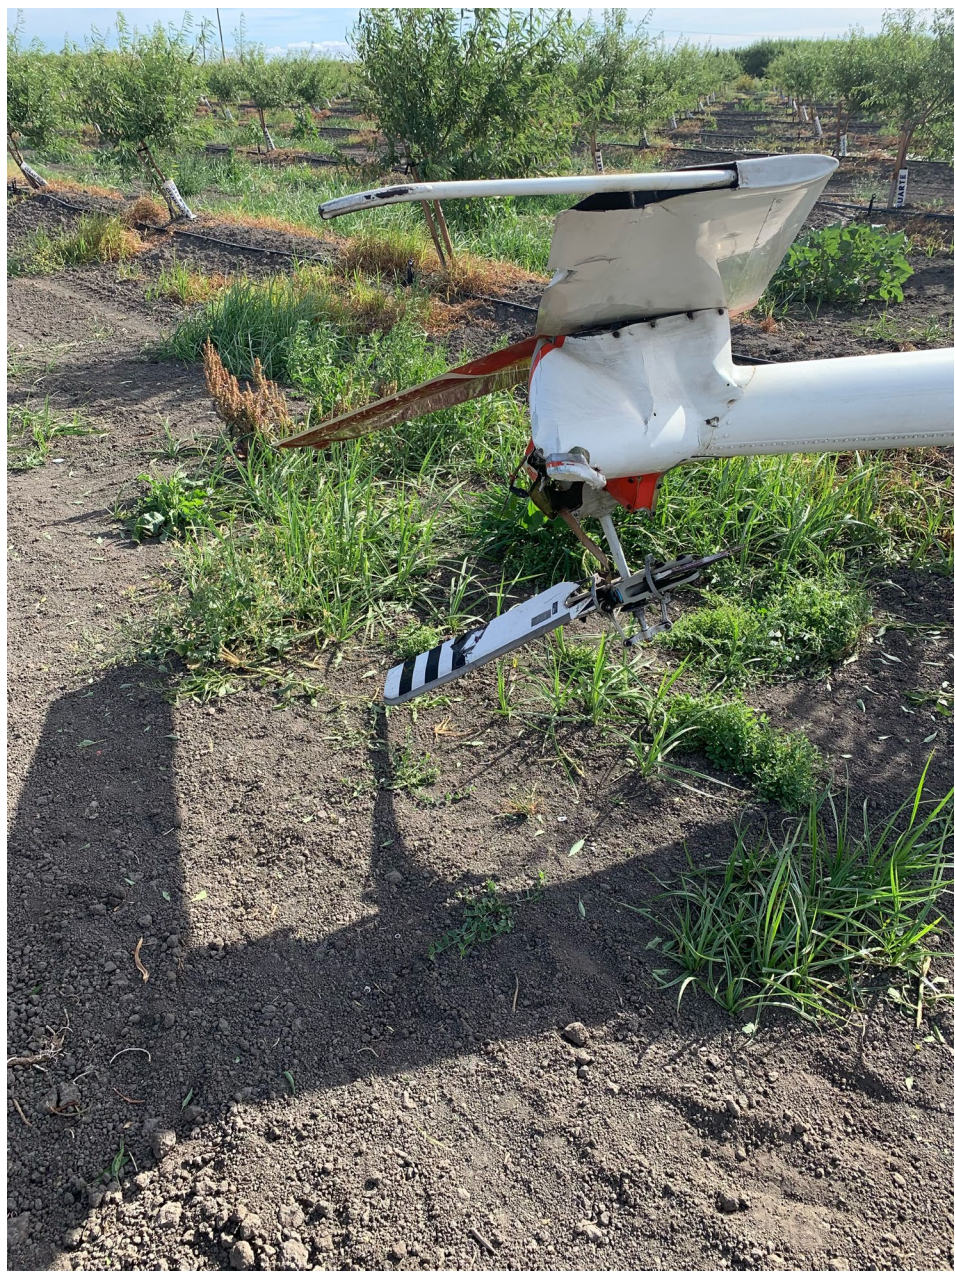
**Photo 3 – Tail rotor assembly, showing the absence of one tail rotor blade. Photo courtesy of the operator.**

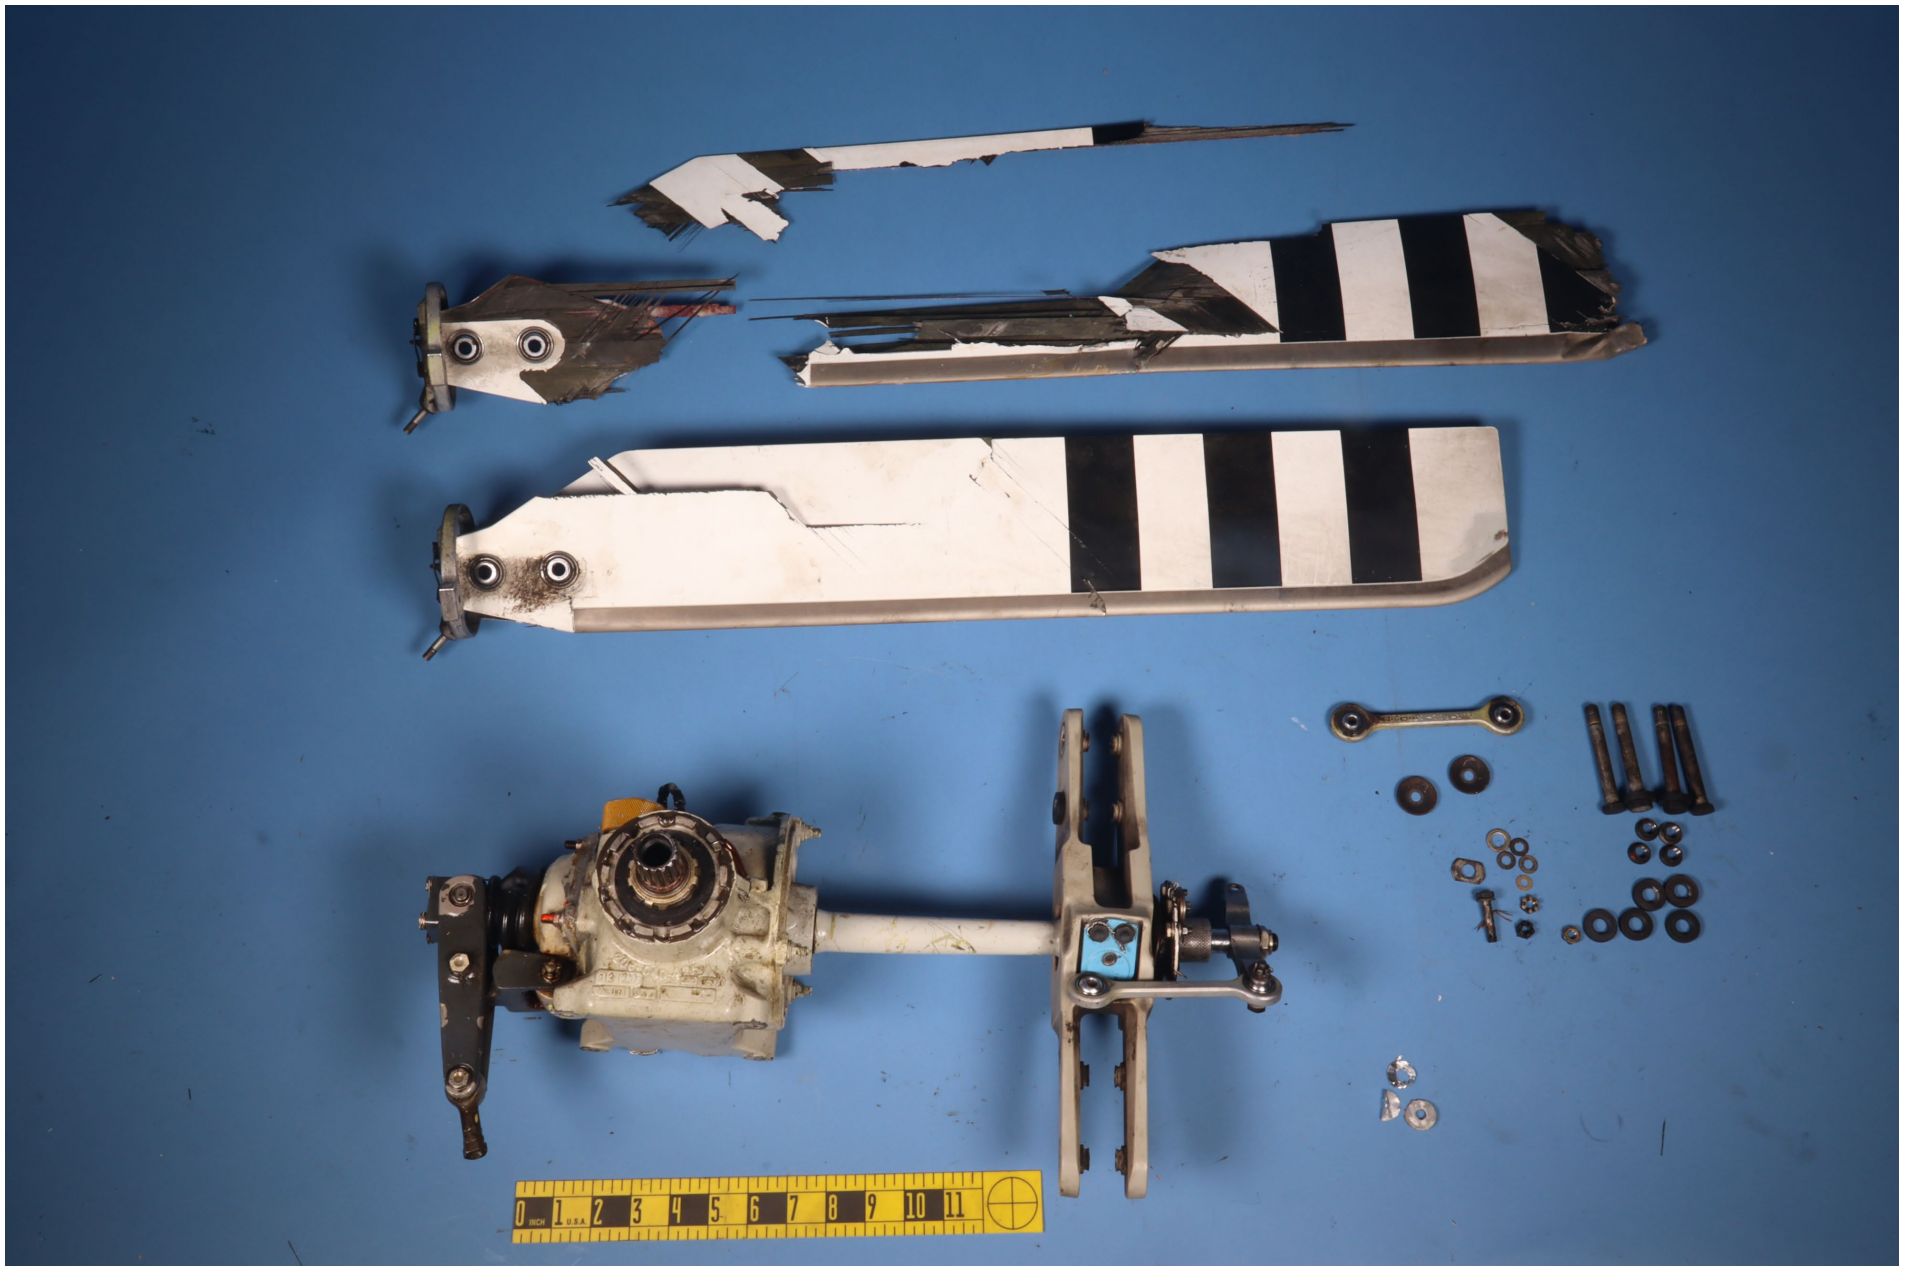
**Photo 4 – Components received by the National Transportation Safety Board’s Materials laboratory.**
