# National Transportation Safety Board

WPR22LA221

## **MATERIALS LABORATORY**

Factual Report 23-052

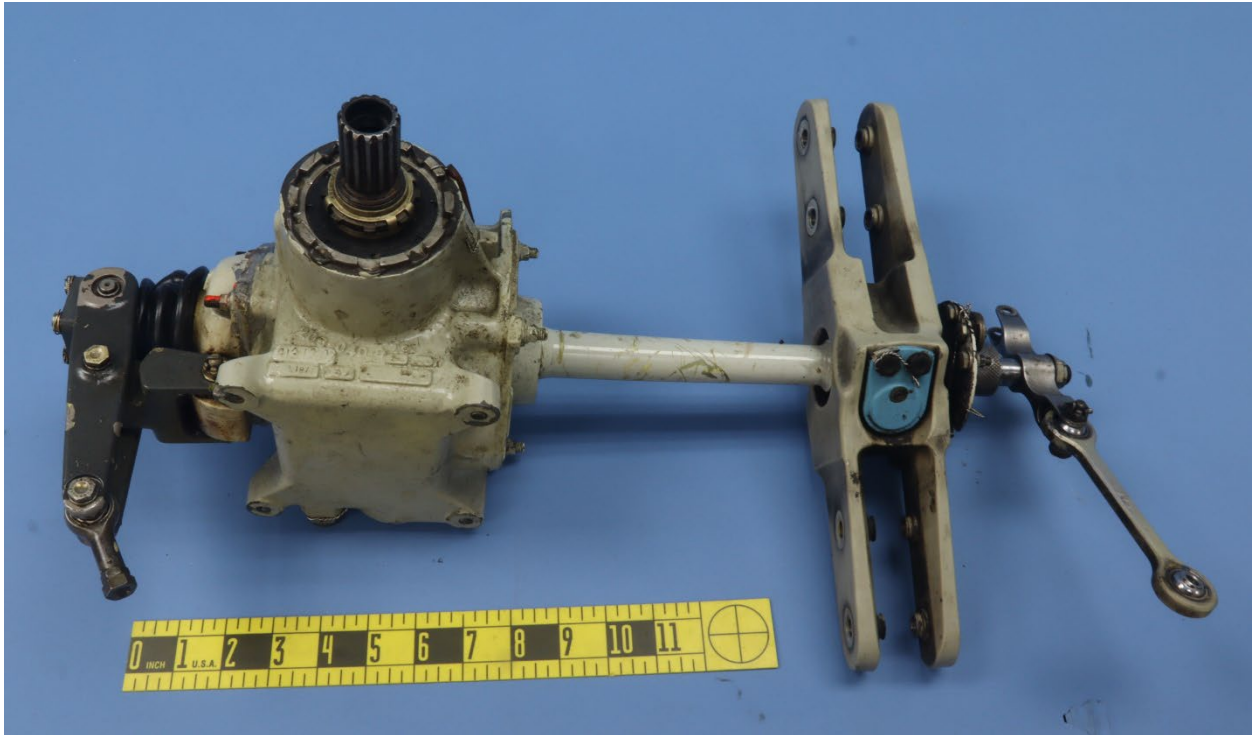
Figure 1 shows the 90° tail rotor gearbox assembly as received. Figure 2 shows the opposite outboard side. The markings on the housing on the plate in Figure 2 stated, "206-040-400 XX 009, ALO-52321, BELL HELICOPTERS, D13." The embossed marking on the side of the housing was similar, stating, "206-040-426, A1312678, 1R71." Several of the seals from the gearbox were leaking oil, primarily from the rubber boot along the shaft connected to the crosshead assembly.

**Figure 1.** The 90° tail rotor gearbox assembly, from the drive shaft side.

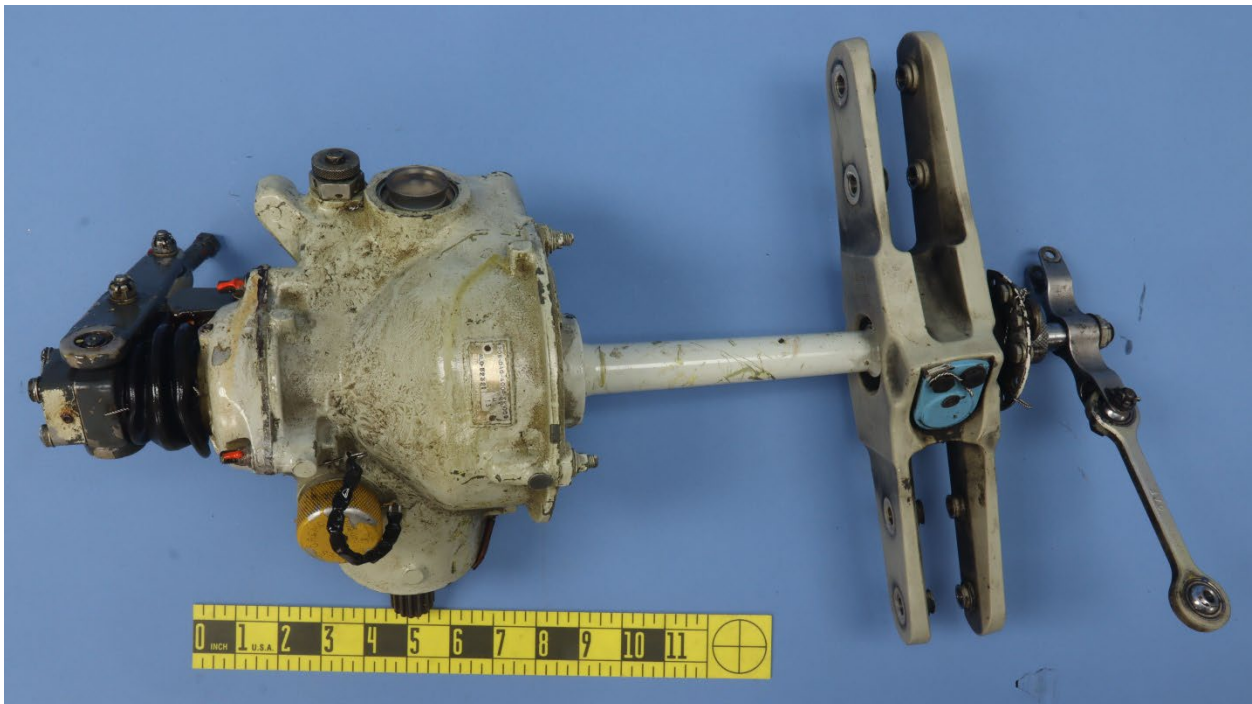
**Figure 2.** The reverse view of the outboard (housing) side of the tail rotor gearbox.

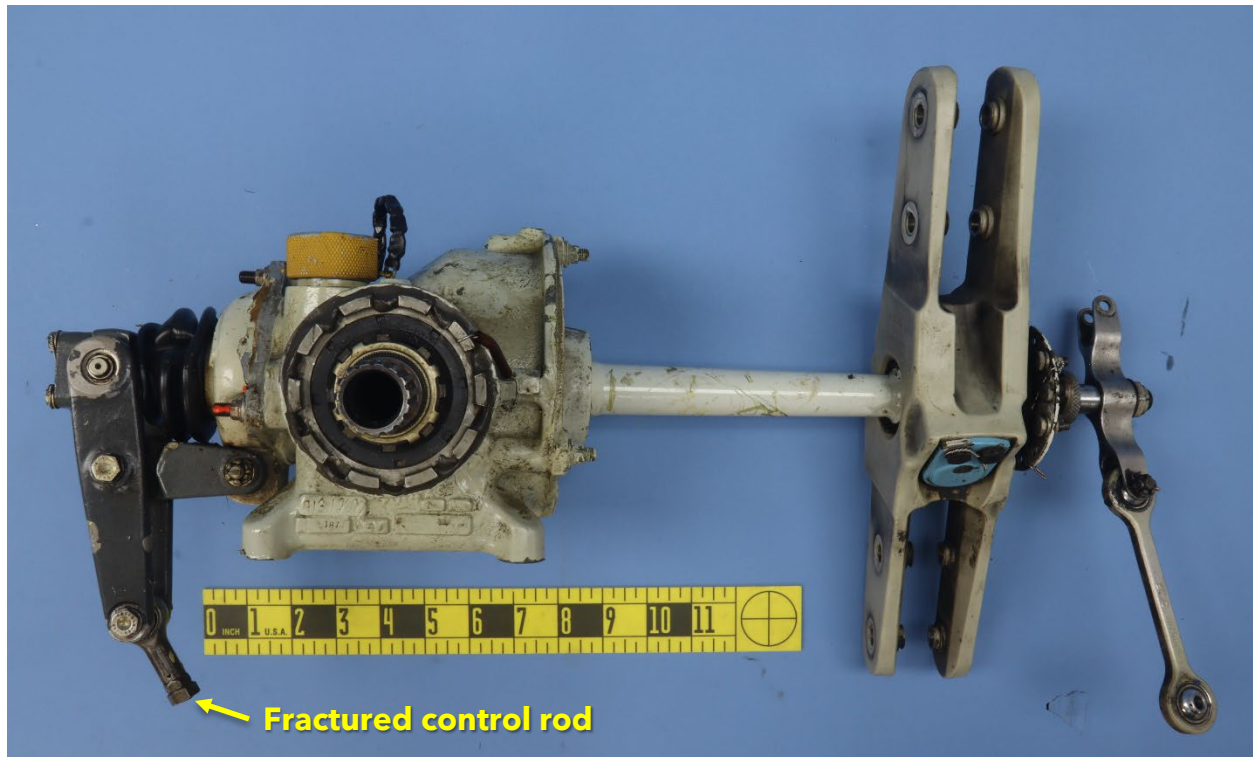
As shown on the rotated side in Figure 3, the control rod on the pitch change lever (left in the figure) had fractured. Figure 4 shows a closer view of the fractured pitch change control rod from the side and from the fracture surface. The rod was approximately 2.212 inches long when assembled (see Figure 5a). When

**Figure 3.** View of the gearbox showing the fractured pitch change control rod in the lower left.

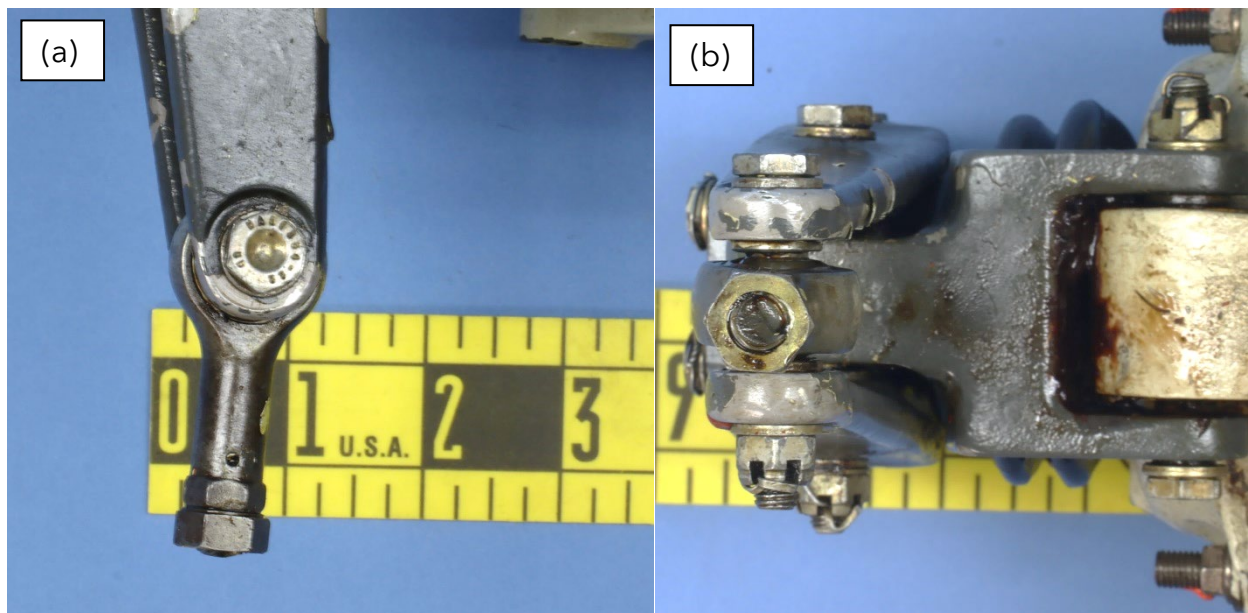
**Figure 4.** View of the fractured pitch change control rod from (a) the side and (b) the fracture surface.

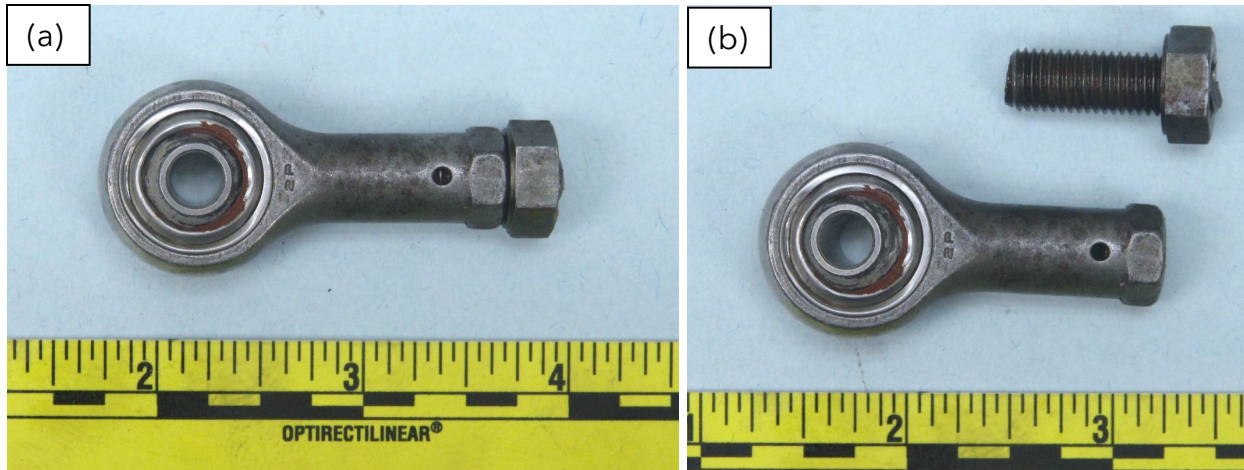
disassembled, the fractured rod end measured 1.003 inches long from the fracture surface to the opposite end face of the threaded shaft portion (Figure 5b).

**Figure 5.** Views of the control rod (a) as assembled and (b) disassembled.

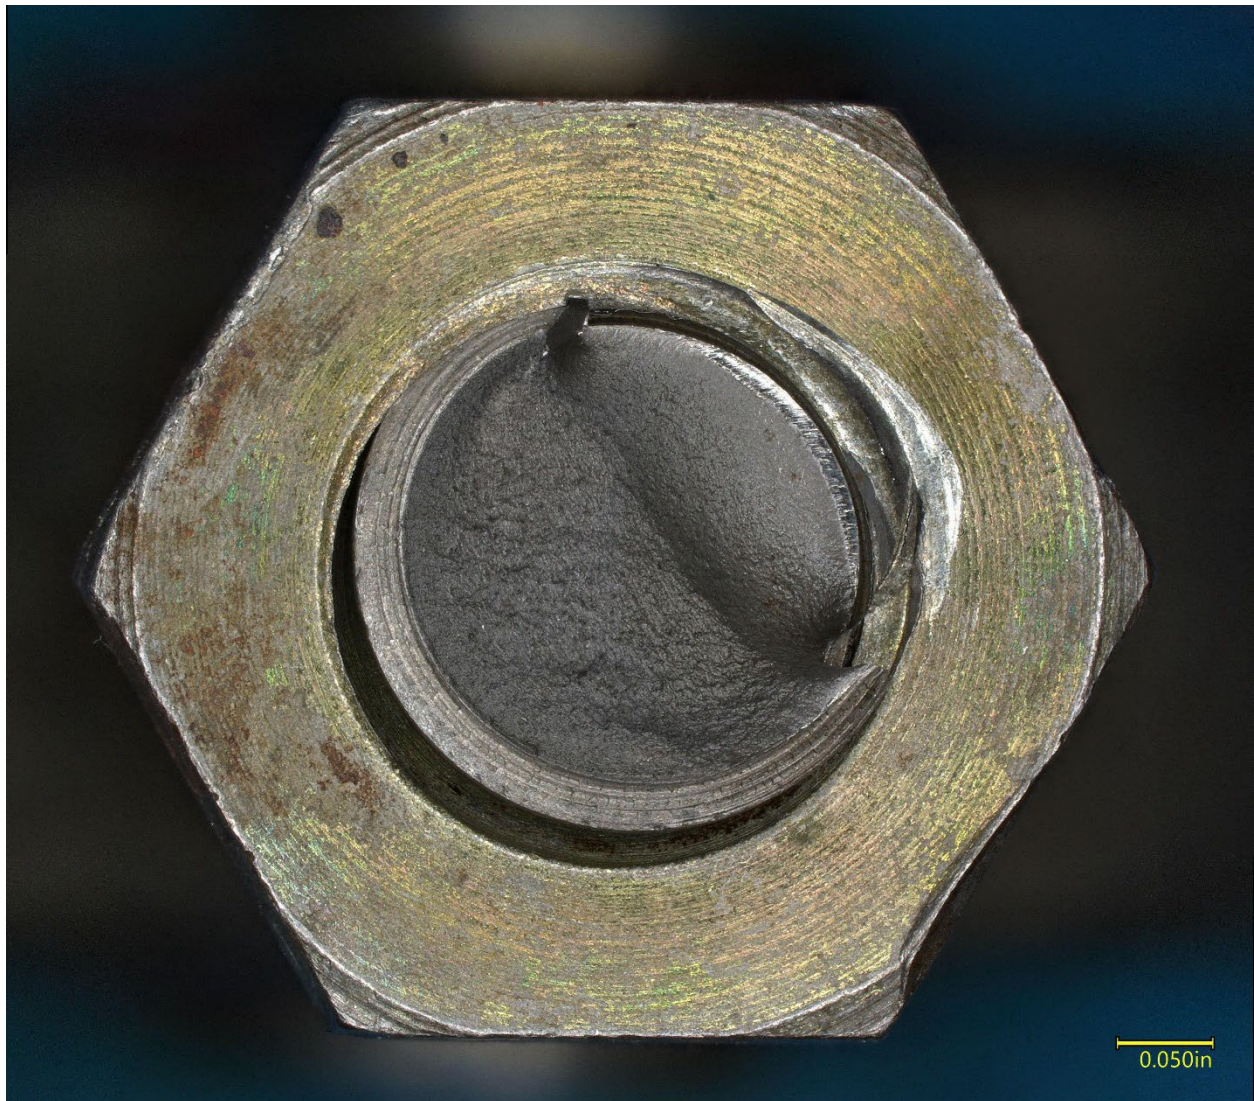
The fractured rod was removed and cleaned in an ultrasonic bath of acetone. The fracture surface is illustrated in Figure 6. This surface exhibited a rough, fibrous texture with a dull luster. The surface showed areas of higher and lower elevation with an area of reflective material on the surrounding nut on the upper left. On the opposite side of the rod, the part had deformed upward and inward. These features were consistent with overstress fracture from bending, with the bending direction being from the lower left to the upper right in Figure 6.

**Figure 6.** Closer view of the rod fracture surface, after cleaning.

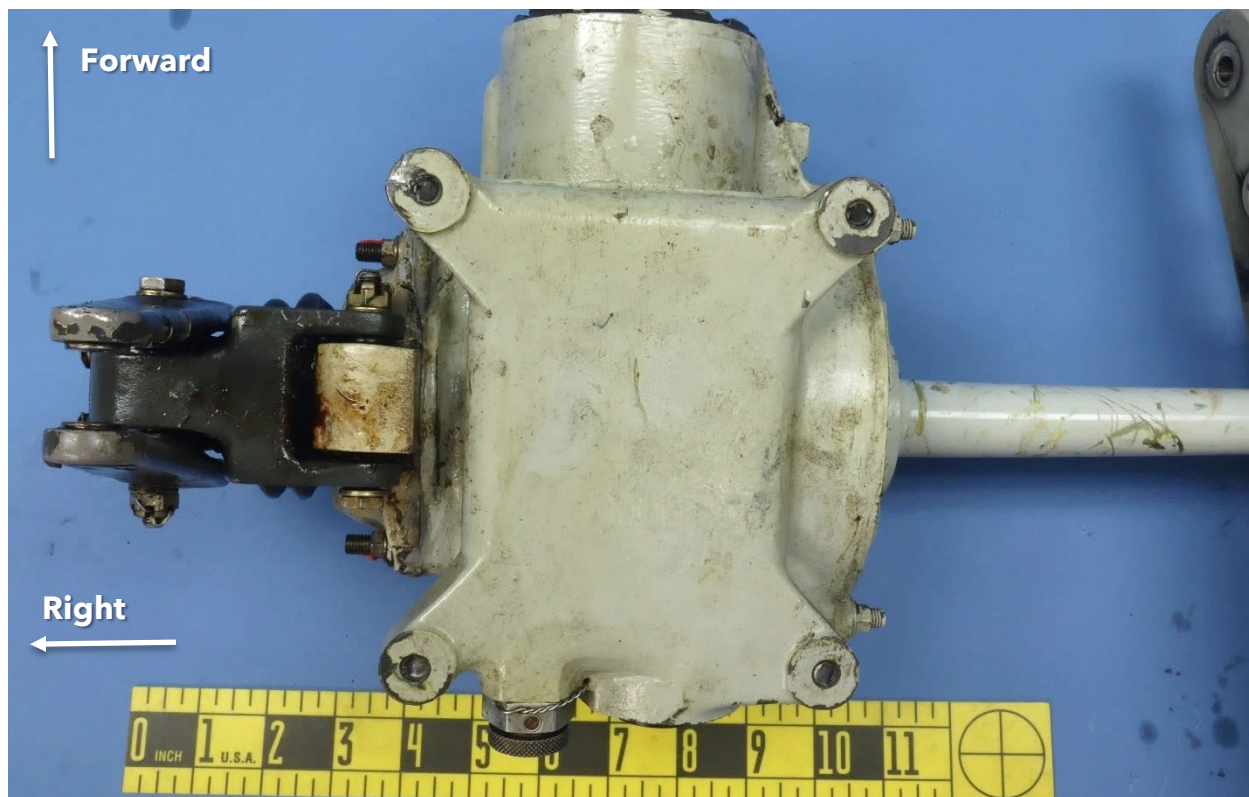
Figure 7 shows the tail rotor gearbox housing in the inboard face, which had attached to the tail boom via four bolts. All these bolts had fractured, as illustrated in the figure. These bolt fractures and the surrounding housing of the gearbox are shown in more detail at higher magnifications in Figure 8 through Figure 19.

**Figure 7.** The interior side of the gearbox housing, showing the four fractured attachment bolts to the tailboom.

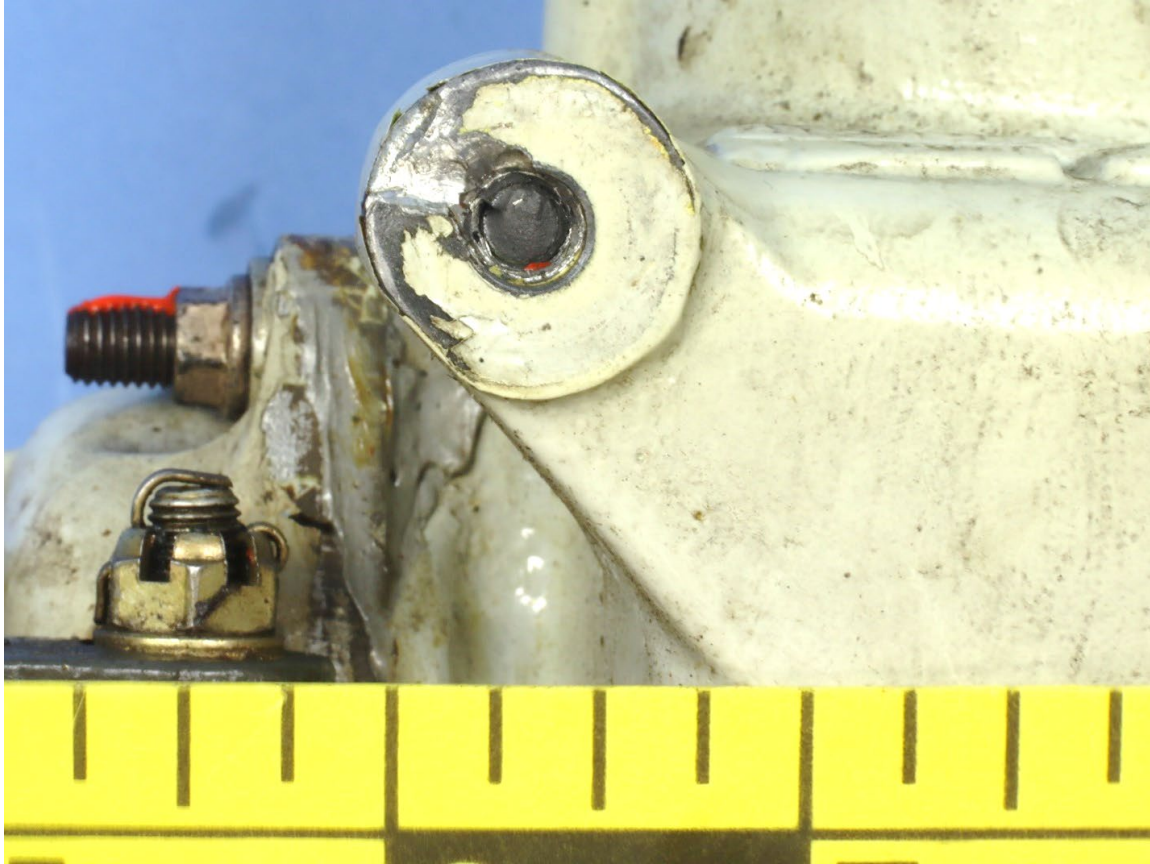
Figure 8 through Figure 10 show the fractured bolt in the upper left of Figure 7, corresponding to the forward location. Unlike the other fractured bolts, this location also exhibited a battered and deformed gouge of the inboard housing face, shown in Figure 9. This location corresponded to a depression and outward material deformation of the fracture bolt, illustrated on the fracture surface in Figure 10.

**Figure 8.** View of the fractured bolt from the forward right (upper left in **Figure 7**).

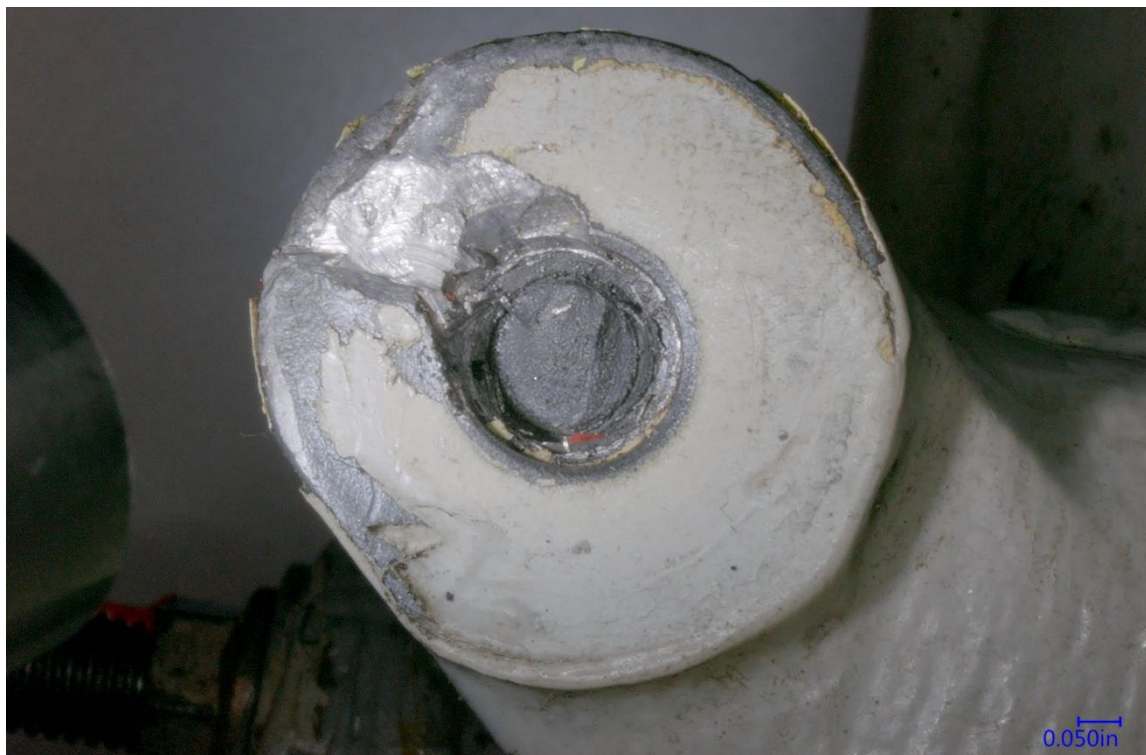
**Figure 9.** Closer view of the fractured bolt and surrounding housing.

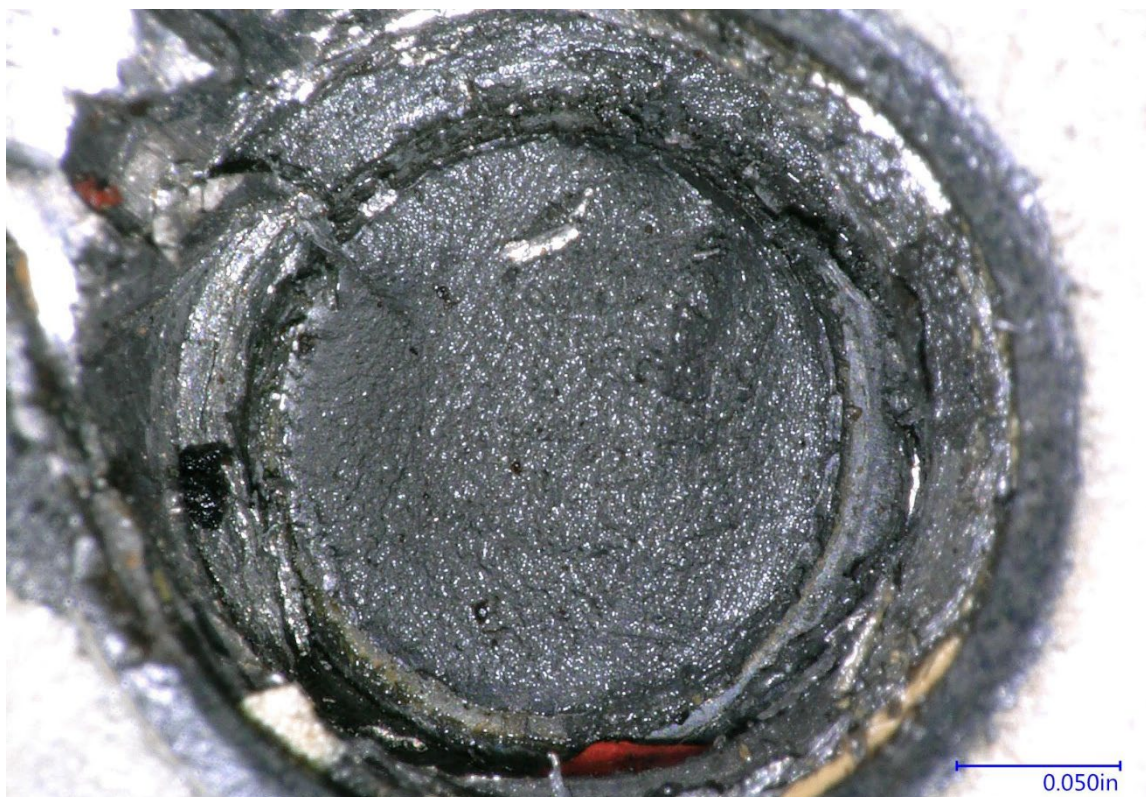
The opposite end exhibited upward and inward deformation of the bolt. The fracture surface showed a rough, fibrous texture and dull luster, consistent with overstress fracture in bending. The features were consistent with bending from the lower right in the figures towards the upper left, in line with the housing deformation and batter. This fracture pattern was consistent with movement in the upward and forward direction of the helicopter.

**Figure 10.** The fracture surface of the bolt remnant in **Figure 9**, as received.

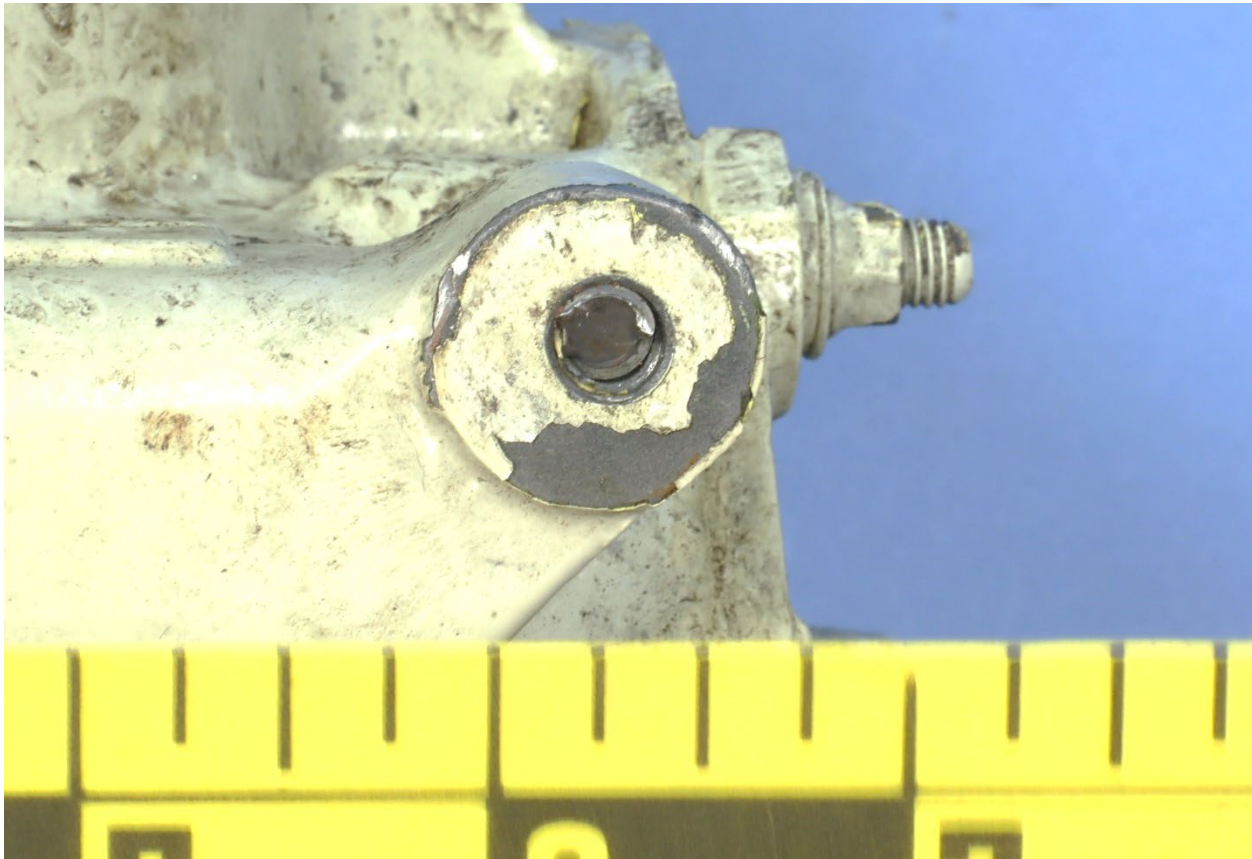
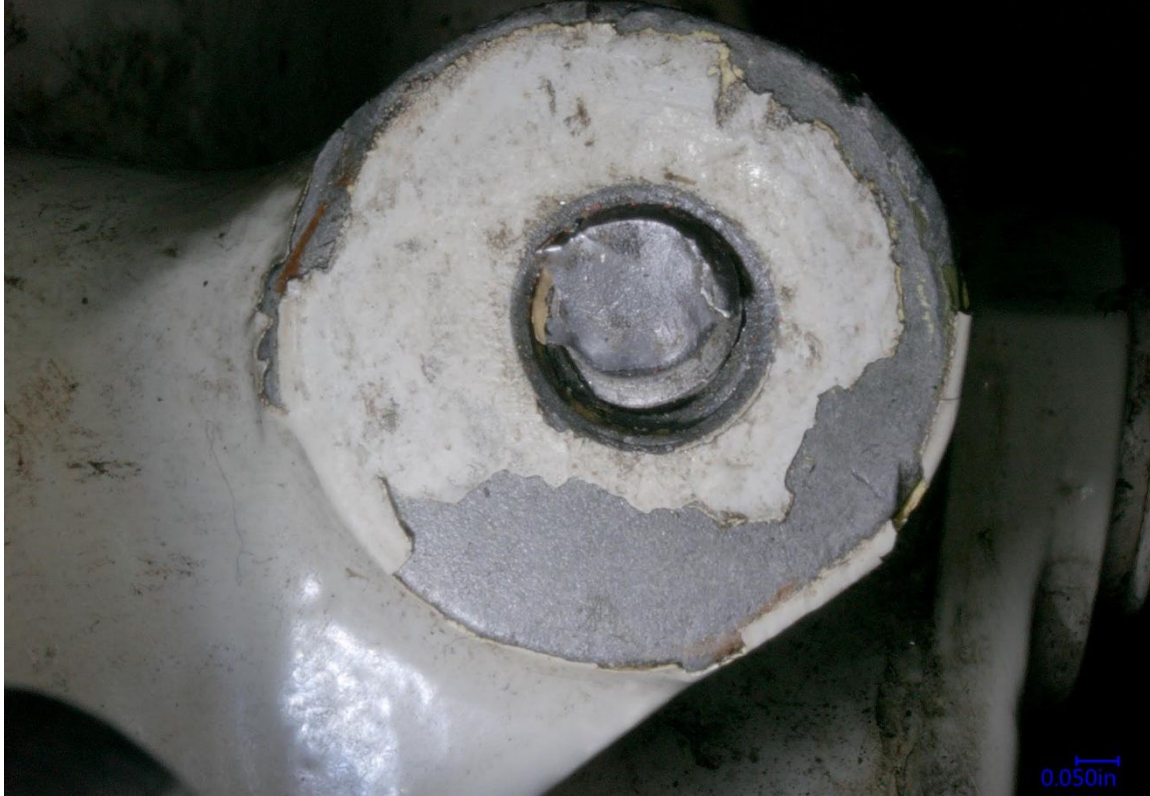
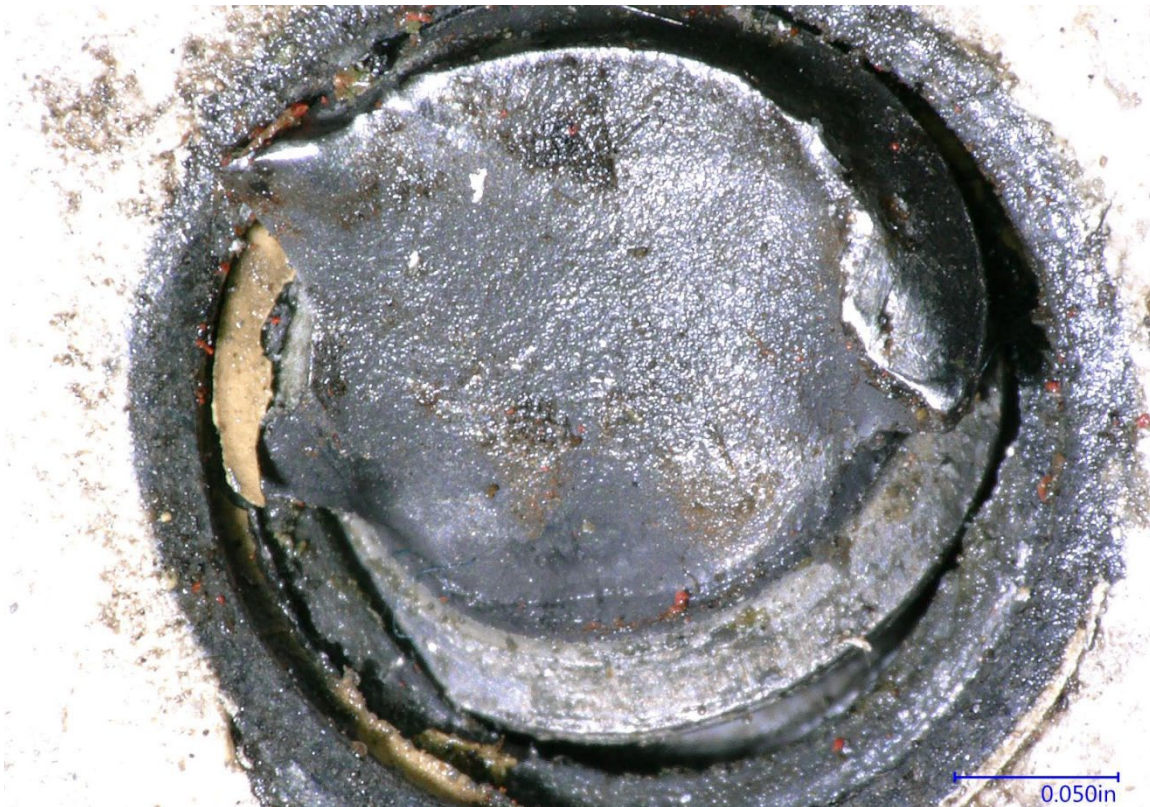
Figure 11 through Figure 13 show closer views of the upper right bolt in Figure 7. This fracture exhibited similar overstress features, such as a rough texture and dull luster. The lower portion of the bolt in the figures exhibited pullout, while the upper areas exhibited outward deformation and battered in the adjacent housing of the gearbox face. These features were consistent with upward bending (as oriented in the figures), corresponding to the upward bending of this gearbox portion relative to the tail boom.

**Figure 11.** View of the fractured bolt from the forward left position (upper right in **Figure 7**).

**Figure 12.** Closer view of the fractured bolt and surrounding housing.

**Figure 13.** The fracture surface of the bolt remnant in **Figure 12**, as received.

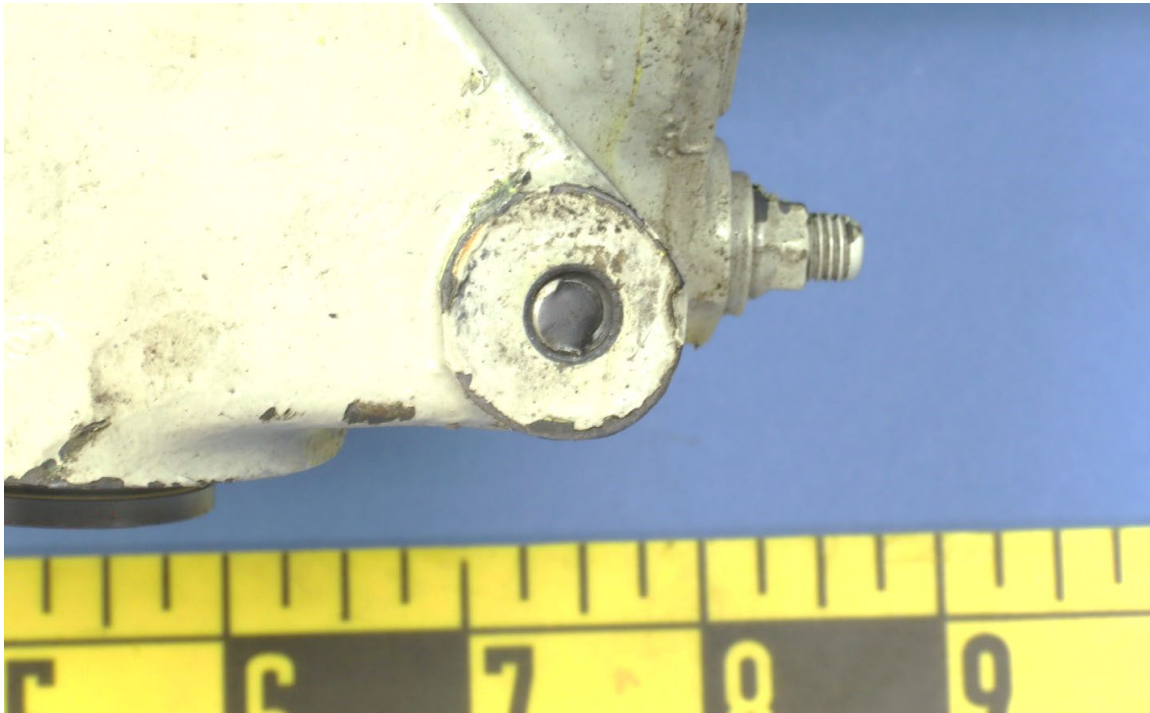
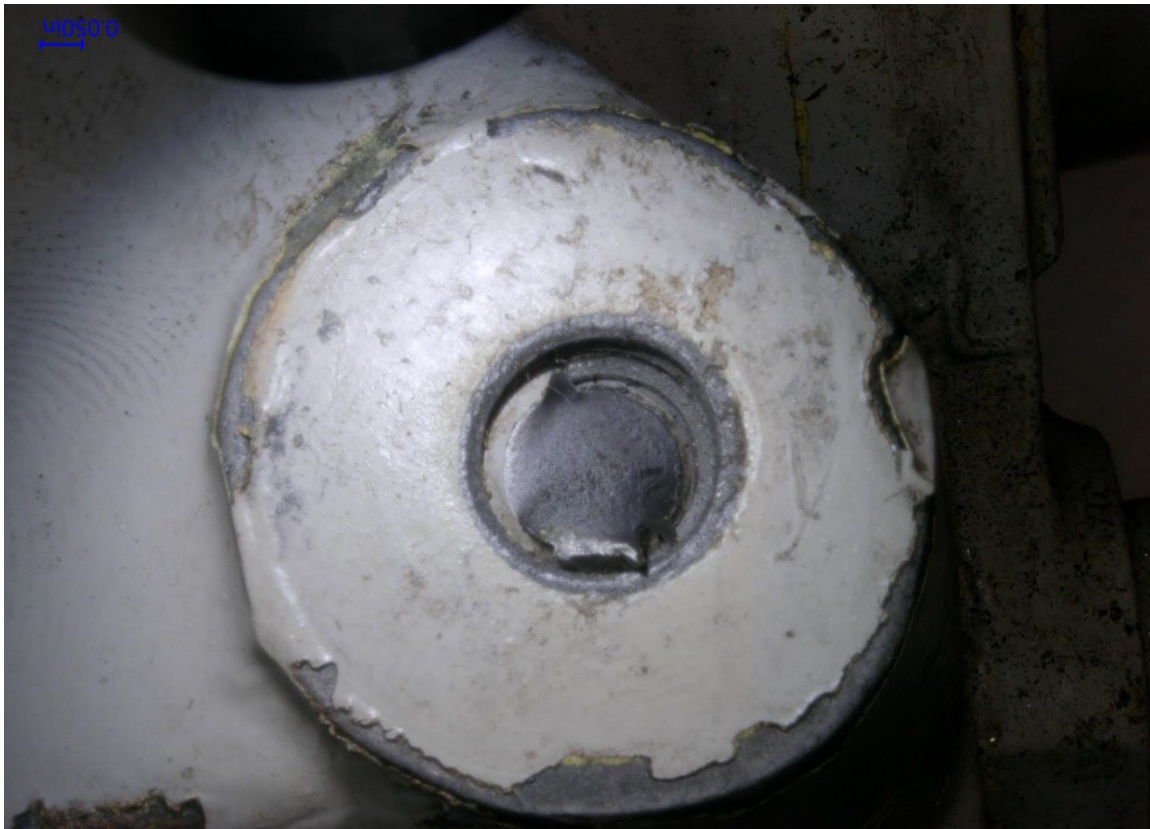
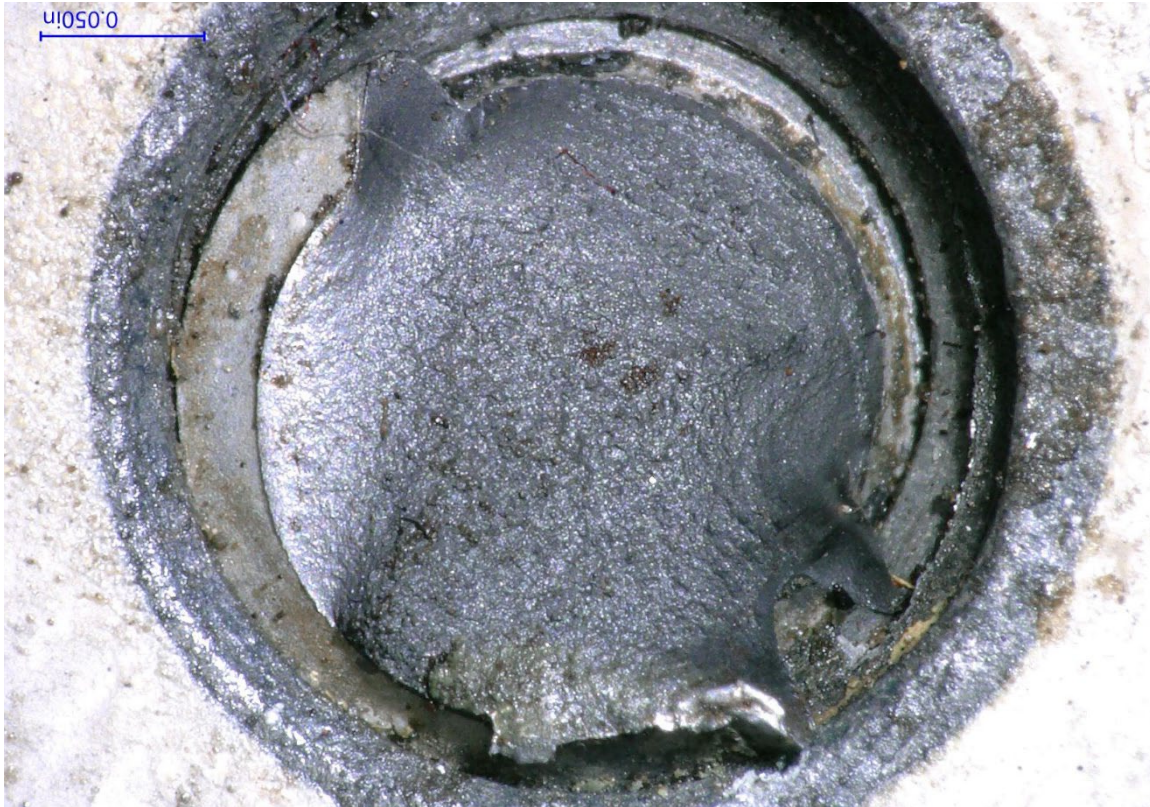
Figure 14 through Figure 16 show the fractured bolt from the lower right in Figure 7. This fracture surface, exhibiting a dull and fibrous appearance, exhibited a sloped transition with two outward protrusions located 180° from each other. The fracture displayed flow lines which could be traced from the left in Figure 16 around and down to the lower right. Similarly, the fractured bolt in the lower left position exhibited similar features with a comparable but inverted morphology (see Figure 17

**Figure 14.** View of the fractured bolt from the aft left (lower right in **Figure 7**).

**Figure 15.** Closer view of the fractured bolt and surrounding housing.

**Figure 16.** The fracture surface of the bolt remnant in **Figure 15**, as received.

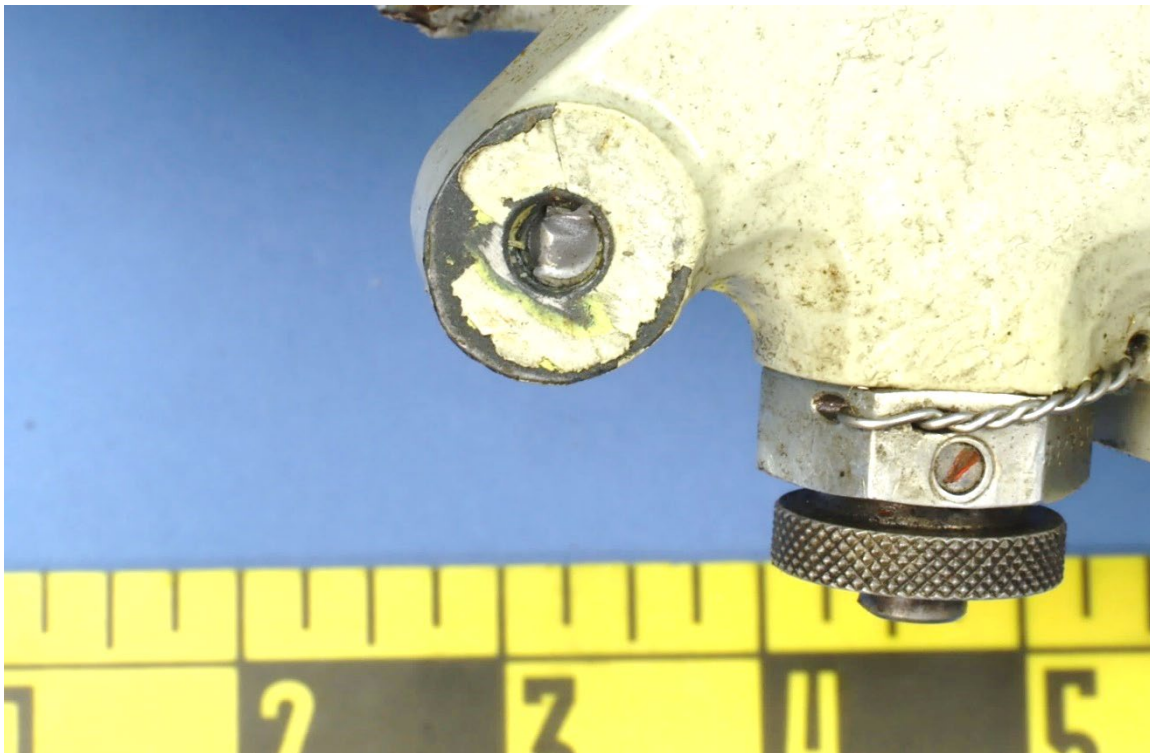
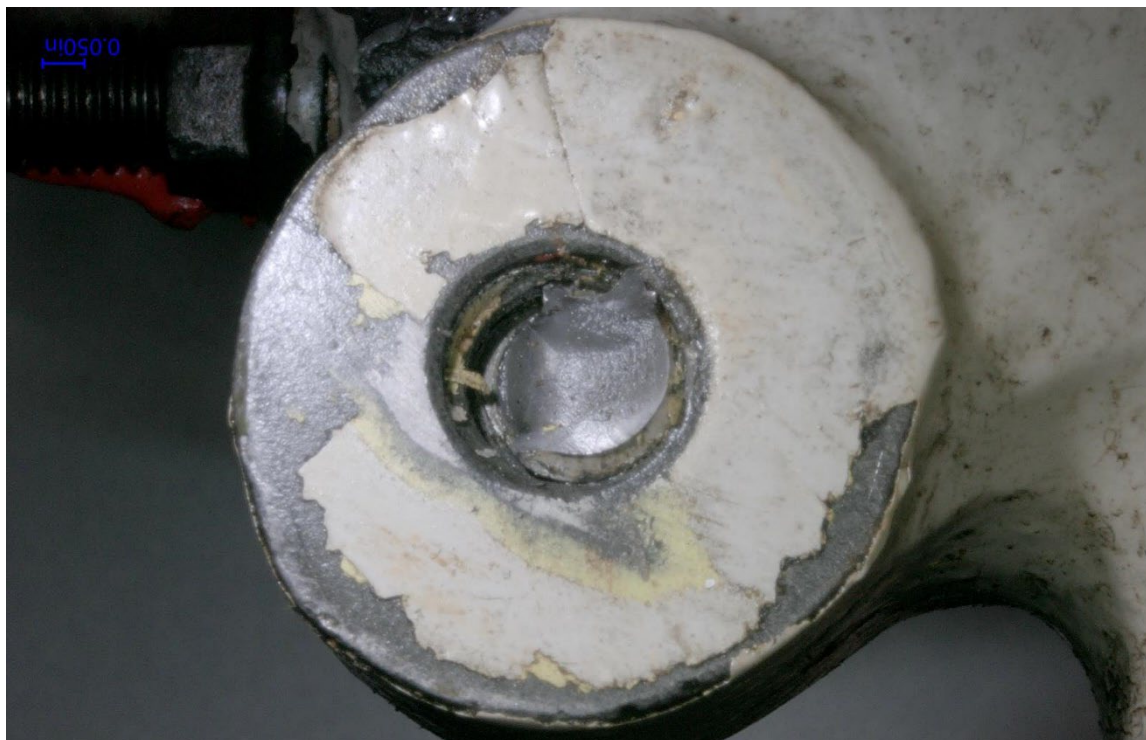
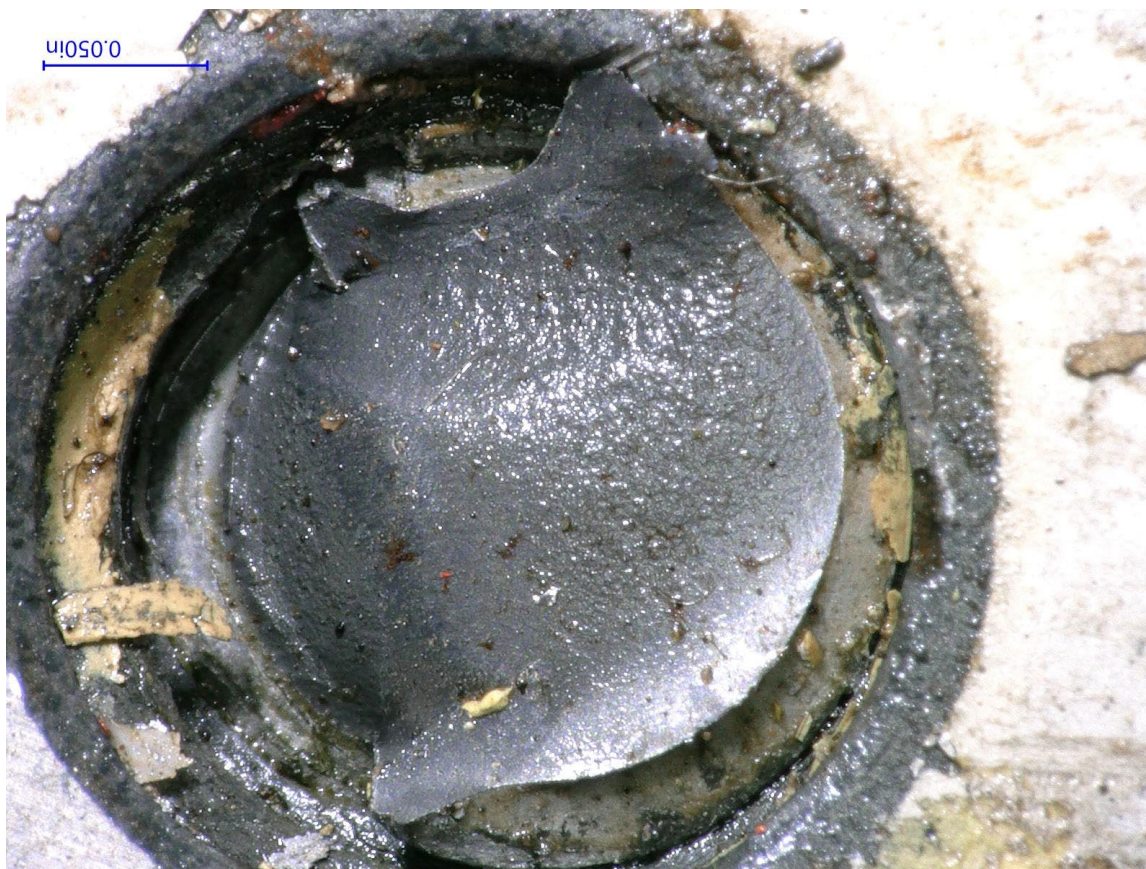
through Figure 19). These features were consistent with overstress fracture of lower two bolts in torsion.

**Figure 17.** View of the fractured bolt from the aft right (lower left in **Figure 7**).

**Figure 18.** Closer view of the fractured bolt and surrounding housing.

**Figure 19.** The fracture surface of the bolt remnant in **Figure 18**, as received.

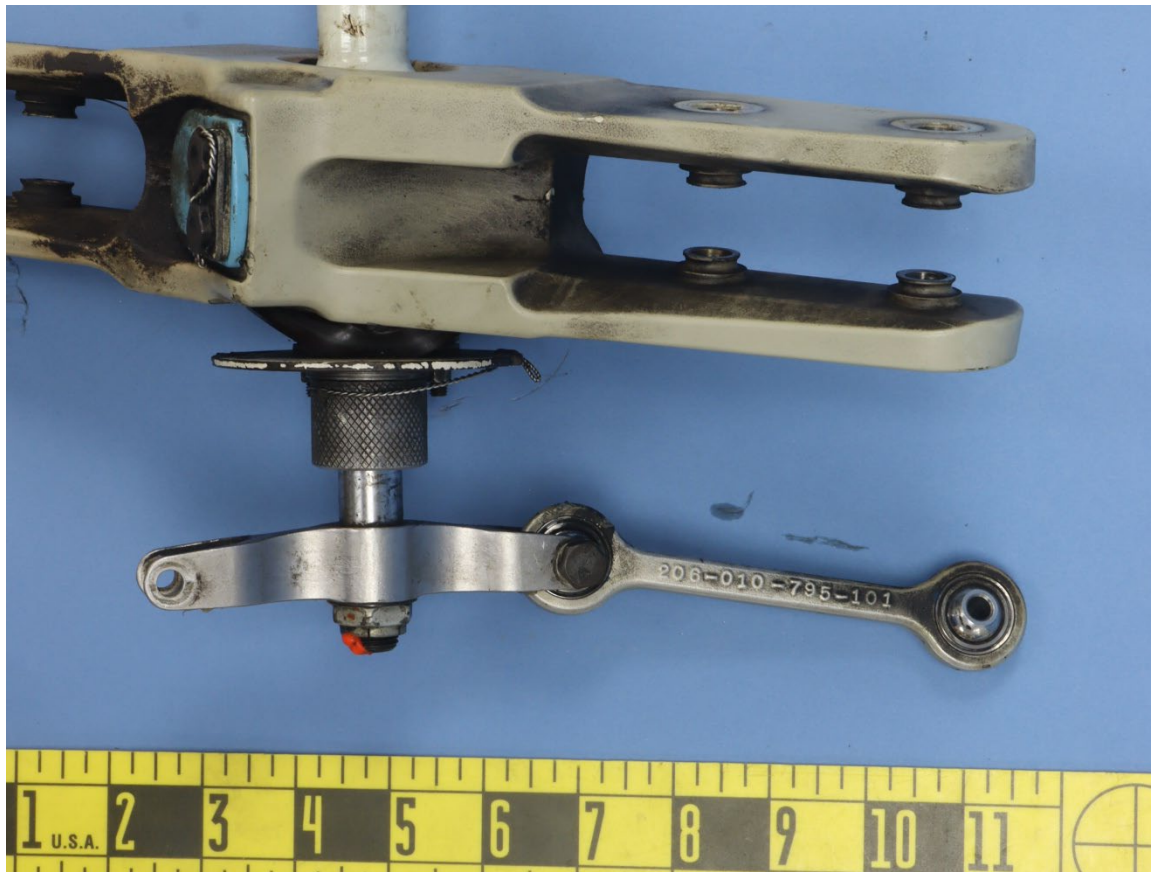
Examination of the blade grips and hub from the gearbox assembly did not reveal any witness marks or indications of pre-existing damage. As shown in Figure 20, one of the links was still attached to the crosshead. The opposite side was absent its link, and the holes of the fork from that link position are shown in Figure 21. The holes exhibited some elongation, being as narrow as 0.2455 inches in one direction and as long as 0.2490 in the direction perpendicular. However, there were no other indications of damage, such as gouging, cracking, or plastic deformation.

**Figure 20.** View of the blade grip portion of the gearbox assembly, showing the crosshead with the still affixed link.

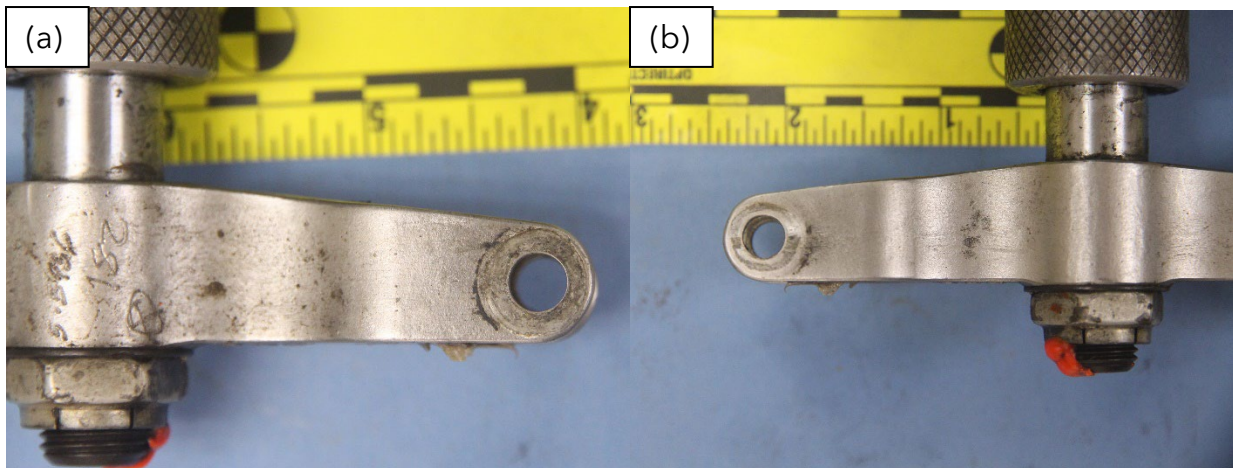
**Figure 21.** The bolt holes from the crosshead where the one of the links had been removed, viewed from opposite sides.

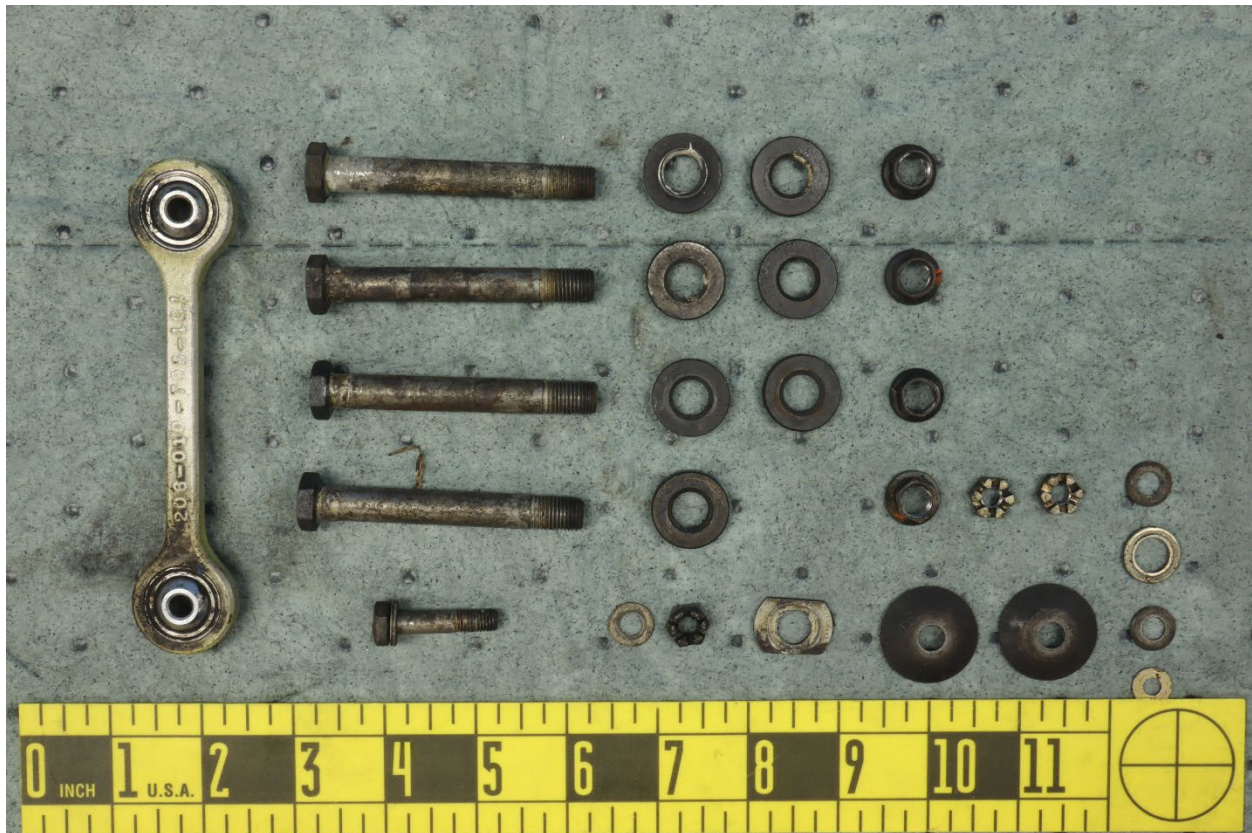
The other link was received separately, as shown in Figure 22. This figure also displays the other bolts, nuts, spacers, and washers submitted, which had been separated before receipt. There were no indications of deformation, cracking, or fracture. The exceptions were the three shims from the gearbox, submitted separately and shown in Figure 23. These parts exhibited impact marks, batter, and bending plastic deformation.

**Figure 22.** View of the bolts, nuts, washers, spacers, and link detached from the gearbox assembly.

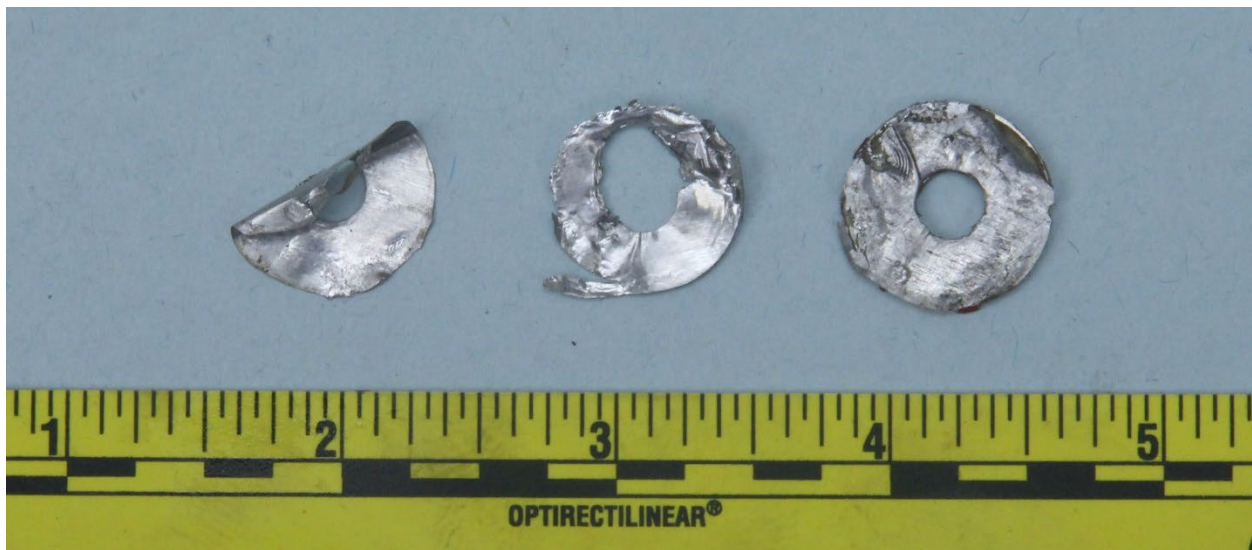
**Figure 23.** The damaged shims from the gearbox assembly, as received.
