# National Transportation Safety Board

WPR22LA221

## **MATERIALS LABORATORY**

Factual Report 23-052

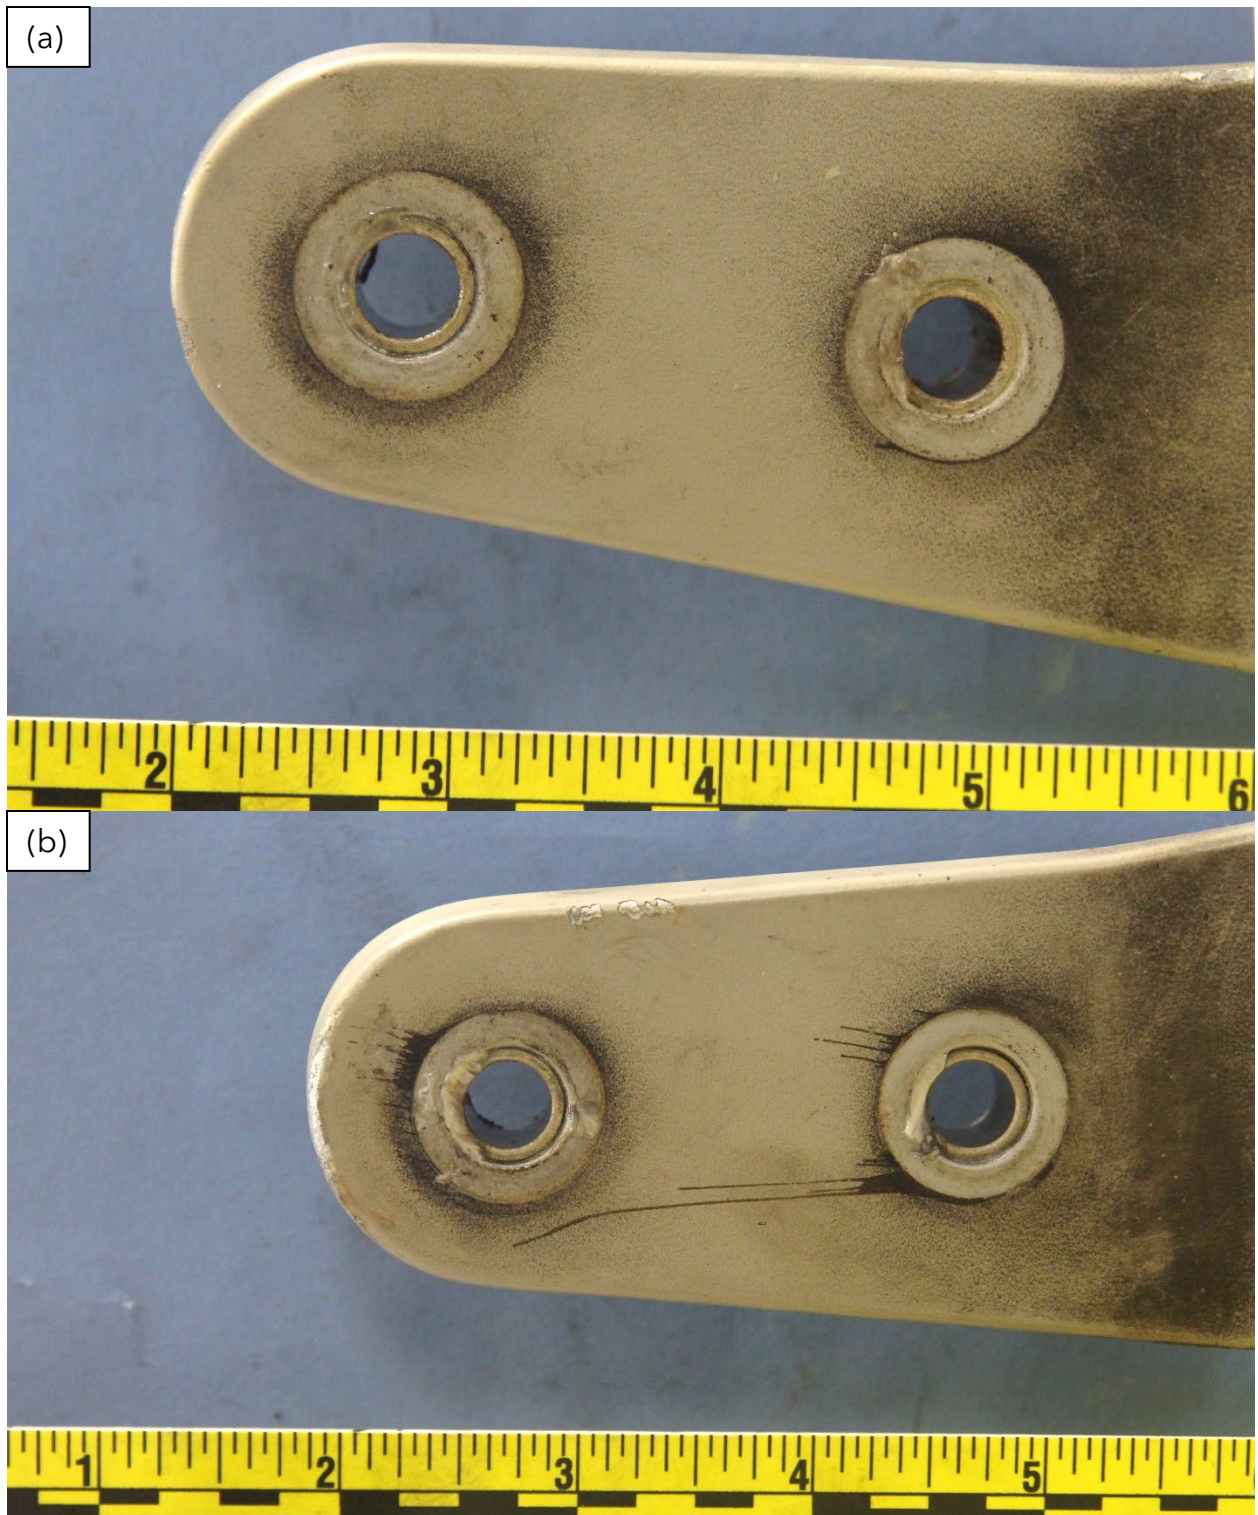
Figure 24 shows the bolt holes where bolts attached the tail rotor blades to the yoke of the gearbox assembly. The bearings were intact and did not show indications of cracking or deformation. There were no indications of battered or deformation of the adjacent yoke material, and the holes still exhibited light-colored grease or lubricant at the bore when received.

**Figure 24.** View of the bolt holes from the blade grips of the gearbox assembly.

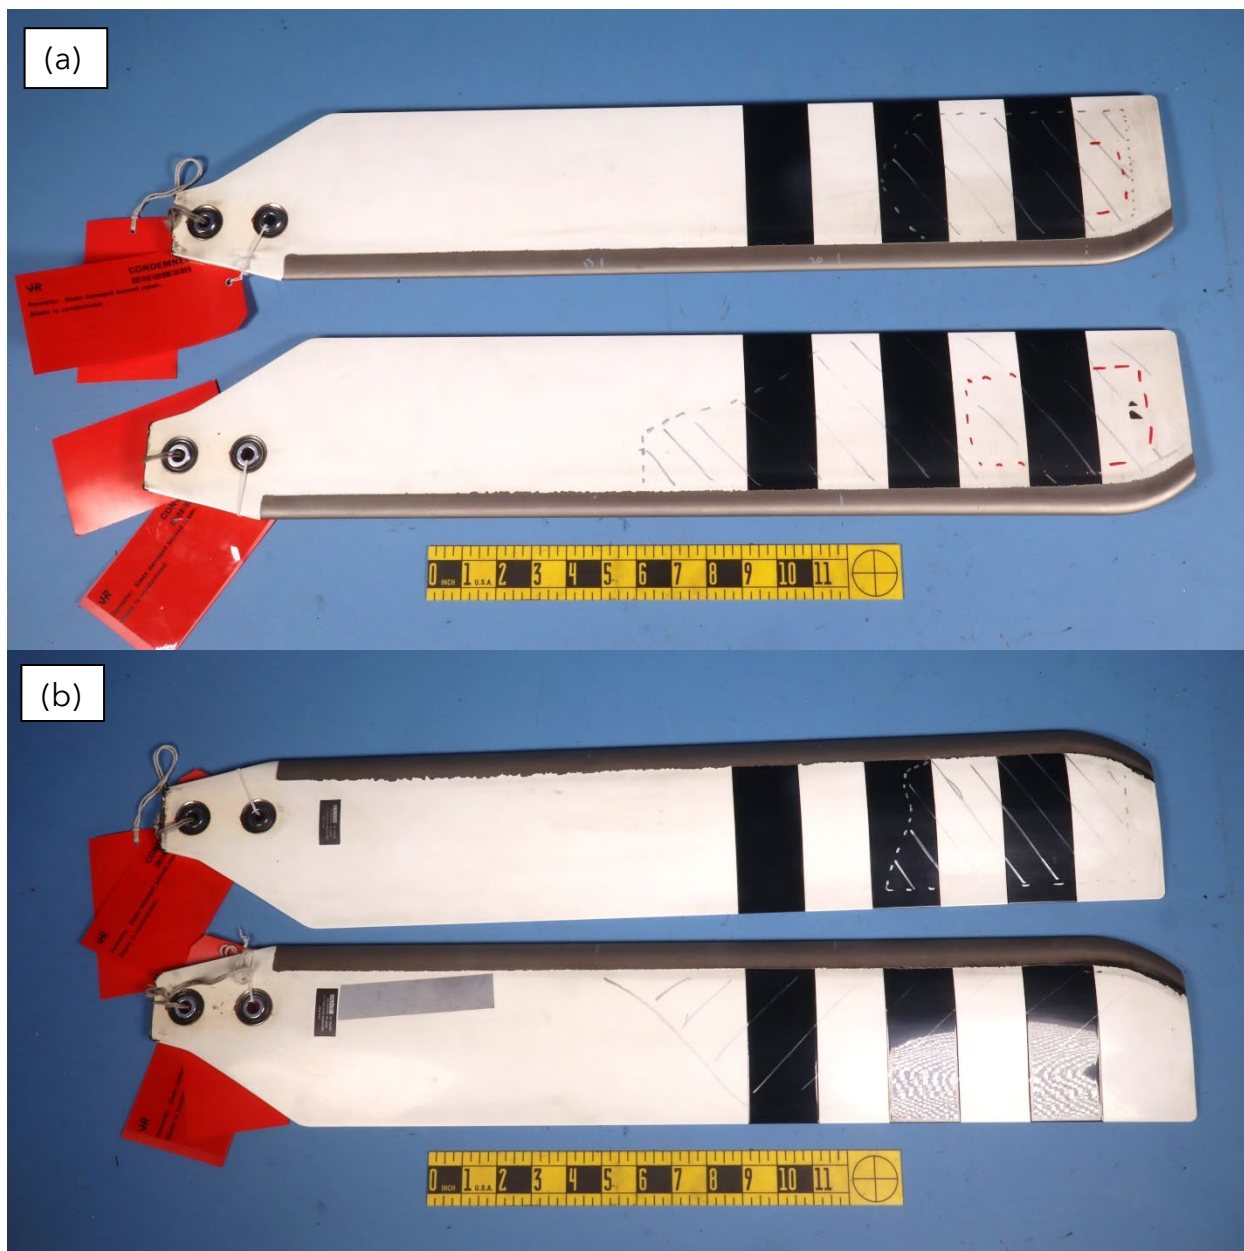
Figure 25 shows the exemplar tail rotor blades, as received. The markings on the blades stated, "FAA-PMA, VAN HORN AVIATION L.L.C., PART NO. 206220-301." The serial numbers for these blades were 'B209' and 'B213.' These blades were intact and had been marked with pen, as shown in Figure 25a, from the outboard side. These areas were not labeled as to the nature of the hashed markings, but a rudimentary tap test of the blades did demonstrate a change in audible sound along the marked regions from the rest of the blades. Affixed to each of the blades was a red tag stating, "Blade damaged beyond repair. Blade is condemned."

**Figure 25.** The intact tail rotor blades, as received, from (a) the interior side with markings of damage and (b) the reverse exterior side.

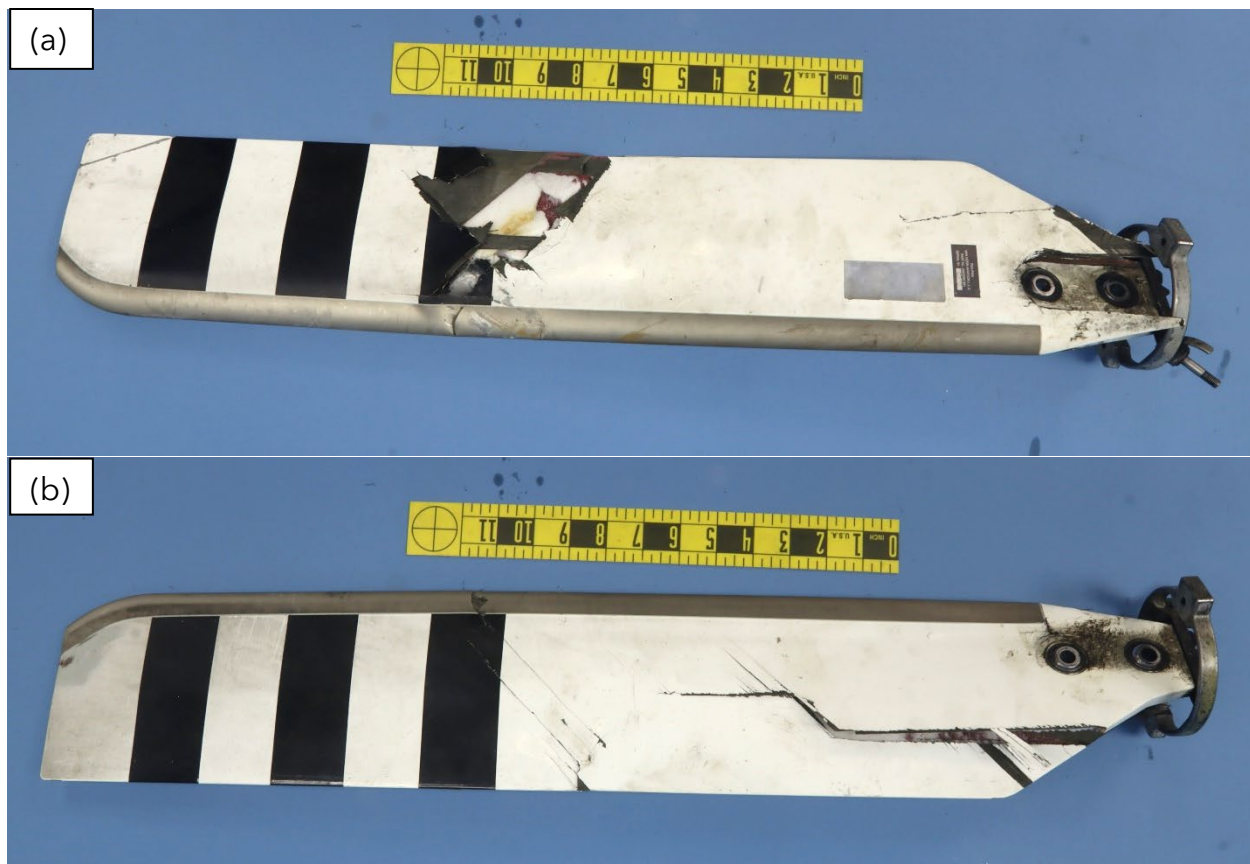
Figure 26 shows one of the accident's two damaged tail rotor blades. This blade was still intact, although it had partially separated along the centerline (see Figure 26b), exhibiting a loss of outboard skin, shown near the black stripe in Figure 26a. The serial number of this blade was 'C548,' whereas the rest of the text on the outboard plate was identical to those of the intact blades in Figure 25a.

The fracture on blade C548 exhibited a zig-zag pattern, oriented 45° in some locations and parallel with the blade direction in others. These orientations were consistent with fracture along the fiber direction of the composite, across different plies, which were oriented in different directions. The location of the parallel portion

of the fracture was consistent with the area of the foam between the plies and the unidirectional strap in the trailing edge of the rotor blade.

**Figure 26.** One of the damaged tail rotor blades from accident, viewed from (a) the exterior and (b) opposite interior sides.

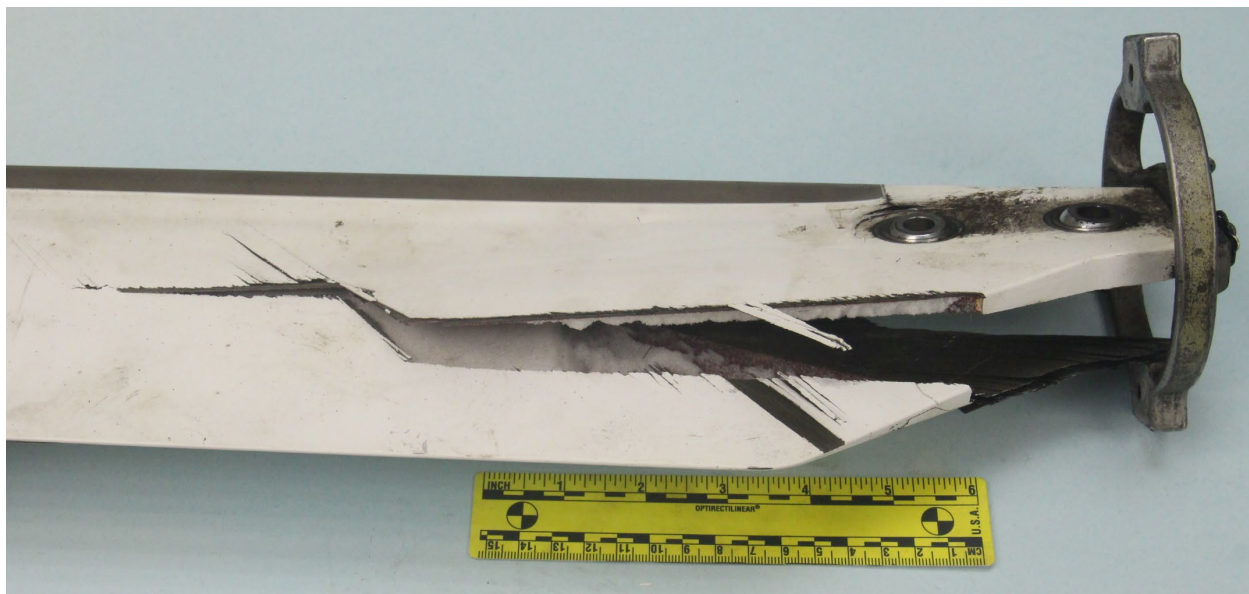
Figure 27 shows a view of the cracked tail rotor blade from the trailing edge. This view shows the character of the tearing, with separation between the fiber composite layup on the interior side from the central base core of the blade. Figure 28 reveals a closer view of the opposite side of the separation, showing a lack of composite material consistent with localized separation of the core adjacent to the composite skin. The fiber composite also exhibited irregular and erratic fracture patterns, consistent with overstress fracture across multiple plies (translaminar).

**Figure 27.** Closer view of the fracture from the blade in Figure 22.

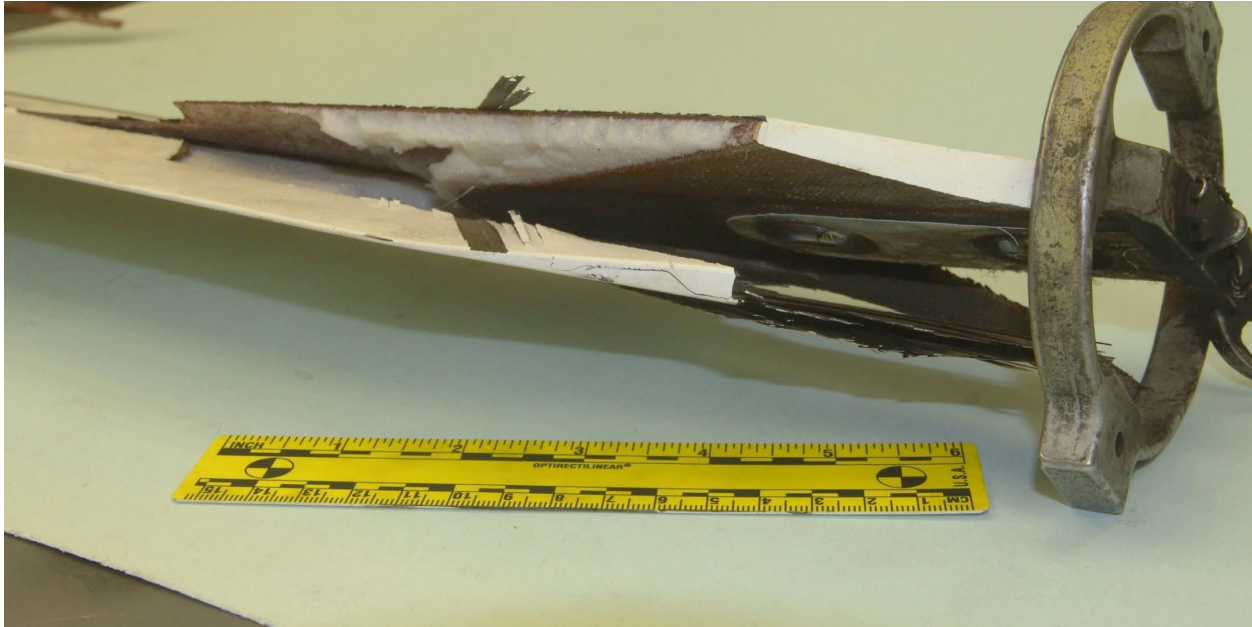
**Figure 28.** View of the interior structure of the cracked tail rotor blade, showing the separation between the base and the composite layup on the interior side.

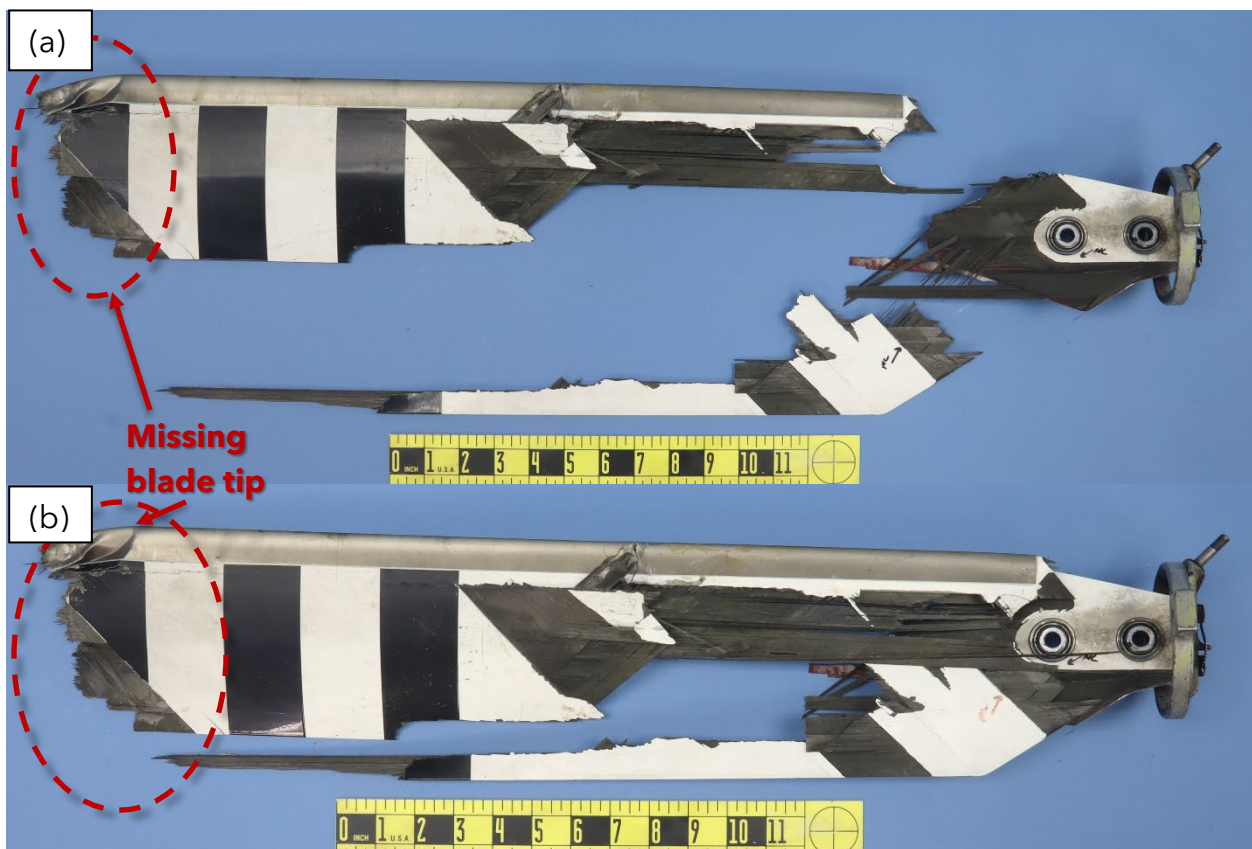
The other accident blade is displayed in Figure 29 and Figure 30 from opposite sides. Although the identification plate was missing, the serial number stated in the maintenance records was 'C549.' This blade had wholly fractured and exhibited three major remnants. The blade fractured along the rhomboid-shaped root of the blade, with the outboard portion cracking along the interior foam core.

Like with the other tail rotor blade, fracture directions were consistent with the fiber direction of the ply when located along the composite layup of the blade. Unlike the other tail rotor blade displayed in Figure 26, this blade was absent the tip, with the outboard 2.5 to 5 inches of material missing.

**Figure 29.** The fractured tail rotor blade remnants, viewed from the outboard face, showing (a) the fragments separated and (b) the fragments positioned together to show the relative locations prior to fracture.

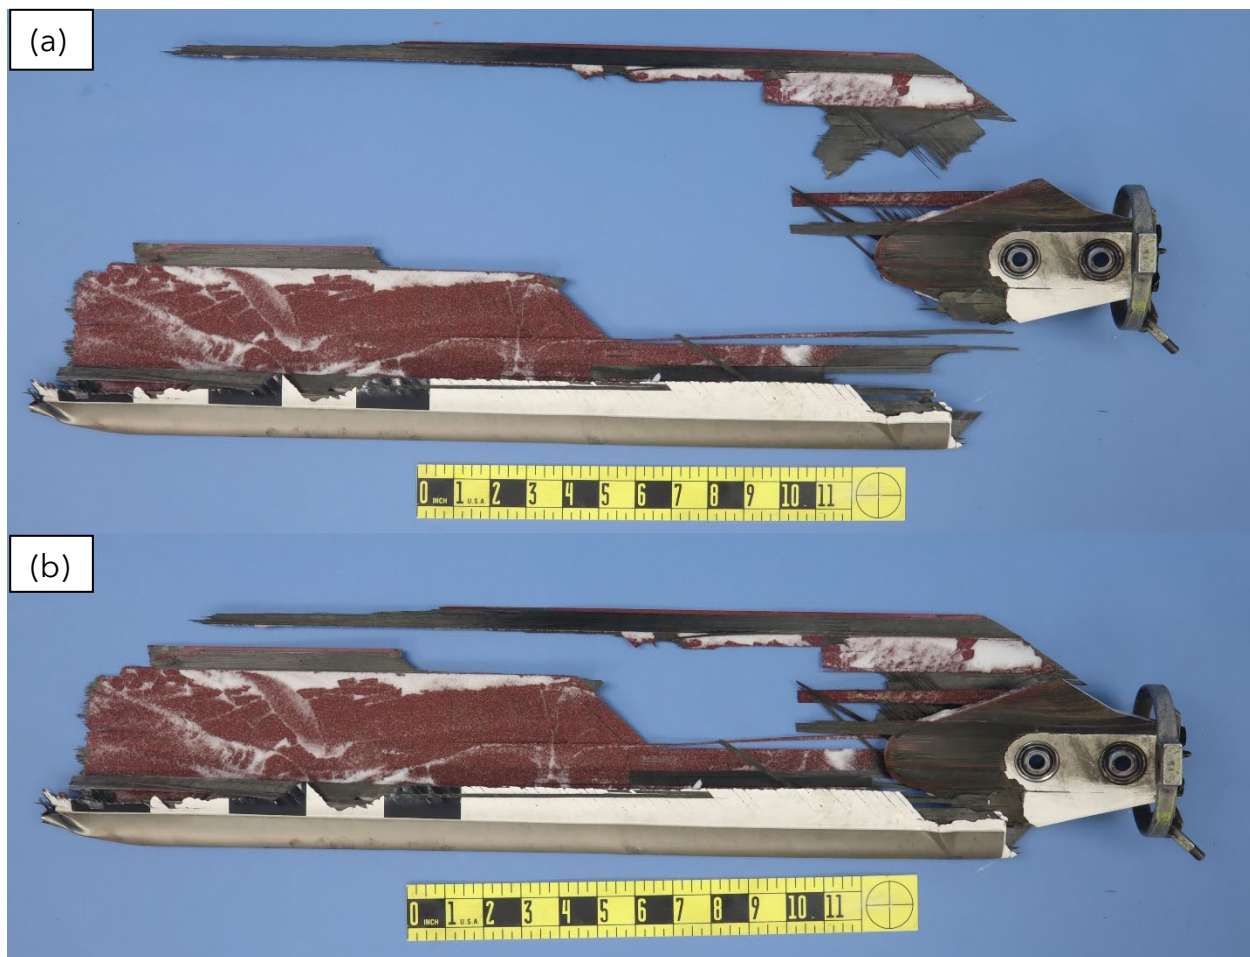
Some of the interior components were visible from the other tail rotor blade from the accident, displayed in Figure 30. Of note on the interior was the lack of foam adhesion to the maroon-colored interior surface of the blade skin. There was some of the white interior foam adherent on the surface (see Figure 30a and Figure 31).

Figure 30 also the location of the unidirectional strap at the trailing edge. The mating sides show a rough strap area with fiber pullout. In addition, there were areas absent any adherent strap material, revealing the maroon interior of the blade skin. The mating blade skin from this area was not received with the rest of the blade fragments and could not be evaluated in this examination.

**Figure 30.** The fractured tail rotor blade remnants, viewed from the inboard face, showing (a) the fragments separated and (b) the fragments positioned together to show the relative locations prior to fracture.

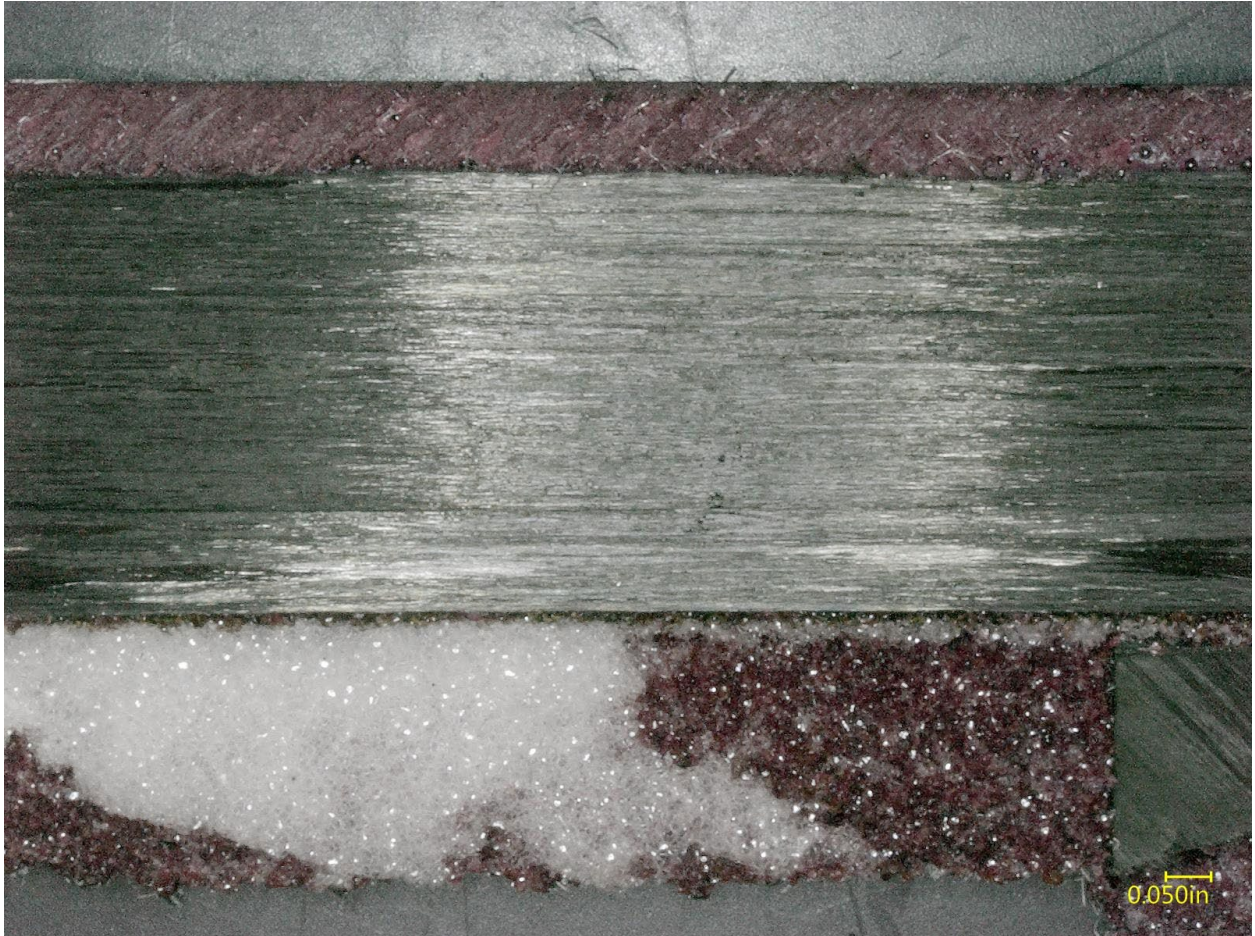
Figure 31 shows a closer view of the strap at the trailing edge. The surface was generally smooth, with little fiber pullout. The surrounding foam had fractured erratically, consistent with mixed adhesive and cohesive fracture. These features were consistent with the trailing edge section of the blade peeling open at fracture, along both the strap and its joint with the blade skin.

**Figure 31.** View of the fractured unidirectional strap adjacent to the trailing edge of the fractured blade.

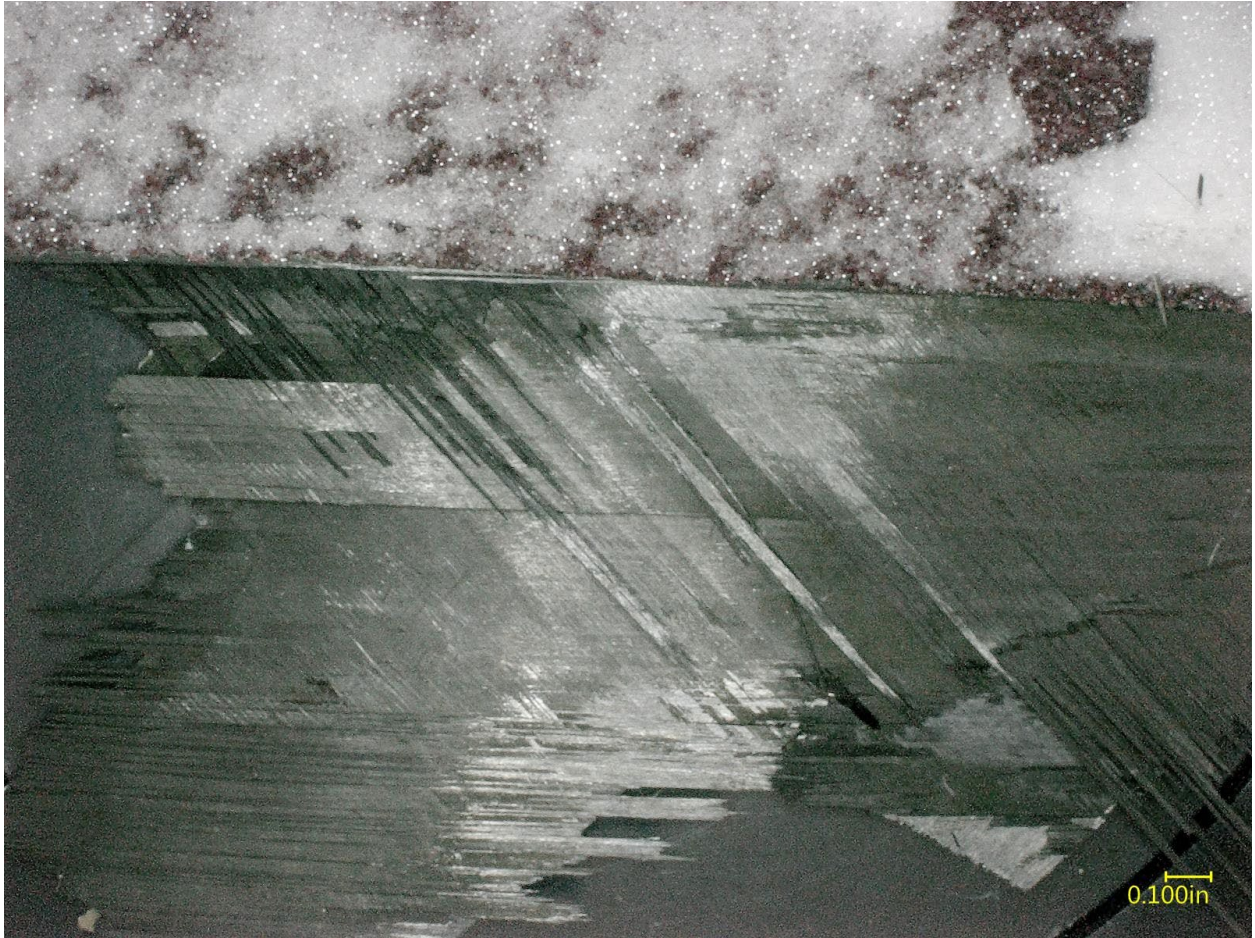
Further inward (toward the leading edge and core), the foam on both sides of the blade interior was consistent with a cohesive fracture of the material (Figure 32). The adjacent composite layup showed a fracture in random directions, with fibers being pulled out and ply splitting in +45, -45, and 90° orientations. These features were

consistent with a translaminar fracture of the composite (as opposed to an interlaminar delamination fracture).

**Figure 32.** View of the fractured composite interior just inside the area shown in **Figure 31**.

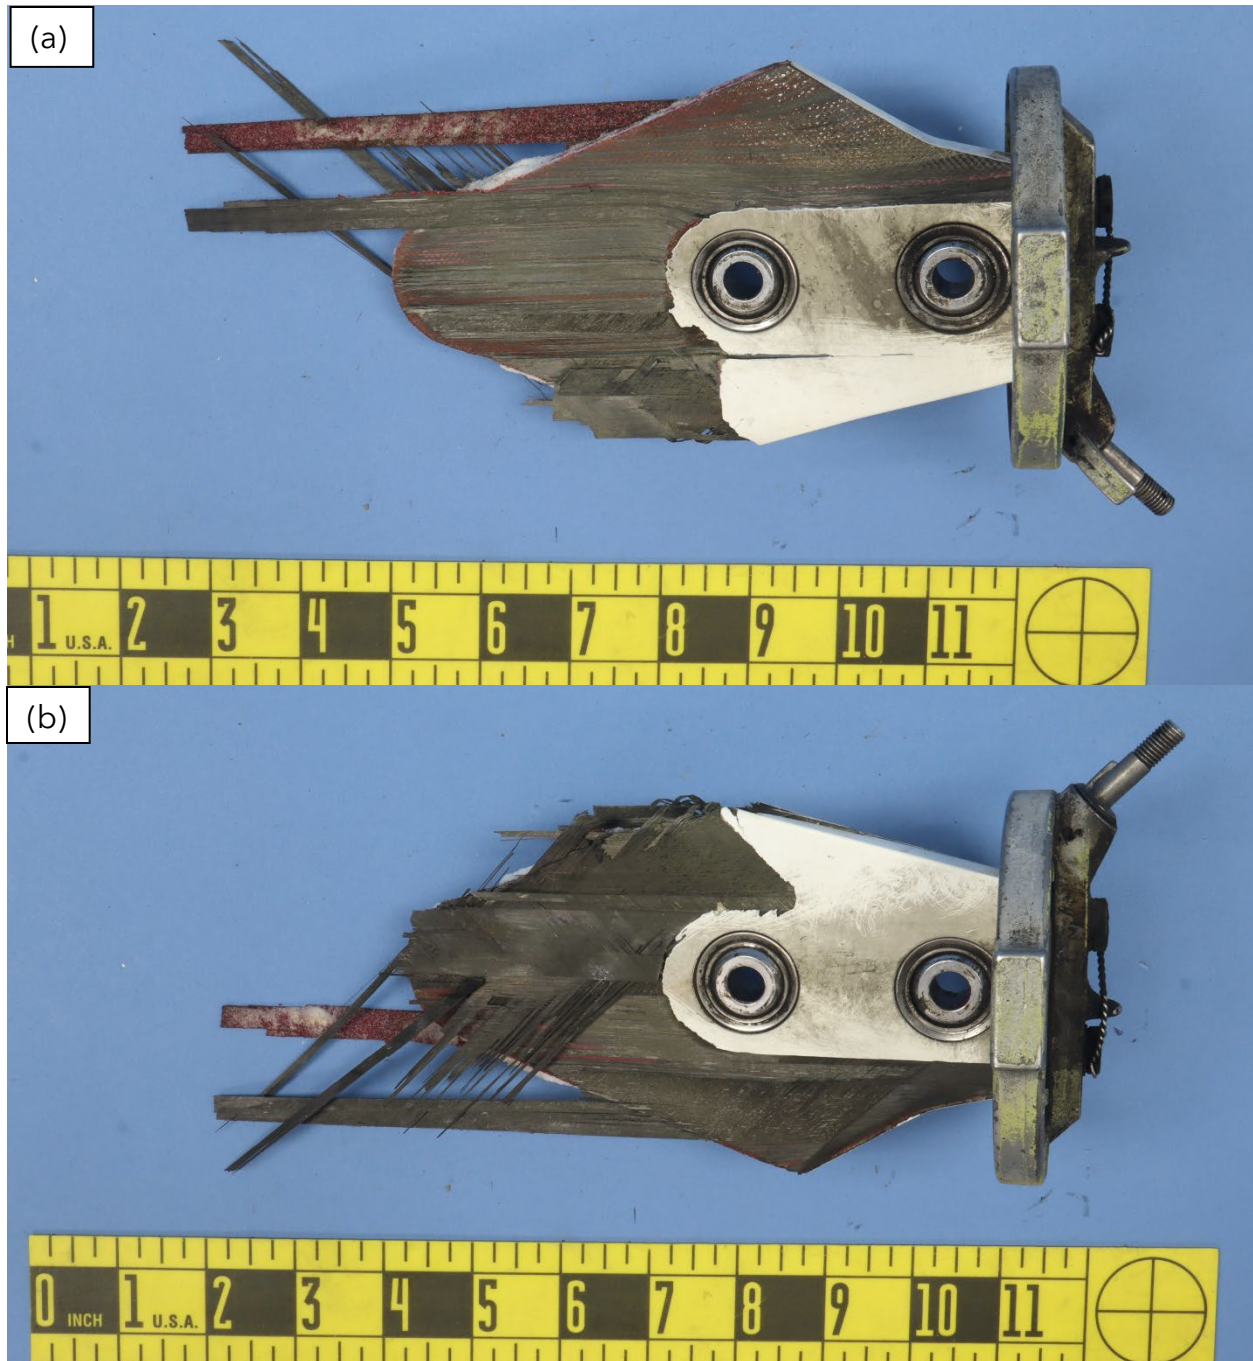
Similar patterns were observed on the fiber composite remnant that was still affixed to the blade base, as shown in Figure 33 from opposite sides. The plies nearest the base were still attached, indicating cohesive fracture in the fiber composite layup. As shown in Figure 33 and Figure 34, the fiber orientations along the fracture were in multiple directions, consistent with a translaminar fracture.

**Figure 33.** The opposite sides of the base of the fractured tail rotor blade.

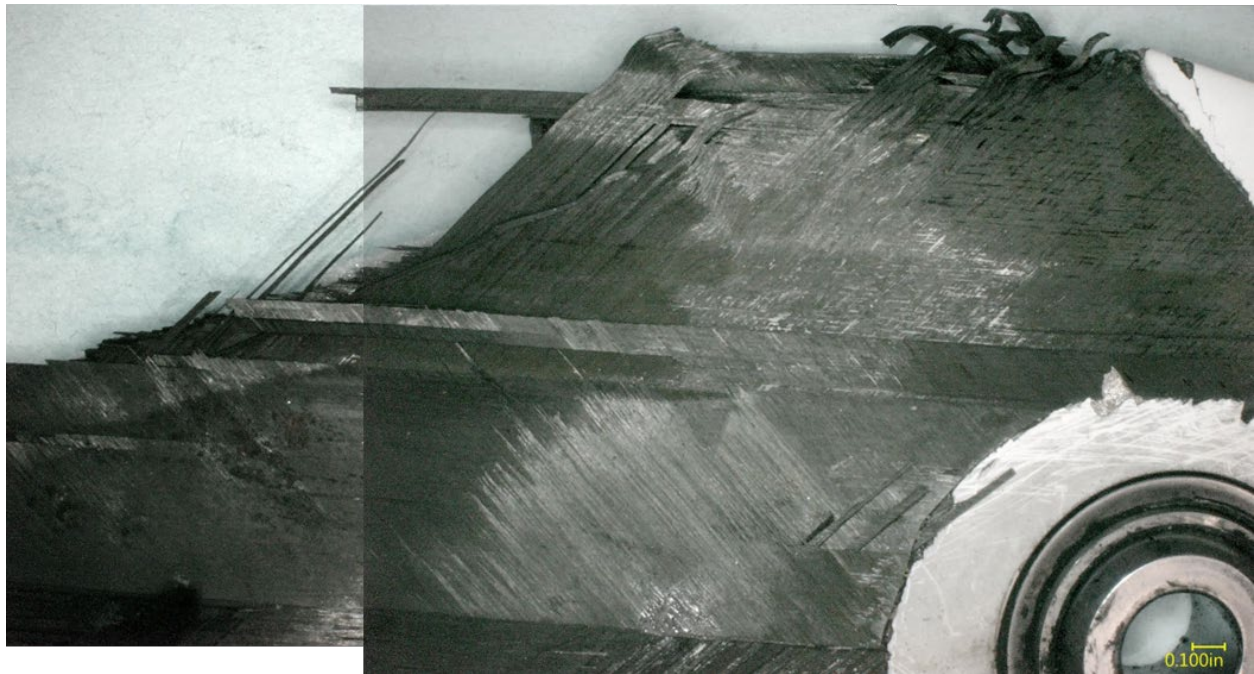
**Figure 34.** Montage of images showing composite fracture patterns of the leading edge of the broken rotor blade.

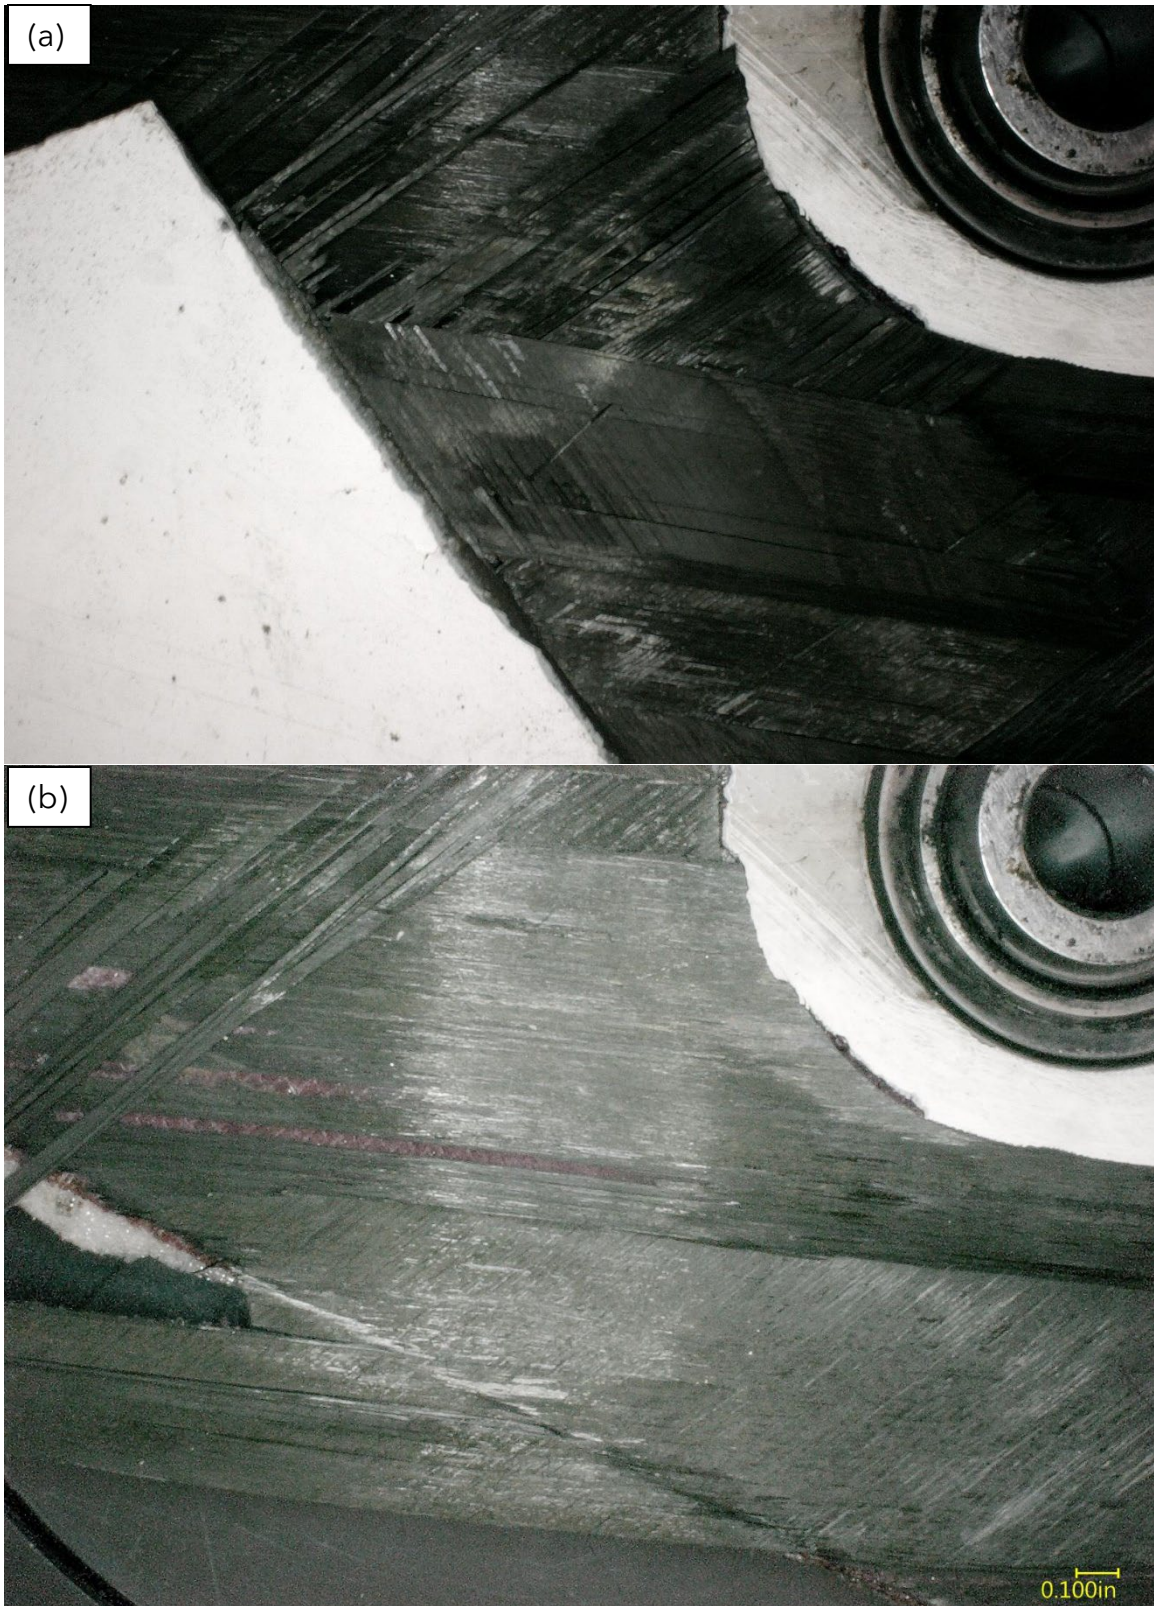
These features were again present, as shown in Figure 35, which shows the area near the outboard bearing of the fractured blade, both with and without the smaller trailing edge remnant laid in its pre-fracture position. This configuration illustrates the colocation of fractures along different ply paths, consistent with emanating from edge areas of the composite—in this case, adjacent to the bearing hole of the blade base.

**Figure 35.** Views of the tail rotor blade fracture about the bearing hole with (a) the small piece laid on top and (b) removed, showing underlying fracture features.
