# National Transportation Safety Board

WPR22LA221

## **MATERIALS LABORATORY**

Addendum Report 23-052B

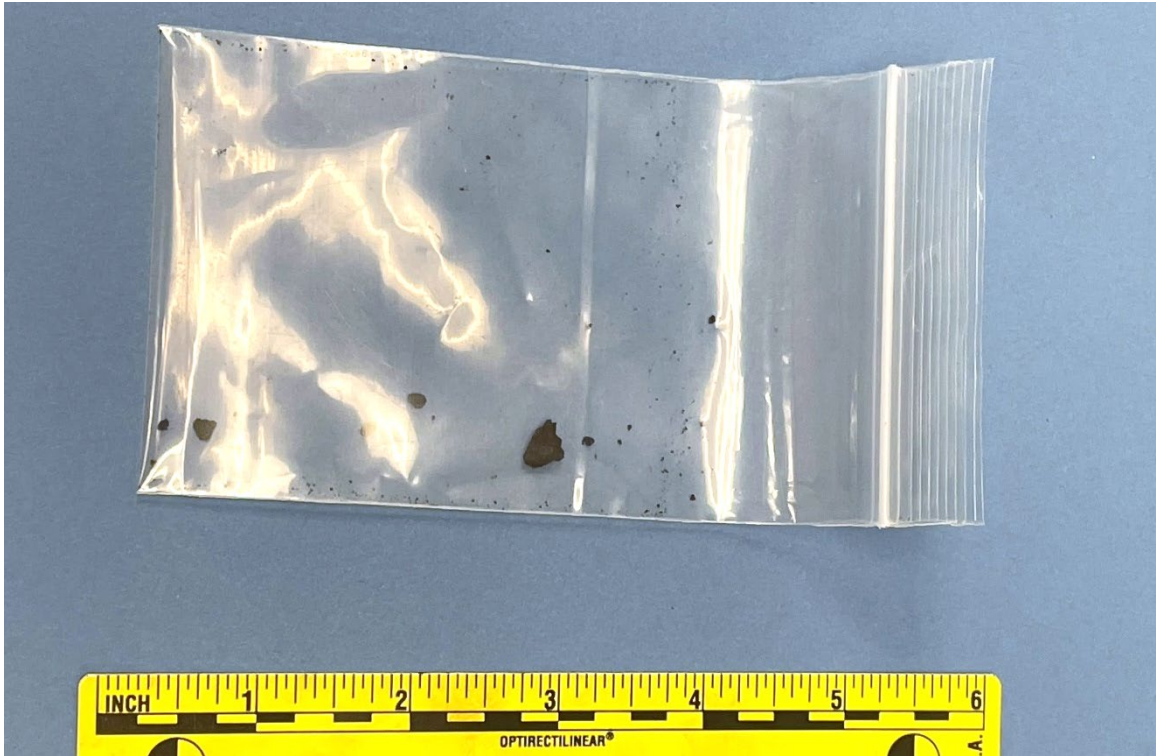
Figure 1 shows the debris in a small plastic bag, as received. The debris exhibited a dull, dark color and was brittle enough to crumble upon handling. The debris was examined using ultraviolet light (UV). The debris did not fluoresce under exposure to UV, which was inconsistent with being or containing biological material.

**Figure 1.** The debris removed from the tail rotor blade, as received.

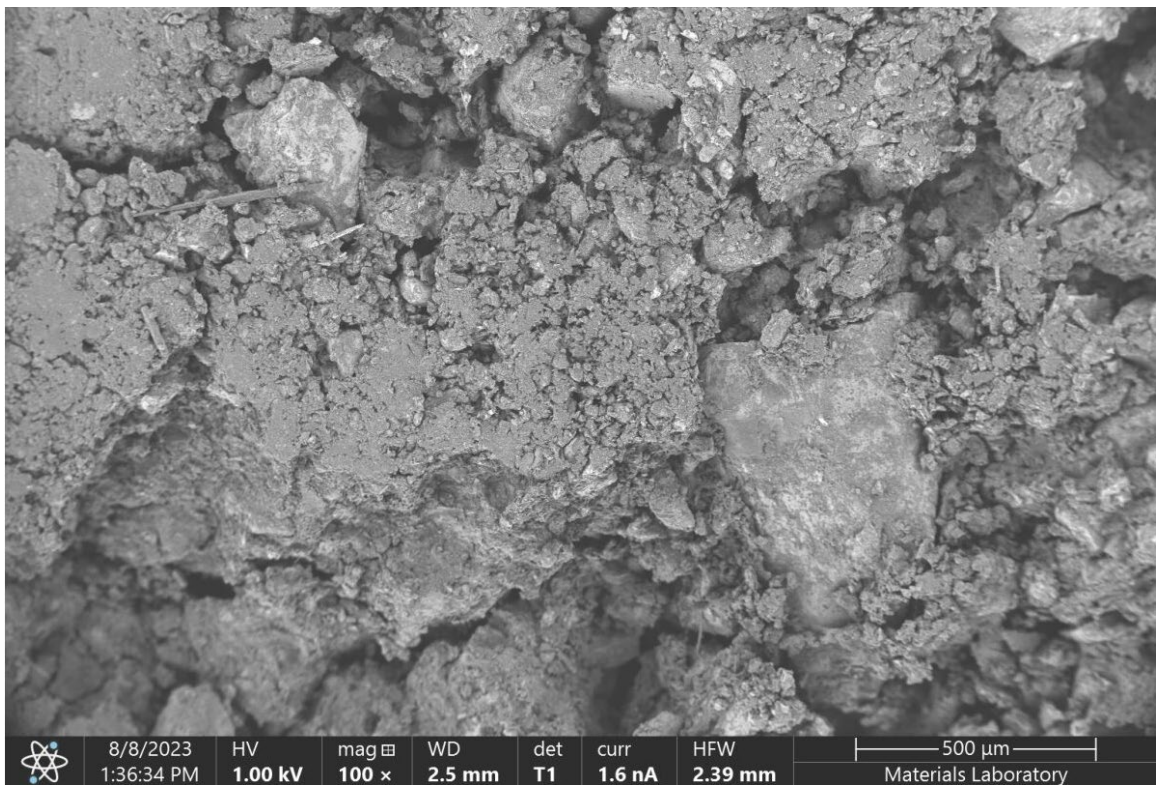
The debris was examined using a field emission scanning electron microscope (SEM). A typical area is illustrated in Figure 2. The debris exhibited electrical charging effects consistent with nonmetallic material at higher accelerating voltages. The debris could be imaged at lower voltages, as shown in Figures 2 through 4. The debris exhibited a rounded globular structure, with regions of voids or absent solid material.

**Figure 2.** Backscattered electron (BE) micrograph of a typical area of the debris.

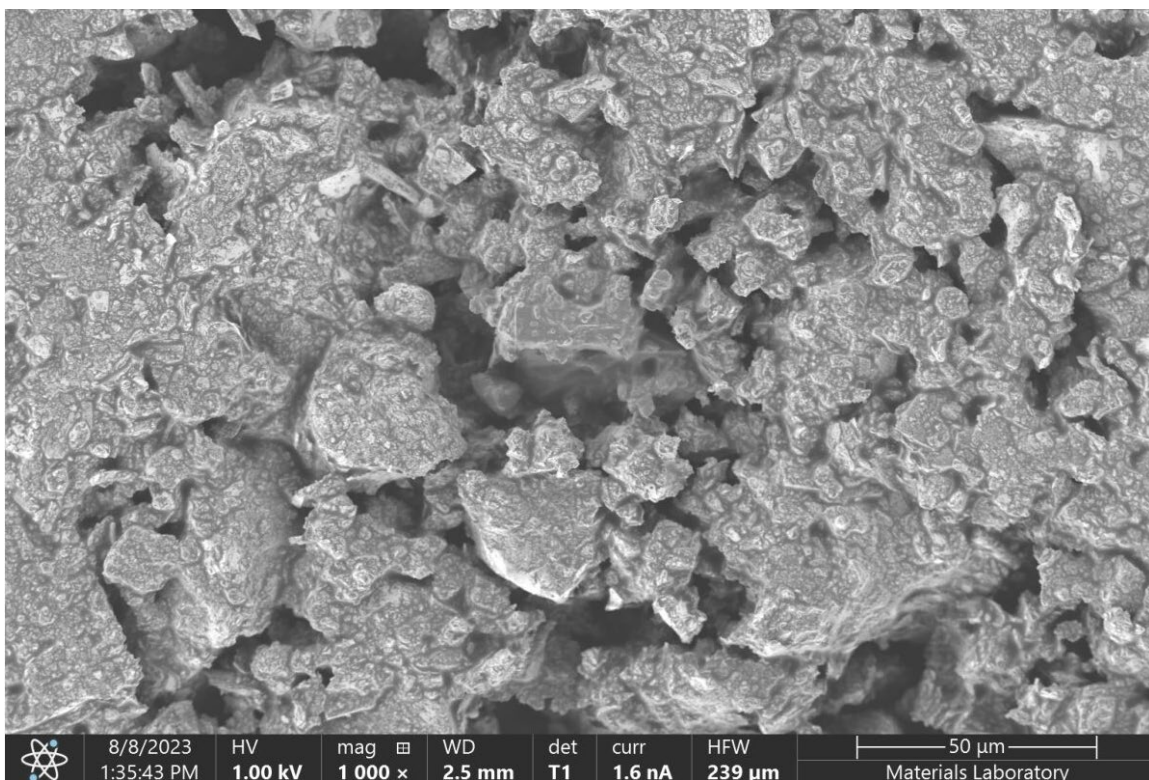
**Figure 3.** BE micrograph of a closer view of the derbis in Figure 2.

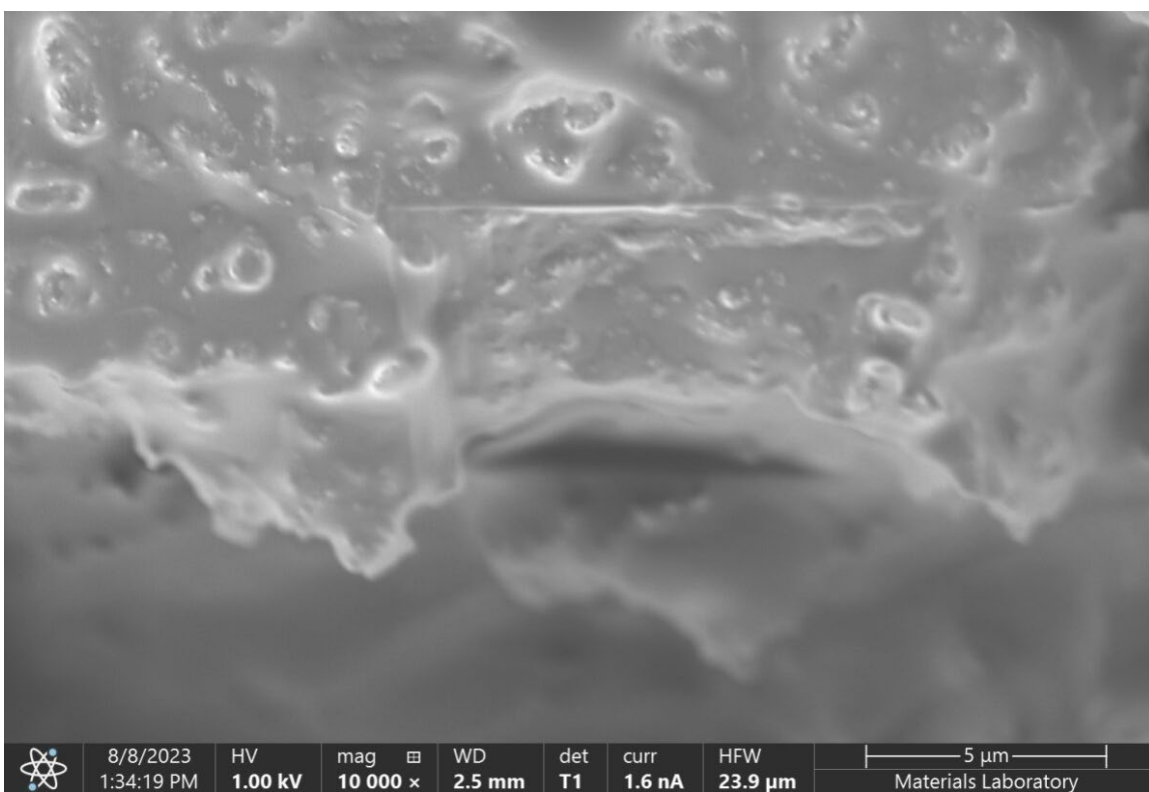
**Figure 4.** BE micrograph of the center lump in Figure 3.

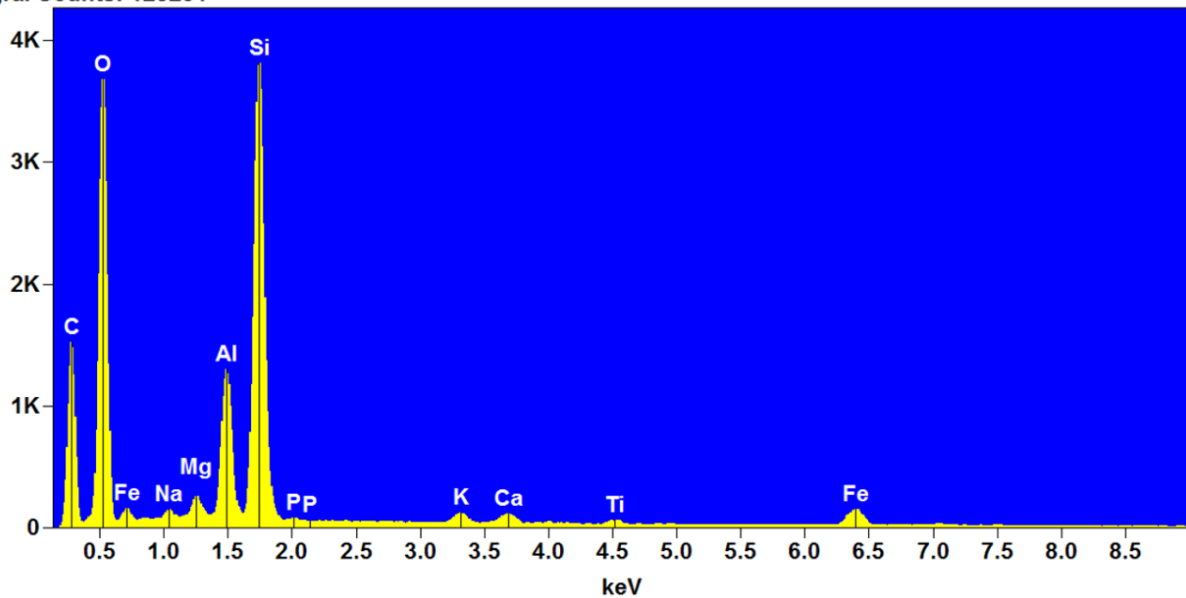
The chemical composition of the debris was examined using energy-dispersive x-ray spectroscopy (EDS). Figure 5 illustrates a typical EDS spectrum from the debris. The material exhibited high silicon, oxygen, aluminum, and carbon peaks. There were also minor peaks of sodium, potassium, iron, titanium, magnesium, phosphorus, and

calcium. No spectra were observed that were substantially different than the one shown in Figure 5 from EDS probes of the debris.

**Figure 5.** EDS spectrum of a typical area in Figure 2.

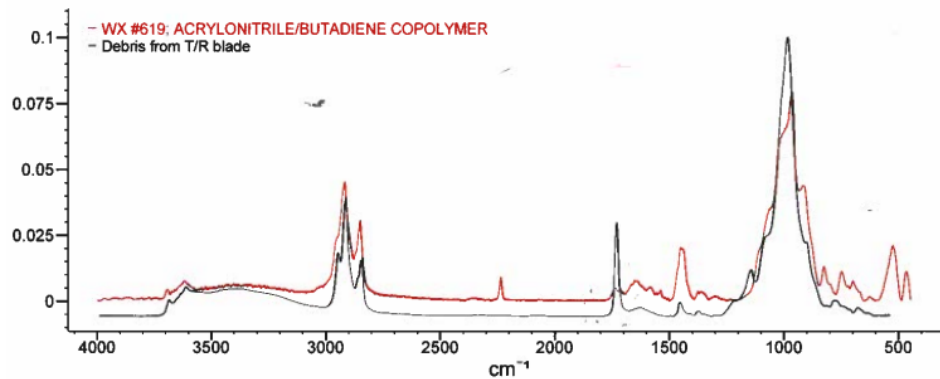
Lastly, the debris was examined using Fourier-transform infrared spectroscopy (FTIR). Figure 6 shows a typical spectrum of the material, shown in black. This was compared against known standards and matched the one of a copolymer between acrylonitrile and butadiene, shown in red. This spectrum was consistent with a nitrile rubber material. No other material spectra were identified that matched those obtained from the debris' infrared examination.

**Figure 6.** FTIR spectra comparison, showing the spectrum of a selected area of debris from the tail rotor blade debris (black) compared with a standard spectrum of acrylonitrile-butadiene copolymer (red).
