VAN HORN AVIATION, L.L.C.  
Tempe, Arizona

**REPORT No. 206BT-STR-508**  
**STRUCTURAL TEST REPORT**  
**EVALUATION OF N90326 CRASH DAMAGE TO 2062200 TAIL**  
**ROTOR BLADES**

July 18, 2023

The following report presents a visual evaluation of damage to 2062200-301 Tail Rotor Blades with serial numbers C548 & C549 installed on Bell 206 JetRanger tail number N90326, which was involved in an accident near Stockton, CA on June 17, 2022 (Reference 1).

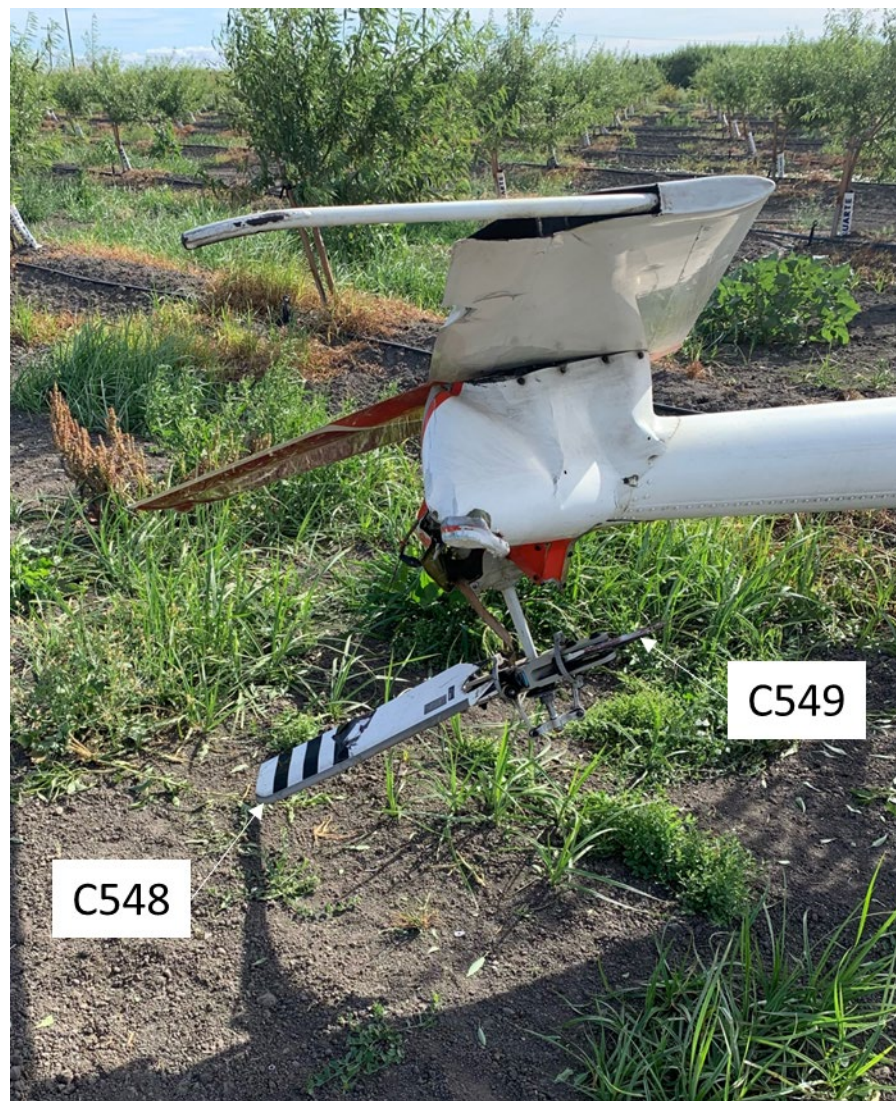
**Figure 3 - C548 & C549 As Found at the Site**

The referenced 2062200-301 blades were sent to Van Horn Aviation for examination after a hard landing in which the pilot reported a vibration, hearing a bang, and a loss of yaw control. The helicopter came to rest in an orchard after contacting a tree. It landed flat but was spinning to the right and rolled onto its left side. Blade C548 was primarily intact and still attached to the tail rotor hub. Blade C549 was fractured into multiple pieces of which only the root fitting was still attached to the hub (Figure 3). According to the pilot, he recovered two additional fragments approximately 2000 ft from the main wreckage. Both blades, including the separated fragments of C549, are shown in Figure 5.

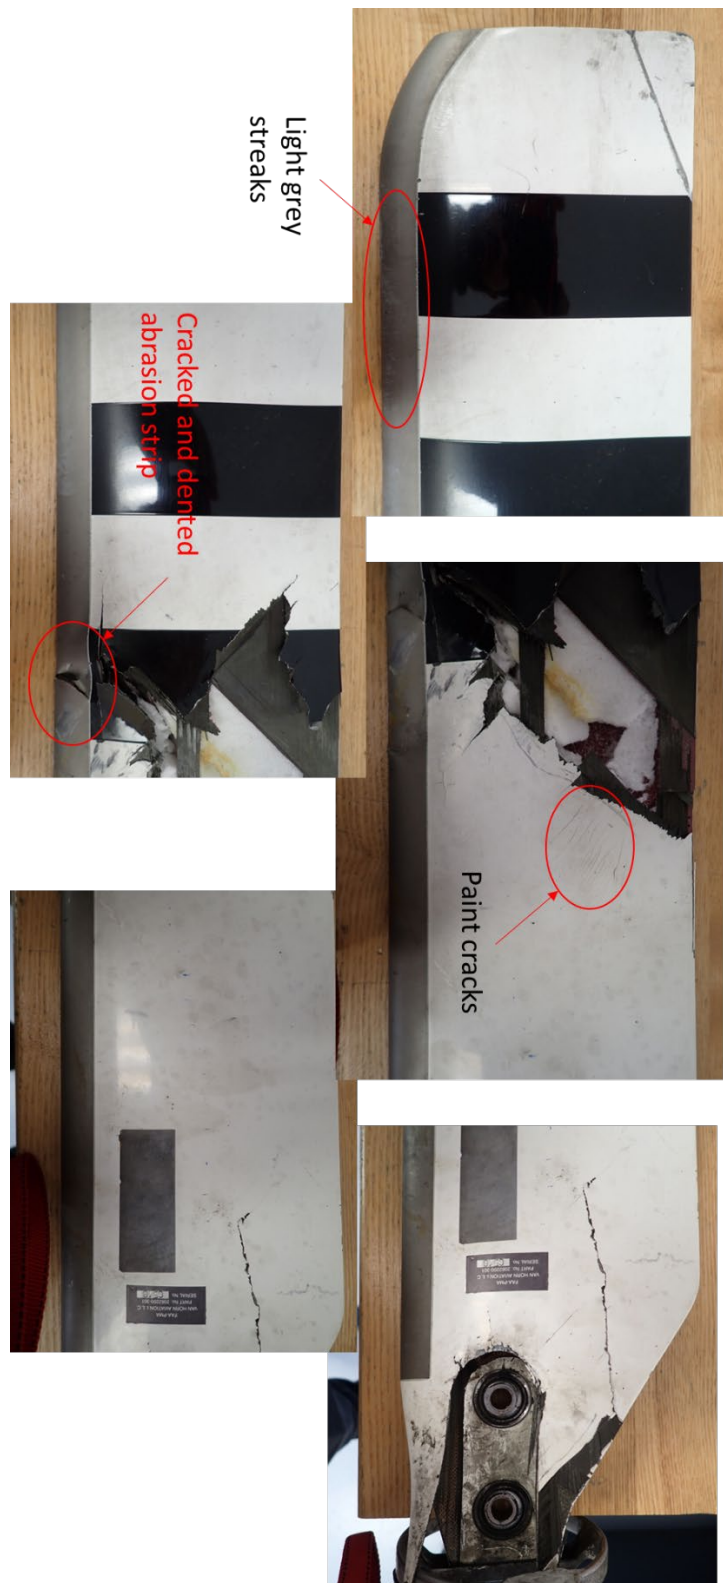
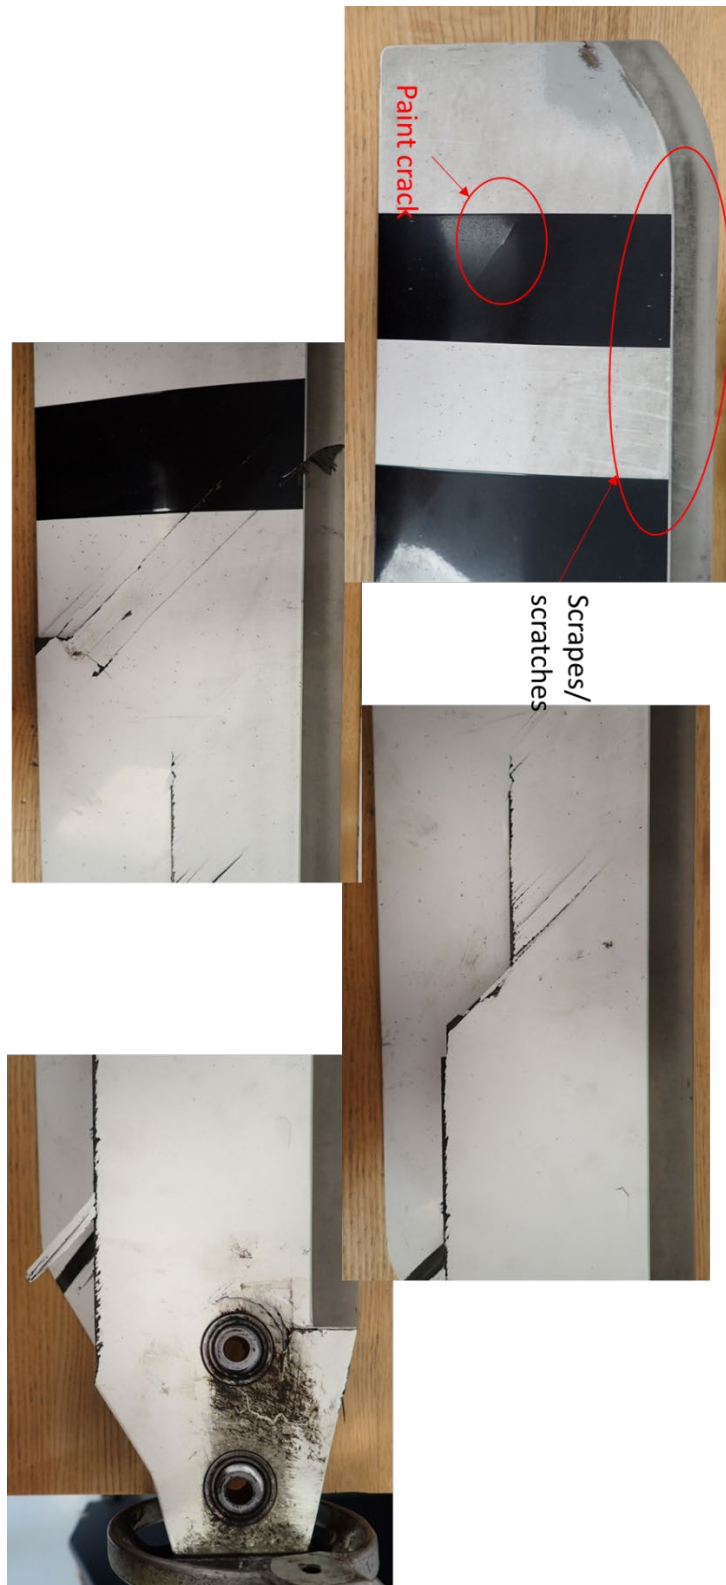
Multiple images of blade C548's upper and lower surfaces are shown in Figure 6 & Figure 7, respectively. As mentioned, this blade was largely intact, which is to say that most of the structure was still in one contiguous piece. However, this blade did exhibit two primary fracture planes, one at the root end (Figure 8) and the other near mid-span (Figure 9). The root end fracture is characterized primarily by a nose-down rotation about the blade axis. This resulted in delaminations within the uni-directional carbon as well as some epoxy matrix cohesive failure adjacent to the titanium root fitting. Translaminar shear failures in the upper and lower laminates propagated outboard along approximately straight lines from the aft corner of the root fitting. On the lower surface, this crack extended 6.5" outboard, moved forward along the 45 deg laminate direction until reaching the aft edge of the spar plies, and then continued another 3.5" outboard before arresting. In this area there is also extensive core peel failure, initially adjacent to the upper skin at the root end but shifting to the lower skin immediately outboard of the root fitting. Of note, the upper laminate at the inboard end was delaminated from the root fitting and deflected so significantly that it came to rest on the outside of the pitch horn balance ring (Figure 8). This is noteworthy because only a tremendous overload such as from an impact event could have forced the laminate passed the ring to the outside.

The mid-span fracture predominantly follows a 45 deg angle from leading to trailing edge. The lower surface (Figure 7) exhibits multiple parallel translaminar fractures following the 45 deg ply with nearly chordwise fractures through the abrasion and trailing edge strips. Of interest, some of the carbon laminate attached to the outboard side of the abrasion strip crack was forced past the lower surface of the inboard portion of the abrasion strip. Similarly, some of the inboard portion of the trailing edge strip was forced past the lower surface of the outboard laminate. On the upper surface (Figure 6), more extensive damage is seen including portions of the upper skin & spar missing and multiple core fractures. At the leading edge there are multiple scrapes and material transfer marks as well as a second smaller crack and a dent approximately 2" inboard of the main fracture (Figure 9). Immediately outboard of the fracture the abrasion strip is buckled on the upper surface and delaminated along its aft edge extending approximately 2 inches outboard. The residual strength and stiffness of the blade allows the tip to move easily upward and rotate nose down along the 45 deg fracture indicating this was the direction of deformation which caused the failure. Such a bending deformation would have put the lower surface in tension and the upper surface in compression. This is consistent with the buckling observed in the abrasion strip as well as the more extensive laminate and core damage observed on the upper surface. The missing laminate likely peeled away from the core, buckled, and fractured at either ends of the buckle which led to its departure.

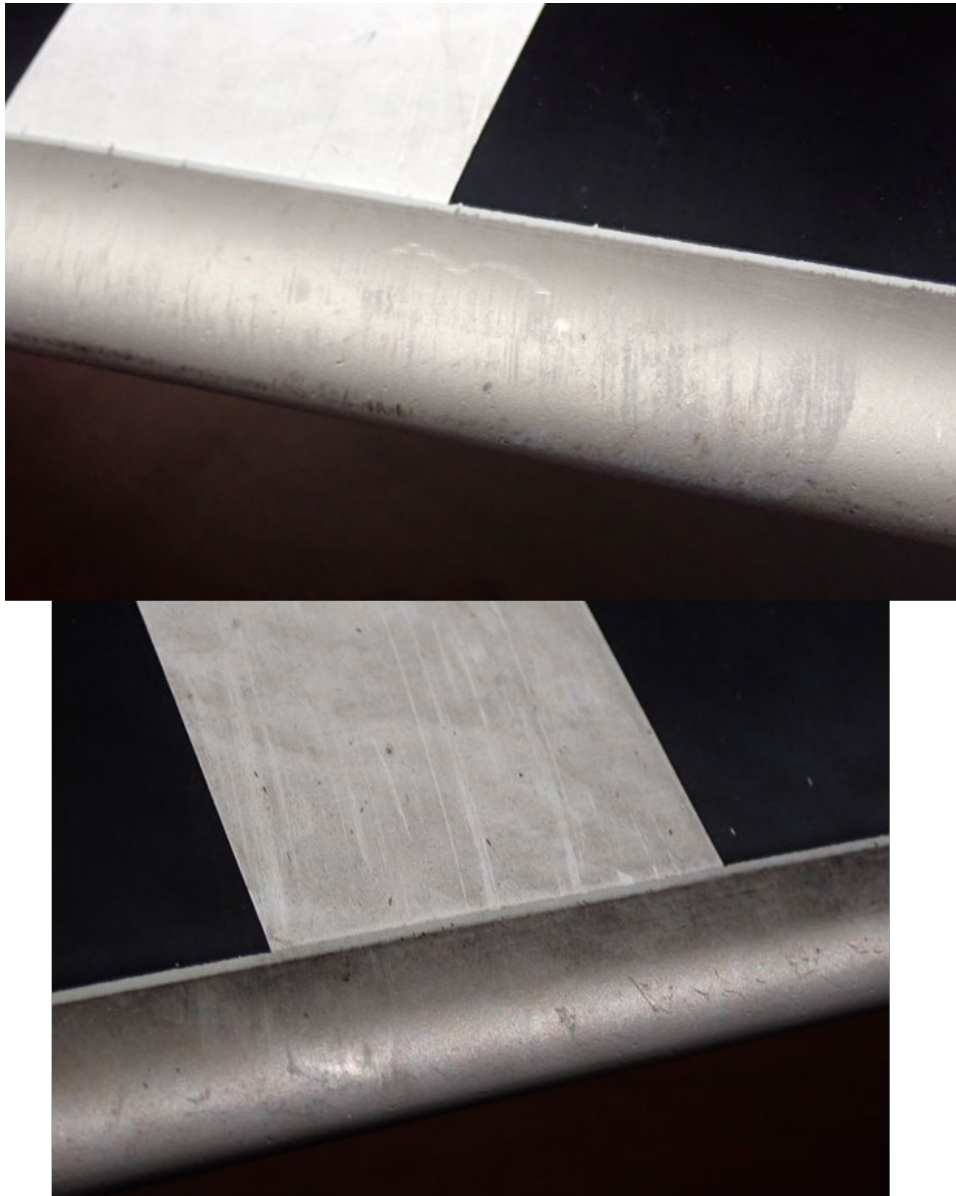
**Figure 10 – C548 Abrasions on Upper & Lower Tip Leading Edge**

The tip end of the blade exhibits relatively little external damage, however, scrapes and material transfer extending in an aftward direction are apparent on the abrasion strip (Figure

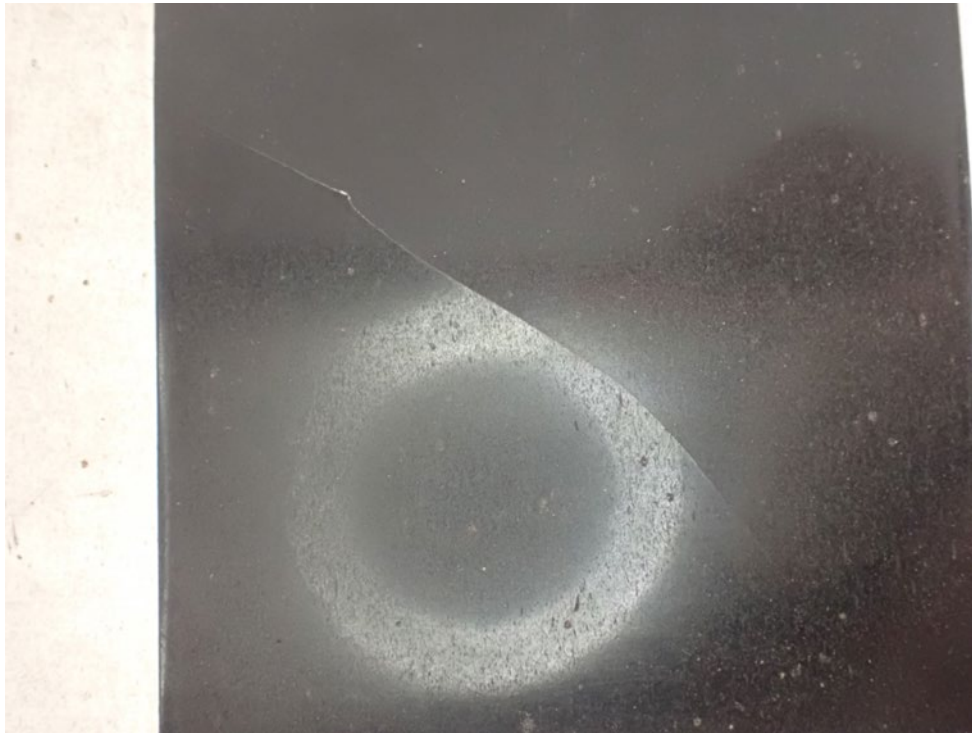
**Figure 11 – C548 Crack on Tip Lower Surface**

| <p>10). In addition, there is an approximately 2” crack visible in the paint on the lower surface (Figure 11). A tap test reveals extensive voiding throughout the tip region and tactile pressure finds the surface to be squishy and produce crunching sounds. This is consistent with internal core failure and separation from the overlying laminate. The paint crack and extensive internal core failure is commonly seen in impacts to the aft body of the blade (Reference 3). Moreover, an impact at the crack site would induce a tip-up, nose-down moment and therefore could potentially have caused the mid-span and/or root end fractures.</p> | | | |

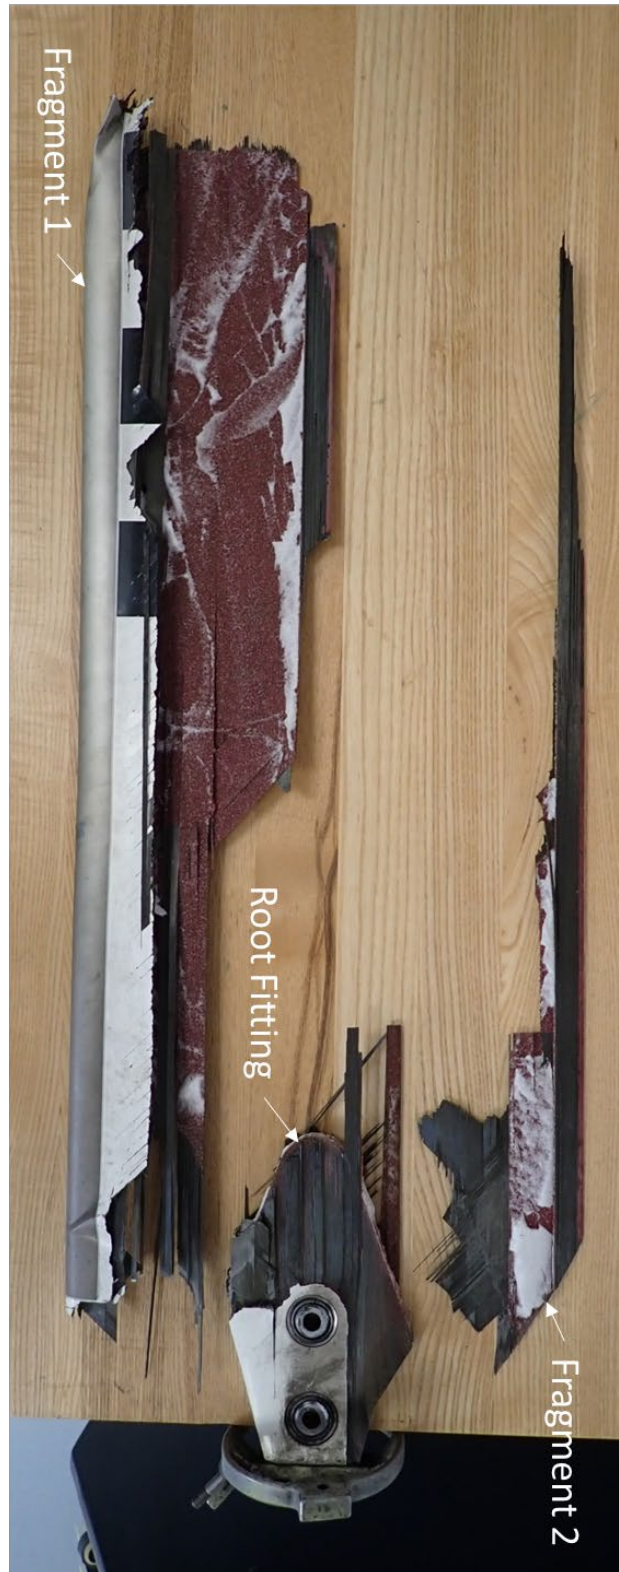
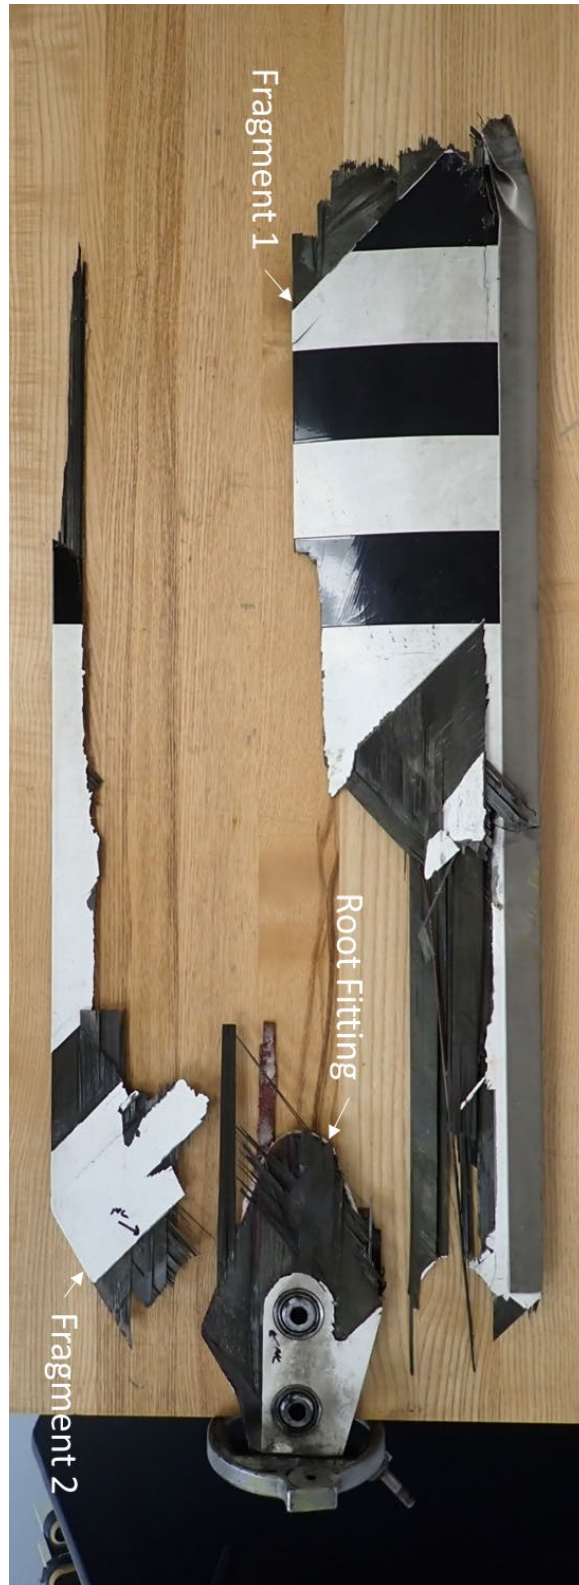
As previously mentioned, only the root fitting portion of blade C549 was still attached to the helicopter. A large lower skin fragment (“fragment 1”) as well as a trailing edge piece (“fragment 2”) were found separated from the root fitting (Figure 12 & Figure 13). However, nearly all the core, most of the upper laminate, and the entire swept tip portion were not recovered. Both recovered fragments have portions of laminate which interface to the root fitting as well as each other. Multiple images of the assembled blade C549’s upper and lower surfaces are shown in Figure 14 & Figure 15, respectively. Of note, both fragments interface primarily with the lower surface of the root fitting, except for that portion of fragment 1 which includes the abrasion strip that wraps around the leading edge and mates with a small portion of the upper surface of the root fitting. The separations at the root fitting are characterized by interlaminar failures primarily between the 0 deg fibers of the spar (Figure 16), however some delaminations within the outer +45/0/-45 deg skin plies are also evident. Figure 17 shows a buckle in the abrasion strip on the upper surface of fragment 1 which mates with the outboard end of the root fitting. The V-shape of the buckled region indicates a deflection primarily in the aftward direction.

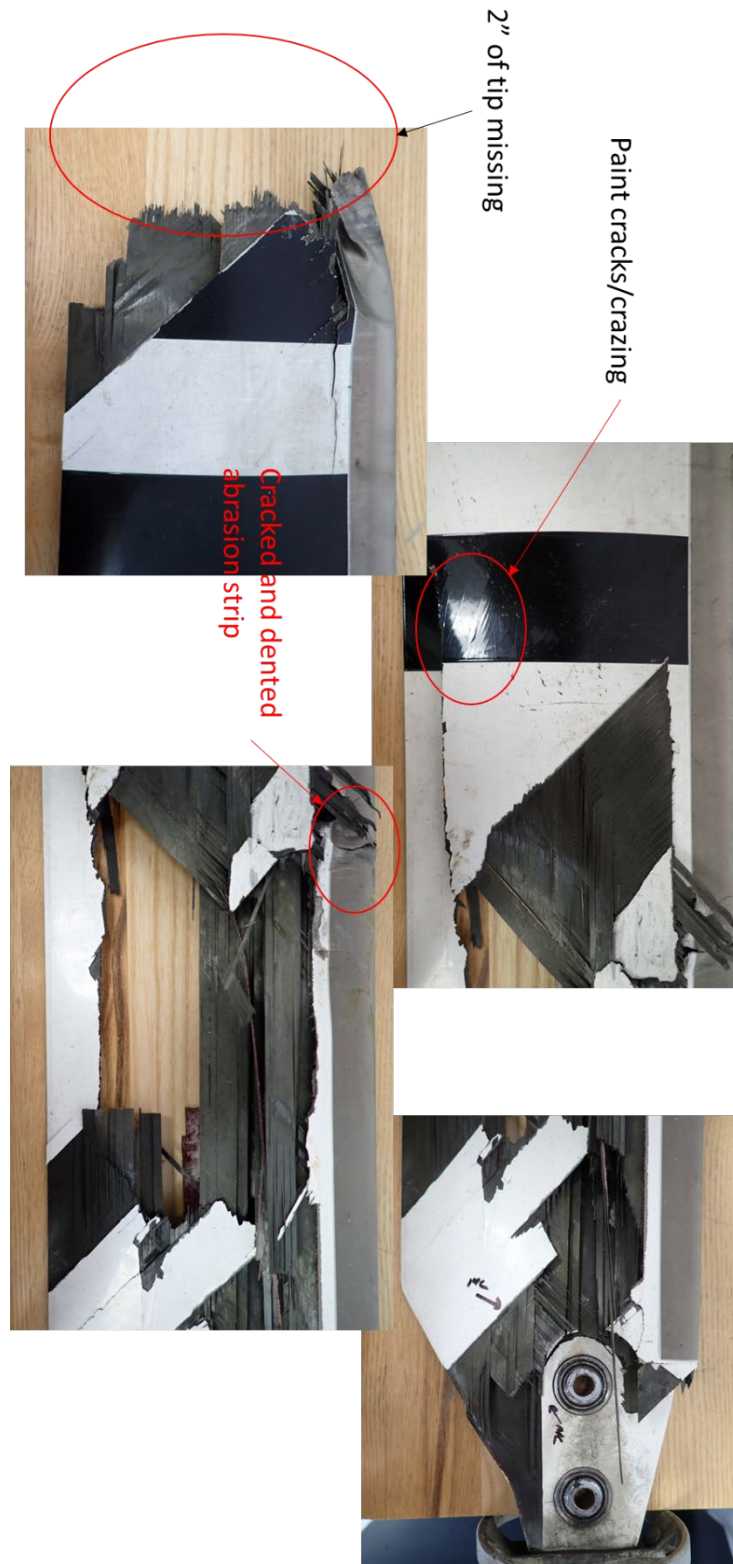
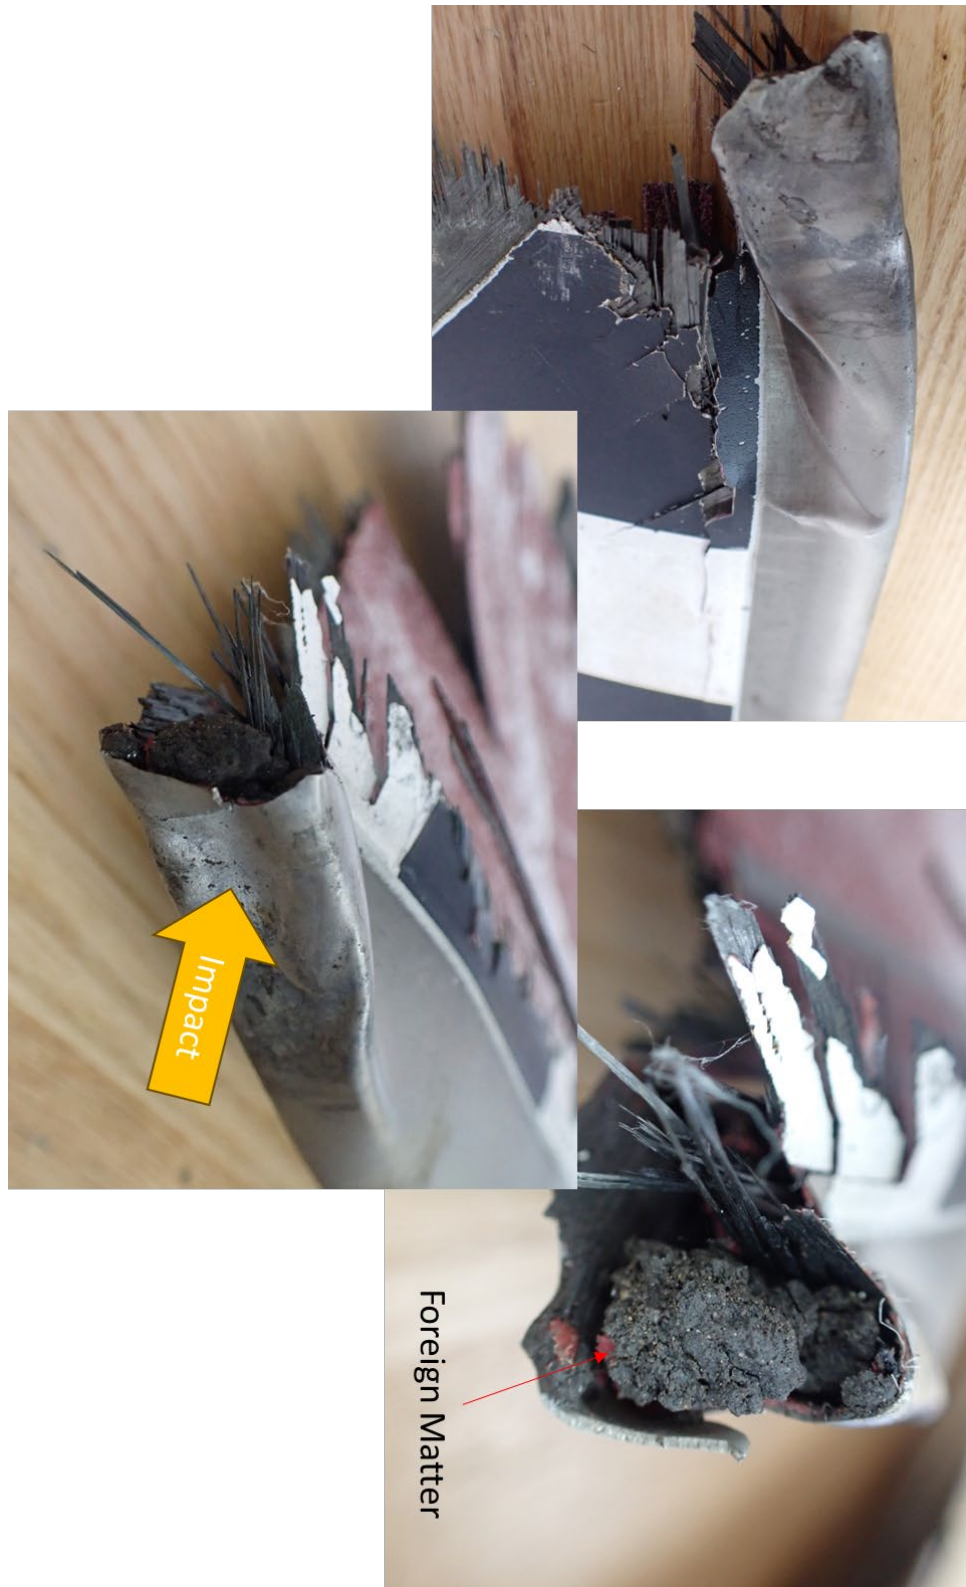
The tip fracture removed the last 2” of the tip of the blade (Figure 15). This constitutes the entire swept tip portion of the blade. This is readily apparent since none of the white paint outboard of the last black stripe is visible. In this area the abrasion strip shows substantial denting, folding, and debonding/delamination along its aft edge as well as discoloration from foreign materials. The abrasions strip is significantly deformed aftward starting just outboard of the inboard edge of the black paint stripe (Figure 20). This extensive amount of deformation to the abrasion strip is indicative of a high energy impact on the leading edge and almost certainly while the blades were turning. The carbon material aft of the abrasion strip exhibits translaminar fracture mostly along a plane at rotor station 29.8 which corresponds with the outboard termination of the spar plies. Many of the cut ends of the spar plies are visible. On the lower surface, a portion of the skin separated along the fibers of the 45 deg ply. Finally, a foreign material, possibly compacted soil, was found embedded behind the abrasion strip at the tip end of the blade.

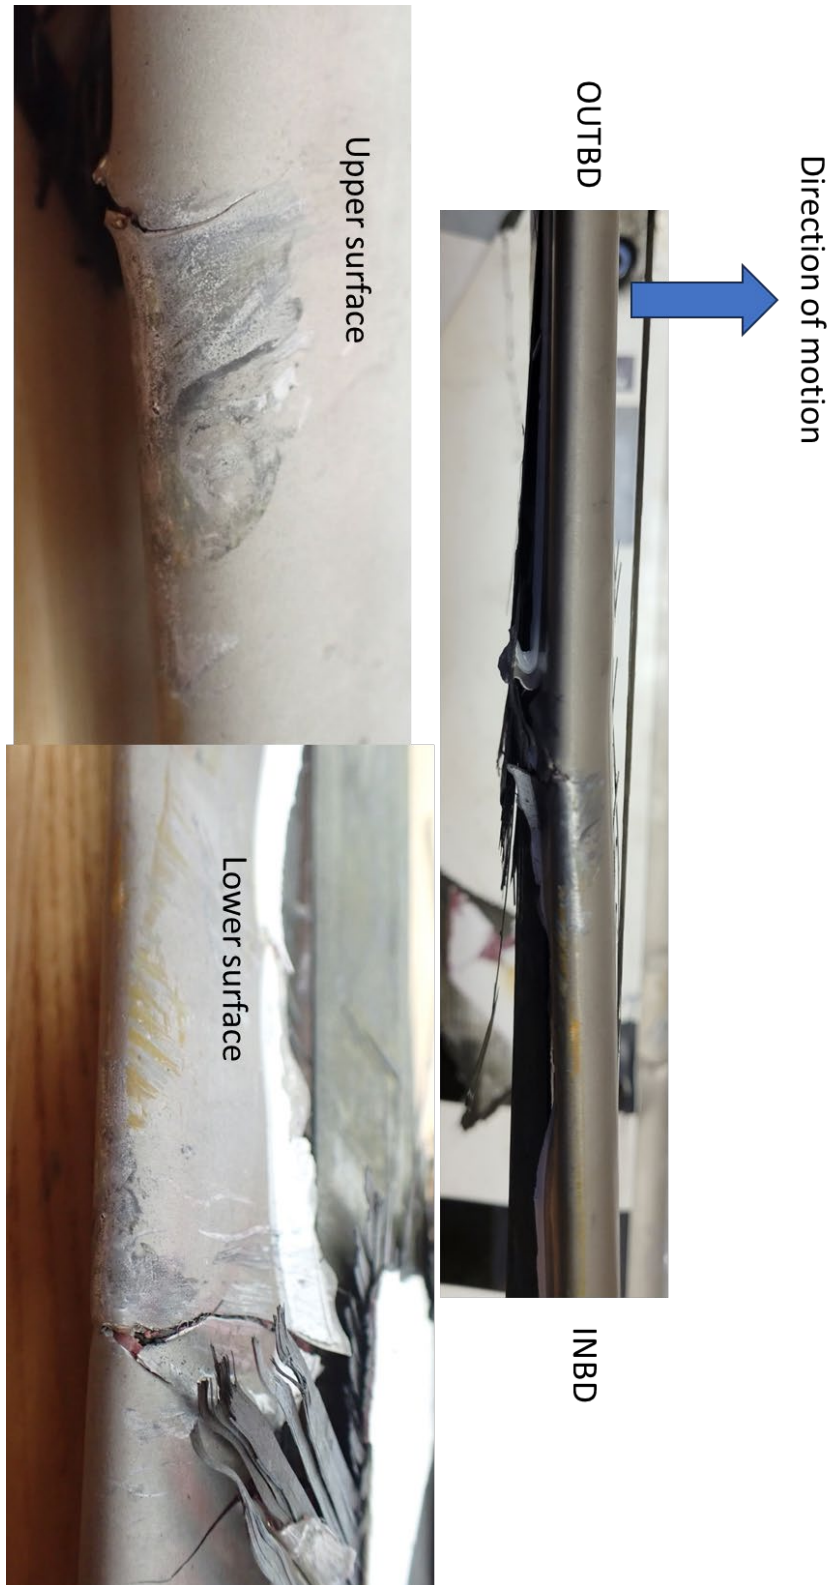
**Figure 18 - C549 Mid-Span Fracture**

The mid-span fracture (Figure 18) shares similarities with that seen on blade C548 albeit somewhat less severe. The abrasion strip is cracked in 3 places on the lower surface and with only one wrapping around slightly onto the upper surface. There are also several delaminations in the 45 deg plies immediately aft of the cracks on the lower surface. The residual strength in the laminate permits motion most easily in the tip up direction, again indicating this was the direction of deflection at failure. The lower surface outboard of this cracking shows an extensive network of fine paint cracks or crazing (Figure 19) which is typically associated with wide area impacts on the aft body of the rotor blade (Reference 3).
