# National Transportation Safety Board

WPR22LA236

## **MATERIALS LABORATORY**

Specialist's Factual Report 22-074

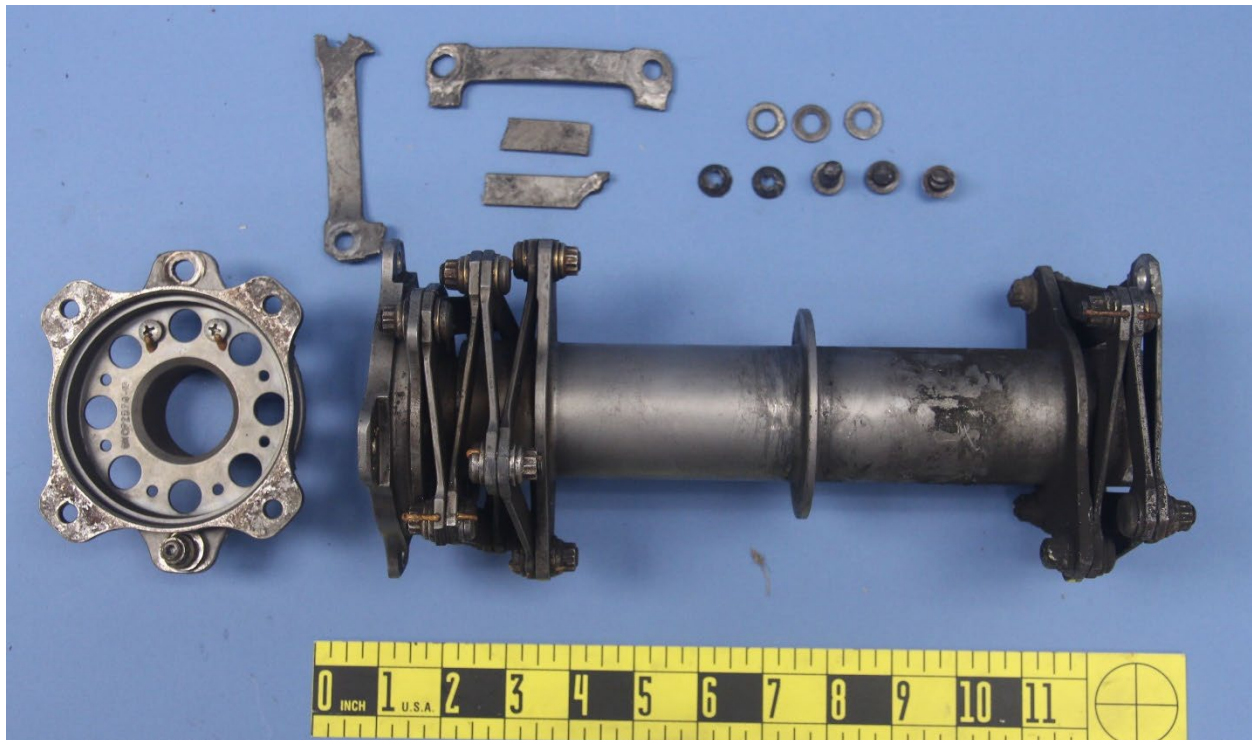
Figure 1 shows all the components received by the NTSB Materials Laboratory, including the Kaflex coupling, fractured flex plate remnants, attachment bolt fragments, and a separated outer shaft end fitting. Figure 2 shows the positions of the outer shaft fitting and interconnect fitting components of the Kaflex coupling, as positioned when attached together, with the male end of the shaft end fitting facing the cylindrical tube body of the interconnect.

**Figure 1.** The components from the Kaflex coupling assembly, as received

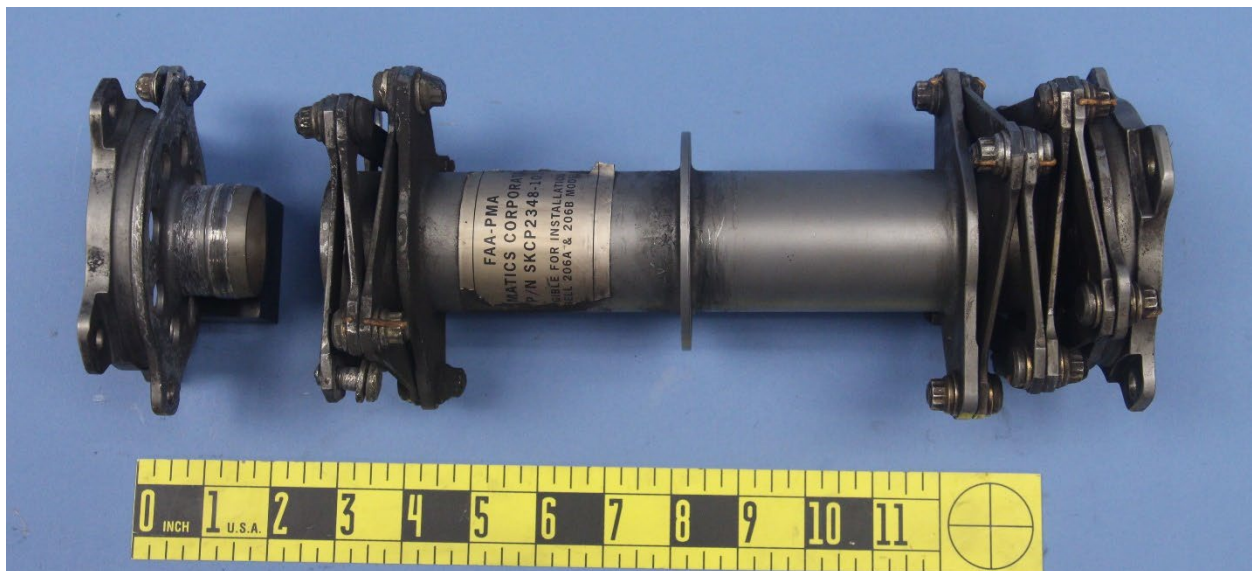
exhibited areas with circumferential wear marks. Figure 2 shows these more reflective rotational wear marks on the wider shoulder surfaces and recessed surfaces of the fitting. These features were mirrored on the interior surfaces of the interconnect, which can be viewed on the left in Figure 3. These features were consistent with the interconnect and shaft fitting rotating against each other.

**Figure 2.** The shaft end fitting and interconnect fitting from the Kaflex coupling, as received.

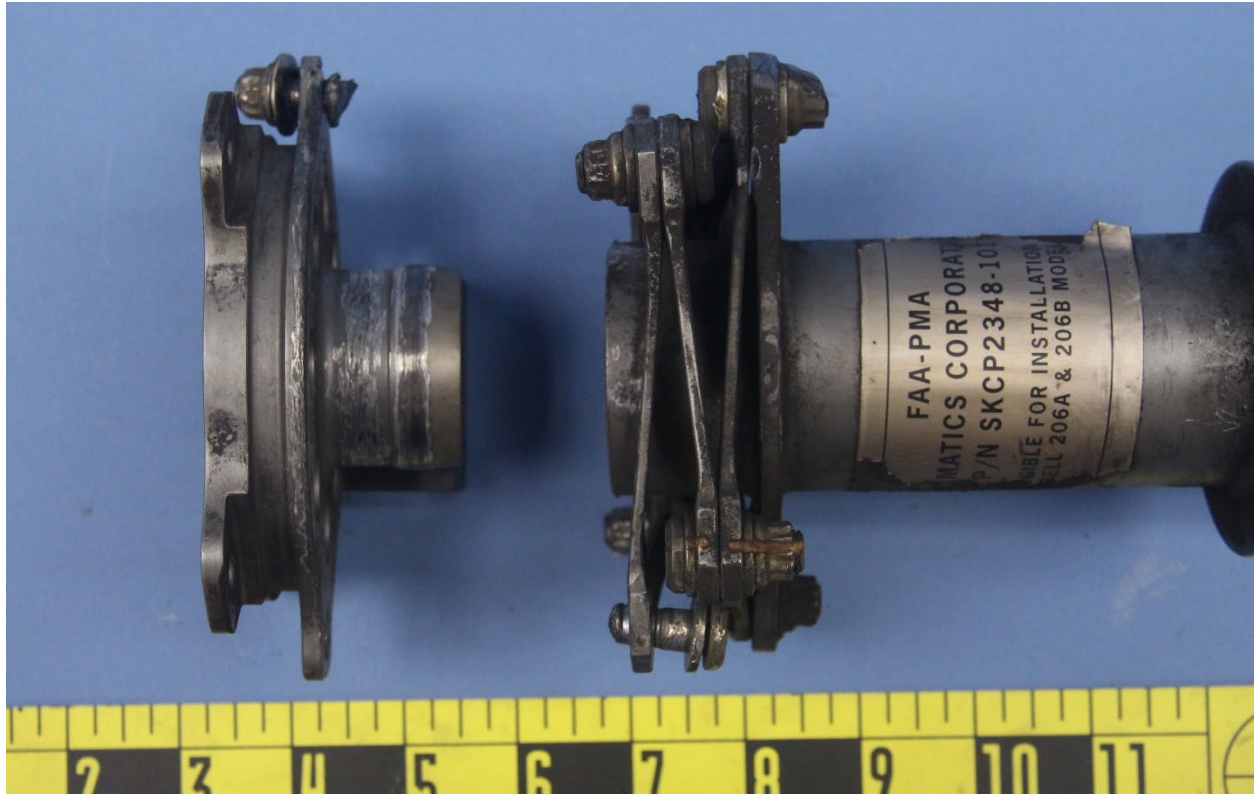
**Figure 3.** Closer view of the connecting cylindrical surfaces of the outer shaft end fitting and interconnect, showing circumferential wear features.

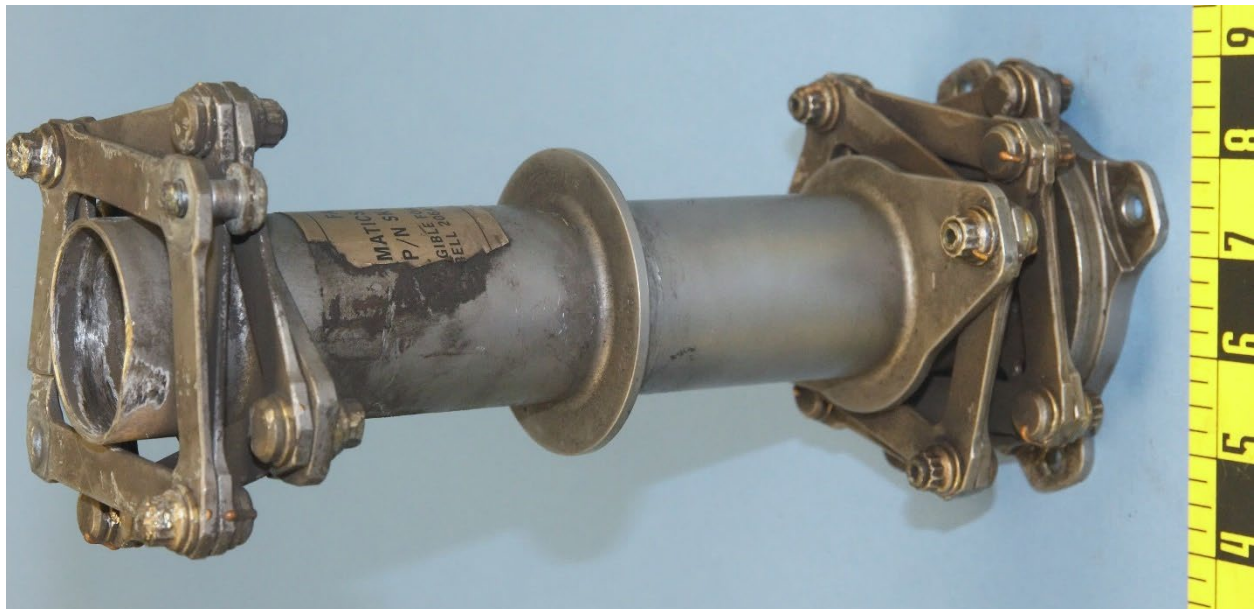
The main body of the Kaflex coupling, including the interconnect fitting and several flex plates joined with attachment bolts, is highlighted in Figure 4. The partially destroyed label on the interconnect body stated: "FAA-PMA, ...MATICS CORPORATION, P/N SKCP2348-101, ...GIBLE FOR INSTALLATION, BELL 206A & 206B MODEL",

The rectangular-shaped flex plates had been joined to the interconnect flanges, outer shaft fittings, and other flex plates by attachment bolts with washers and nuts. Each intact bolt assembly had a small amount of orange wax to denote the as-torqued position (see the bolt nuts on the right side of Figure 4). The plates and bolts on the left side of Figure 4, however, were not intact, with the bolts in those positions having fractured or separated entirely. Figure 1 shows three of the bolt remnants, with one of the remnants still in a bolt hole of a flex plate (left side of Figure 4).

**Figure 4.** Angled view of the main body of the interconnect fitting and plate assembly, showing internal wear marks and deformation of the tube.

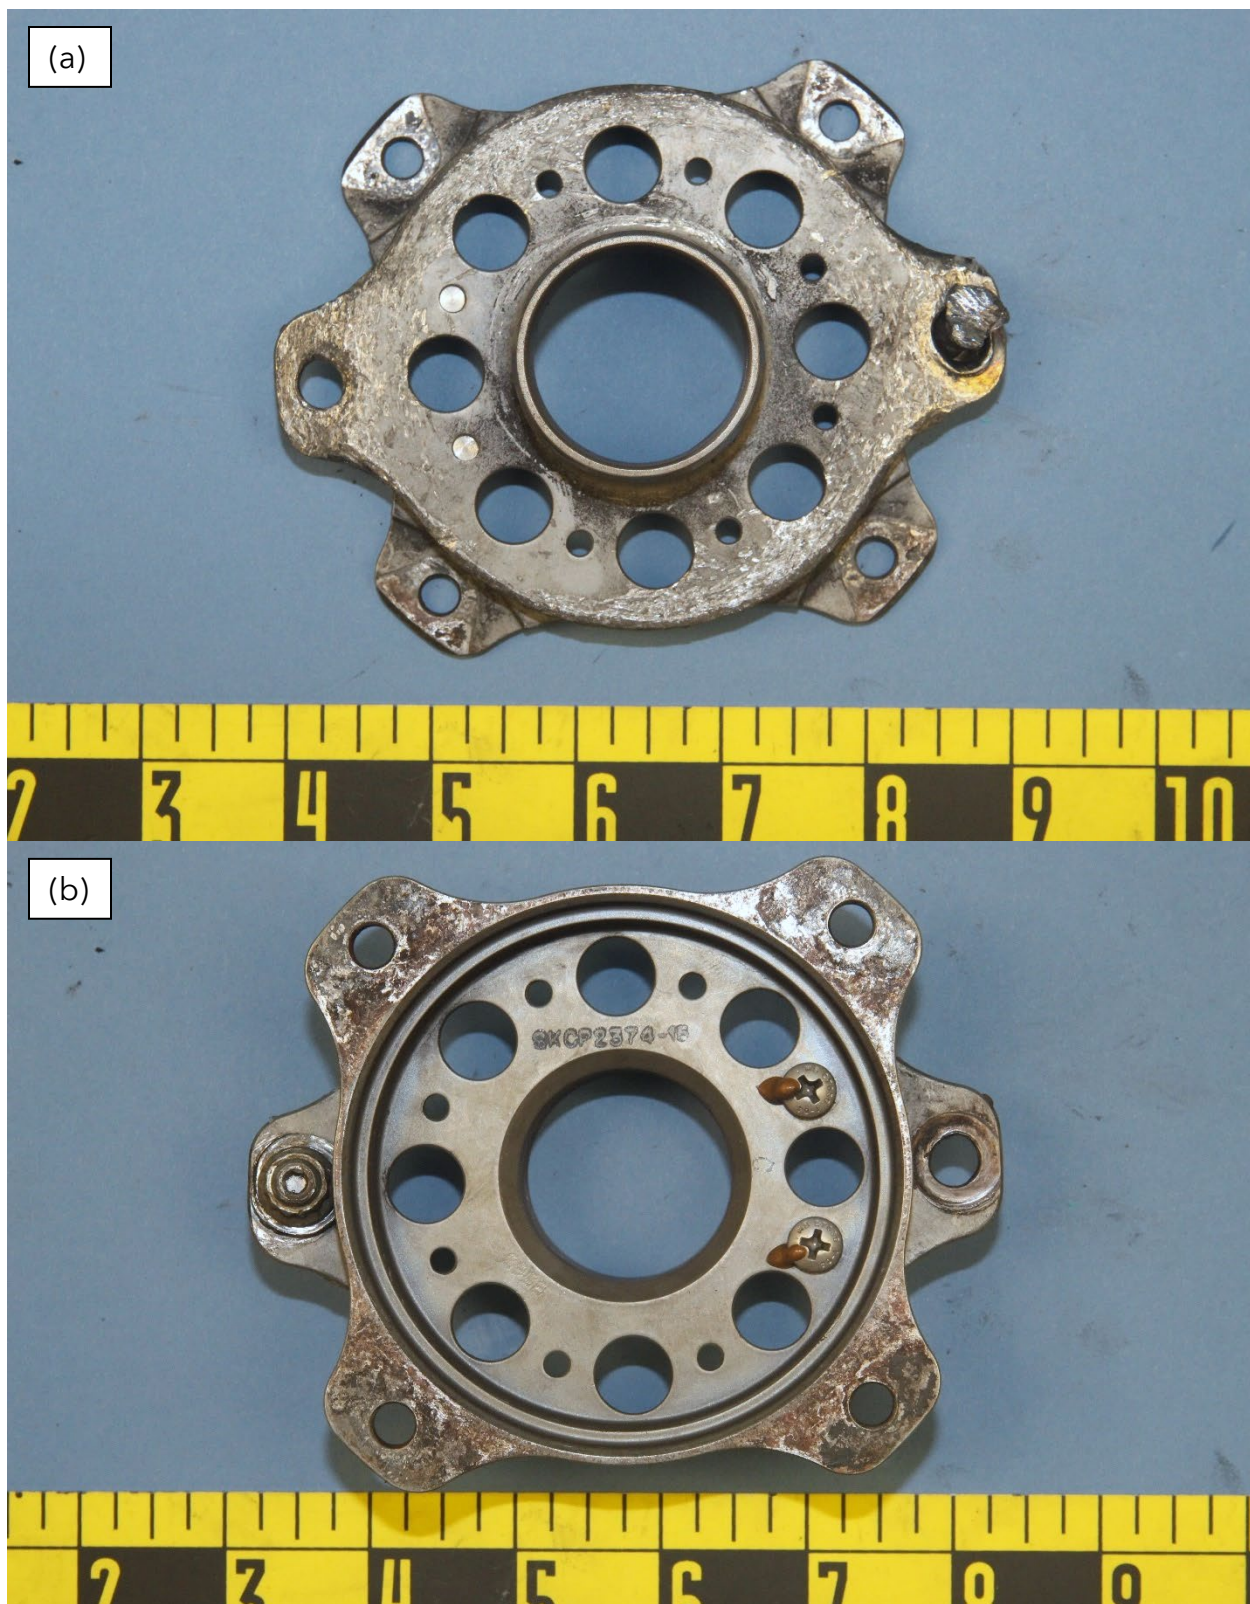
Figure 5 shows both surfaces of the separated outer shaft end fitting. The flange surfaces on the exterior and the inward-facing surfaces all exhibited streaks, scrapes, and gouge marks. These marks were rotational or circumferential in orientation. In addition, there was a remnant of a bolt still within one of the fitting flanges, shown on the right in Figure 5a and the left in Figure 5b. The nut was still affixed to the threaded portion of the shank, and the bolt remnant was intact, but the head had experienced severe batter and deformation—enough to pull part of the head and shank out and over the fitting flange. The hole at this location and one on the opposite 180° location both experienced elongations, consistent with the circumferential orientation of the other wear and impact marks.

**Figure 5.** Views of (a) the interior and (b) exterior of the shaft end fitting.

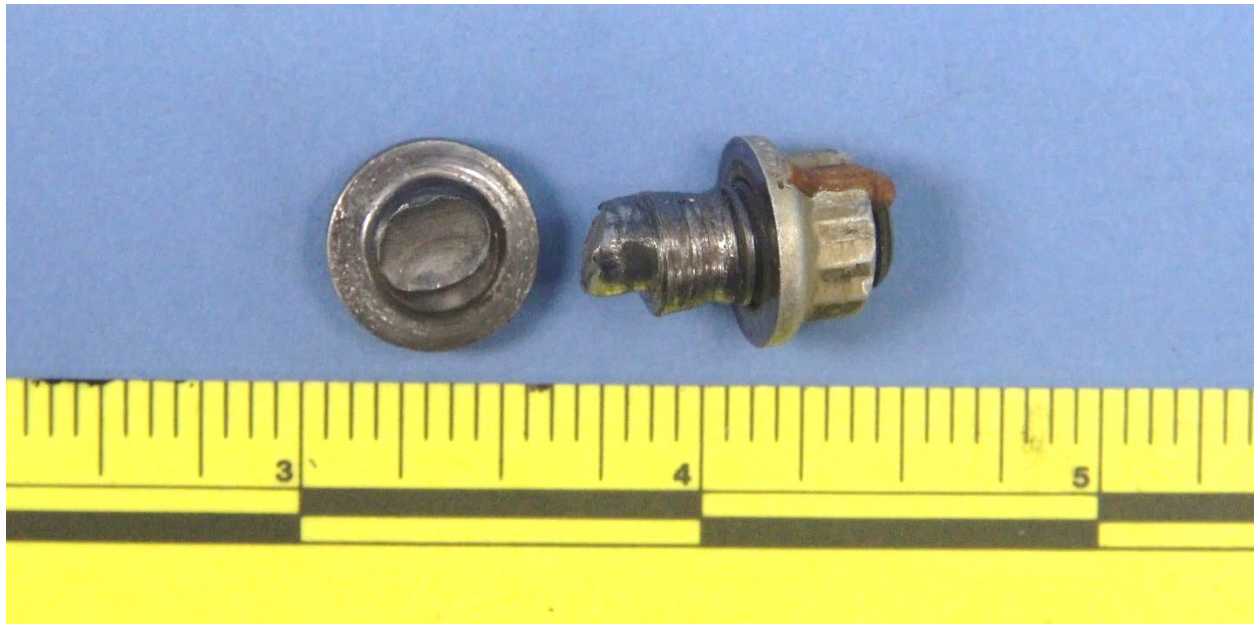
Figure 6 shows two mating sides of a fractured attachment bolt. Each face of the bolt fracture surface exhibited thumbnail-shaped crack features. Both sides of the bolt exhibited a smaller cross section at the location of the fracture surface. This area exhibited gouges and a more reflective luster, consistent with rubbing, impact, and wear. The shank diameter was measured with digital calipers as 0.295 inches wide, but only 0.234 inches wide at the fracture surface. Likewise, on the bolt head side, the shank remnant diameter was measured as 0.305 inches, but 0.236 inches at the fracture surface. The length of the head remnant was 0.207 to 0.268 inches, with the location of the fracture surface initiation location on the shanks being 0.058 inches from the bottom surface of the head. The shank and threaded remnant of the fractured bolt measured 0.753 inches long.

**Figure 6.** Mating pieces of the fractured bolt from the coupling.

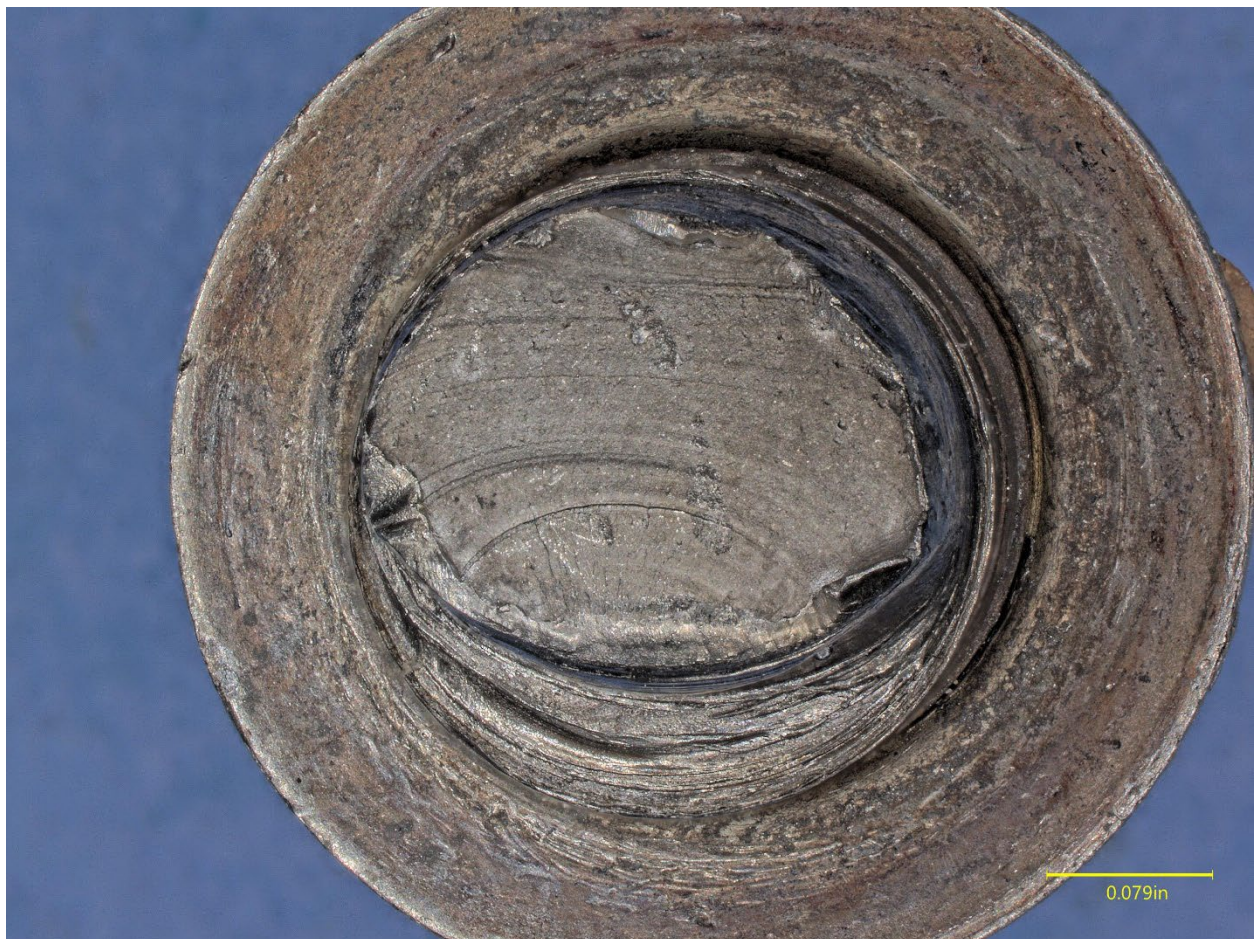
The remnants of the bolt were cleaned in an ultrasonic bath with acetone. Figure 7 shows the fracture surface from the shank and threaded side. The surface exhibited crack arrest marks, which were convex inward, consistent propagation from the worn area of the shank. Several distinct areas of this fracture surface exhibited oblong areas with a more reflective luster—these regions were consistent with smearing from post-fracture impact damage.

**Figure 7.** View of the bolt fracture surface from the shank remnant attached to the nut.

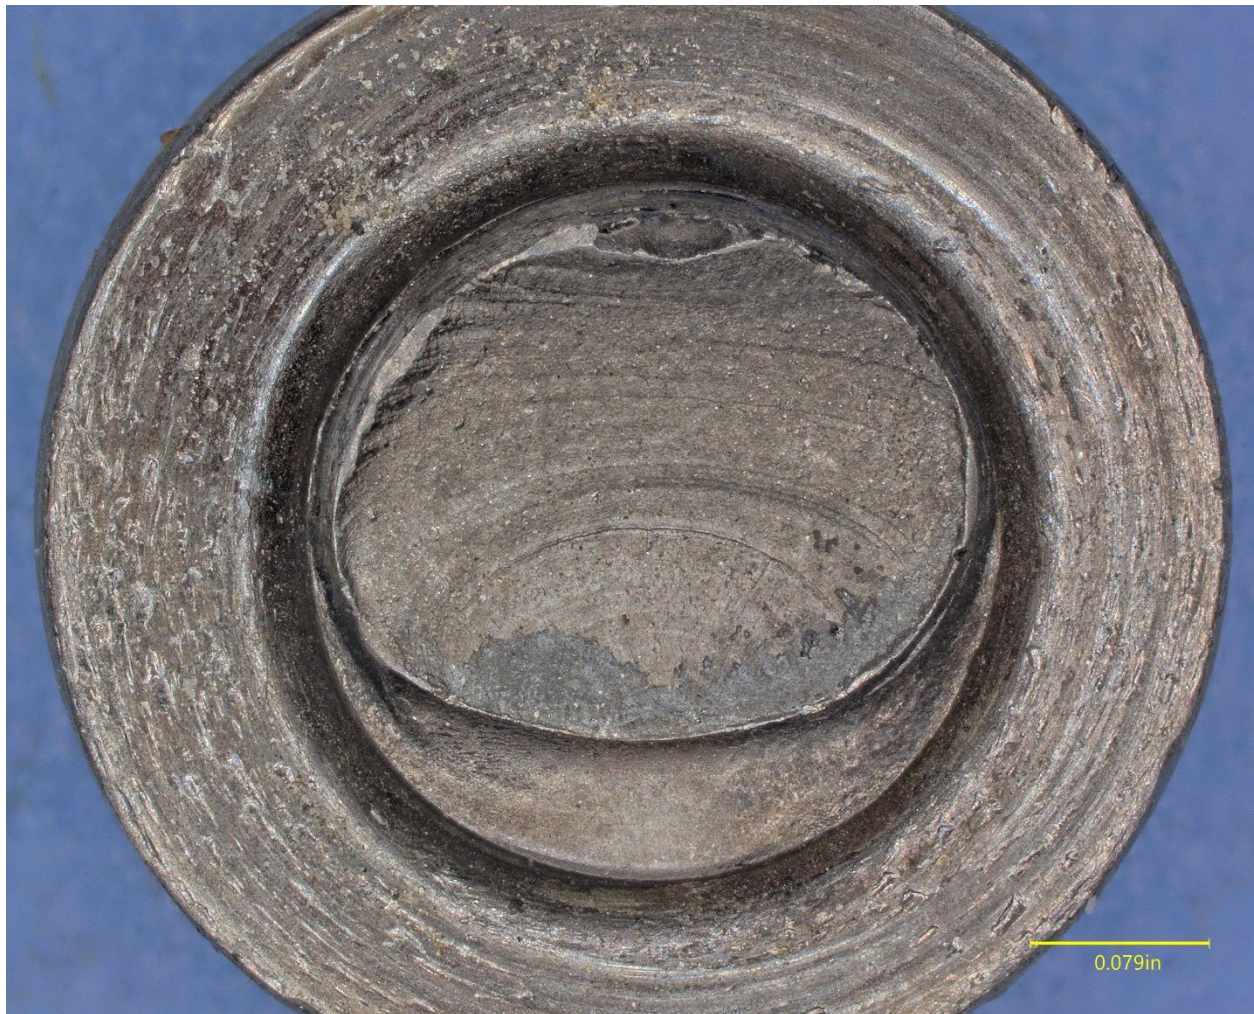
Figure 8 shows the mating fracture surface from the head of the bolt. This surface exhibited less damage and shows the crack arrest marks emanating from an initiation site along the worn area of the shank (bottom of the figure). Figure 9 shows the fractured head of the bolt viewed from the side. Figure 9a shows the initiation site along the edge with the worn area, with crack arrest marks oriented consistent with inward propagation (downward in the figure). When viewed rotated 90° (Figure 9b), the fracture surface was shown to exhibit an angled orientation relative to the direction of the shank.

**Figure 8.** View of the bolt fracture surface from the head remnant of the bolt.

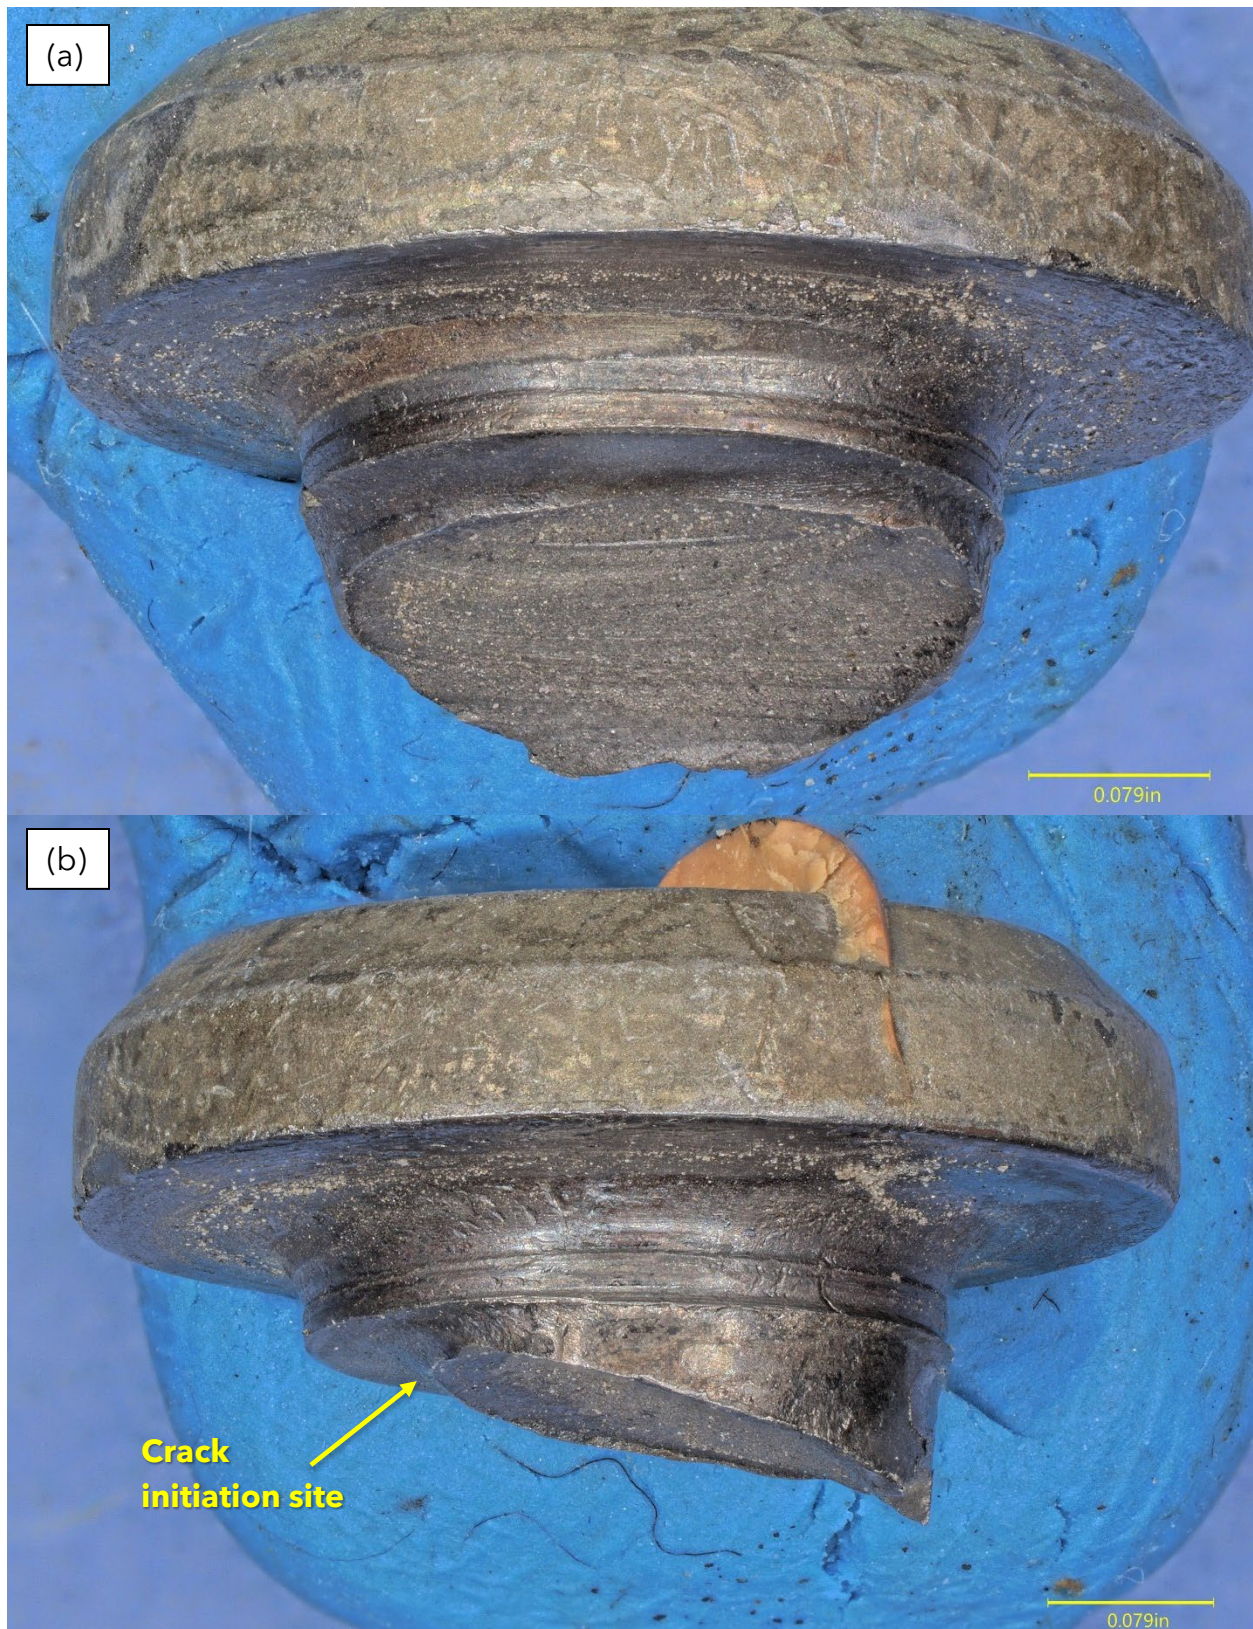
The crack initiation site was depicted on the left in Figure 9b, in the area that had been worn away (approximately 0.07 inches of the shank diameter). A closer view of the crack initiation site and its location are shown in Figure 10. The mating fracture surfaces are shown from the side in Figure 11, demonstrating the degree of material loss on the shank diameter of the bolt.

**Figure 9.** Side views of the head remnant of the bolt, showing (a) the crack initiation site and (b) rotated 90°, demonstrating the wear near and geometry of the fracture.

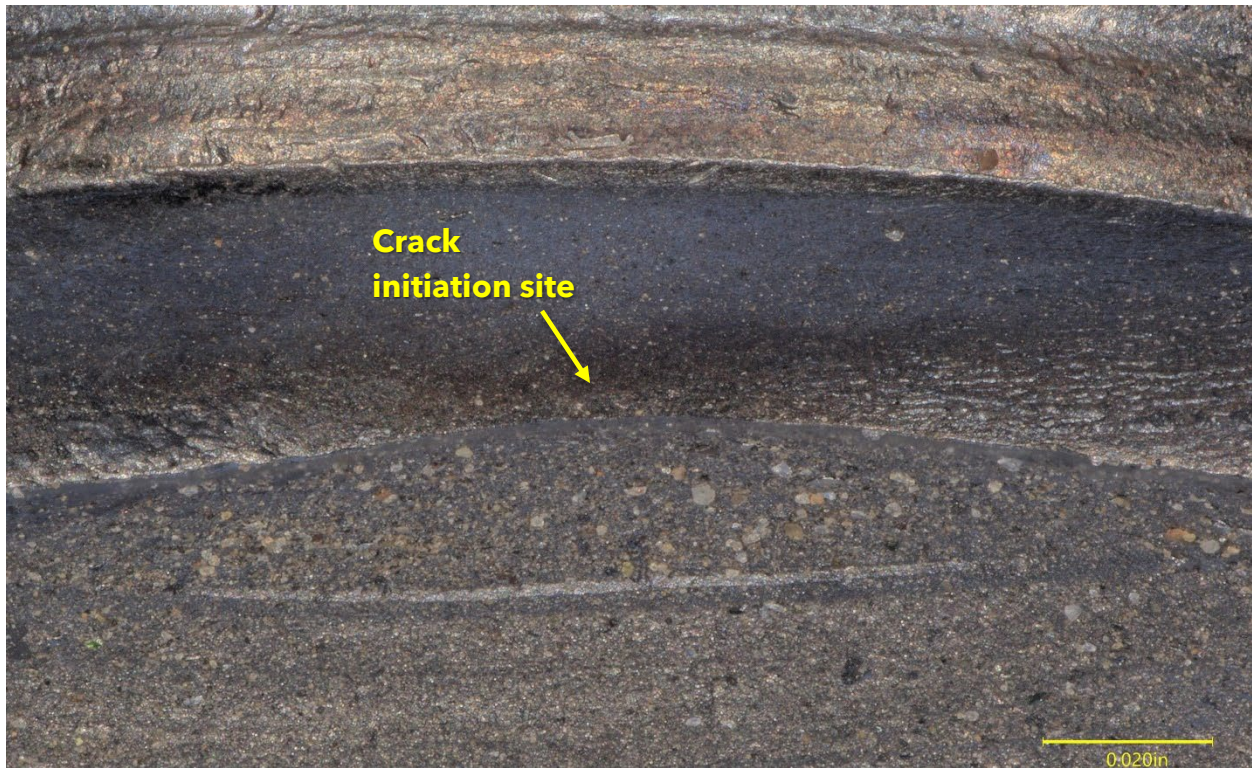
**Figure 10.** Closer view of the crack initiation site (arrow) of the bolt head remnant.

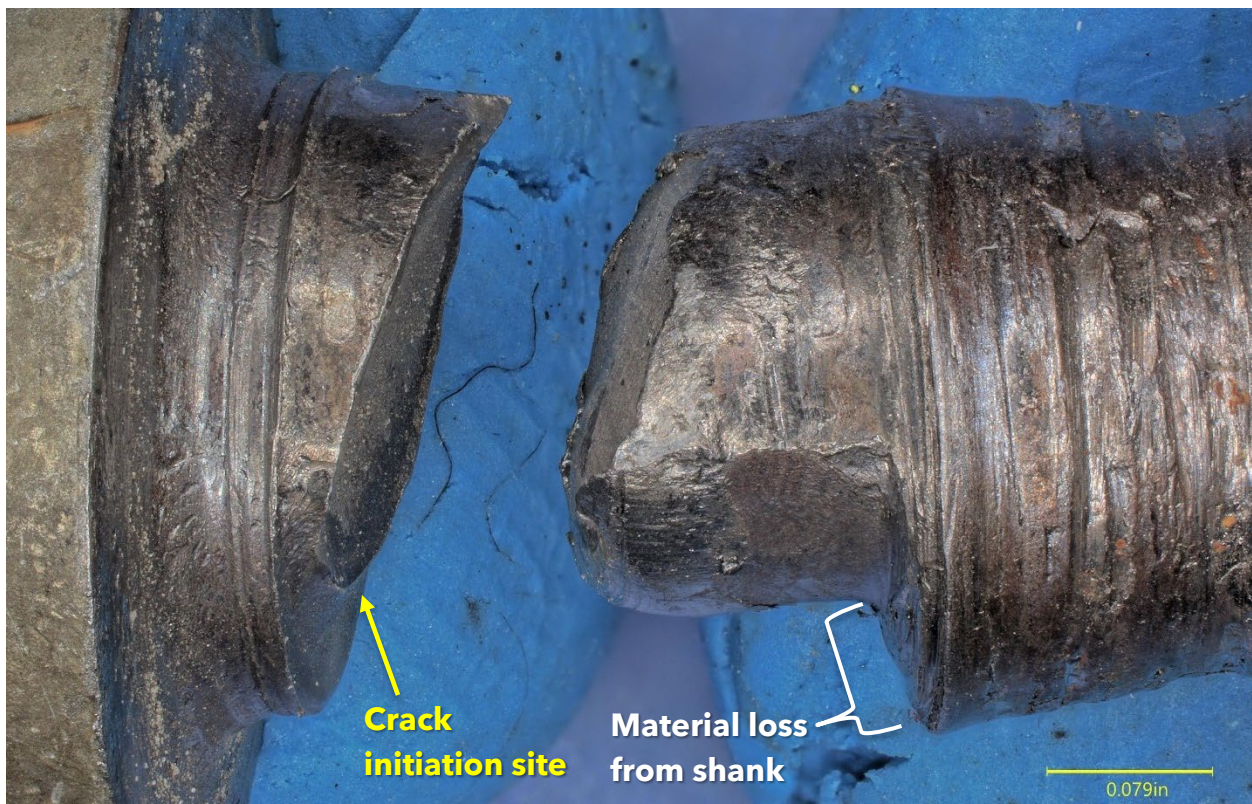
**Figure 11.** Closer view of the mating fracture surfaces of the bolt, positioned facing each other, with the degree of wear highlighted.

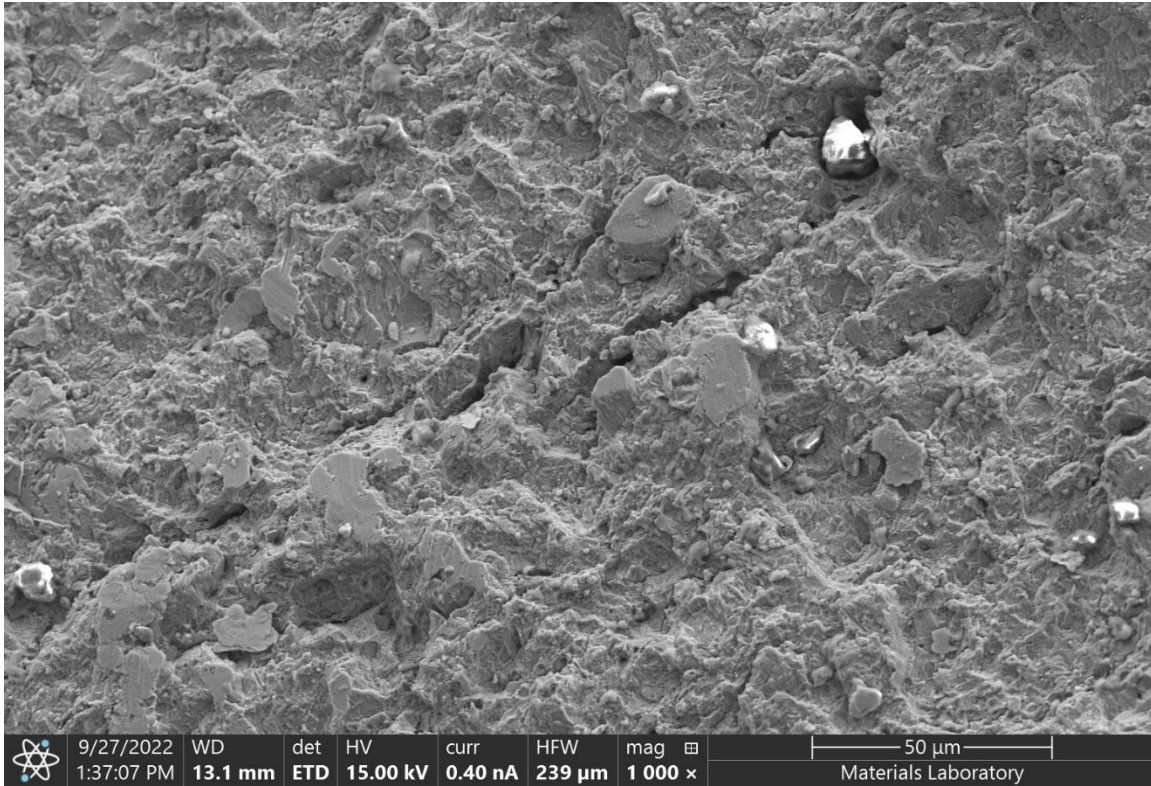
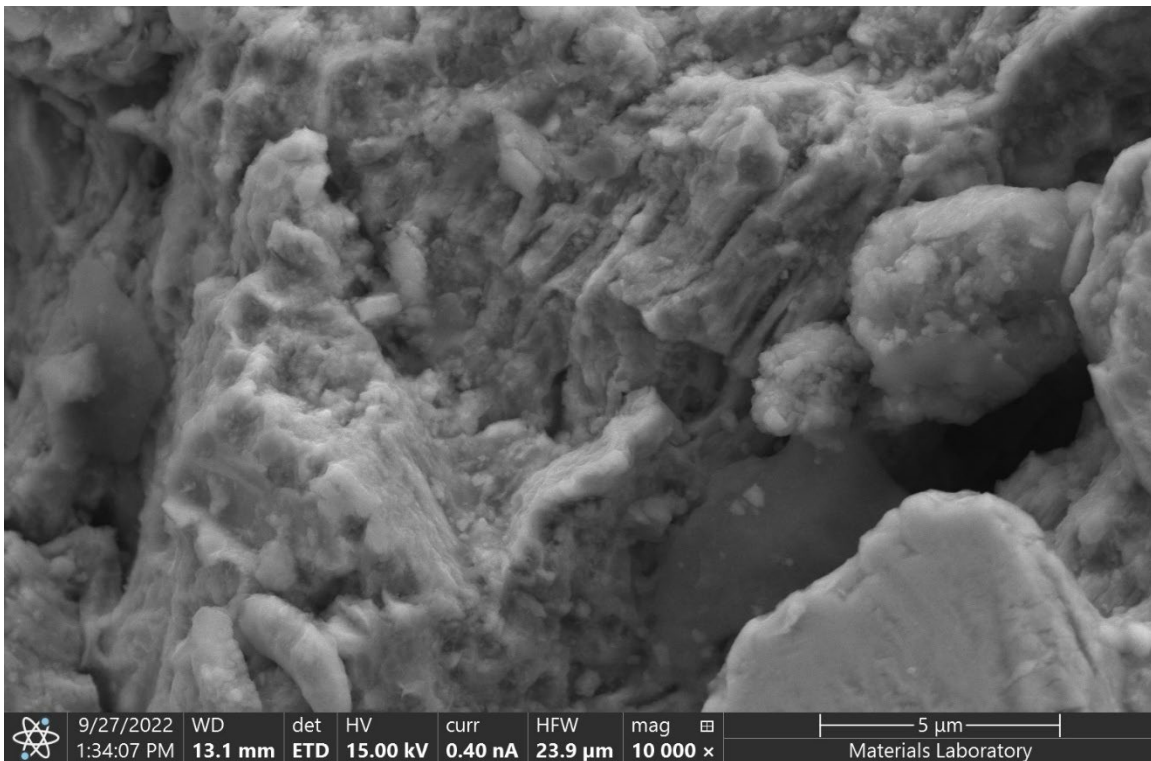
The bolt head fracture surface was examined using a field-emission scanning electron microscope (SEM). The majority of the fracture surface exhibited fatigue striations, consistent with fatigue crack propagation, as illustrated in Figure 12 and Figure 13. Near the end of the fatigue crack terminus, the surface exhibited more acicular morphology consistent with the material microstructure (typical of hardened alloy steels), along with fatigue striations (Figure 14). Outside of the fatigue crack, located as shown near the top of Figure 8, the surface exhibited dimpled rupture, consistent with subsequent overstress fracture of the remaining cross section of the bolt (illustrated in Figure 15).

**Figure 12.** Secondary electron (SE) micrograph of a typical area of the bolt head fracture surface.

**Figure 13.** SE micrograph of a closer view of Figure 12, showing fatigue striations.

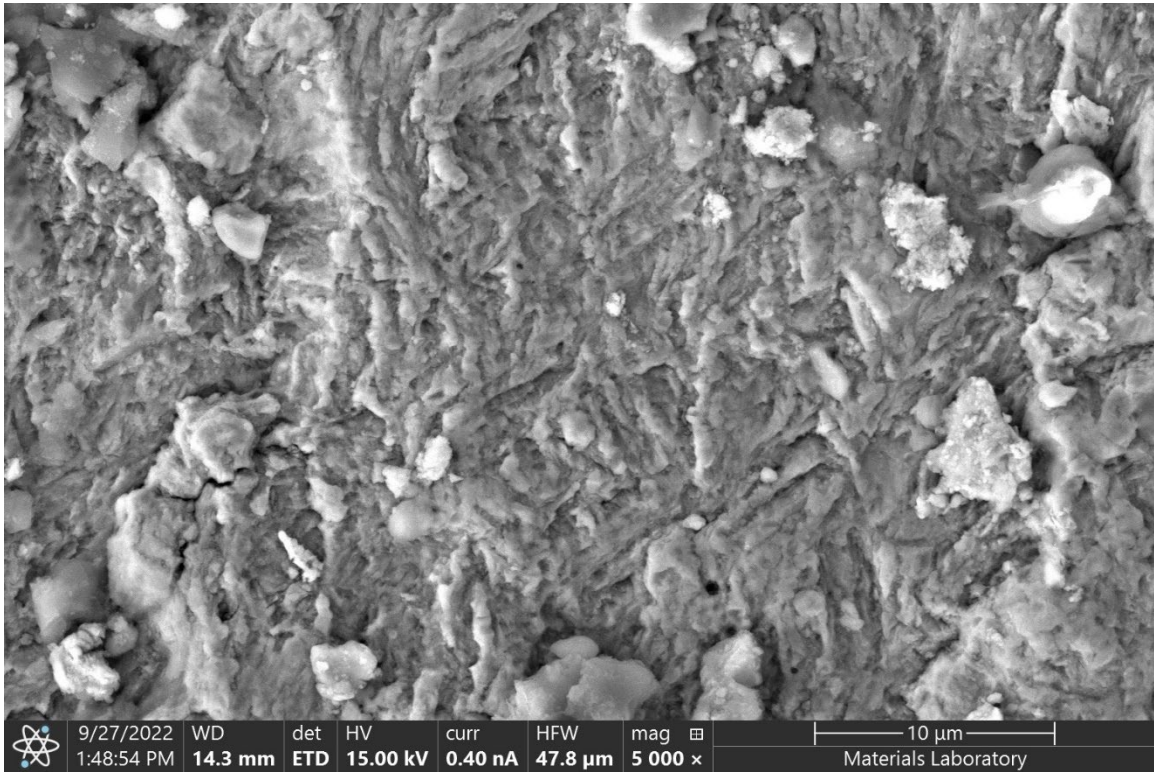
**Figure 14.** SE micrograph of striations near the end of the crack on the bolt fracture.

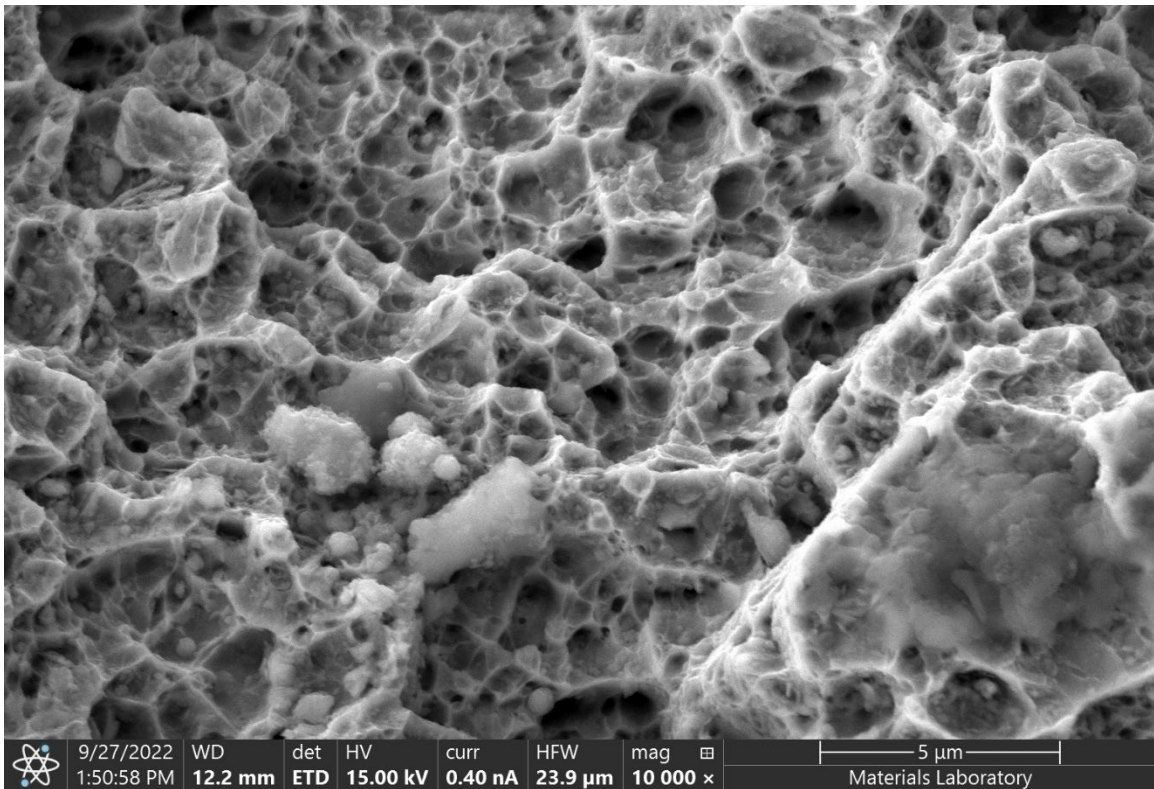
**Figure 15.** SE micrograph of dimpled rupture outside the fatigue crack on the bolt.

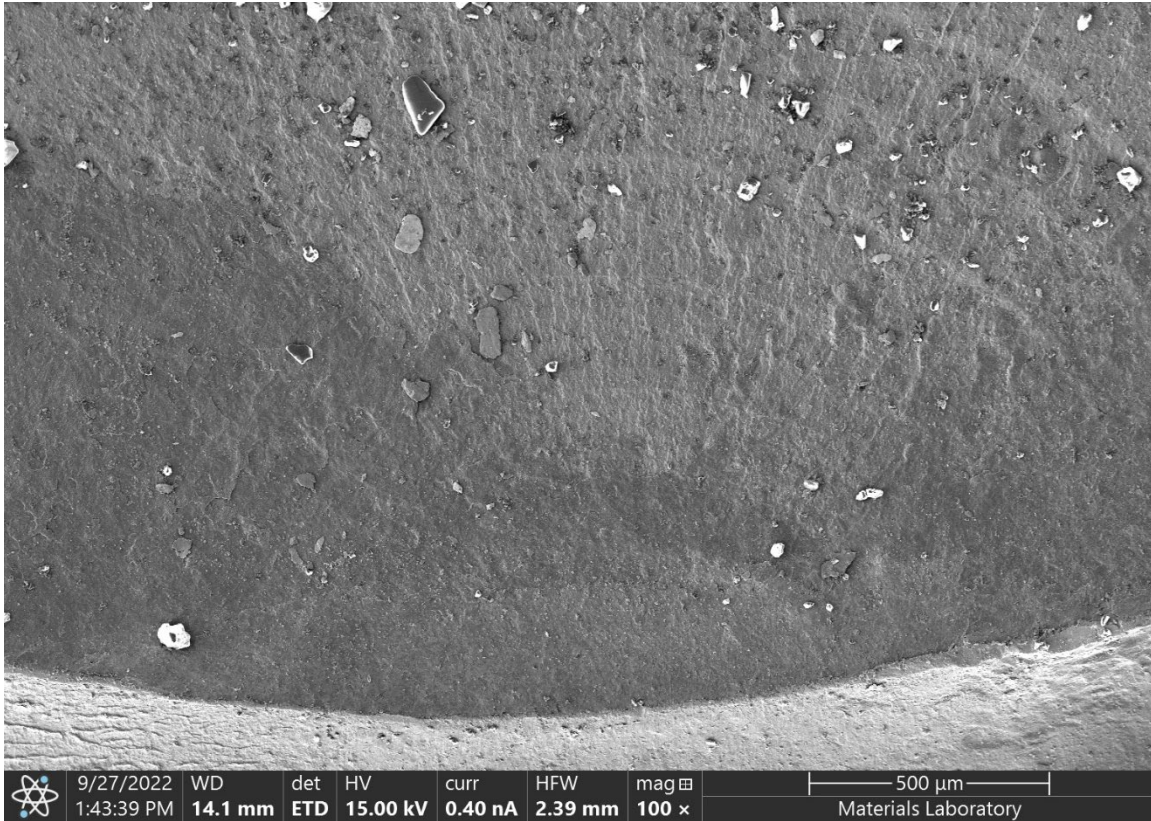
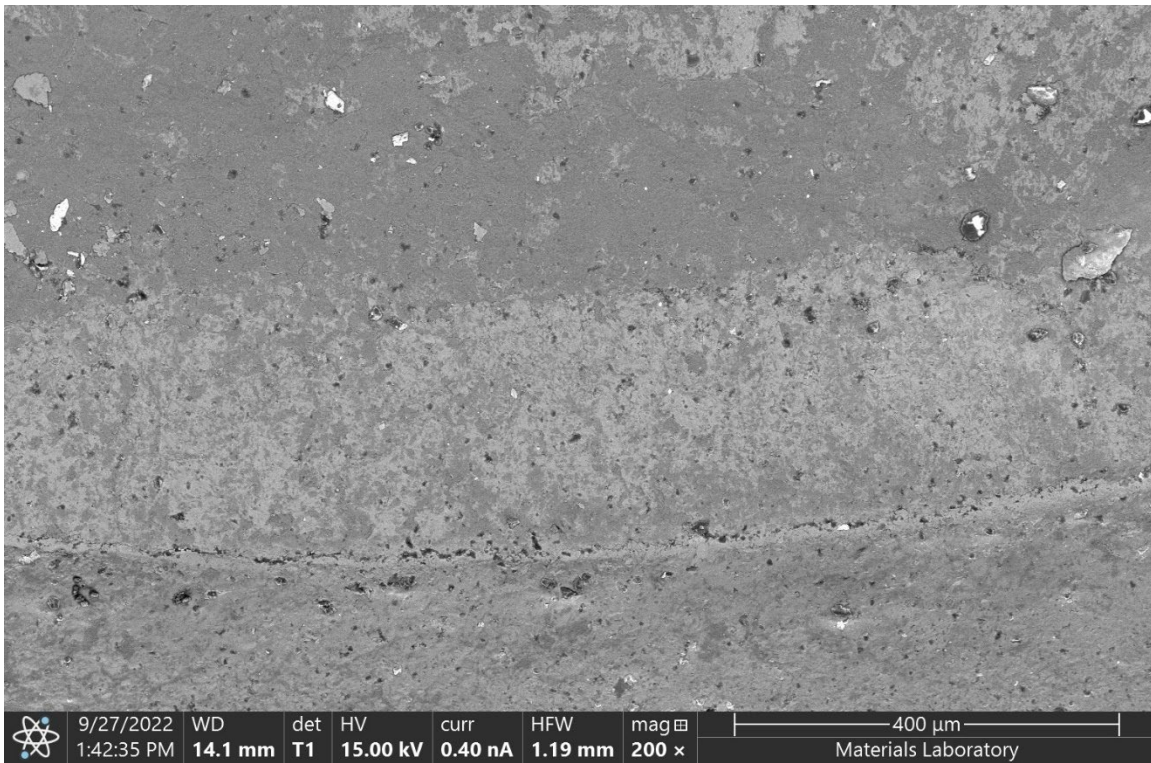
Figures 16 and 17 show a closer view of the fatigue crack initiation site on the bolt head. This location exhibited crack arrest marks and river patterns emanating from the edge of the fracture surface (upward crack propagation in the figures). The initiation site itself, shown in Figure 18, did not exhibit any material discontinuities, such as voids, pores, or inclusions. There were localized areas of smoothing and smearing, consistent with post-fracture impact damage. However, the location near the initiation site did exhibit some microscopic surface scratches and grooves, present throughout the worn region of the shank material.

**Figure 16.** SE micrograph of the fatigue crack initiation site on the bolt fracture.

**Figure 17.** Backscattered electron (BE) of a closer view of the initiation site.

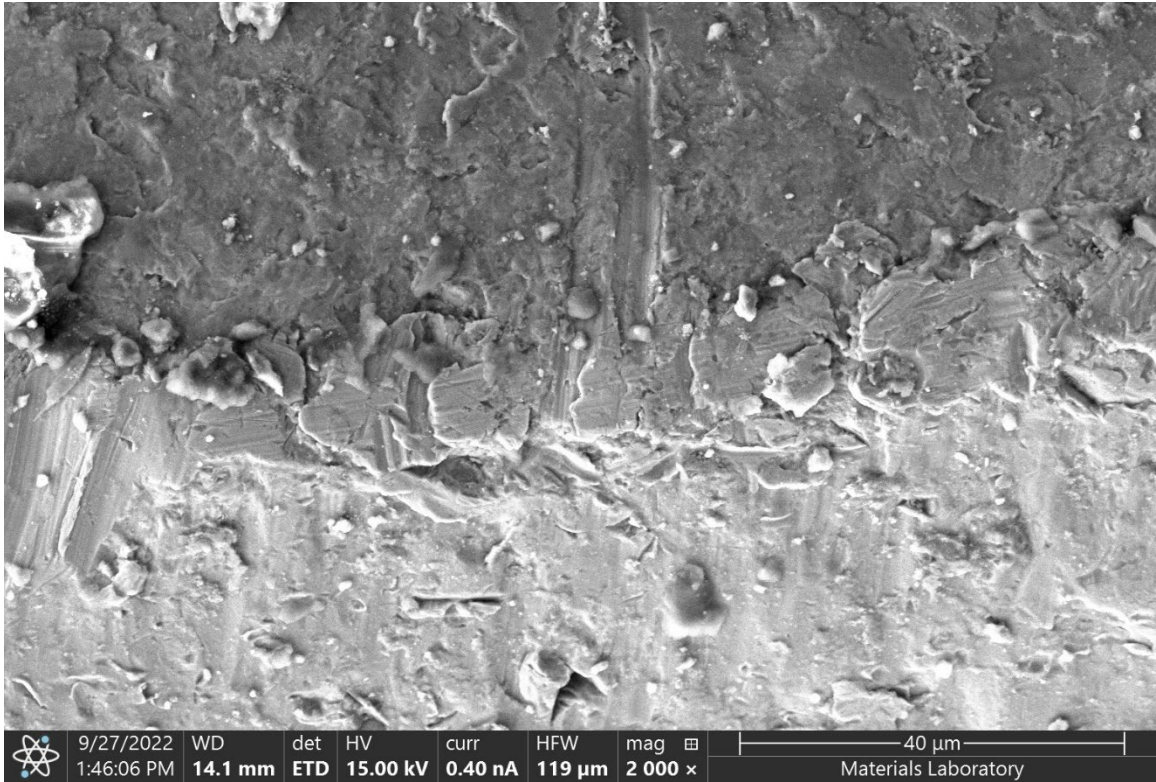
**Figure 18.** SE micrograph of the edge of the fatigue crack initiation site, showing smearing and edge deformation.
