# National Transportation Safety Board

WPR22LA236

## **MATERIALS LABORATORY**

Specialist's Factual Report 22-074

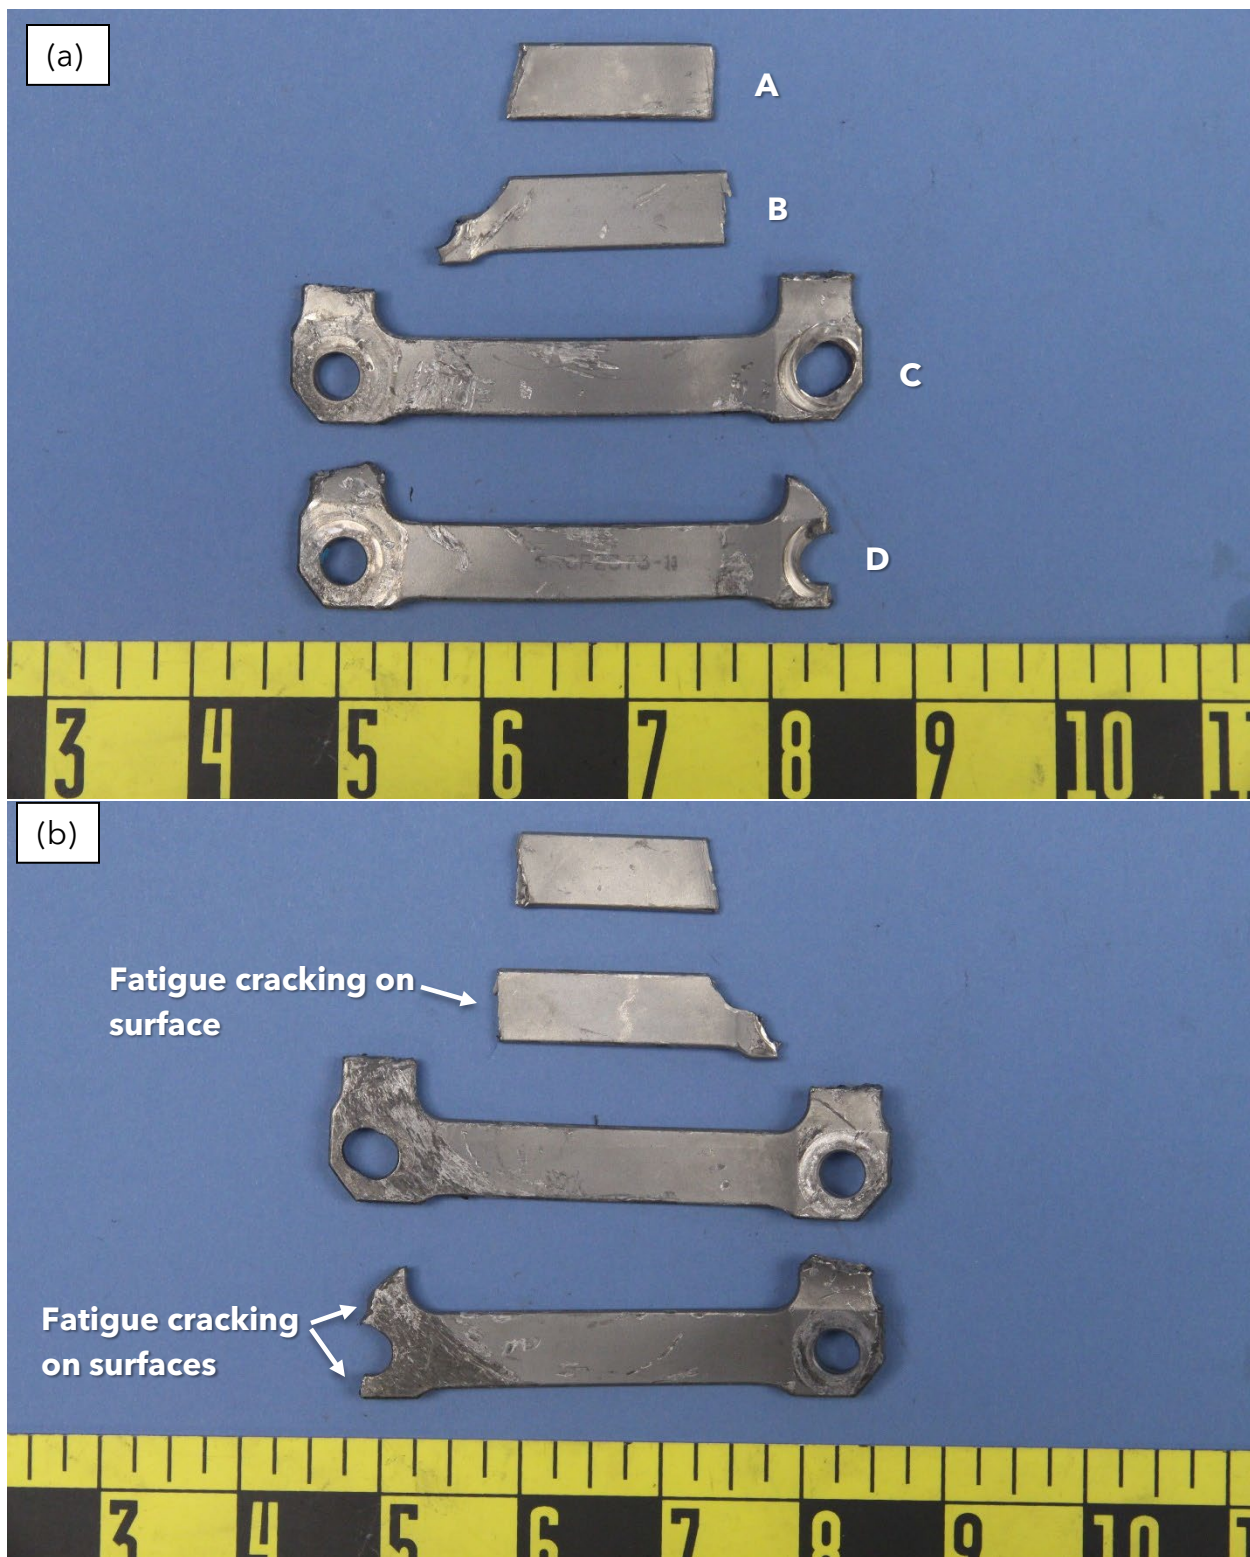
The four fractured flex plate remnants are illustrated in Figure 19. The plate remnants were labeled 'A' through 'D' for the purposes of this report, as annotated on Figure 19a. The face of the bottom plate remnant (D) in Figure 19a exhibited damaged markings stating, "CP 2373-11". The faces of plates C and D exhibited discoloration and reflective smoothing towards and around their bolt holes. This was consistent with rubbing and impact against adjacent components. In addition, the bolt holes (left side in Figure 19b) of plate remnants C and D had deformed and elongated from their original circular shapes. With plate D, the intact hole exhibited a diameter of 0.314 inches, whereas the diameter of the fractured hole was 0.354 inches in diameter.

Except for two surfaces, annotated in Figure 19b, the plate remnant fracture surfaces exhibited rough texture with a dull luster. There were often features consistent with shear lips. All these features were consistent with overstress fracture of these plates. On the left surfaces of plate remnants B and D, annotated on the left in Figure 19b, repeating parallel concentric features consistent with crack arrest marks were present. The features of these surfaces are detailed further below.

**Figure 19.** Opposite views of the fractured flex plates remnants. The annotated plate fracture surfaces were examined further.

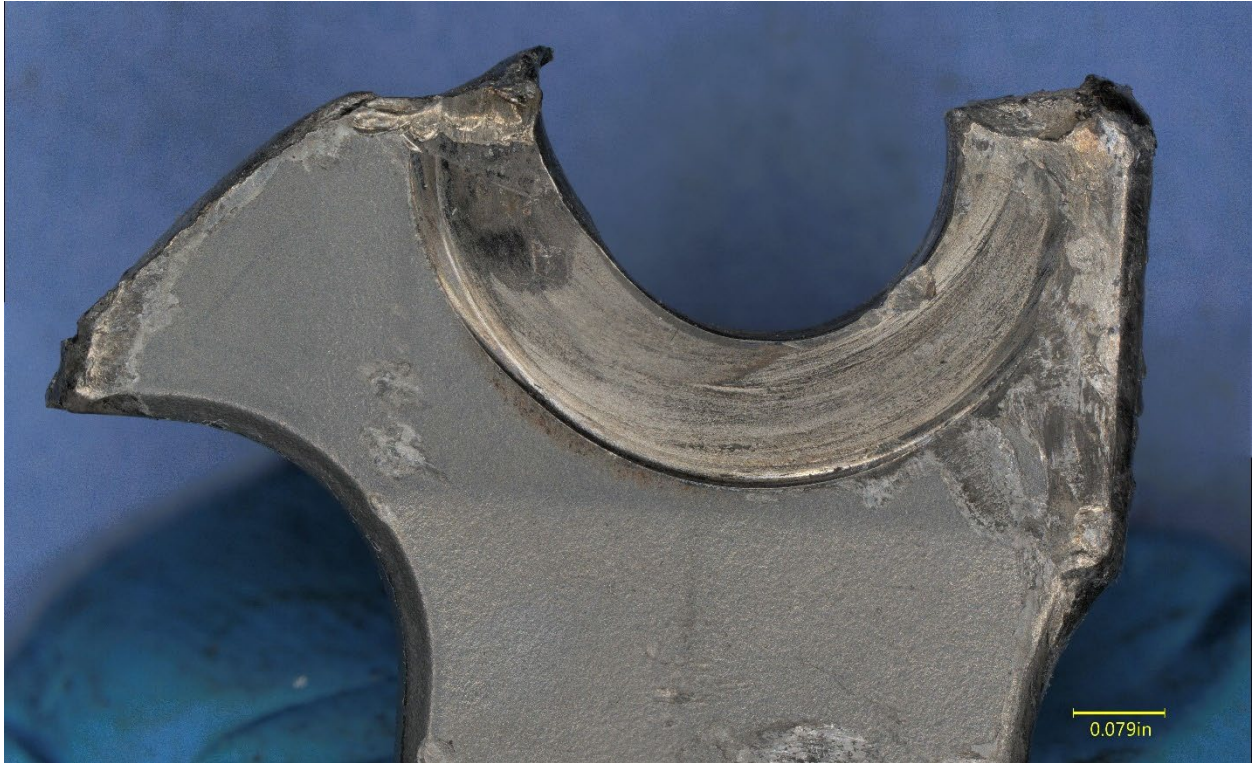
The fractured surface of plate remnant D is shown from the top face in Figure 20 and the surface and opened hole in Figure 21. The top-down view in Figure 20 shows a smooth, reflective region with rotational wear marks. The depression was consistent with the size and shape of the washers shown in Figure 1. The depression on the plate remnant was inconsistent with a countersinking or chamfering machining operation, as the profile was uneven with sharp corners, and most of the other bolt holes of the other plate remnants did not exhibit such a feature (the elongated hole of plate C also exhibited a similar washer-shaped depression).

The plate thickness was measured as 0.150 inches. In the washer-shaped depression, the plate remnant thickness reduced to 0.136 inches.

The bolt hole in plate D had been elongated, in a direction parallel to the fracture surfaces. This elongation was consistent with wear on the material along the hole surface, not as gross plastic deformation was present on the left side of the remnant in Figure 20.

**Figure 20.** Top down view of the larger fractured flex plate remnant D, showing circular wear marks.

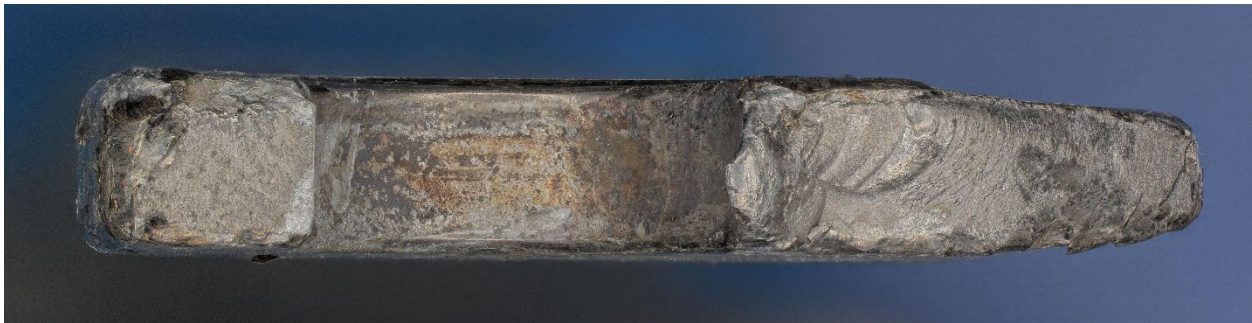
Figure 21 shows the plate D remnant fracture surface. On surfaces on either side, crack arrest marks were observed. Figure 22 shows a closer view of the fracture surface to the right of the bolt hole. The entire surface exhibited crack arrest marks, consistent with propagation from the bolt hole on the side with the washer-shaped depression. Further outward on the right-side fracture surface, crack arrest marks were seen continuing, as illustrated in Figure 23. Figure 24 shows a closer view of the left-side fracture surface, which also exhibited crack arrest marks.

The fracture surface on the left side of the bolt hole in Figure 21 was also examined, and found to exhibit fatigue striations, as typified in Figure 31. The orientation of these striations was consistent with having propagated from an initiation site at the corner of the bolt hole surface (see Figure 32).

**Figure 21.** View of the fracture surface of the plate remnant D in Figure 20, showing crack arrest marks consistent with crack propagation from both sides of the bolt hole.

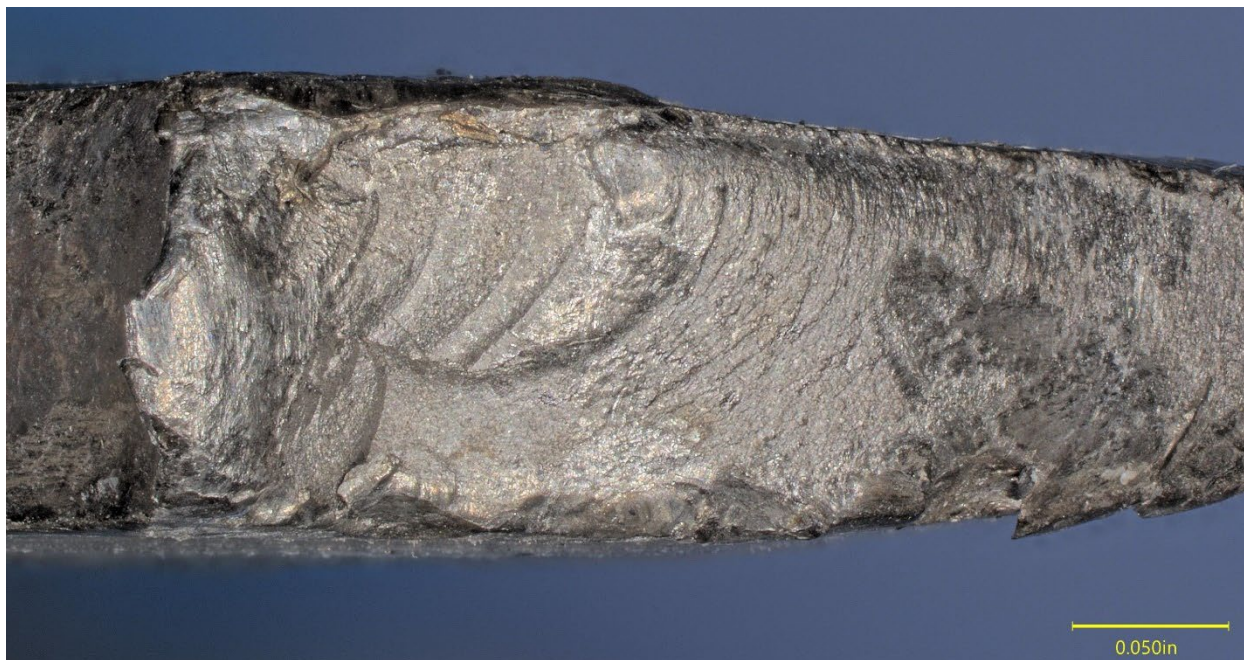
**Figure 22.** Closer view of the plate fracture surface on the right side of Figure 20.

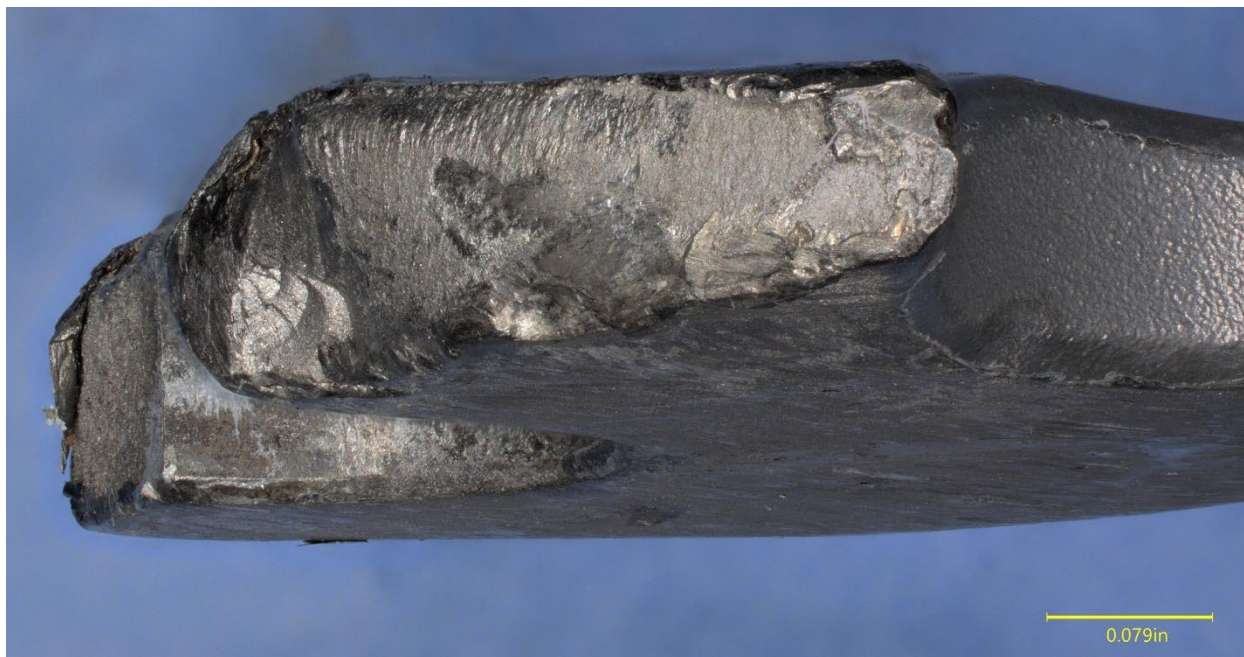
The area near the initiation site on the right-side fracture did exhibit crack arrest marks and initiation sites, as shown in Figure 28. A closer view of the individual striations is shown in Figure 29. Outside the fatigue crack terminus, located to the rightmost side depicted in Figure 23, was an area exhibiting dimpled rupture. This location was consistent with overstress fracture of the remaining plate cross-section after the fatigue crack had propagated to that location.

**Figure 23.** The remainder of the right-side fracture surface, located to the right of Figure 22.

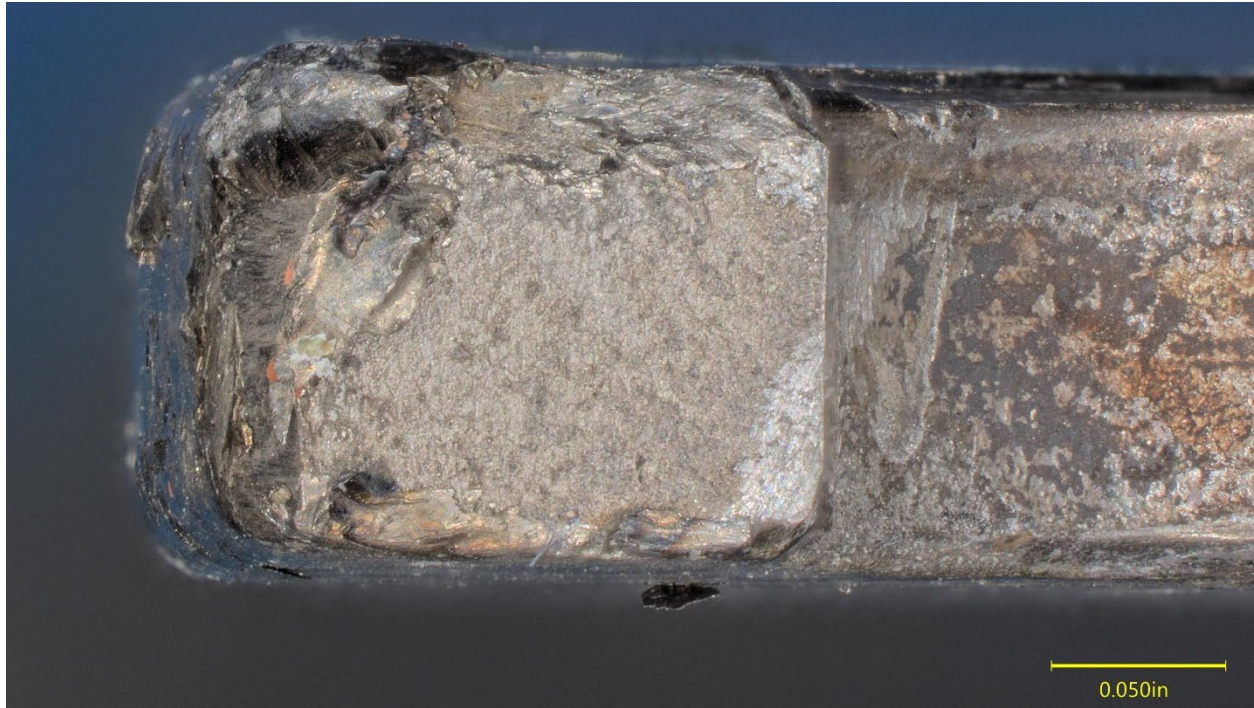
**Figure 24.** Closer view of the link fracture surface on the left side of Figure 20.

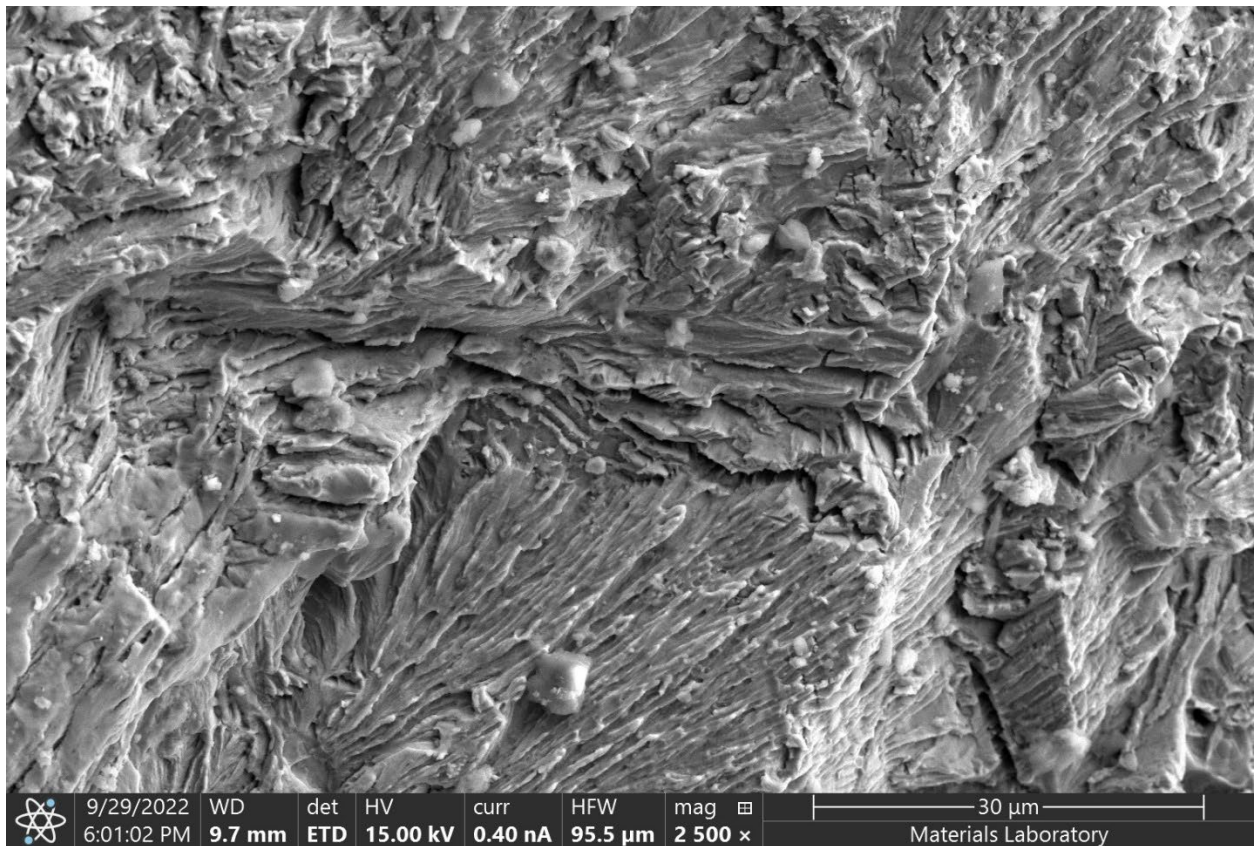
The fracture surfaces of plate remnant D were examined using a SEM. Figure 25 shows a typical view of features of the fracture surface on the right-side fracture surface. While faceted in morphology, this region of the fracture surface exhibited fatigue striations, consistent with fatigue crack propagation.

**Figure 25.** SE micrograph of a typical area of the right-side fracture surface.

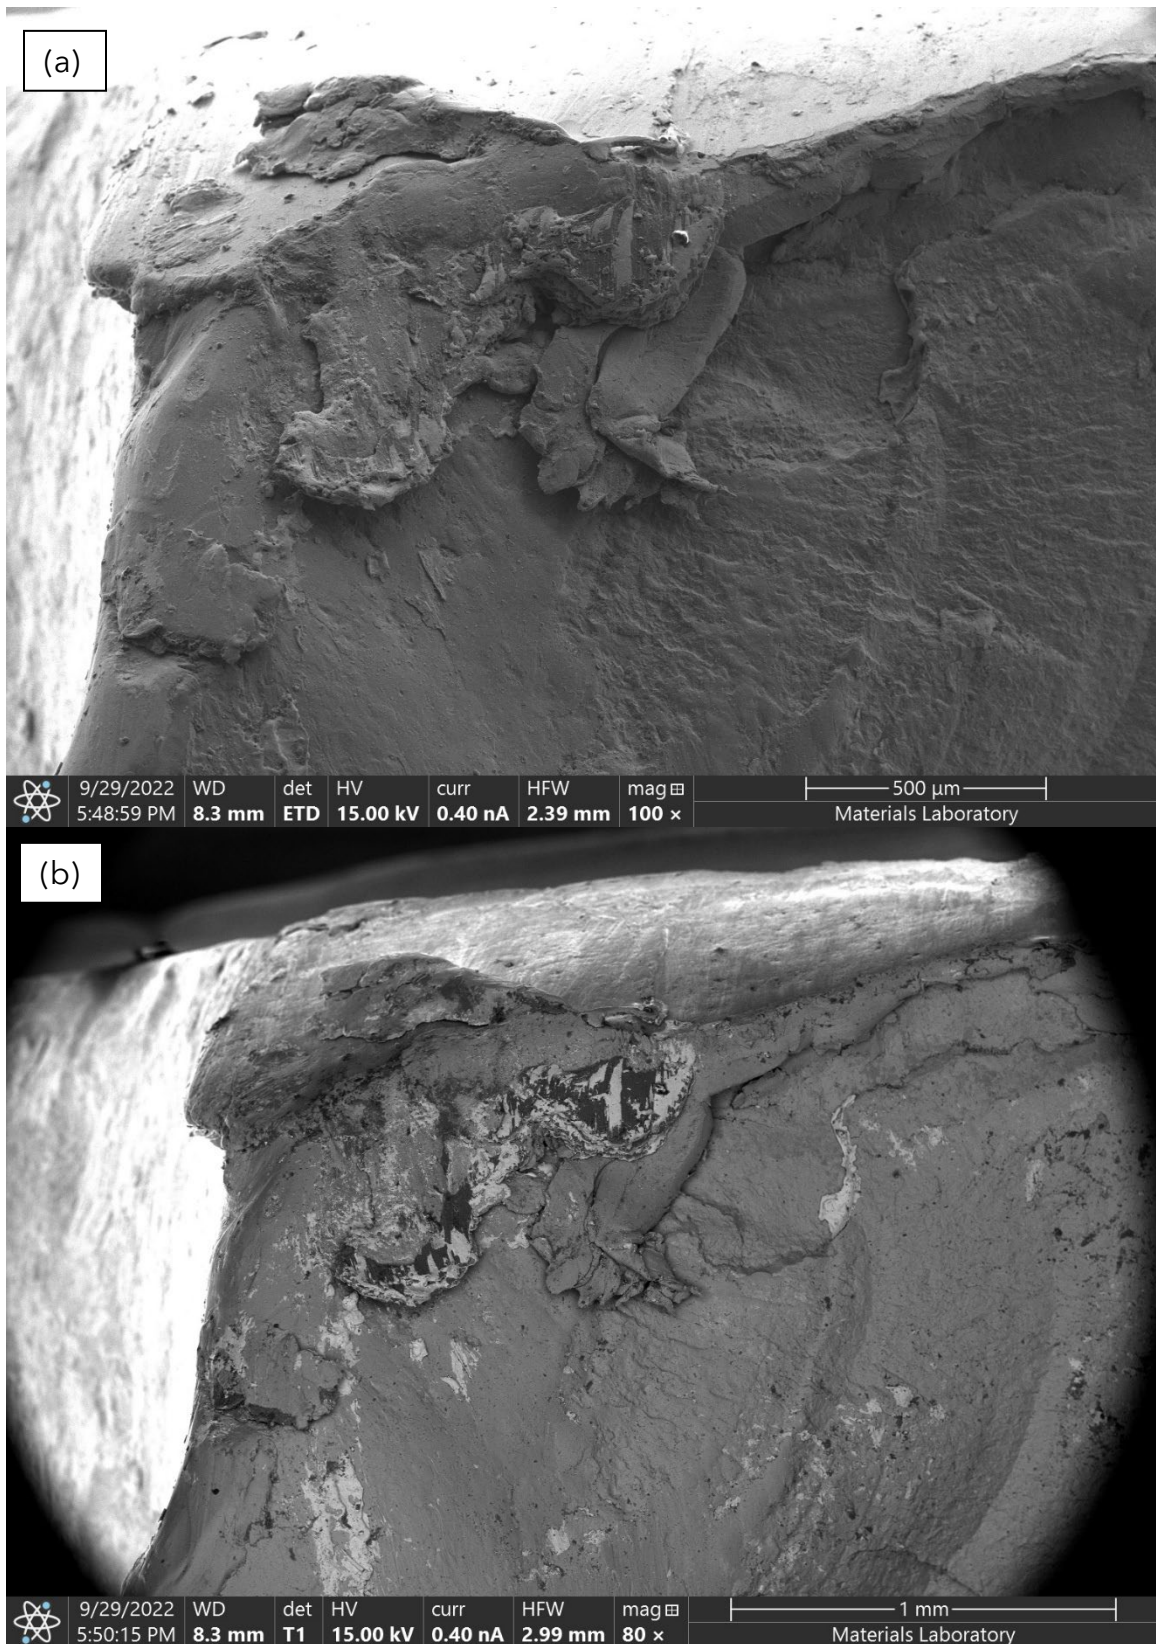
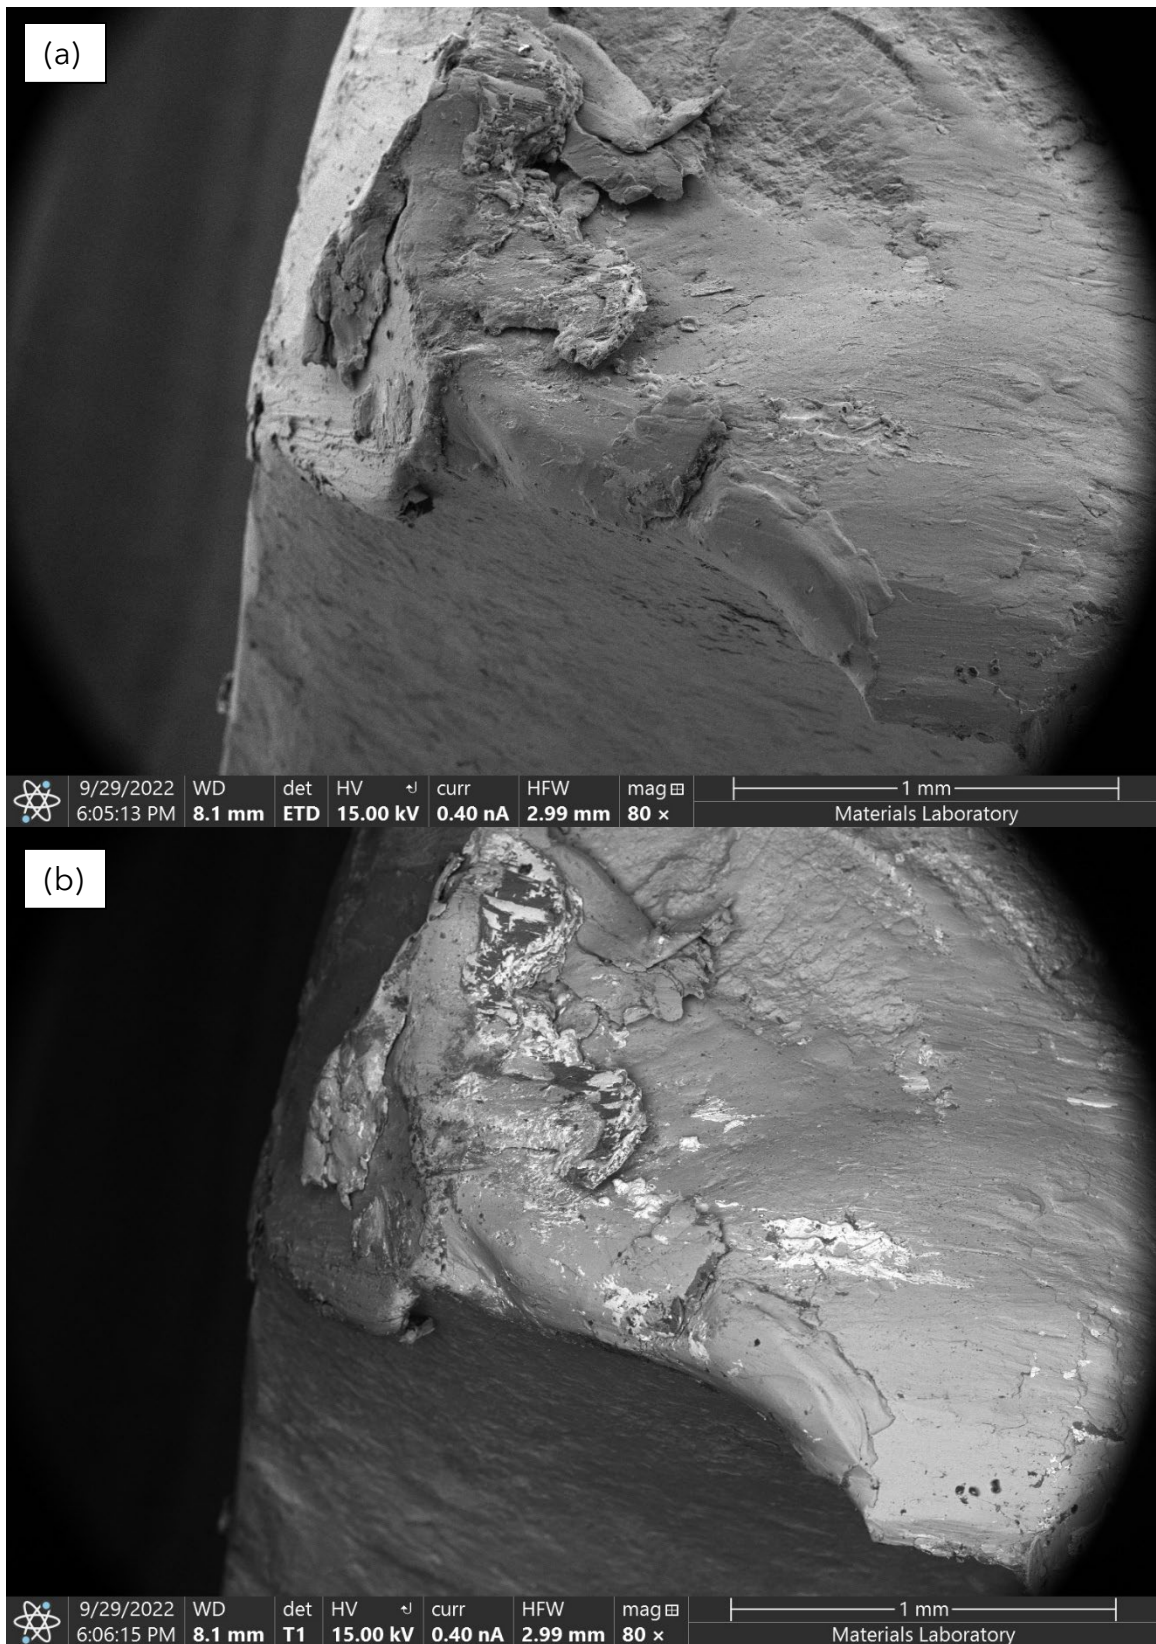
Figures 26 and 27 show different views of the fatigue crack initiation site. The area was located along the corner of the fracture surface, bolt hole surface, and the washer-shaped depression. As shown in the figures, crack arrest marks present were oriented convex outward, consistent with propagation from the corner initiation site. This corner exhibited deformation, impact marks, and smearing, all consistent with post-fracture damage indicative of contact with adjacent metallic parts. This damage prevented further conclusive examination of the location.

**Figure 26.** (a) SE and (b) BE micrographs of the fatigue crack initiation site of the right side fracture surface of the plate remnant D.

**Figure 27.** (a) SE and (b) BE micrographs of an angled view of the fatigue crack initiation site of the right side fracture surface of the plate remnant.

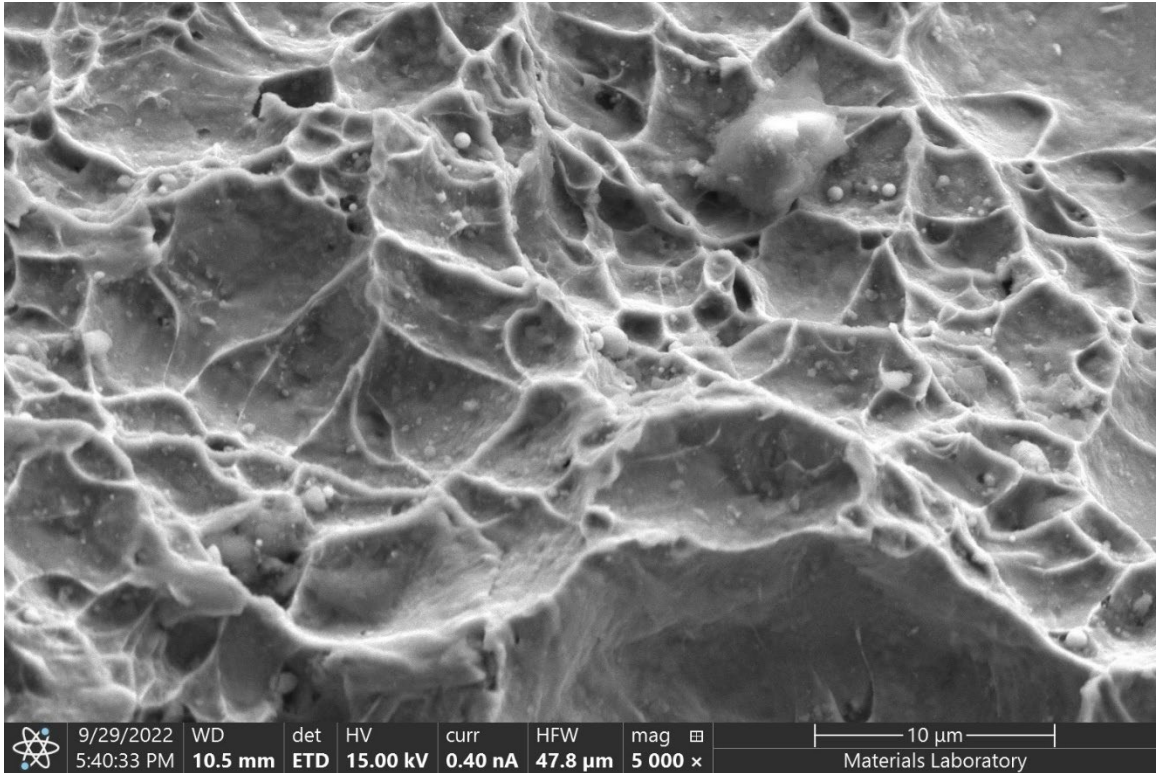
**Figure 30.** SE micrograph of dimpled rupture outside the right-side fatigue crack.

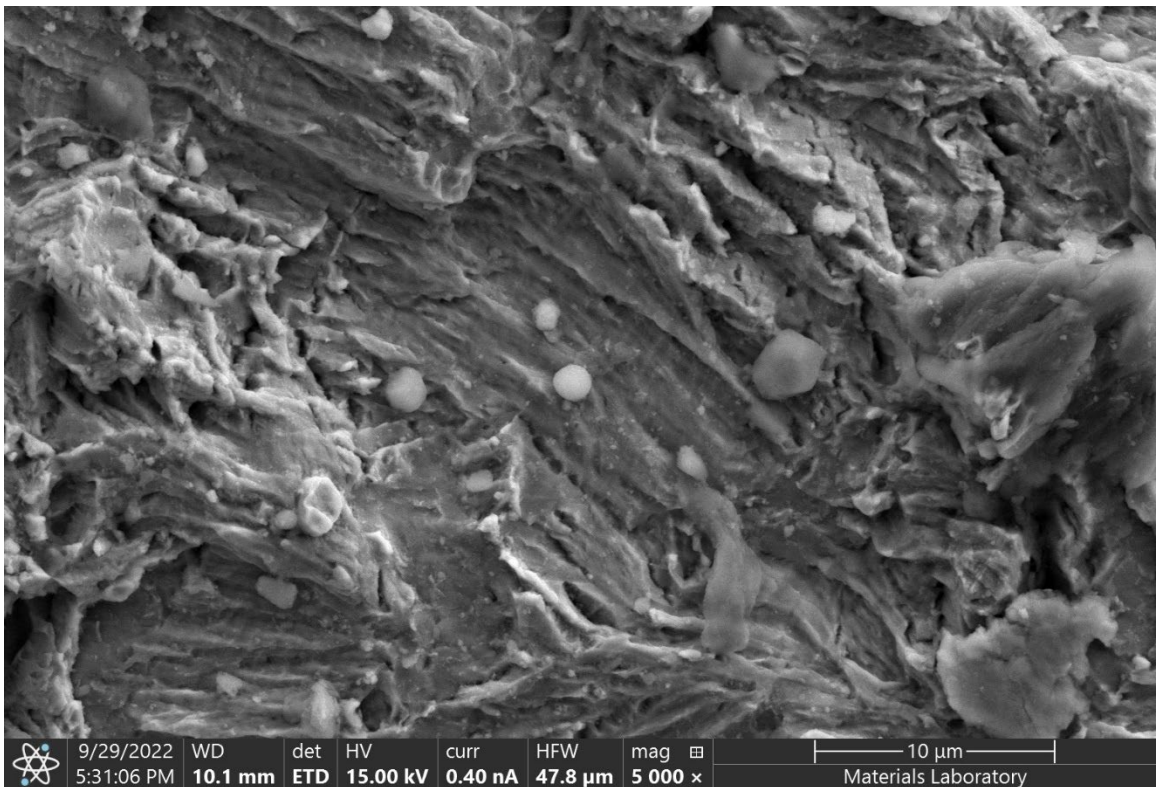
**Figure 31.** SE micrograph of striations near the left-side crack initiation site.

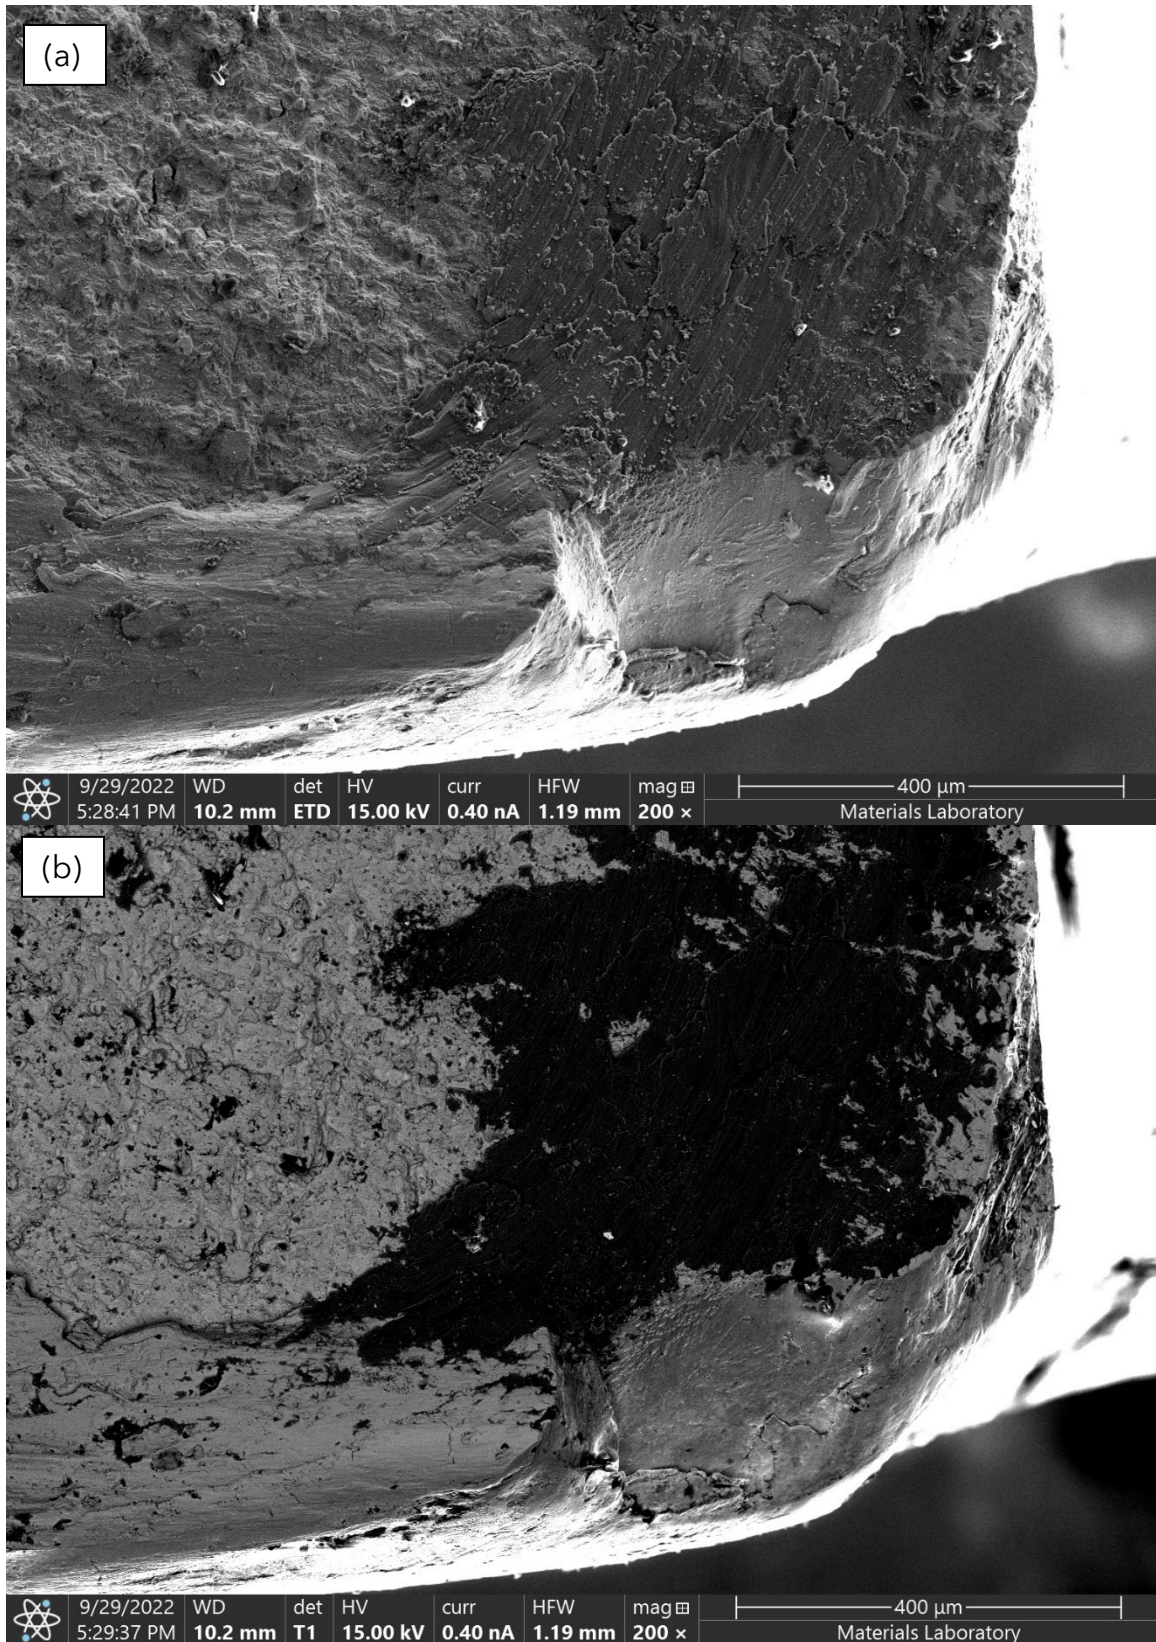
Unlike the right-side fracture surface, this initiation site was located on the corner of the face opposite that of the washer-shaped depression. The darker area was examined using EDS and was found to contain aluminum and minor amounts of copper, consistent with a 2000-series aluminum alloy. This initiation site also exhibited smearing and batter, consistent with post-fracture impact damage to the area.

**Figure 32.** (a) SE and (b) BE micrographs of the fatigue crack initiation site of the left-side fracture surface of the plate remnant D.

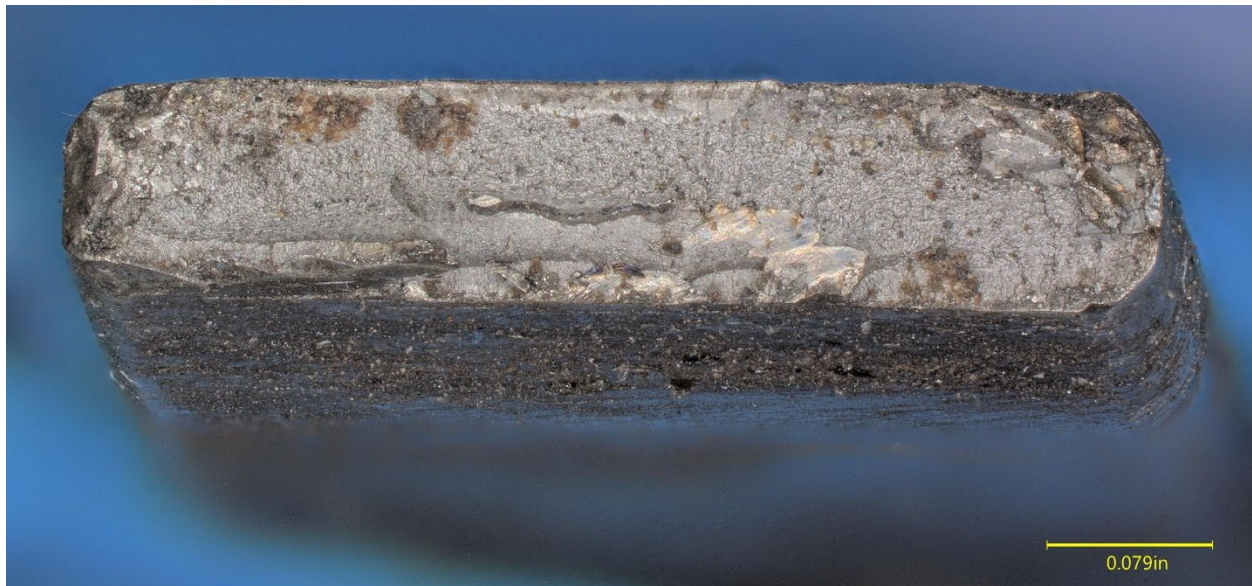
One of the fracture surfaces of plate remnant B is shown in Figure 33. The bottom edge of the fractured plate remnant contained multiple thumbnail shaped cracks, which exhibited features distinct from the rough, dull remainder of the fracture surface. These thumbnail cracks exhibited arrest marks and ratchet marks, consistent with fatigue cracking at multiple initiation sites. The largest crack depth was 0.05

inches, whereas the fatigue fracture on plate D was the entire thickness of the part, or 0.150 inches.

**Figure 33.** The fracture surface of the flex plate remnant B, showing fatigue regions, as small thumbnail cracks along the bottom edge.

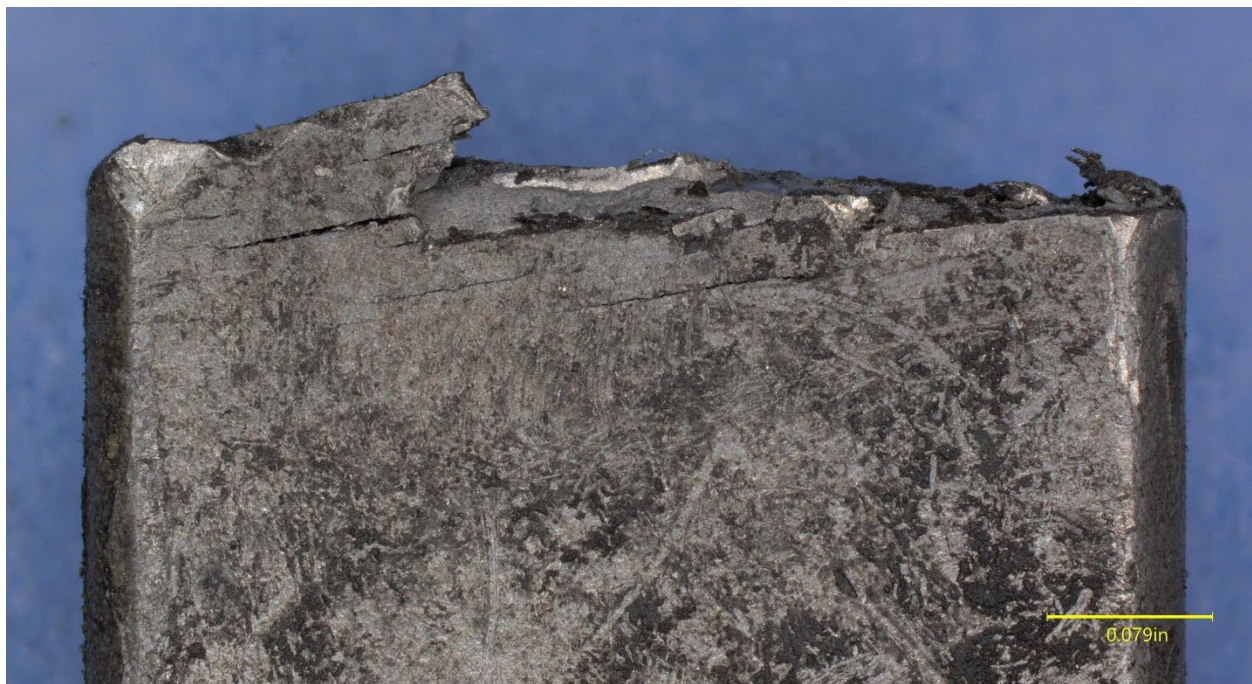
A view of the lower face of the plate remnant B, shown in Figure 34, found multiple parallel cracks along the face. These cracks were consistent in orientation with the fracture surface and the thumbnail crack that had initiated from that side.

**Figure 34.** View of the bottom surface of the fractured plate remnant B in Figure 33, showing multiple parallel angled cracks.
