# National Transportation Safety Board

WPR22LA242

## **AIRFRAME AND ENGINE EXAMINATION**

Location: San Carlos, California  
Date: June 28, 2022  
Time: 1146 Pacific daylight time  
Airplane: Cessna 120, N2056V

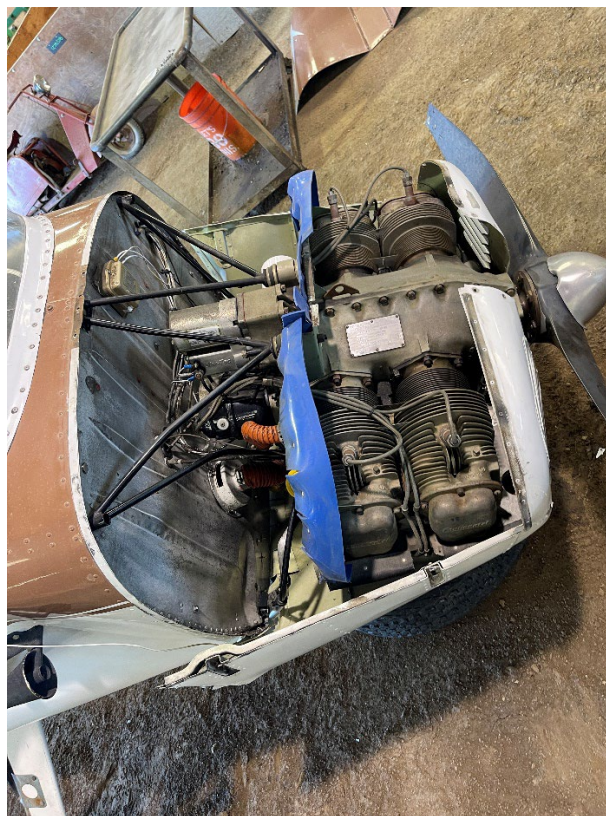
The engine, a Continental O-200-A, S/N: 250700, remained attached to the engine mount. The upper spark plugs, and rocker box covers were removed. The internal areas of each cylinder were examined using a lighted borescope. All intake and exhaust valves, pistons, and cylinder combustion areas were unremarkable.

**Figure 1: View of the recovered engine.**

The crankshaft was rotated by hand using the propeller. Thumb compression was obtained on all 4 cylinders and mechanical continuity was established throughout the engine and valve train. Spark was produced on all 8 ignition leads with impulse coupling engagement when the crankshaft was rotated by hand. Equal movement of the intake and exhaust valve rocker arms was observed. The valve springs appeared to be intact and undamaged. All intake and exhaust rocker arms were oil coated.

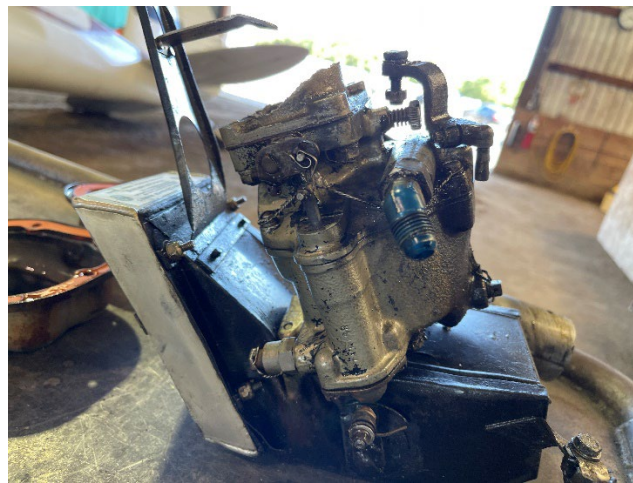
The carburetor remained attached to its mount, however, the mount was fractured from the induction "wye." The throttle and mixture control cables remained secure to their respective control arms. Fuel expelled from the accelerator pump port when the throttle arm was actuated by hand. Both the throttle and mixture arms moved from stop to stop by hand. The carburetor was disassembled. The floats were intact and undamaged. About a teaspoon of fuel was observed within the carburetor float bowl. The mixture metering sleeve was free of debris. The fuel inlet screen was free of debris.

**Figure 2: View of the carburetor and air box.**
