# National Transportation Safety Board

WPR22LA243

## **FUEL SYSTEM EXAMINATION**

Location: Oxnard, California  
Date: July 10, 2022  
Airplane: Mooney M20C; N6416U

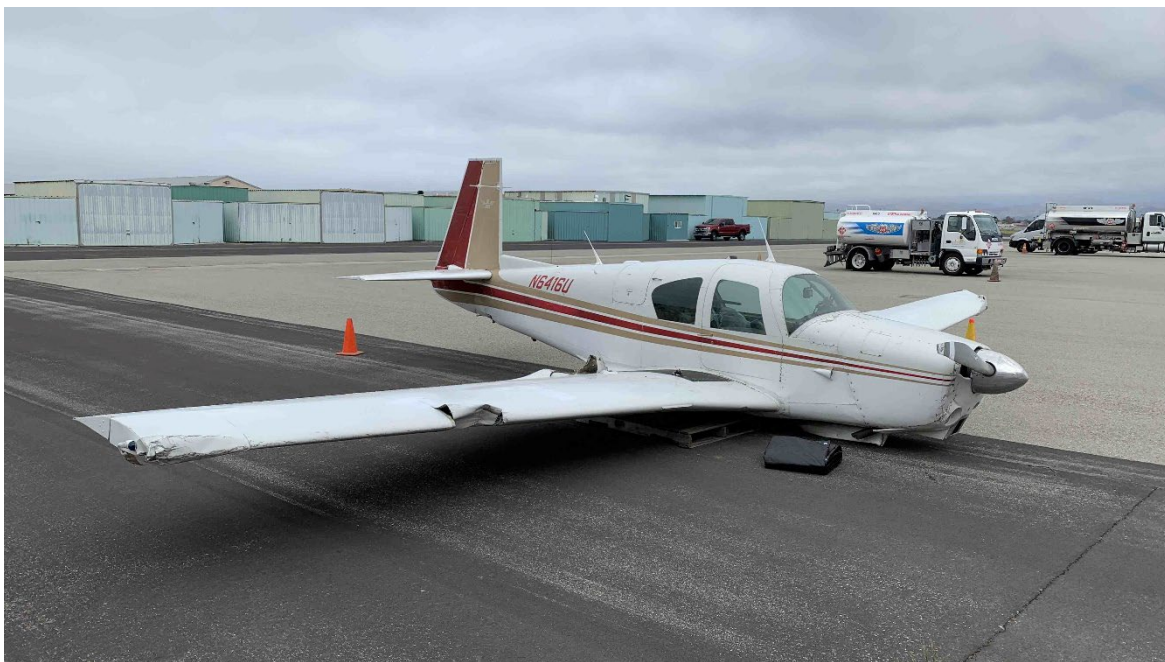
**Figure 1 - Airplane after accident**

Both fuel caps were firmly in place, and there was no evidence on the airframe or wings of staining or streaks consistent with an inflight fuel leak. Both fuel tanks were empty, the underside of the right tank was breached by impact damage (figure 1), and the left tank appeared intact but was empty.

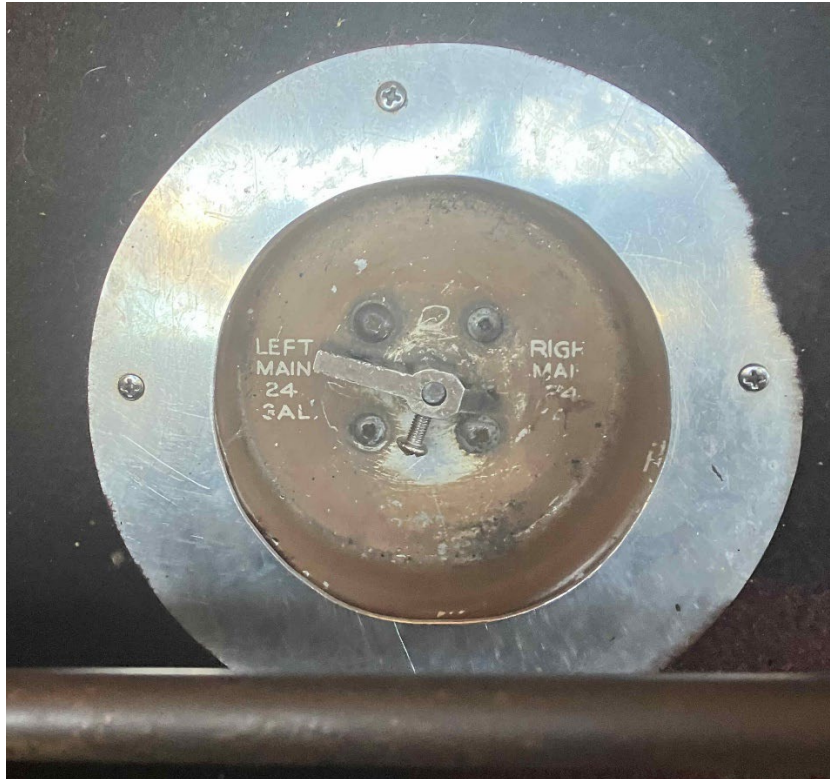
**Figure 2 - Fuel selector valve immediately after accident (courtesy of Oxnard Airport Ops).**

Photos taken right after the accident indicated that the fuel selector valve handle was pointing in the general direction of the right tank (figure 2).

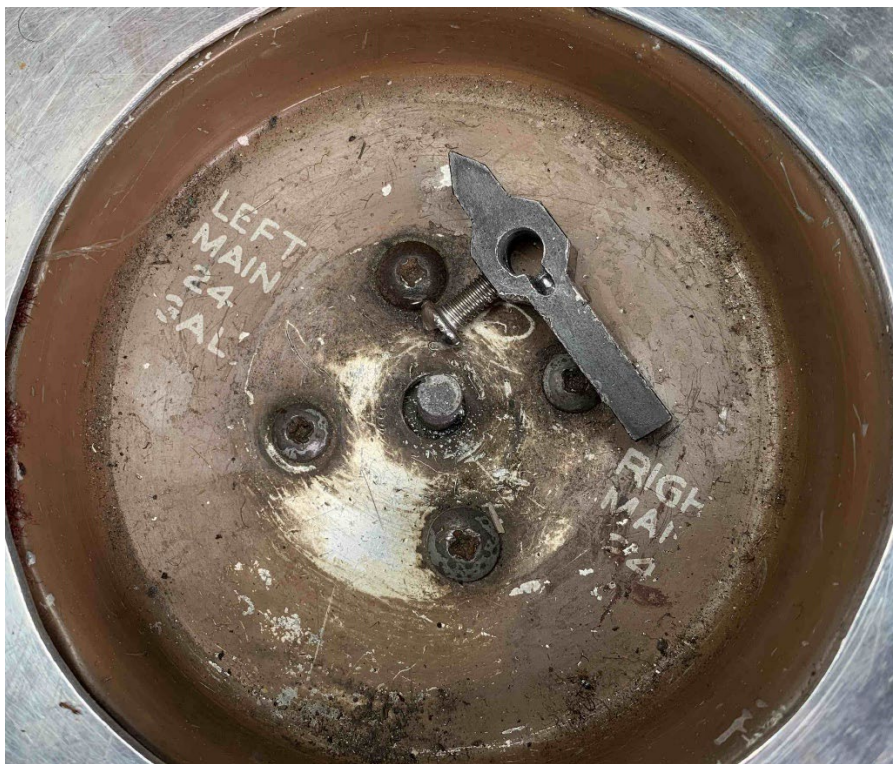
**Figure 3 - Fuel selector valve handle removed.**

The fuel selector valve handle came off with ease and was held on with a single oversized stainless-steel screw, rather than the set screw and roll pin called out in Mooney drawings (figure 3).

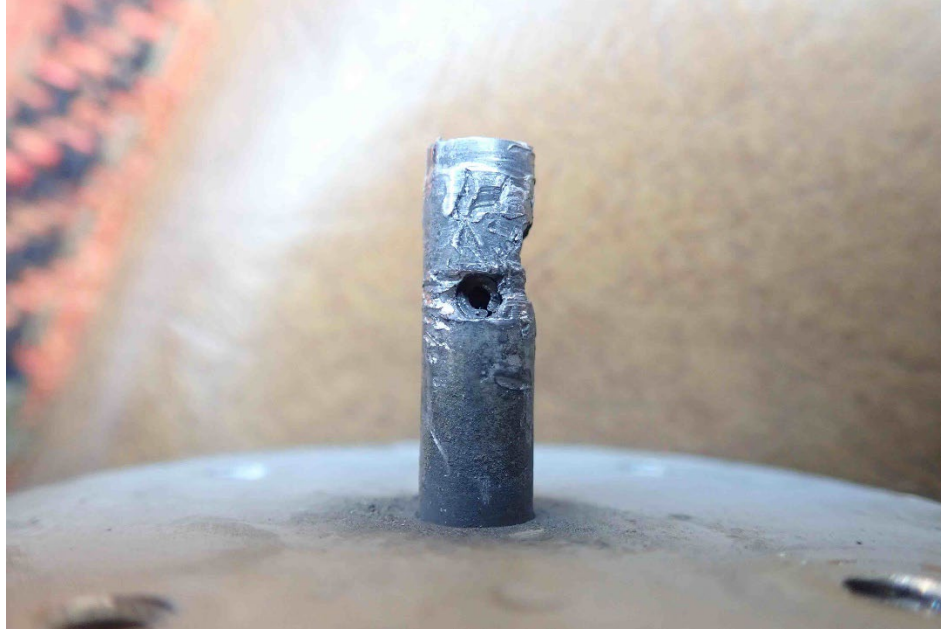
**Figure 4 - Fuel selector valve shaft**

A partial section of the roll pin was still present within the selector shaft but had not extended out into the barrel of the handle. The shaft was worn and exhibited

evidence of significant wear, along with witness signatures consistent with manual rotation, possibly with pliers (figure 4).

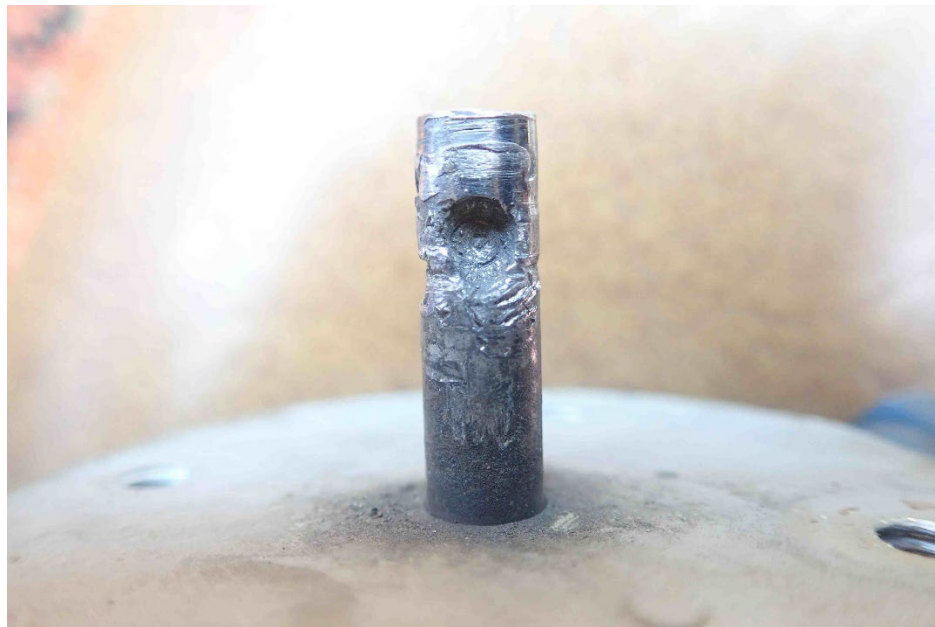
**Figure 5 - Fuel selector valve shaft**

The dimple in the shaft that accepted the set screw was elongated and worn, and the stainless-steel screw did not extend into it (figure 5, 6).

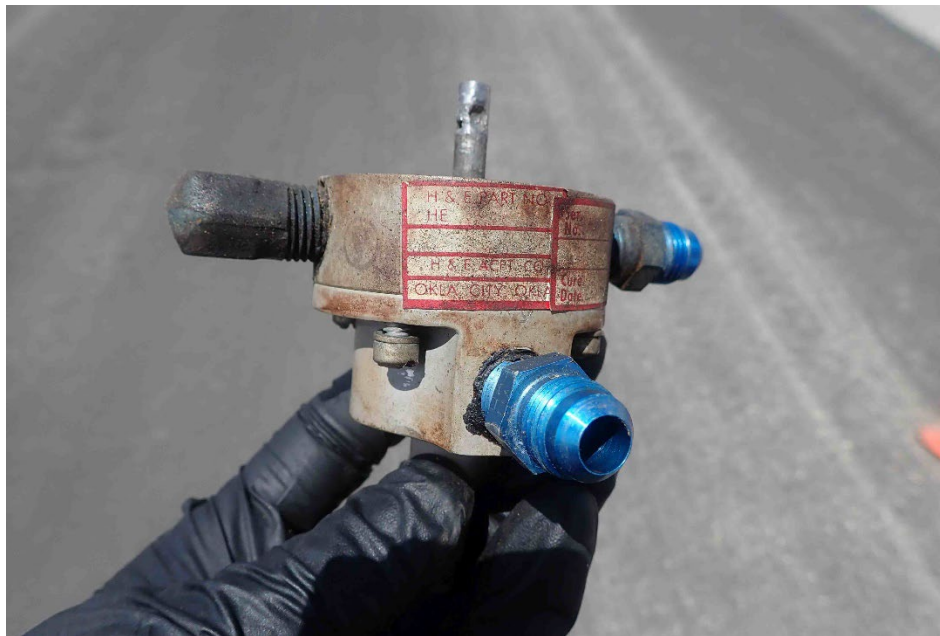
**Figure 7 - Fuel selector valve removed with backed out screw.**

The selector valve was removed, and one of its four case screws while not loose, was installed about 5 mm short of its full travel (figure 7).
