Elliott Simpson  
Senior Aviation Accident Investigator  
Air Safety - WPR

**Subject:** WPR22LA243

**Contact:** Jack St Marie

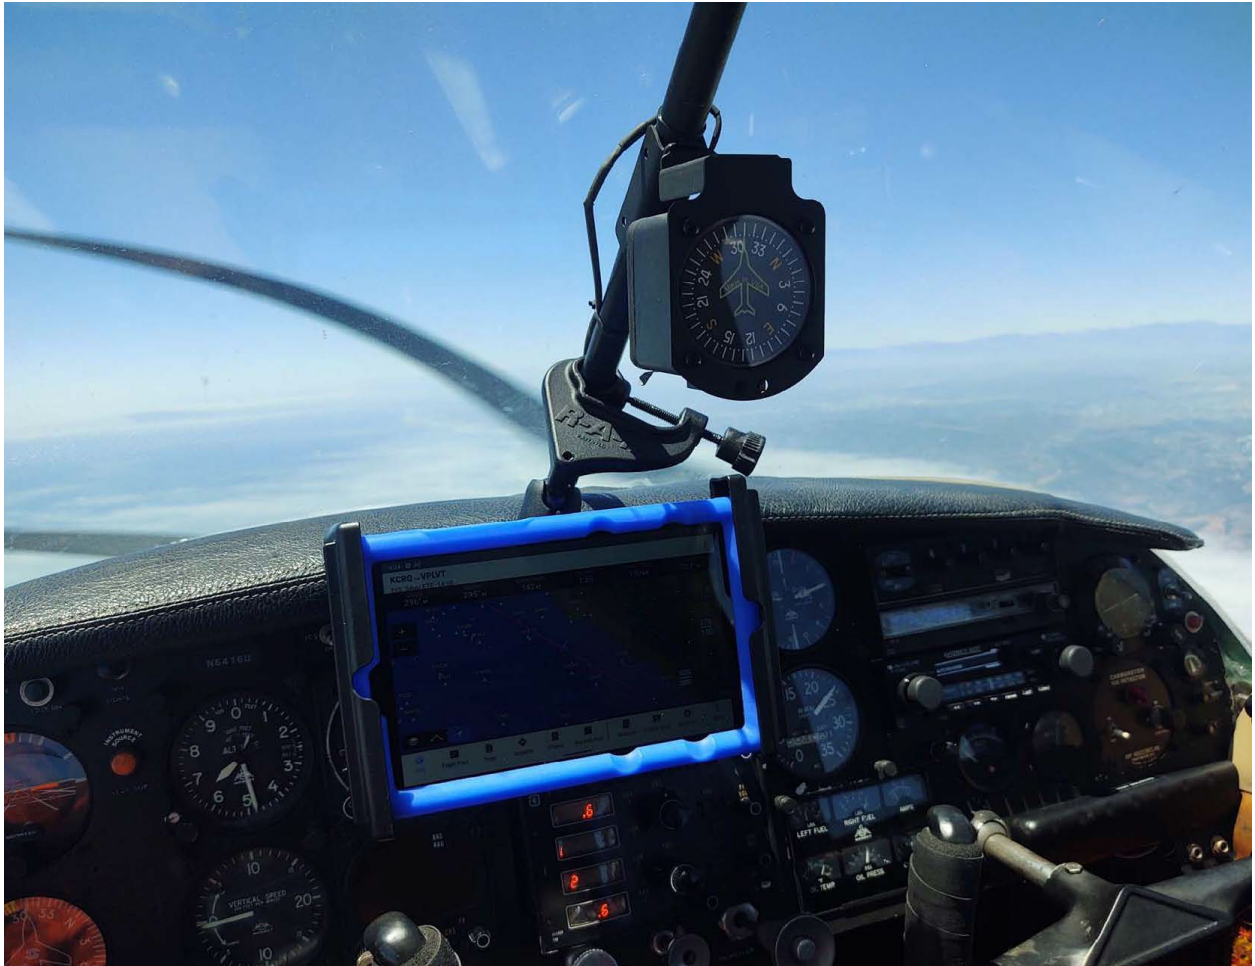
Thanks for the call last Thursday. I wanted to pass along a photo I just found that might help with your investigation. Looking at the tablet in the photo, I snapped this in cruise over Dana Point on the day of the accident. Based on the flight tracker this would have been about 16 minutes after takeoff and 37 minutes before I lost power. The gauges show 6,500' altitude, 2,400rpm (which I later brought back to 2,300 around LAX), ~22" man pressure, 4psi of fuel pressure, normal temps, full fuel on the right tank, and ~68# of fuel on the left tank.

One thing I can't figure out is if I was unknowingly on the left tank how I could have burned 11 gal in just over 38 min at that power setting. The fuel consumption rates in the POH are much lower. Do you think there could have also been a fuel leak?

**Figure 1 - Photo provided by pilot in email dated July 17, 2022**
