On July 14, 2022, at approximately 0052 UT, a Cessna 208B airplane, N877FE, was substantially damaged when it was involved in an accident at the Salt Lake City International Airport (SLC), Salt Lake City, Utah. The pilot sustained minor injuries.

**Salt Lake City TRACON (S56) / Salt Lake City (SLC) ATCT – Thursday July 14, 0052 UT:** (Air Spur) CPT7727/C208 was in communication with the Local Control Center (LCC) controller, and crashed while executing a pilot-initiated go-around on Runway 34R.

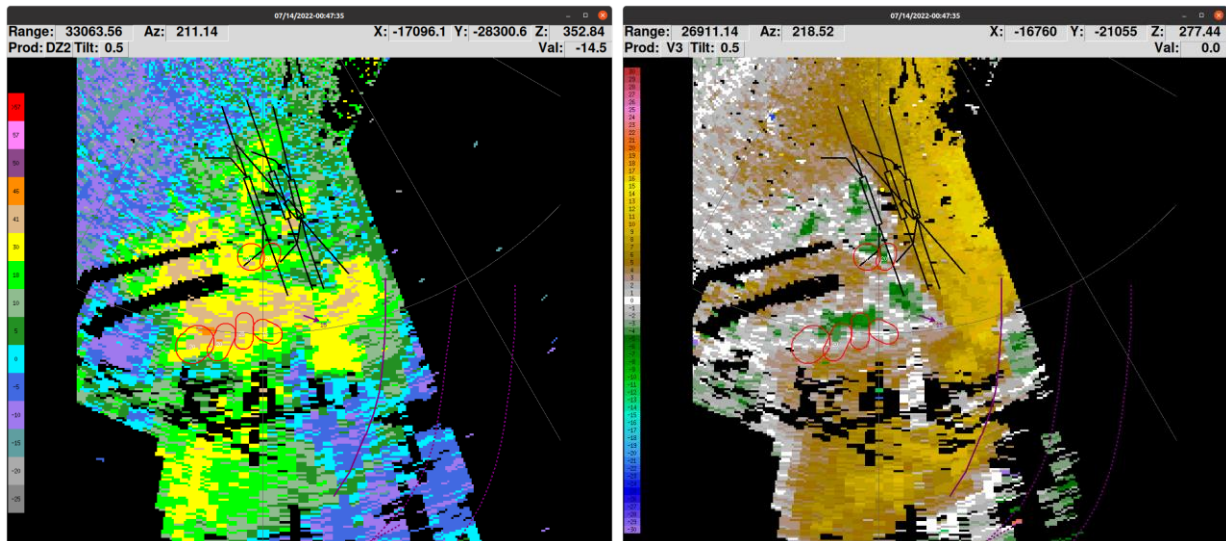
Figure 1. TDWR reflectivity and velocity at 004735 UT.

At 004831 UT, ATC issued a windshear alert of 15 kt loss on 3 mile final to runway 34L. This is confirmed in Figures 1 and 2.

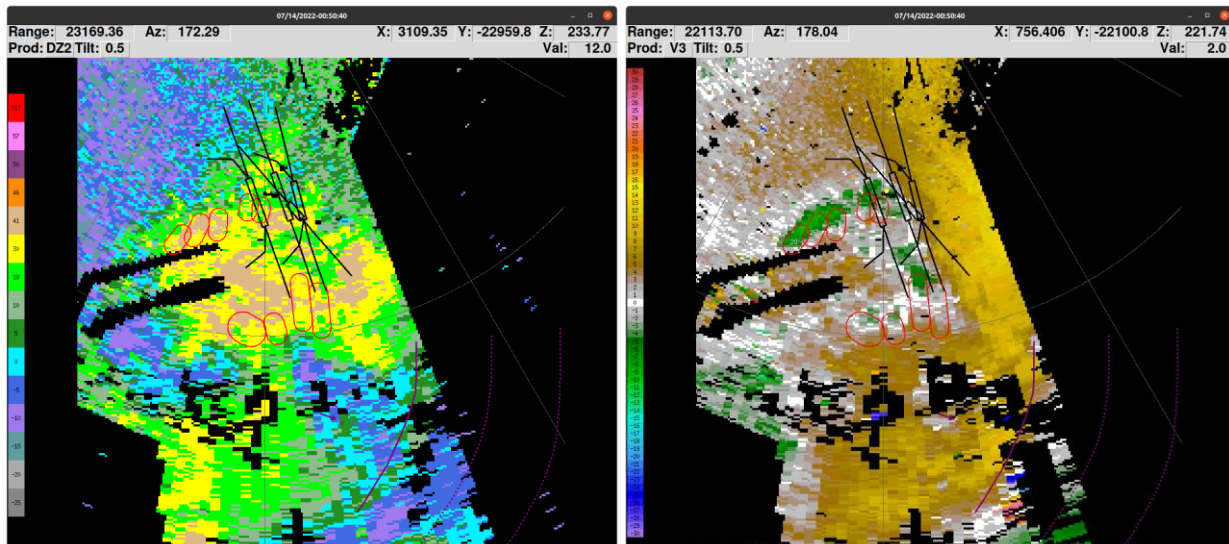
*Figure 3. TDWR reflectivity and velocity at 005040 UT*

At 005056 UT, a Delta 757 aircraft that had just landed on 34R issued a PIREP reporting windshear of +10/-10 kts on final. The location on final was not indicated. The Figure 3 velocity plot shows an area of windshear on the runways. Figure 4 shows a 15 kt windshear on runways 34L and 34R at 005058 UT as issued by ITWS. At 005107 UT, a windshear alert for 15 kt loss was issued for approach and departure on runway 34R. Figure 5 shows windshear on the runway. The windshear on the runway is highlighted by the yellow circle in Figure 5. The windshear alert that was issued was generated by ITWS as indicated in Figure 6.

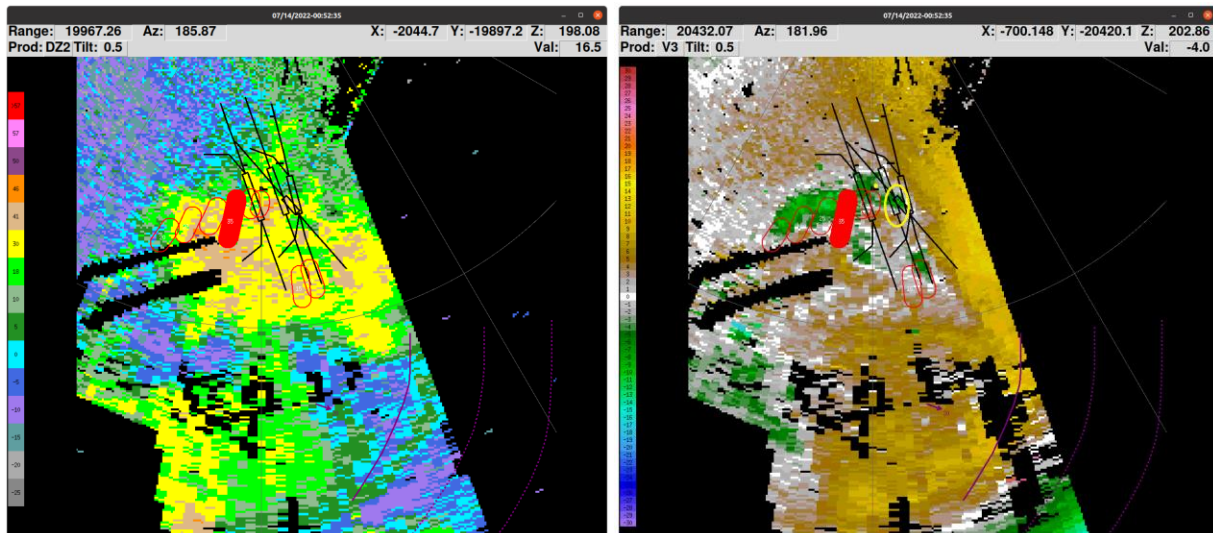
Figure 7. TDWR reflectivity and velocity at 005235 UT.

At 005208 UT, CPT7727 requested a go around and was approved. At 005240 UT, the controller reported that CPT7727 had crashed off the runway. The windshear that the aircraft most likely encountered is highlighted in yellow in Figure 7
