# National Transportation Safety Board

WPR22LA251

## **OPERATIONAL FACTORS**

Group Chair's Factual Report

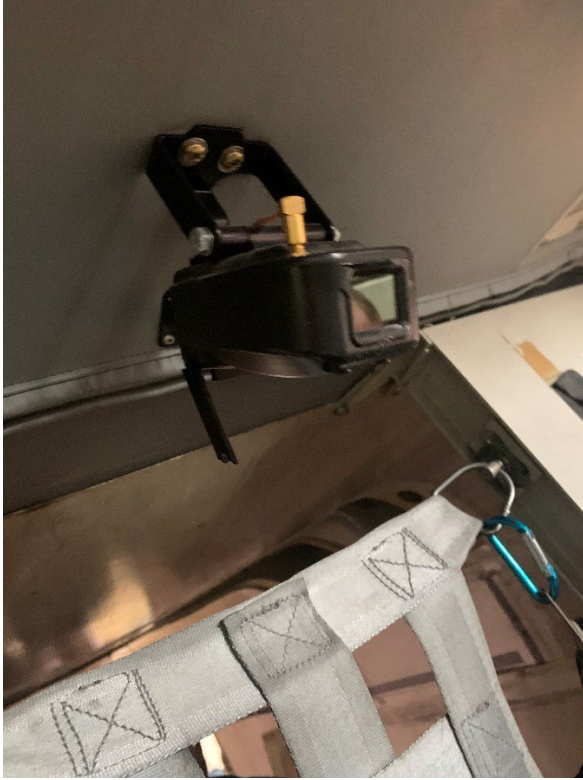
**Figure 3: Appareo Camera as found in the Airplane.**

The unit was removed and sent to the NTSB Recorder's laboratory for download. The removable SD card did not capture the accident flight. For further information reference the Onboard Image, Audio and Data Recorder, Specialist's Factual report associated with this accident.

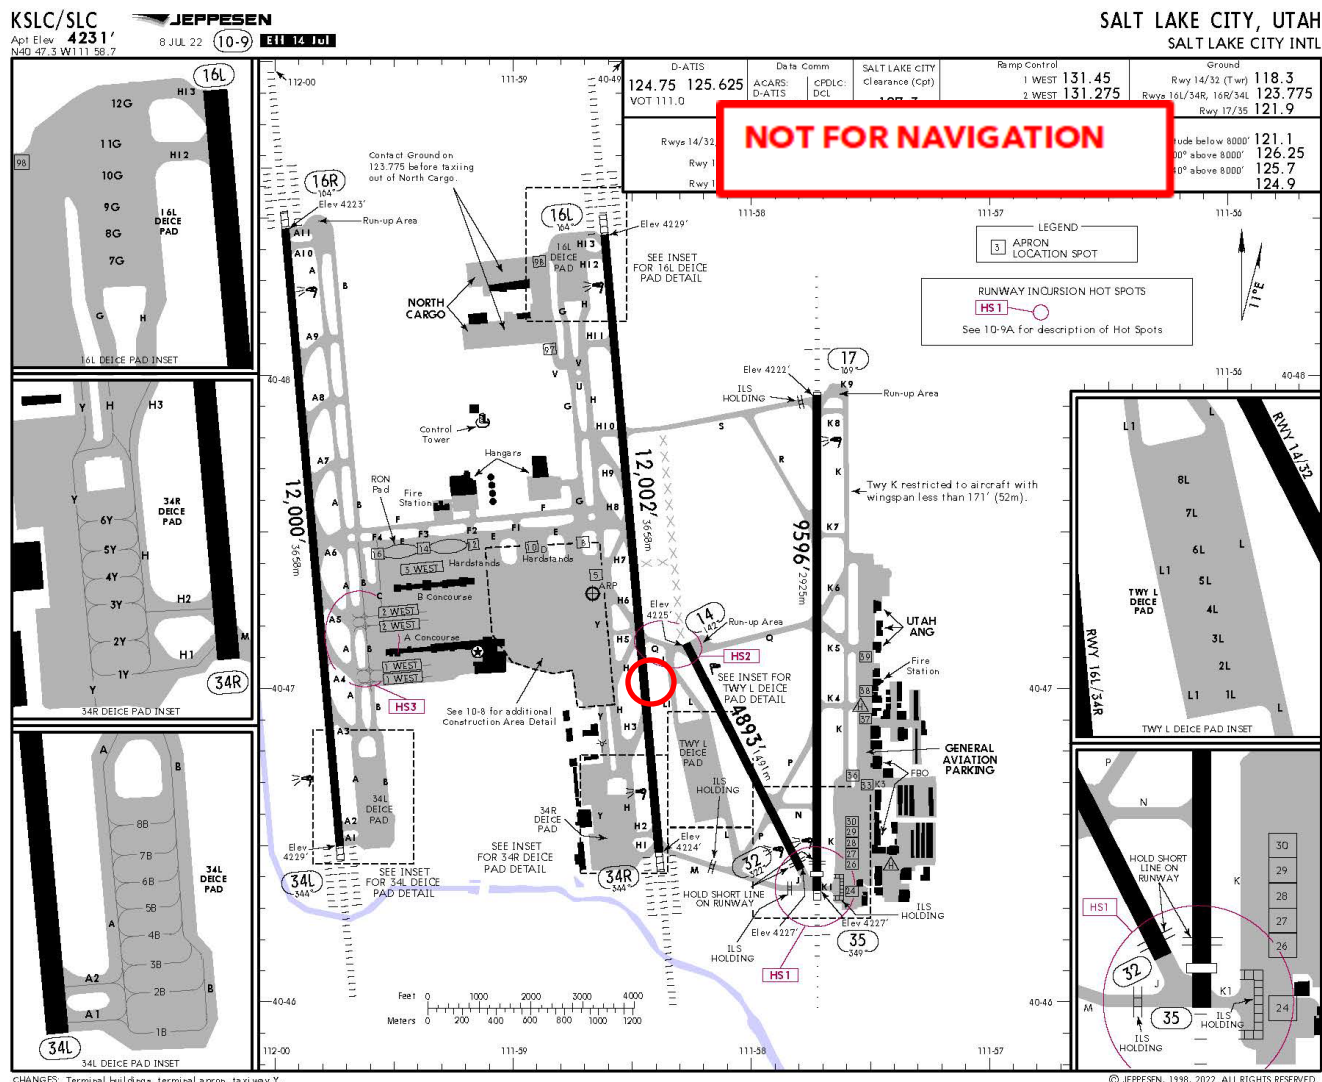
**Figure 4:** SLC Airport Diagram Chart (Source: Jeppesen). The red circle is the approximate location of where the accident plane came to rest.

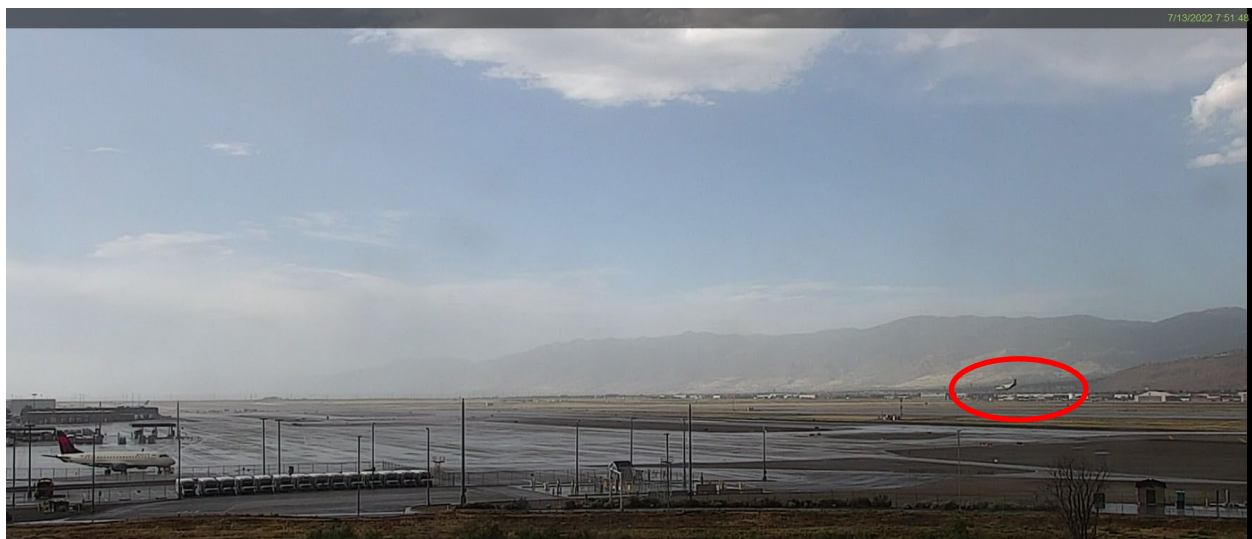
**Figure 6:** Looking Northeast from the Airport South boundary (Accident airplane in the red circle while on the approach prior to landing, camera time 1951:48, actual time 1851:48)

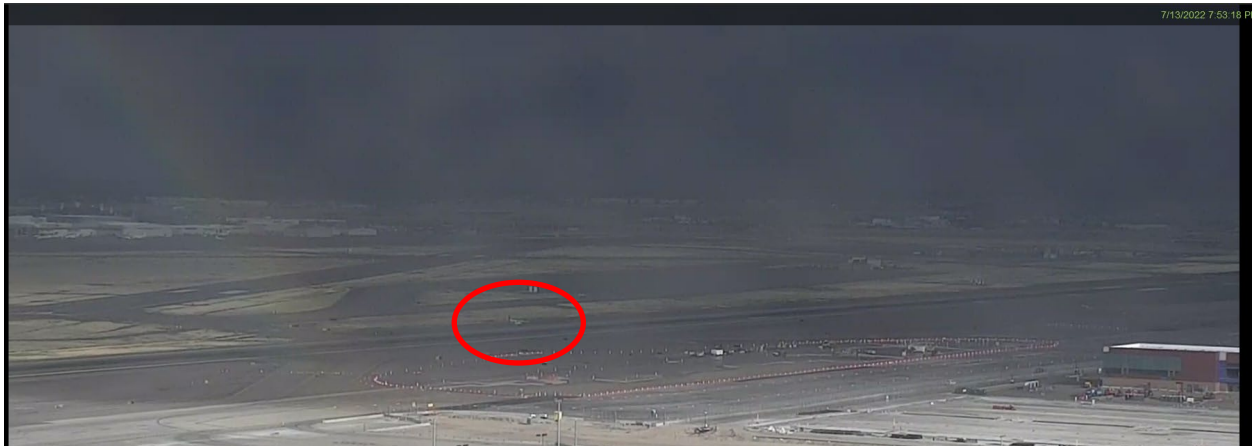
Surveillance video showed, the aircraft impacted the right side of the runway in a left-wing low, nose down attitude. The airplane's tail came up to a near vertical position and then settled back down. The airplane came to a rest on its belly and right main landing gear. The left main and nose landing gear collapsed during the accident sequence.

**Figure 7:** Looking Southeast of the Airport from the Air Traffic Control Tower Location (Postaccident – accident airplane in red circle at camera time 1953:18, actual time 1853:18).
