# National Transportation Safety Board

WPR22LA259

## **MATERIALS LABORATORY**

Factual Report 23-032

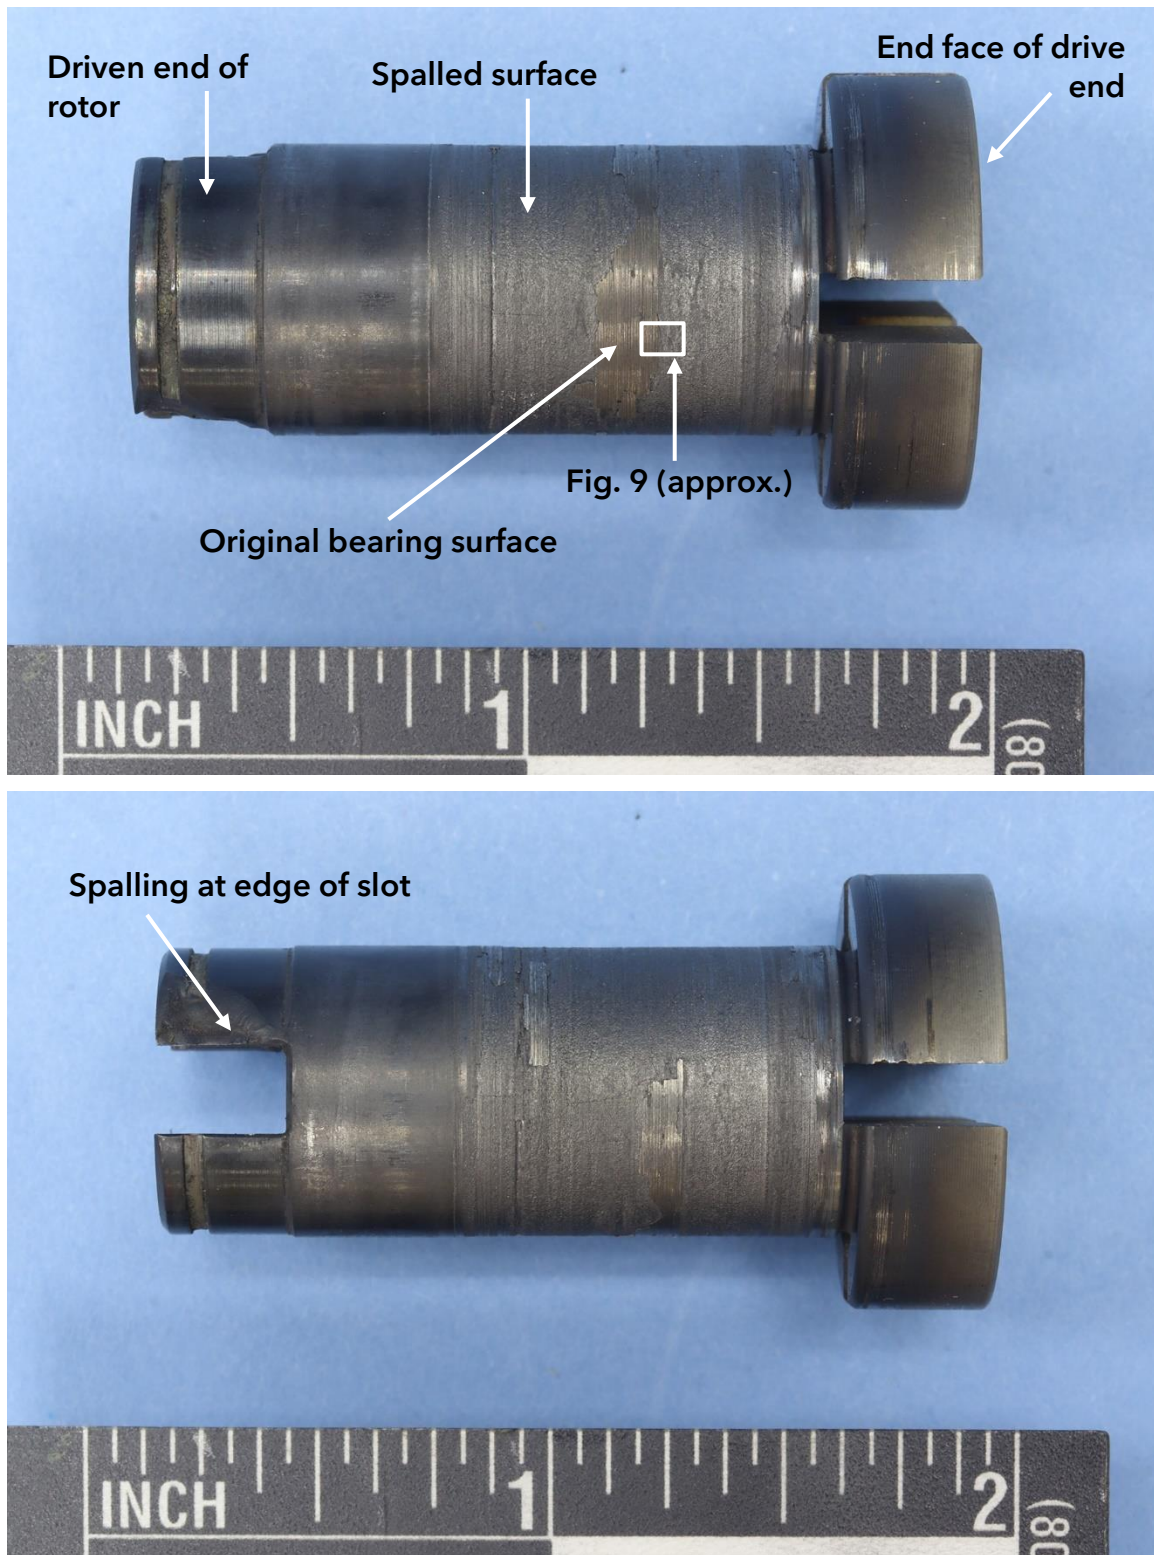
The rotor, shown in figure 2, exhibited severe thermal distress. The entire rotor was dark and discolored, except for the end face of the drive end (figure 6a). The rotor's bearing journal had spalled from the rotor over most of the region that contacted the carbon bearing and material had spalled from the edges of the drive coupling slot (figure 2, lower image). The rubber seal installed at the driven end of the rotor (near the groove) exhibited softening and deformation, also consistent with thermal distress, as seen in figure 4. The journal diameter was measured by

micrometer inside and outside of the spalled region. Outside the spalled region, the diameter was measured twice, both times reading 0.6237 inch, in accordance with the manufacturer's requirements. Inside the spalled region, the diameter varied, but read as low as 0.6175 inch. The thickness of the drive head was measured twice, reading 0.2998 inch both times, in accordance with the manufacturer's requirements. The larger diameter drive end of the rotor had worn into the thrust plate (figure 6b). Pieces of rotor material had chipped off along the edges where the vane slots met the outer diameter of the drive end, as shown in figure 7. Rub marks were observed on the outer diameter surface adjacent to the chipped regions.

**Figure 2.** Two views showing extensive dark discoloration of the rotor surface and spalling of the rotor's bearing journal surface, consistent with thermal distress.

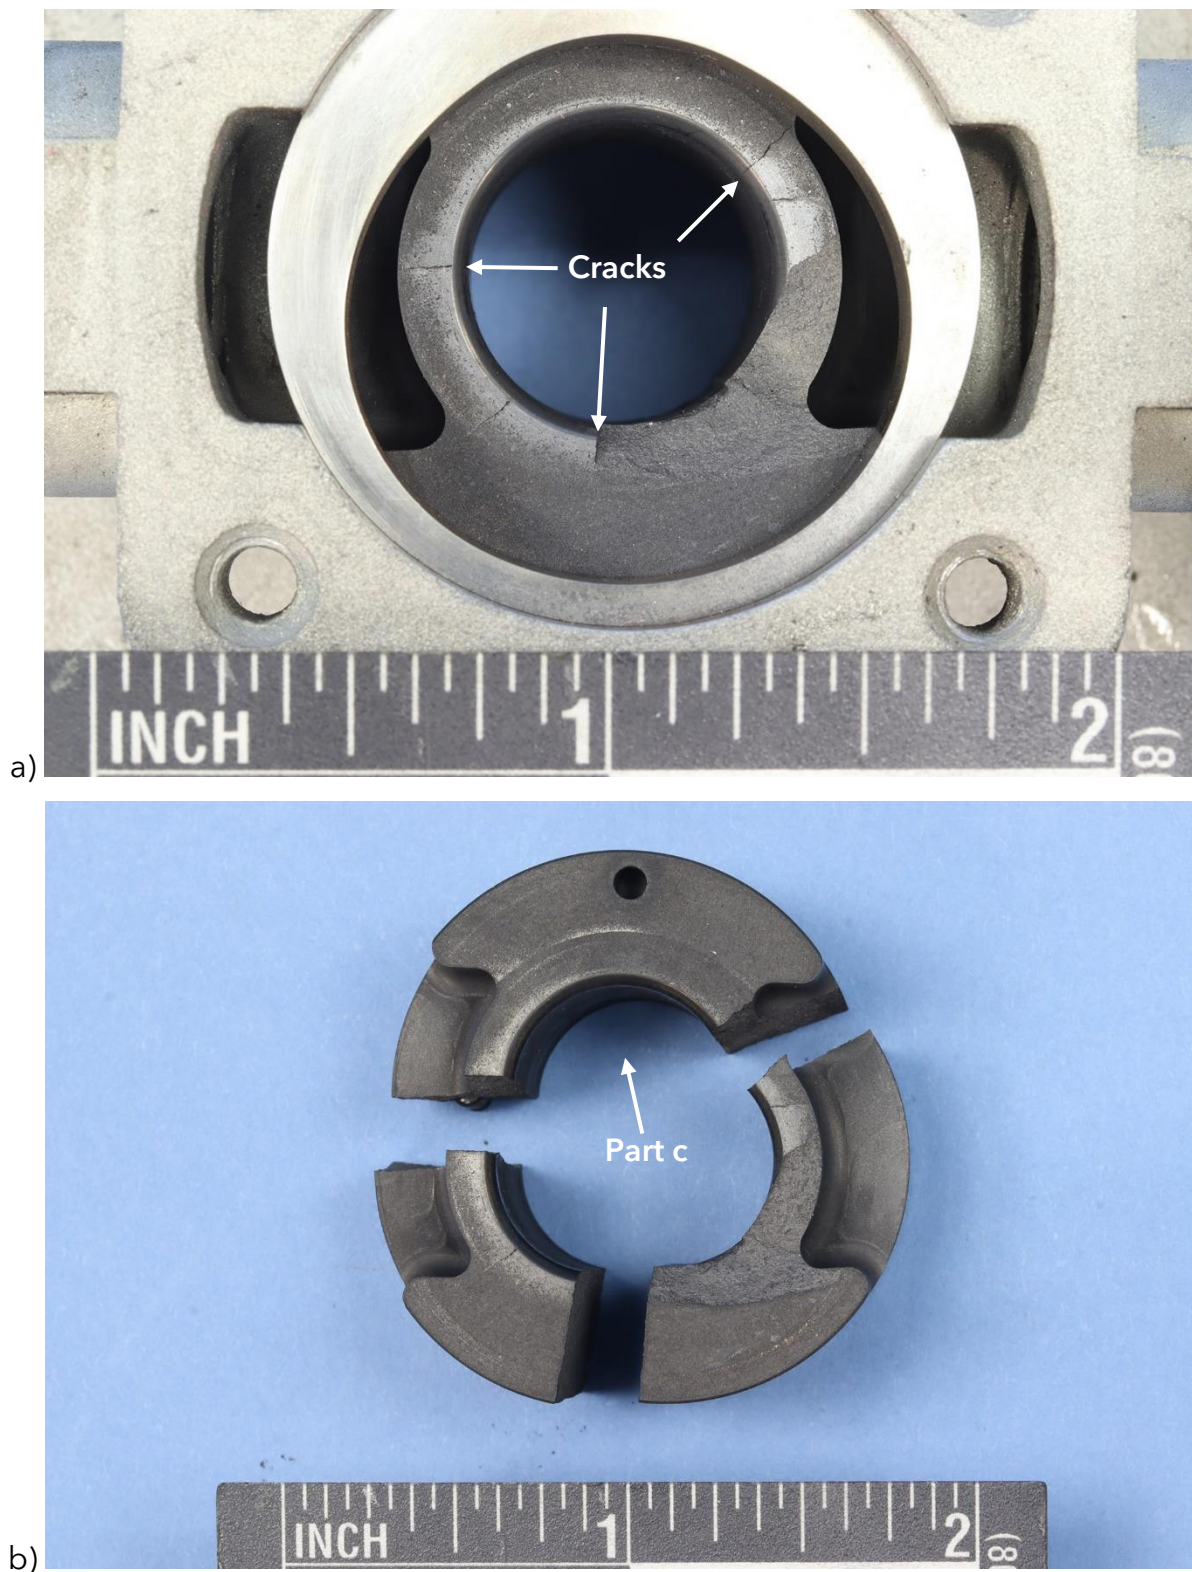
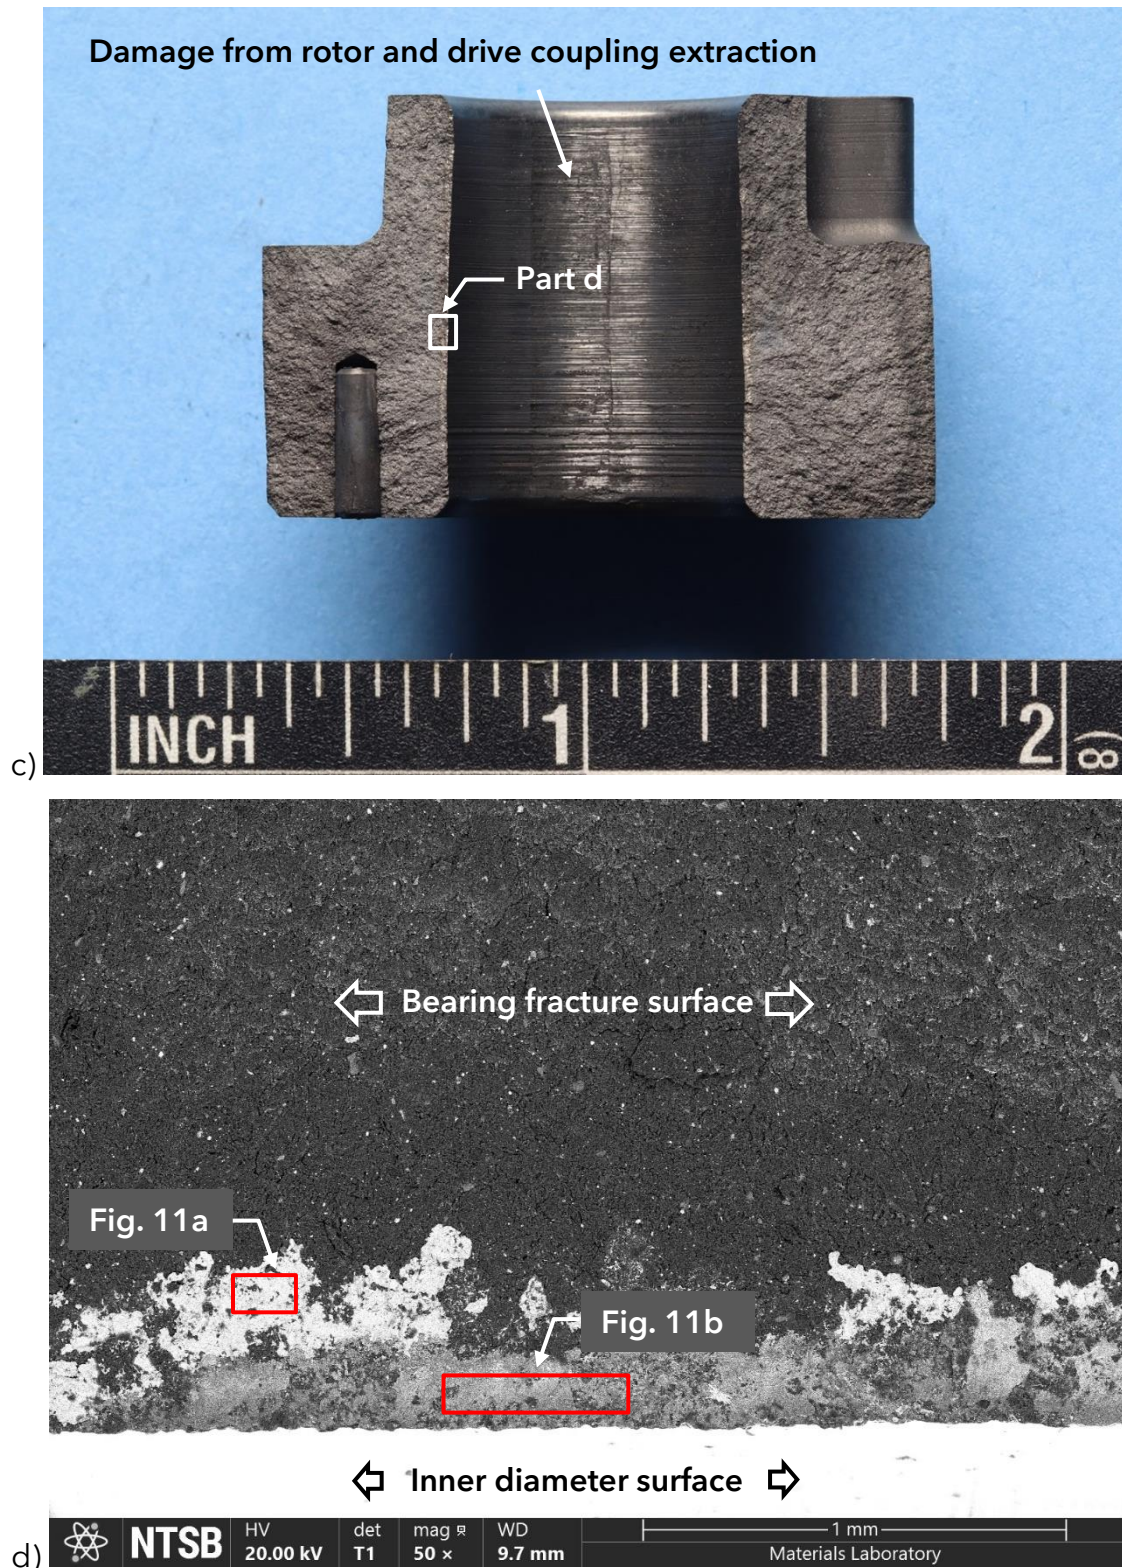
The bearing, shown in figure 3, was also mechanically damaged. The bearing had fractured into three pieces and the bearing surface exhibited circumferential scoring marks. Examination of the fracture surfaces with the aid of a stereomicroscope revealed coarse fracture features radiating away from the inner diameter surface (consistent with overstress) and foreign debris on the fracture surface adjacent to the bearing's ID surface (see figures 3c and d and the chemical identification below). The inner diameter of the bearing was measured with an inside micrometer and read between 0.626 inch and 0.627 inch.

**Figure 3.** Images of the bearing: a) inside the housing and b) after heating the pump assembly in an oven and pressing the bearing out of the housing.

**Figure 3 (cont.).** c) fracture surfaces on one of the bearing pieces; and d) SEM image of bearing fracture surface adjacent to the inner diameter bearing surface.

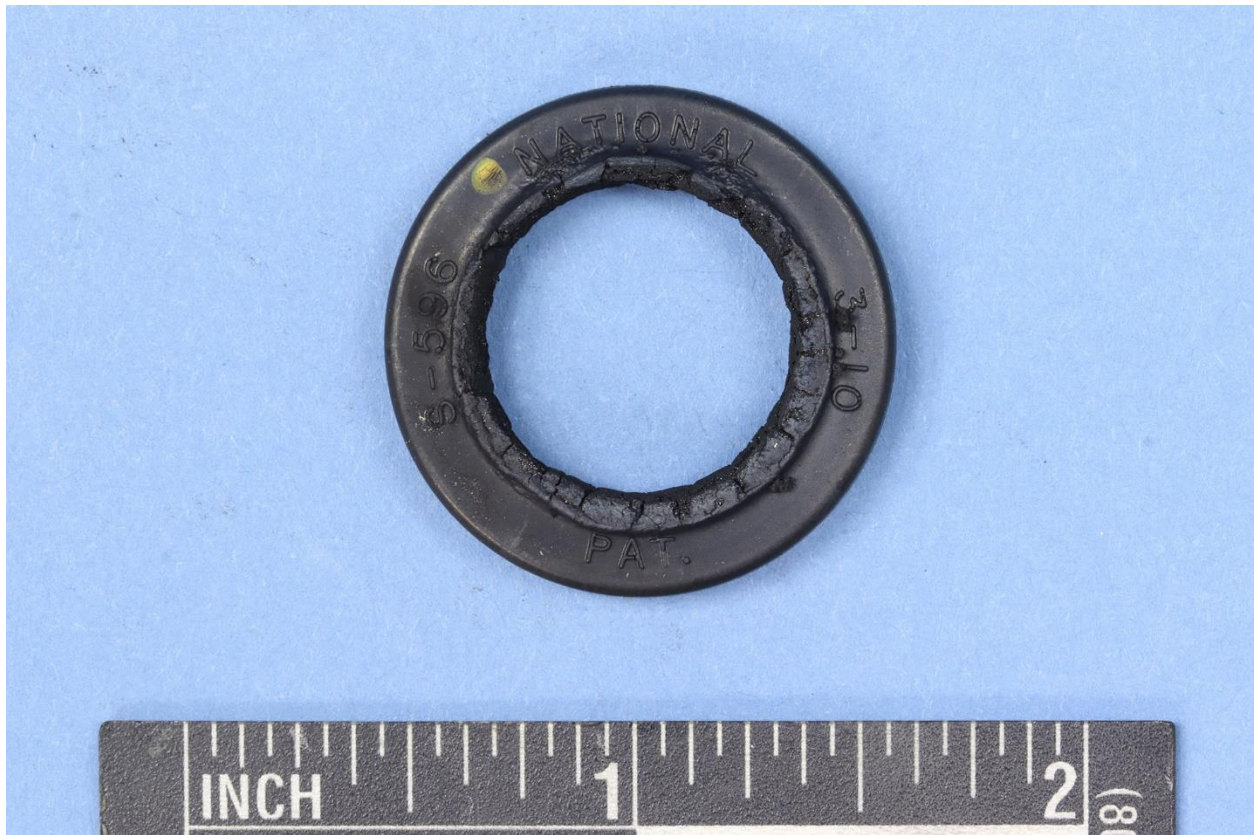
**Figure 4.** Image of the rubber seal that is installed on the driven end of the rotor showing thermal damage to the rubber.

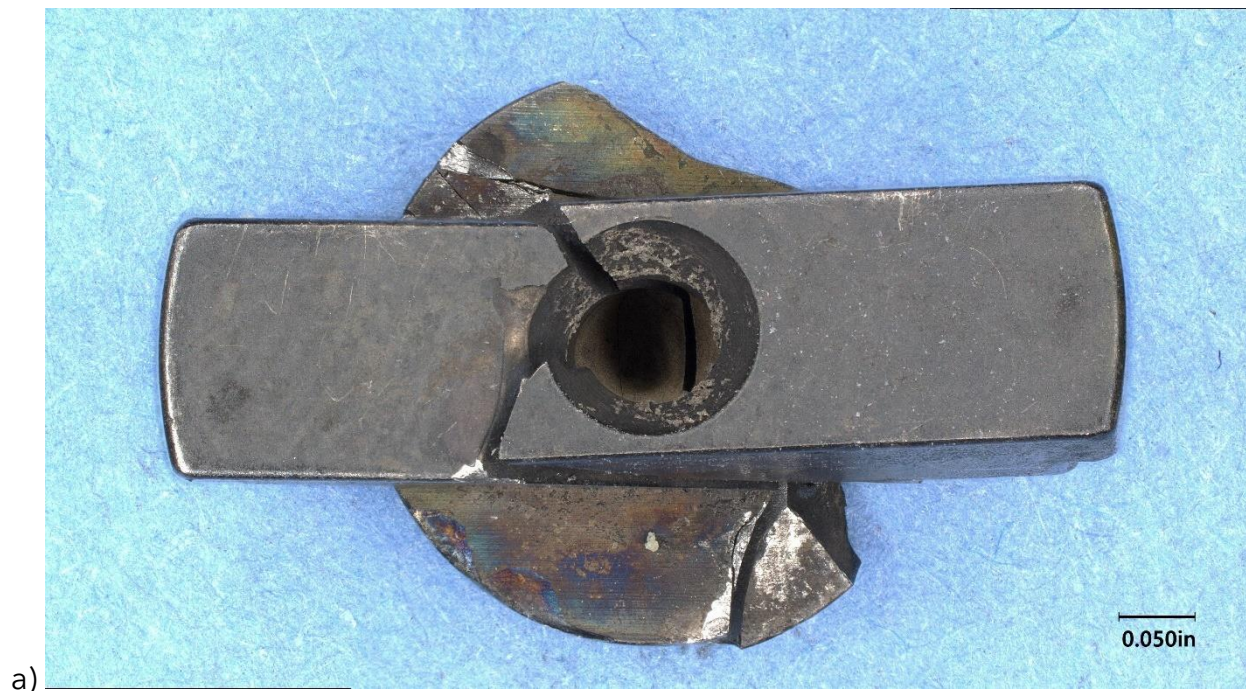
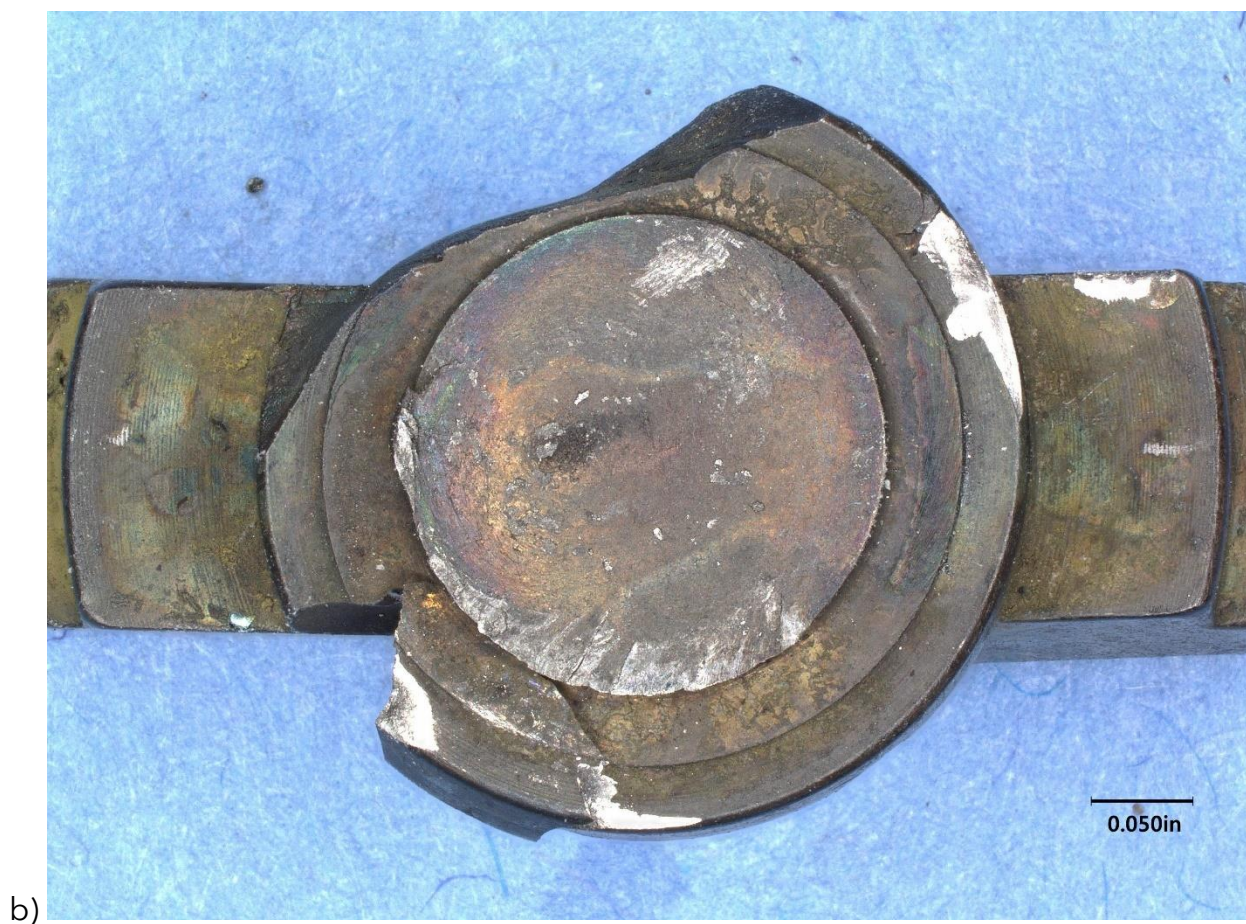
The tongue of the drive coupling is shown in figure 5. The tongue was fractured, and the drive shaft had sheared in the narrow-diameter section of the coupling, as seen in part b. Examination with a stereomicroscope revealed circumferential smear marks on the fracture that were consistent with a shear overstress fracture. During the initial disassembly, the tongue could not be separated from the rotor and was pushed through the bearing ID, causing damage to the bearing and possibly the tongue.

**Figure 5.** Images of the fuel pump drive coupling's tongue: a) cracked tongue and b) fractured drive shaft sheared by torsional overstress.

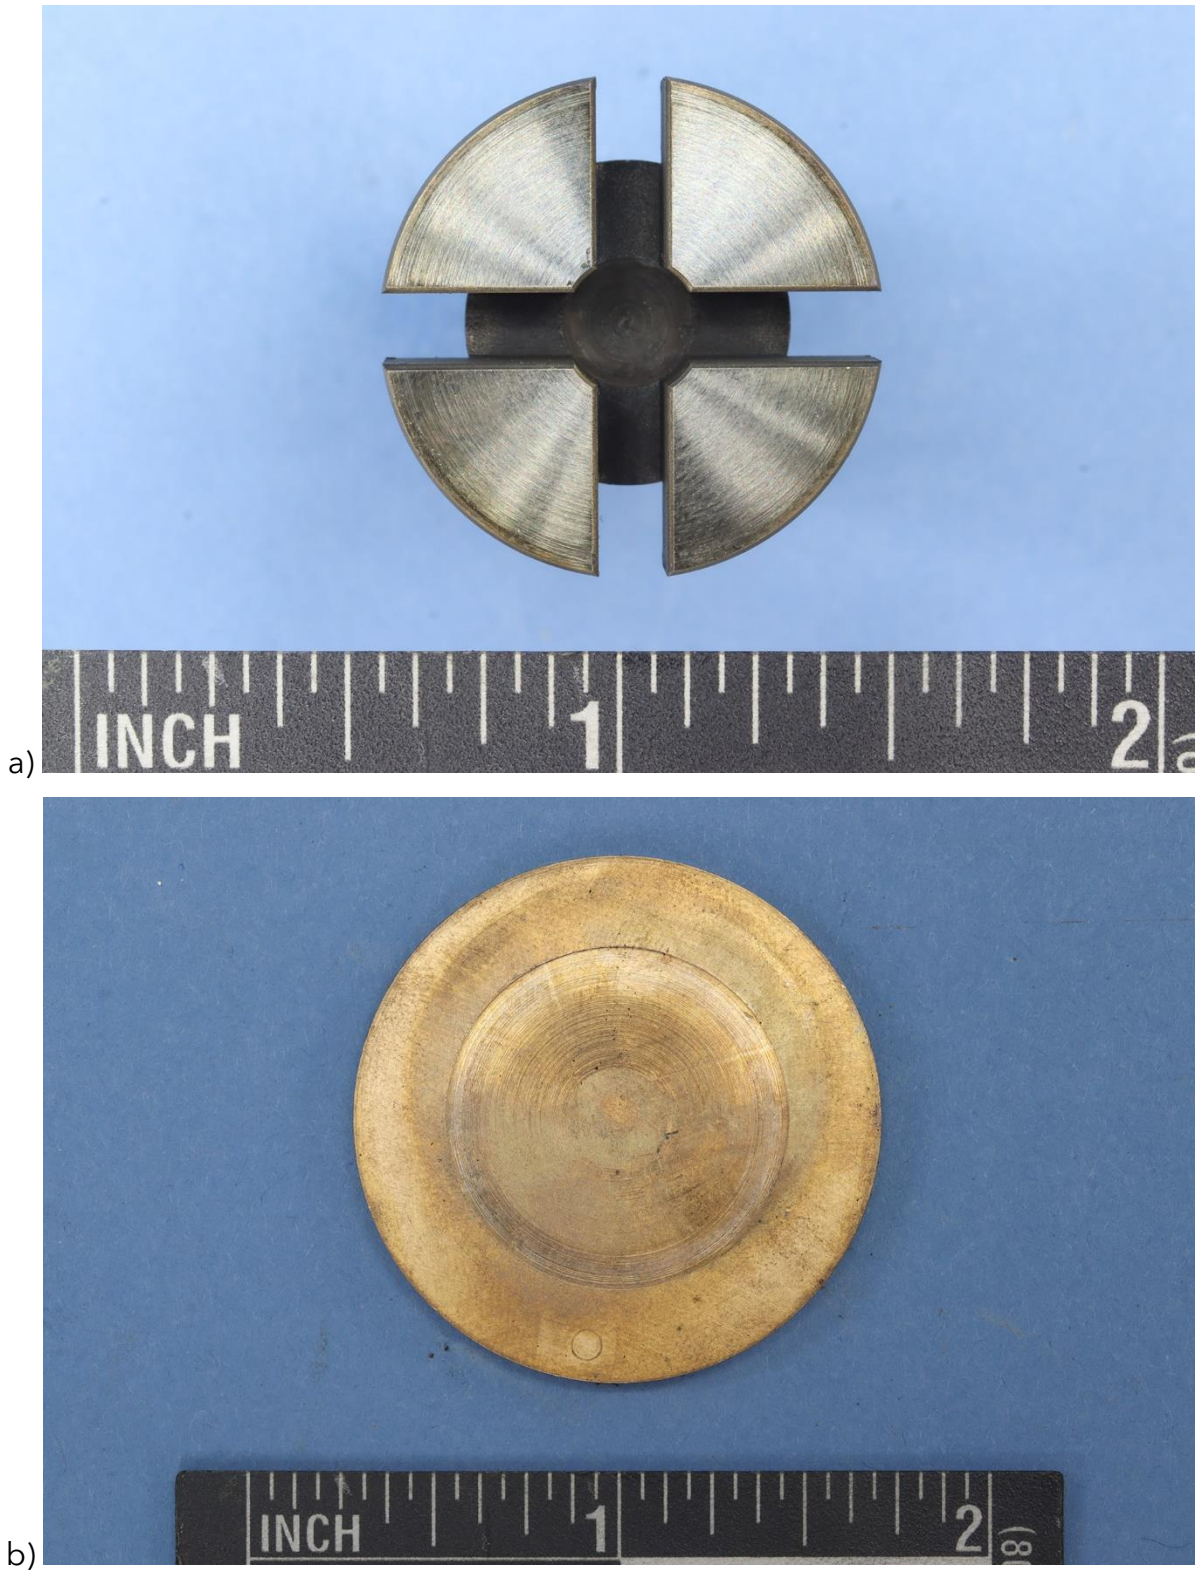
**Figure 6.** a) View of the rotor's drive end face and b) thrust plate against which the end face of the rotor rides.

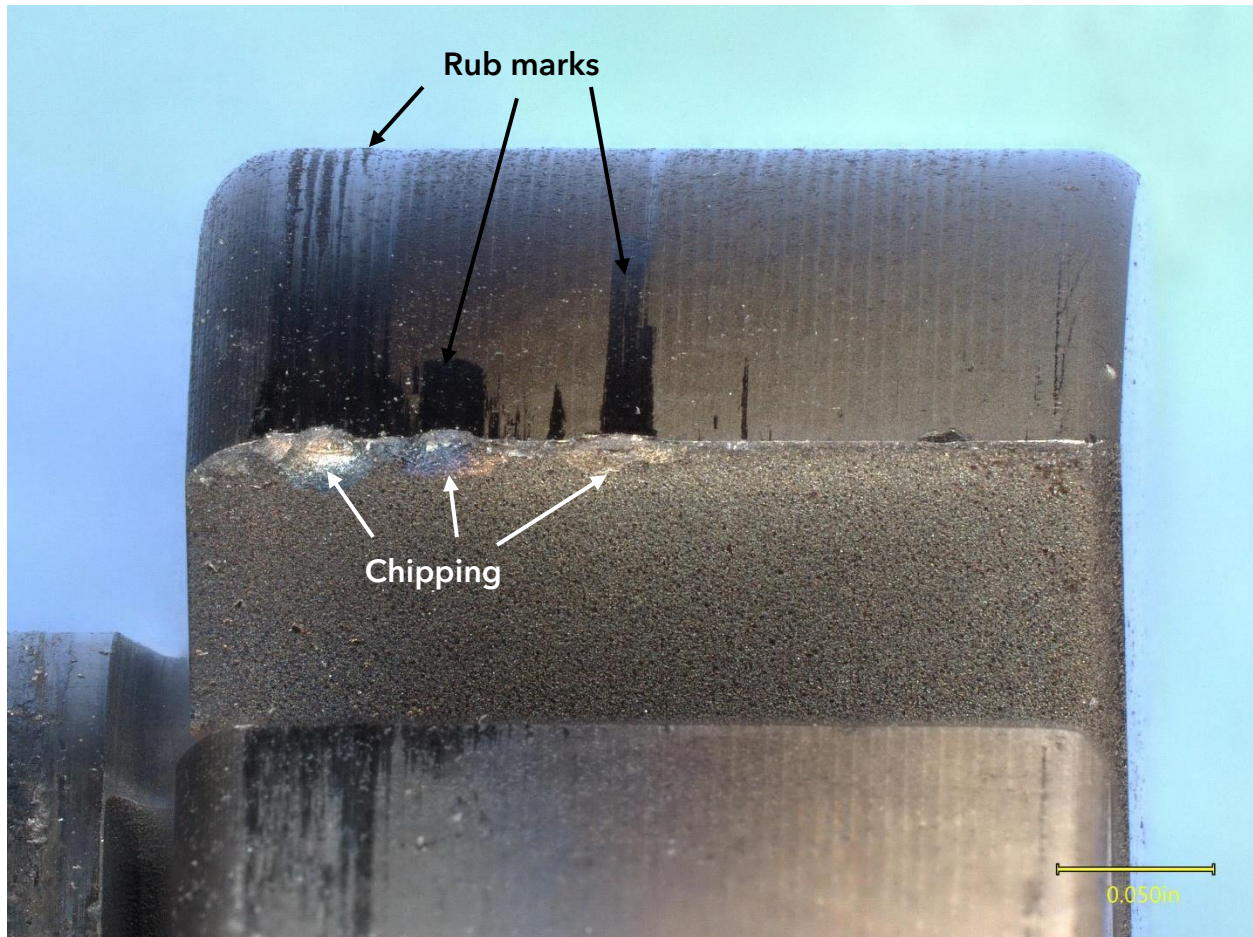
**Figure 7.** Image of the rotor's drive end outer diameter showing chipping/spalling of material at the edge of the slot and rub marks on the outer diameter surface at the same locations.

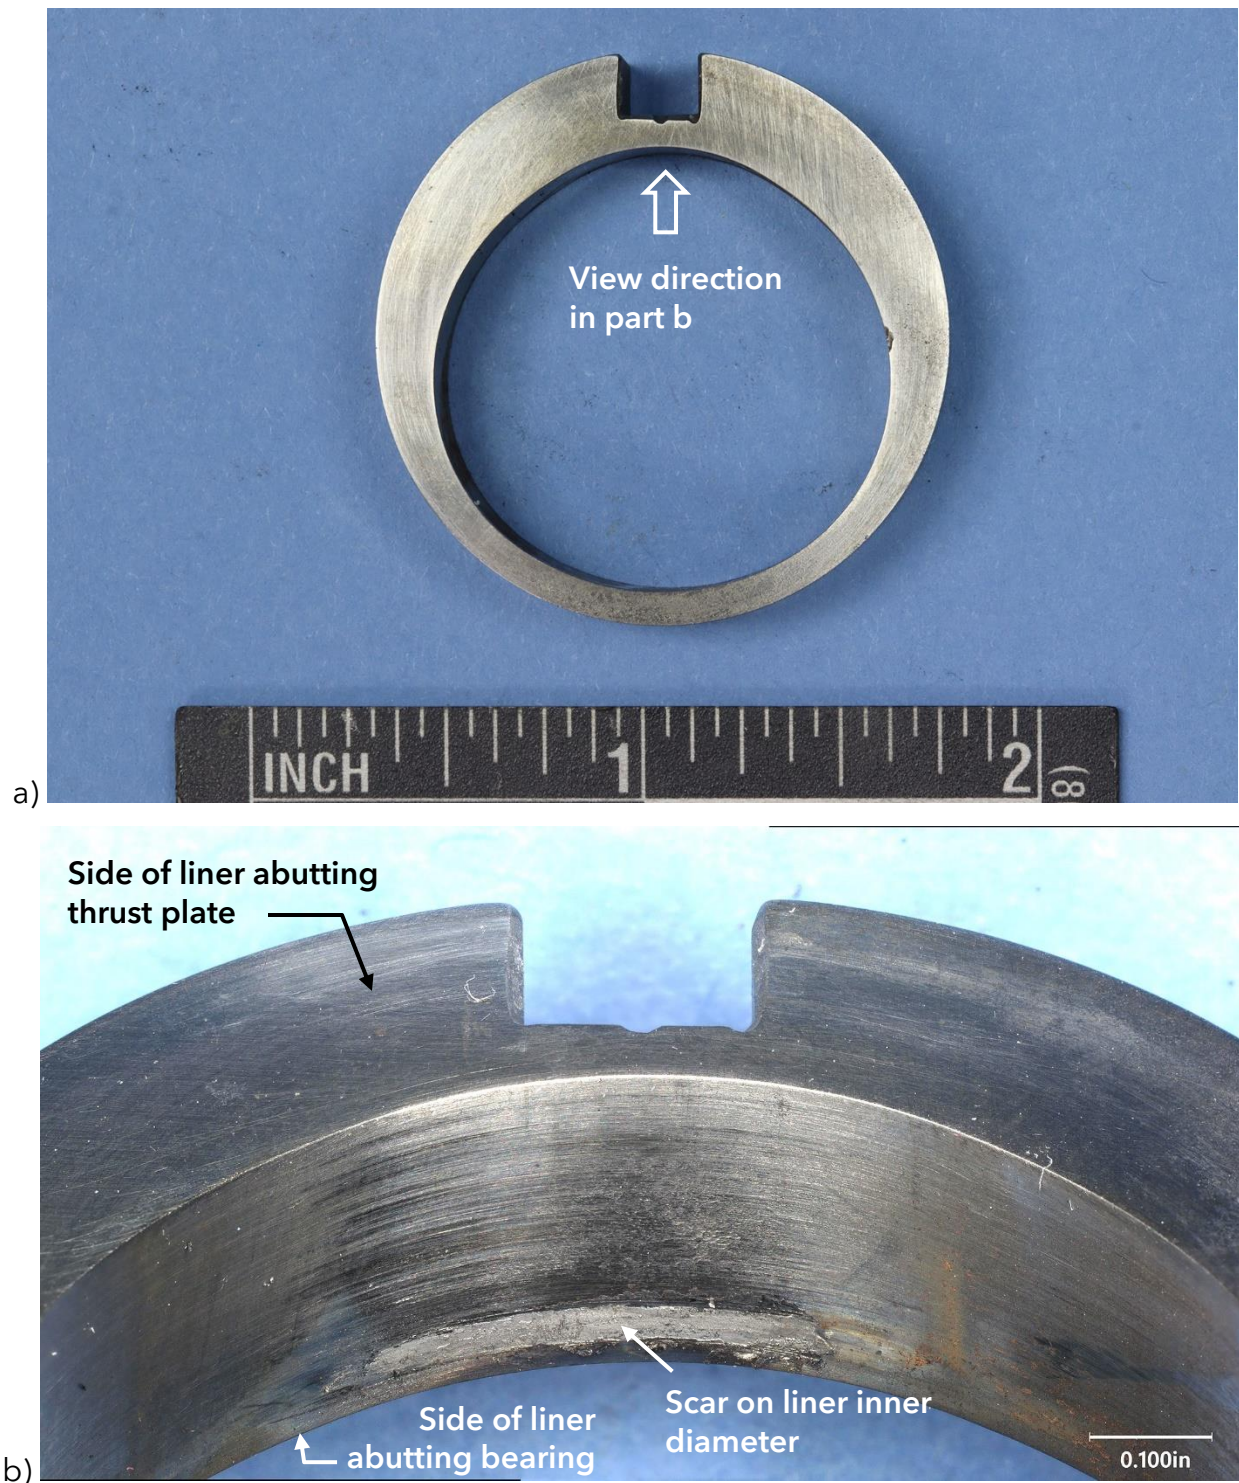
The liner, shown in figure 8, had a material scar on its inner diameter, as indicated in part b. The scar was located close to the face of the liner abutting the bearing and the pump body (as opposed to the side abutting the thrust plate). Chemical identification of the scar material is discussed below.

**Figure 8.** Images of the liner: a) overview image and b) oblique angle image with scar indicated on the inner diameter surface.

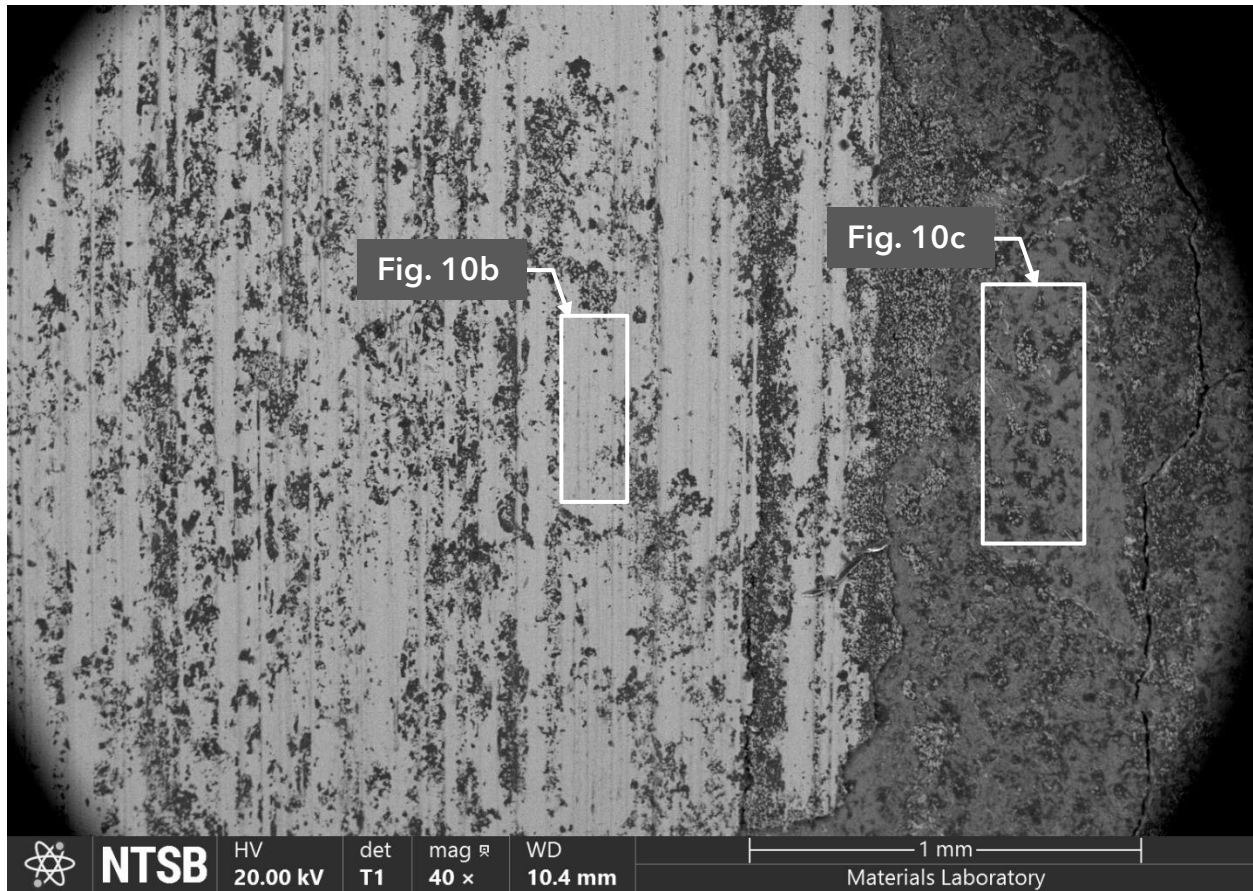
The pump components were examined by a scanning electron microscope (SEM) equipped with an energy-dispersive X-ray spectrometer (EDS). A backscatter image of the rotor is shown in figure 9 at the location indicated in figure 2. The image shows elemental contrast, with the lighter regions indicating heavier elements and the darker regions indicating lighter elements. The bright region on the left side of the image was from a region of the remaining journal surface. The dark region on the right side of the image was from a region where the surface had spalled from the rotor body.

**Figure 9.** Scanning electron microscope image of the rotor bearing journal. The lighter colored region is intact bearing journal surface and the darker region is where the surface spalled from the rotor body.

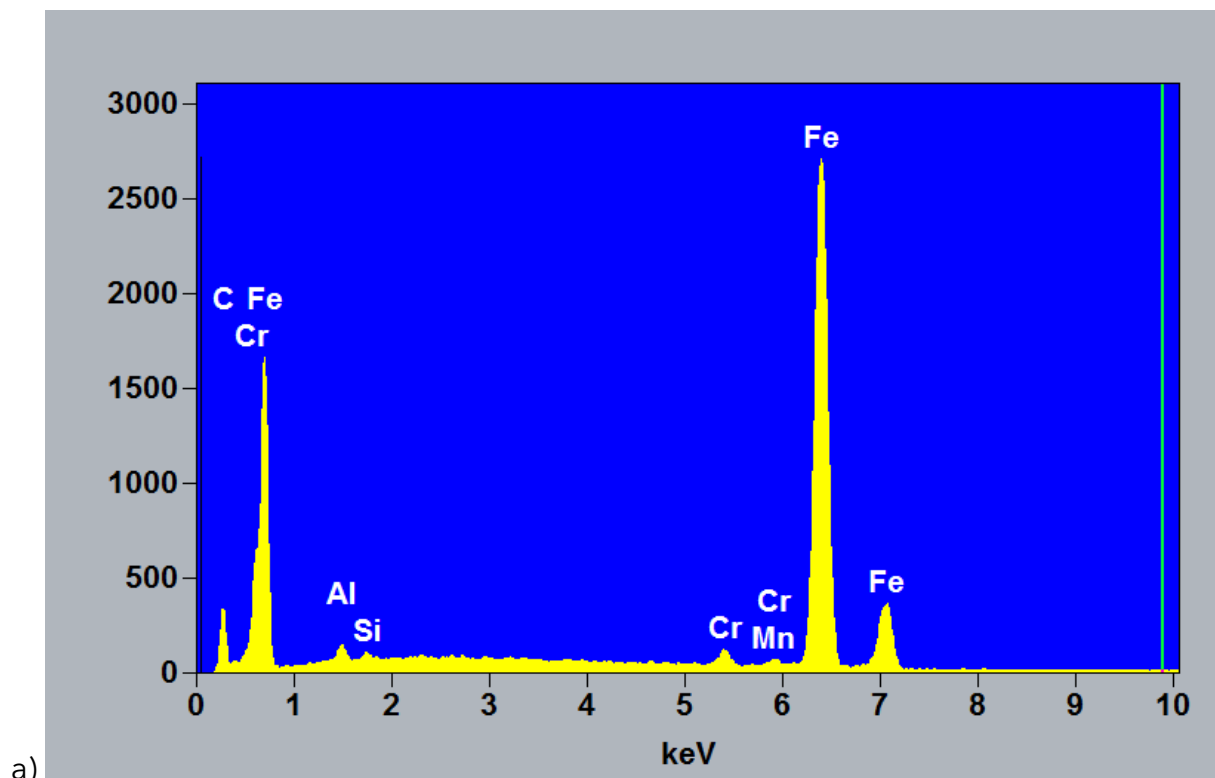
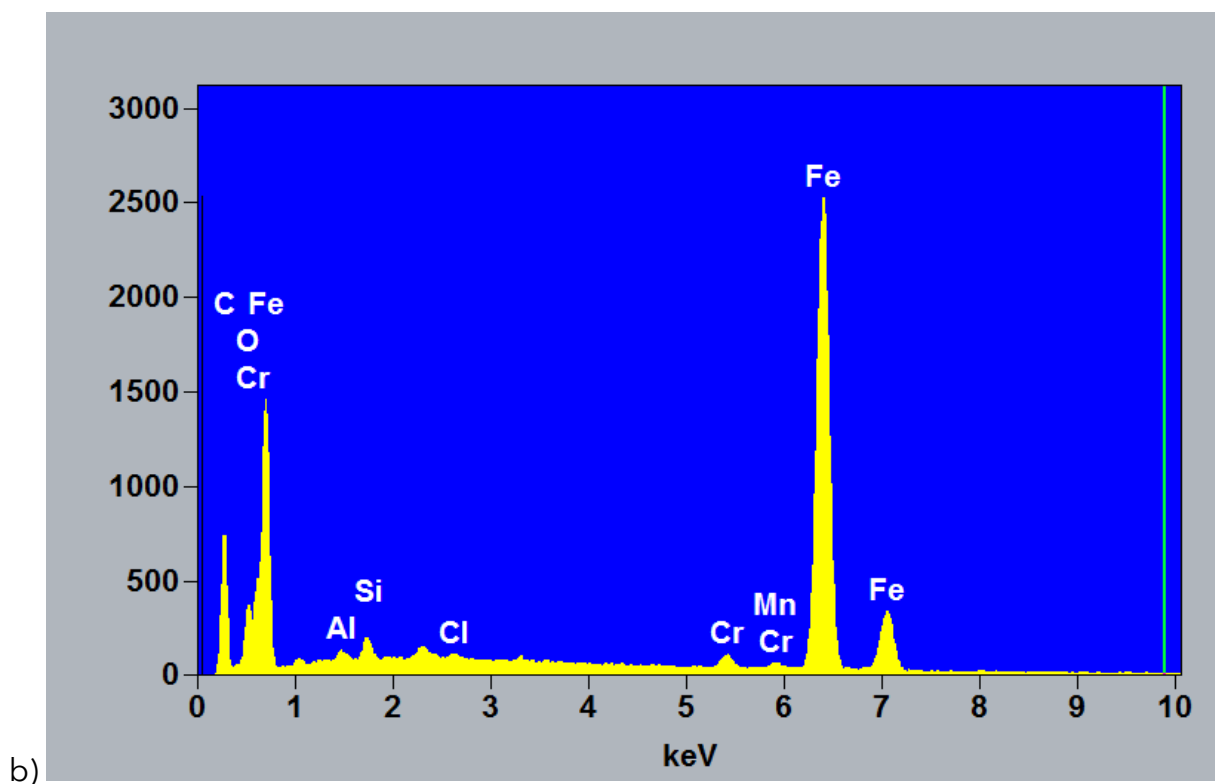
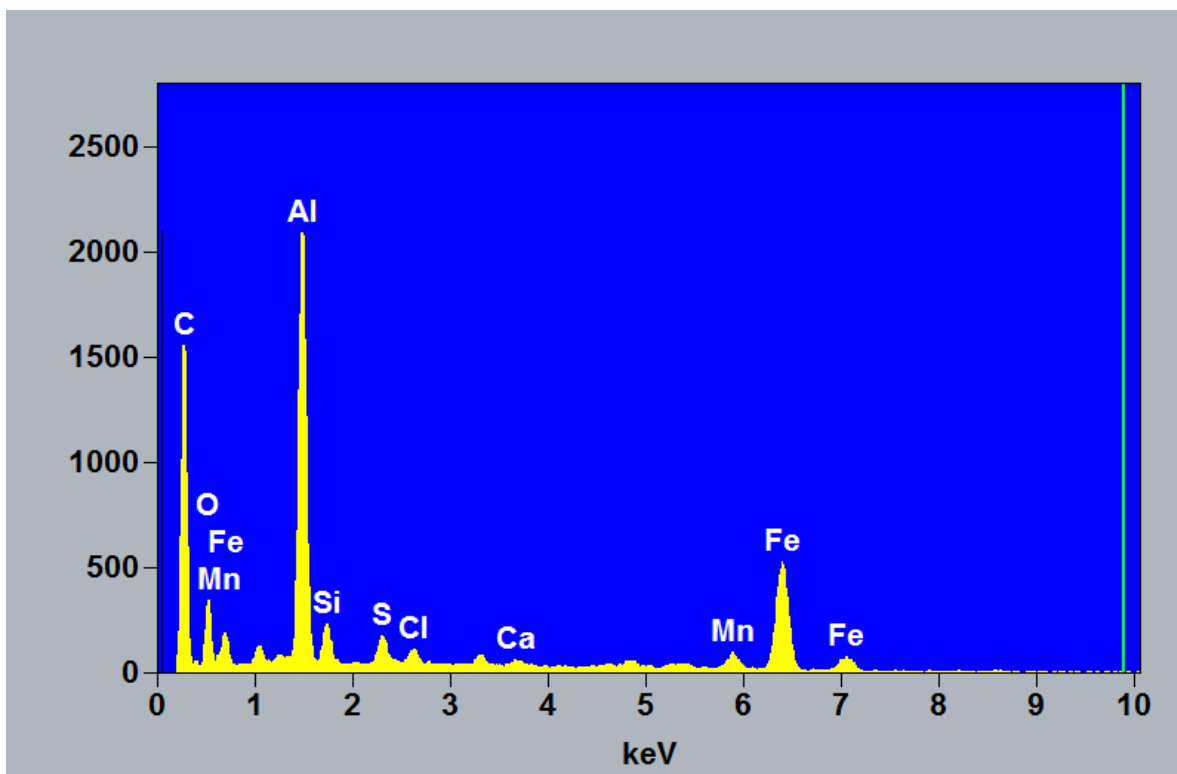
Several EDS spectra are shown in figure 10. Figure 10a shows a reference spectrum of the rotor material, taken from a cross section through the rotor head (prepared for the purpose of case depth measurements as described below). The primary element was iron (Fe) with small alloy additions of chromium (Cr), aluminum

(Al), and silicon (Si). An EDS spectrum taken from the remaining journal surface (left side of figure 9) showed similar elements and relative peak heights, as shown in figure 10b. By contrast, the spectrum from the spalled region, shown in figure 10c, exhibited primarily aluminum (Al) and silicon (Si) with additional peaks of sulfur (S) and iron (Fe).

**Figure 10.** Energy dispersive X-ray spectra (EDS): a) Rotor base metal on a polished cross section; b) intact original bearing surface as indicated in figure 9; and

**Figure 10 (cont.).** c) region indicated in figure 9 where the nitride layer spalled from the rotor body.

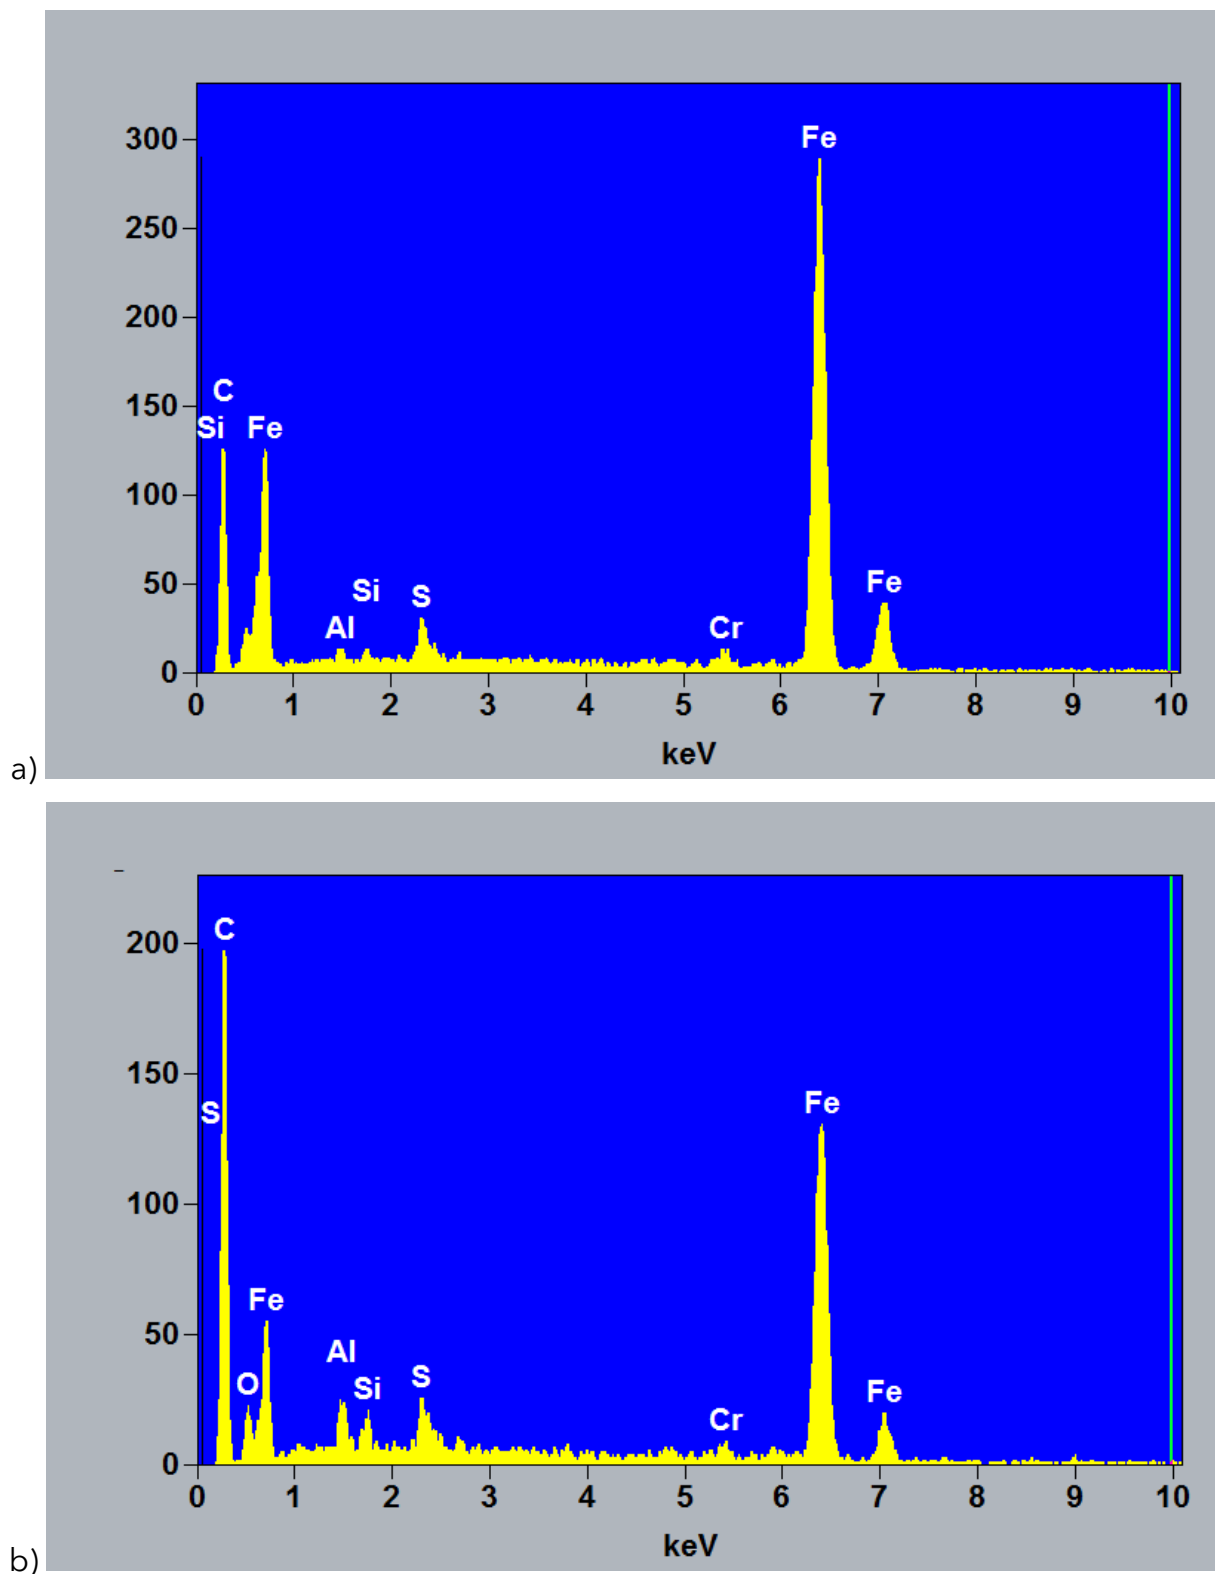
The foreign debris on the carbon bearing was examined by EDS as shown in figures 11a and 11b, at the locations indicated in figure 3d. The lighter contrast region exhibited primarily Fe peaks (as well as carbon and sulfur). The middle contrast region was similar but with an increase in the relative peak heights of Al and Si.

**Figure 11.** EDS spectra from carbon bearing fracture surface as indicated in figures 3b and 3d: a) from region indicated in the SEM image and b) second region indicated in the figure.

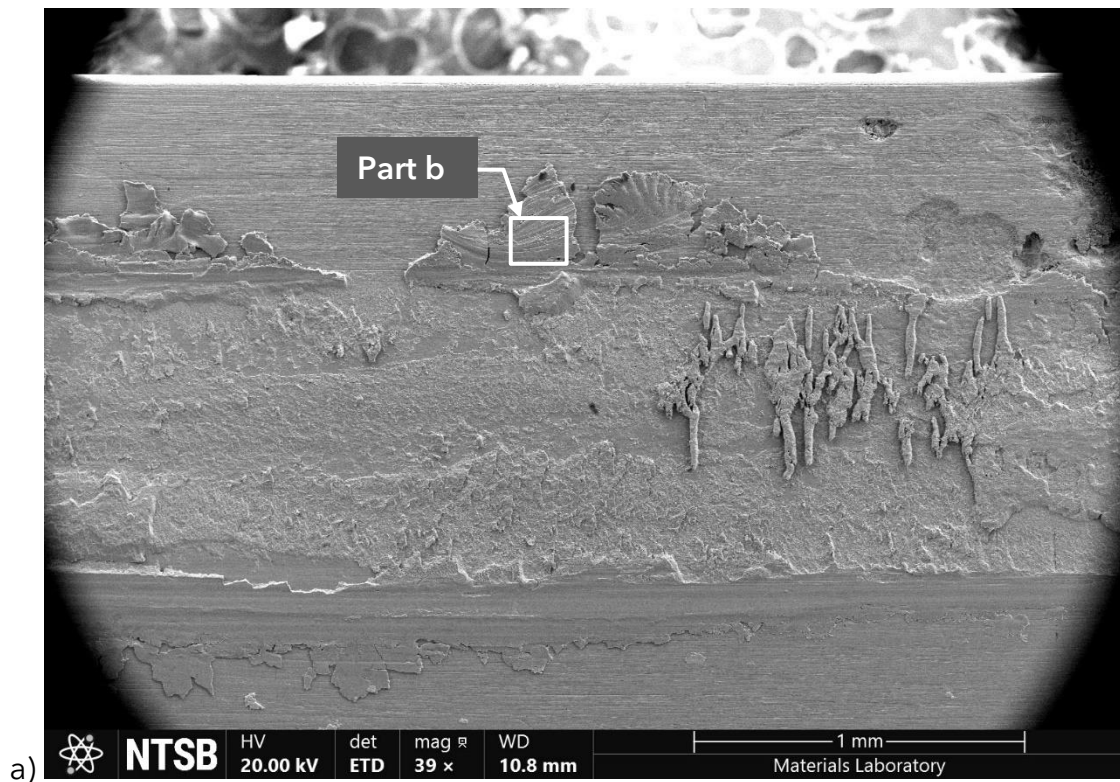
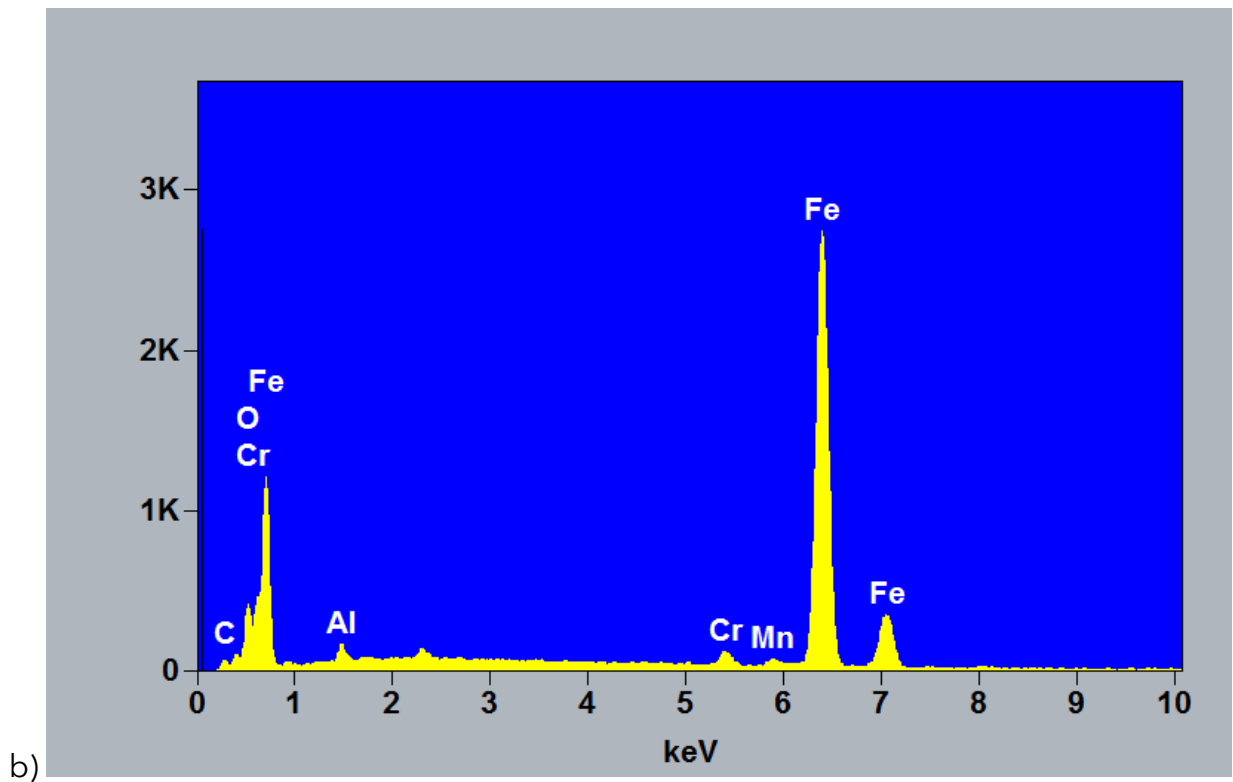
An SEM image of the scar on the liner is shown in figure 12a and the EDS spectrum is shown in figure 12b. The EDS spectrum consisted primarily of Fe, with additional peaks of Cr and Al, consistent with the rotor's base material.

**Figure 12.** a) SEM image of scar on inner diameter of liner with region indicated and b) EDS from indicated region.
