# National Transportation Safety Board

WPR22LA259

## **MATERIALS LABORATORY**

Factual Report 23-032

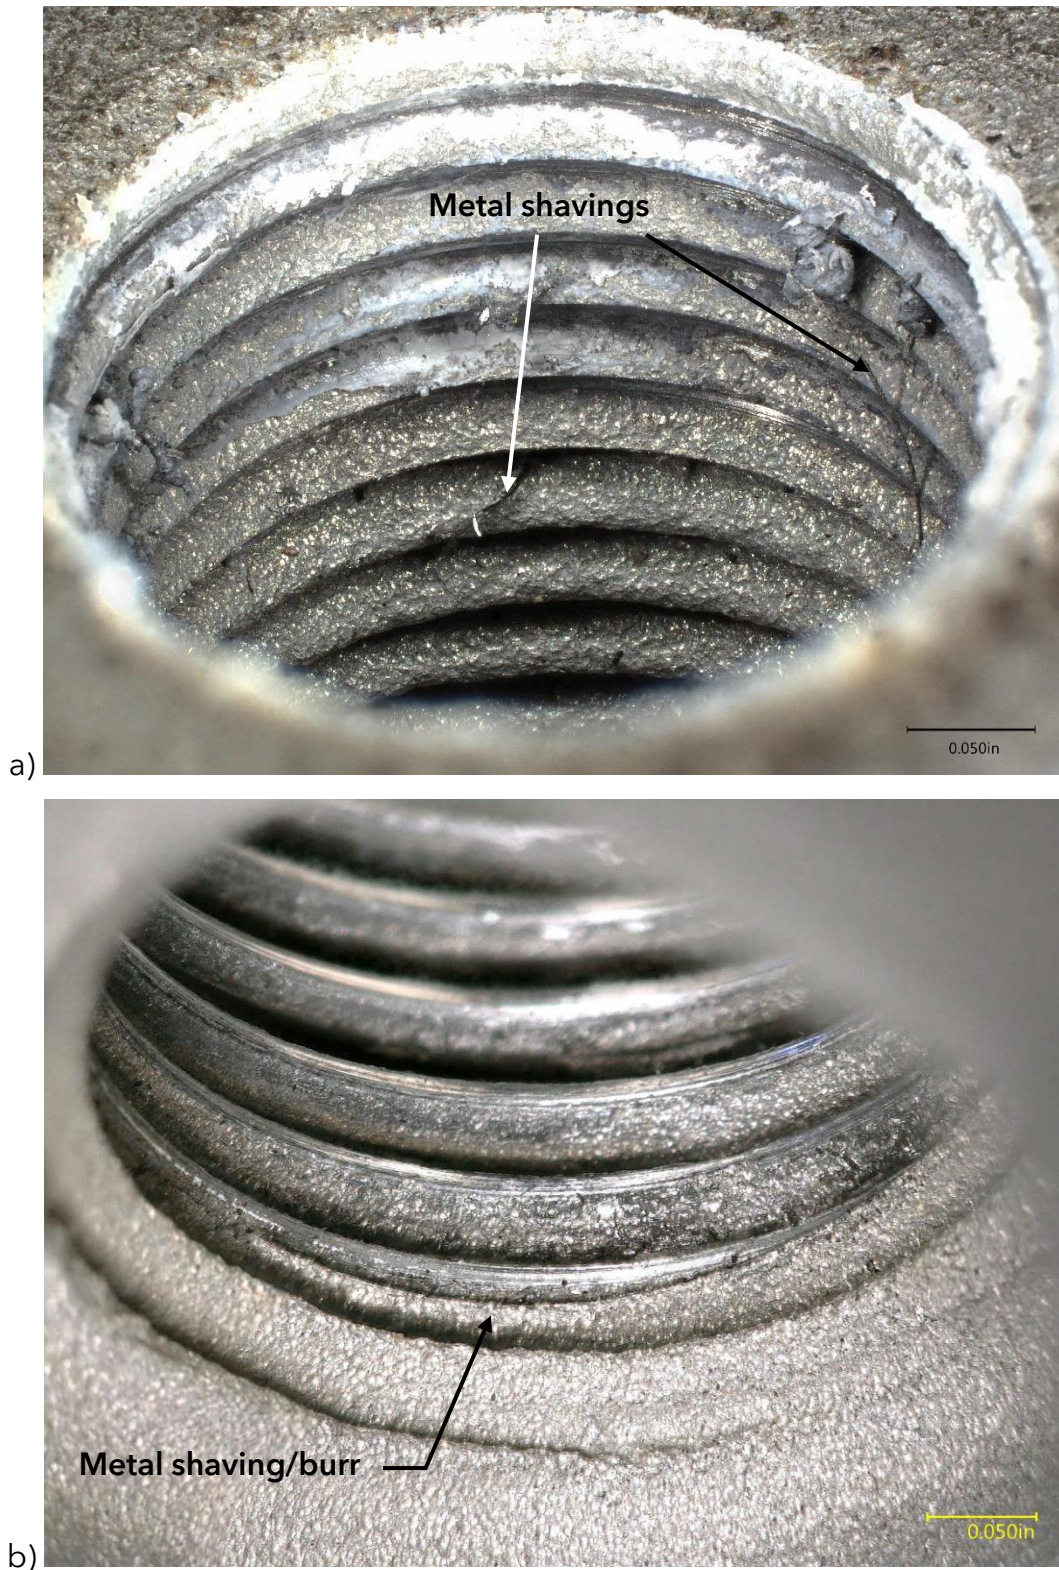
Several of the ports on the pump exhibited metal shavings or burrs, as indicated in figures 13 and 14. Two of the three plugged ports on the mounting flange contained one or more metal shavings, as shown for one of the ports in figure 13a. A shaving/burr was observed on one of the fuel flow ports, indicated in figure 13b, and shavings were observed at the threaded port on the relief valve housing cover plate, shown in figure 14. A thread was removed from one of the plugged mounting flange ports and is shown by SEM in figure 15a. An EDS spectrum of the shaving, shown in figure 15b, indicated it consisted primarily of Al and Si, with a trace of zinc (Zn) from the zinc-plated port plug. A reference EDS spectrum of the pump housing, shown in figure 15c, consisted primarily of Al and Si. The surfaces of the pump housing were examined for any signs of notable mechanical damage, but none were found.

**Figure 13.** Metal shavings/burrs found in several of the pump's threaded connections: a) overflow port on mounting flange of pump with zinc-plated plugging screw removed and b) inlet/outlet fuel line connection port.

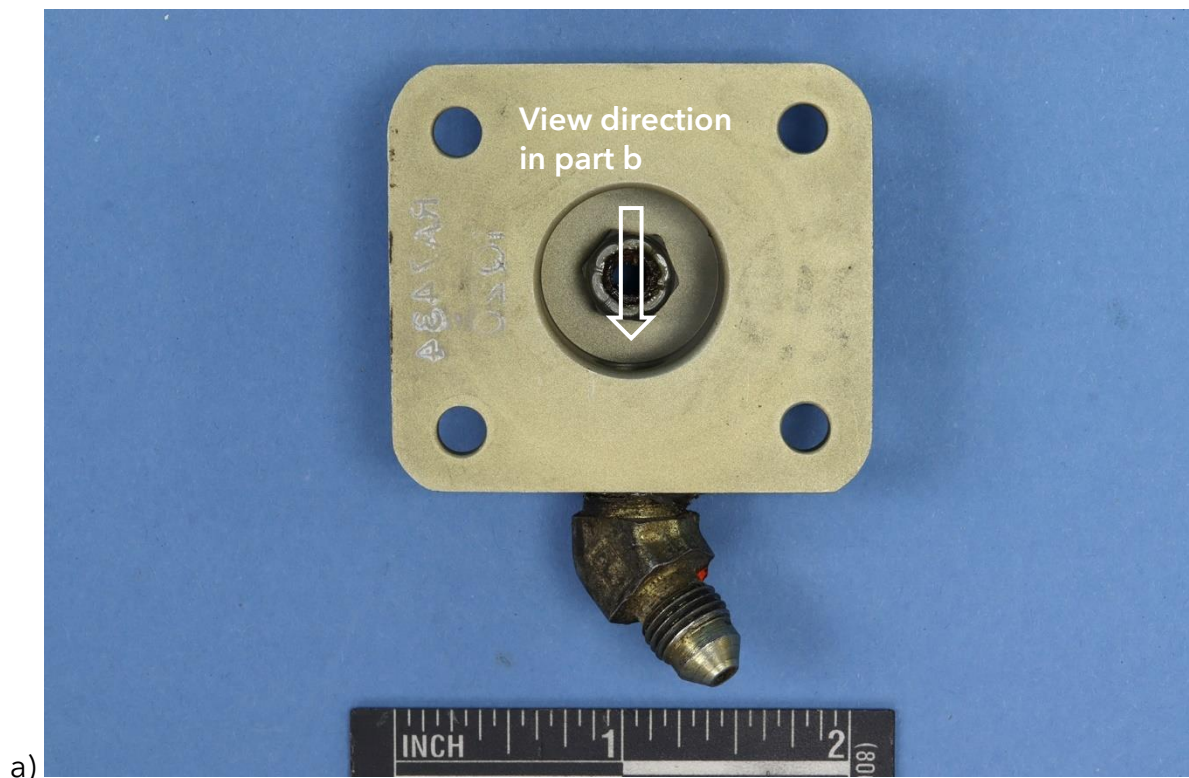
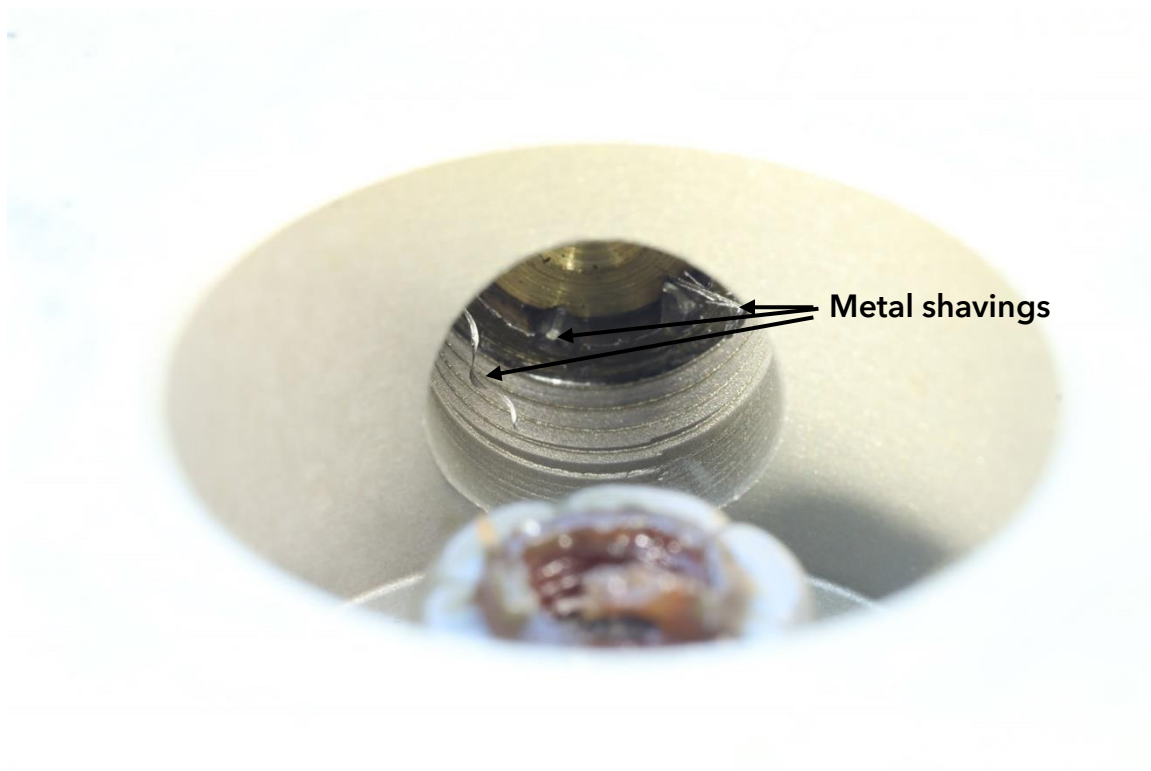
**Figure 14.** Image of underside of relief valve housing cover plate and b) oblique view showing metal shaving in threaded port connection.

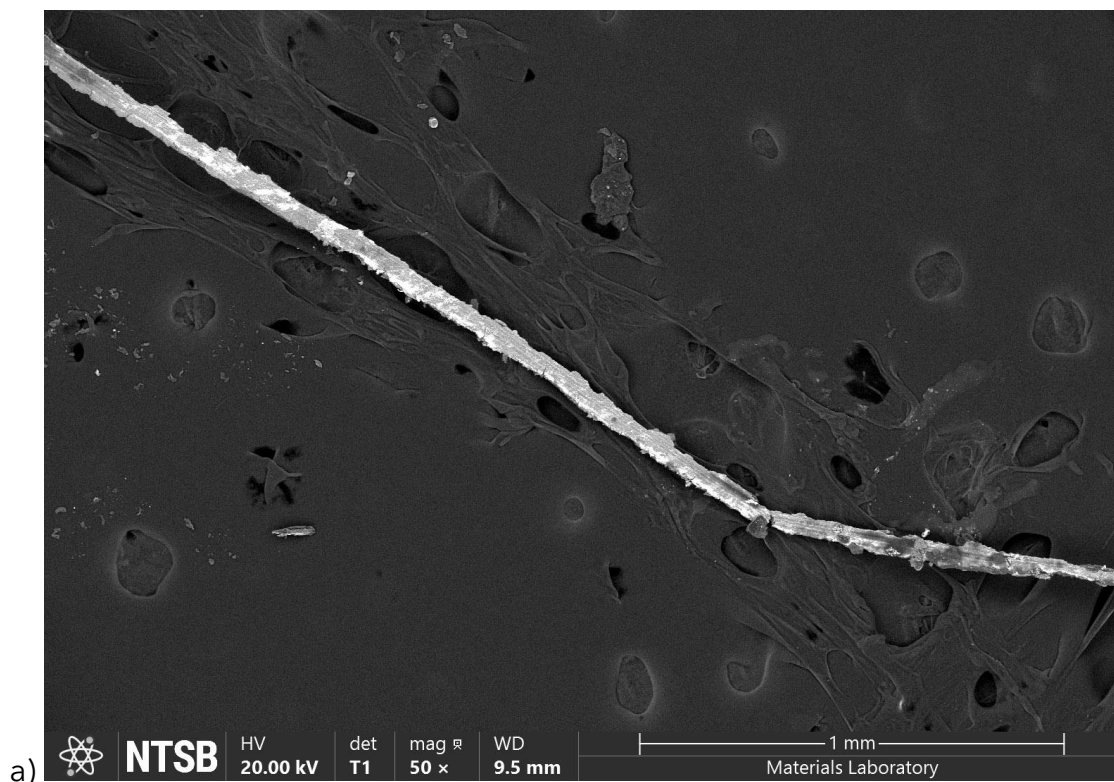
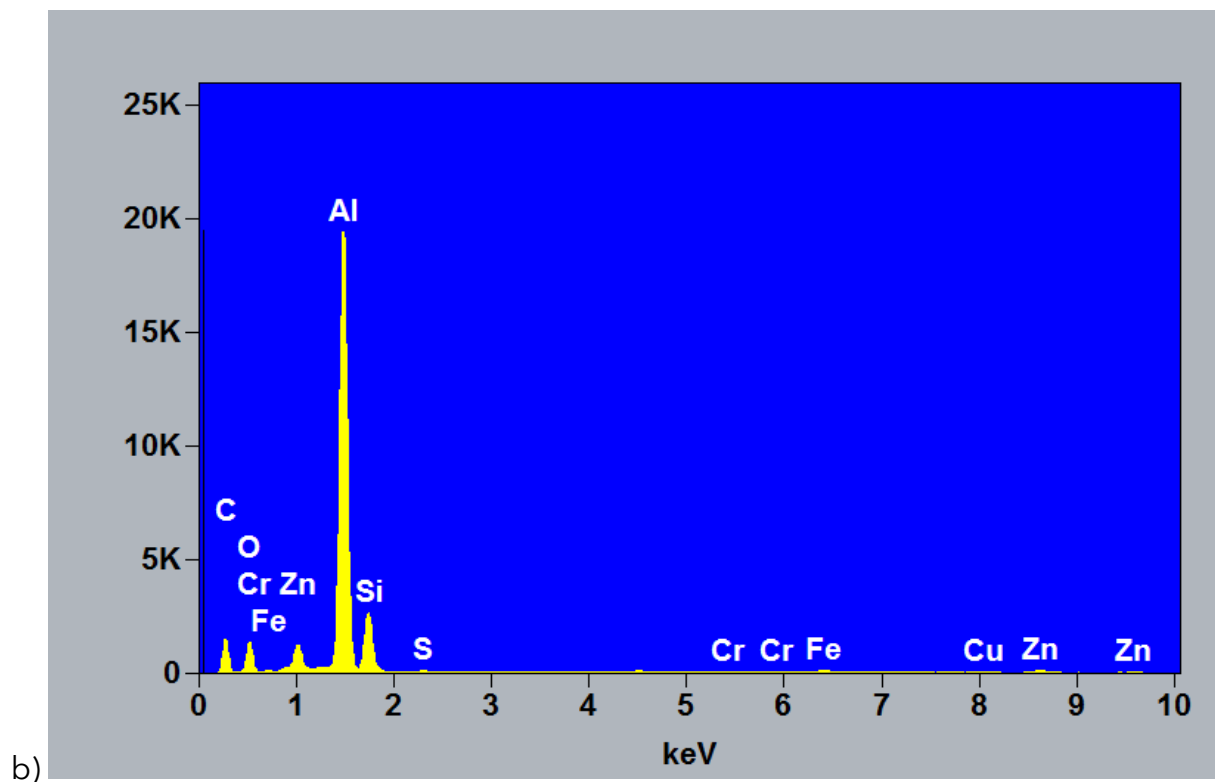
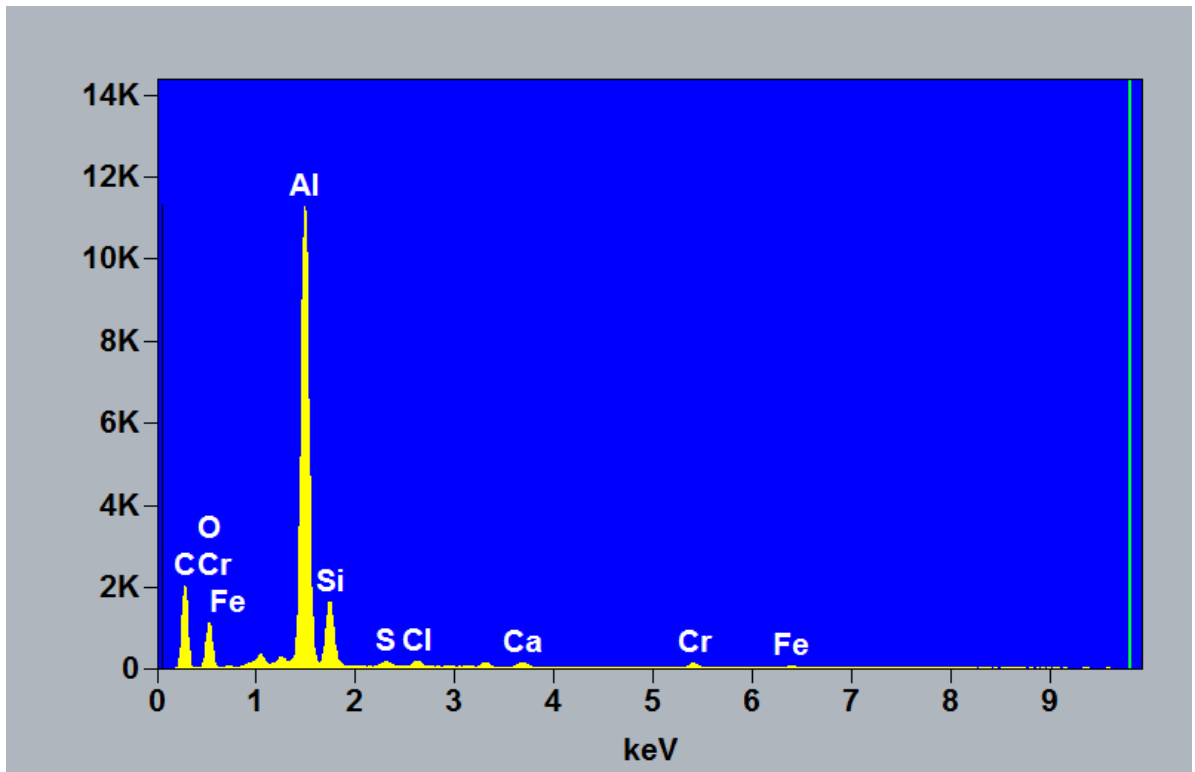
**Figure 15.** a) SEM image of metal shaving removed from the top plugged mounting flange port after the zinc-plated plug was removed; b) EDS of the metal shaving; and

**Figure 15 (cont.).** c) EDS of the pump housing.

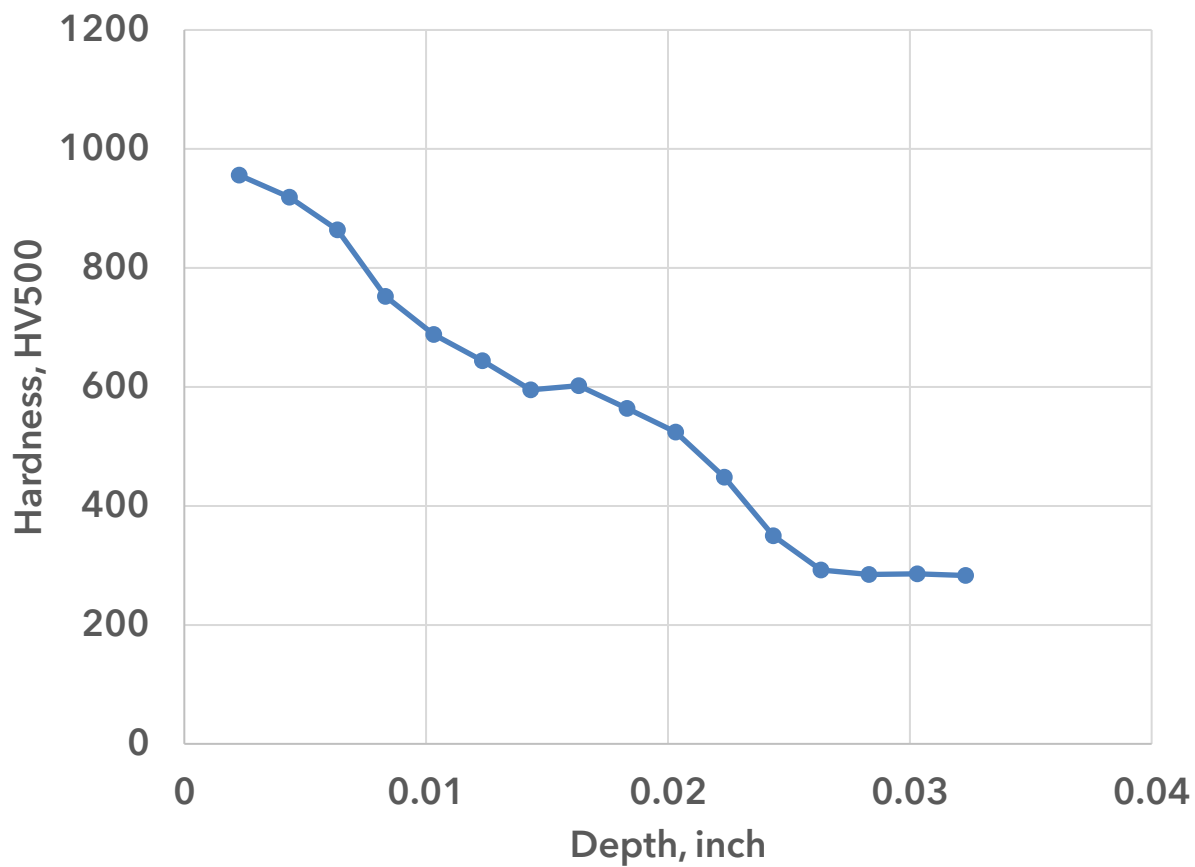
The case depth on the rotor was measured by Vickers hardness, in accordance with ASTM E384-17. A quadrant of the rotor head was sectioned with a wet abrasive saw and mounted in resin. The exposed surface was ground and polished in accordance with standard laboratory protocols. The case depth was then measured on the rotors outer diameter using a 500 g load. The resulting depth profile, shown in figure 16, was in accordance with the manufacturer's requirements.

**Figure 16.** Case depth of nitride layer on pump rotor bearing journal. Case depth was taken on the outer diameter of the slotted drive end.
