# **NTSB File No. WPR22LA259**

## **Quality Aircraft Accessories (QAA) Fuel Pump Exam Notes**

Aircraft: Socata TB21, N718TB

P/N: RG17980P/M

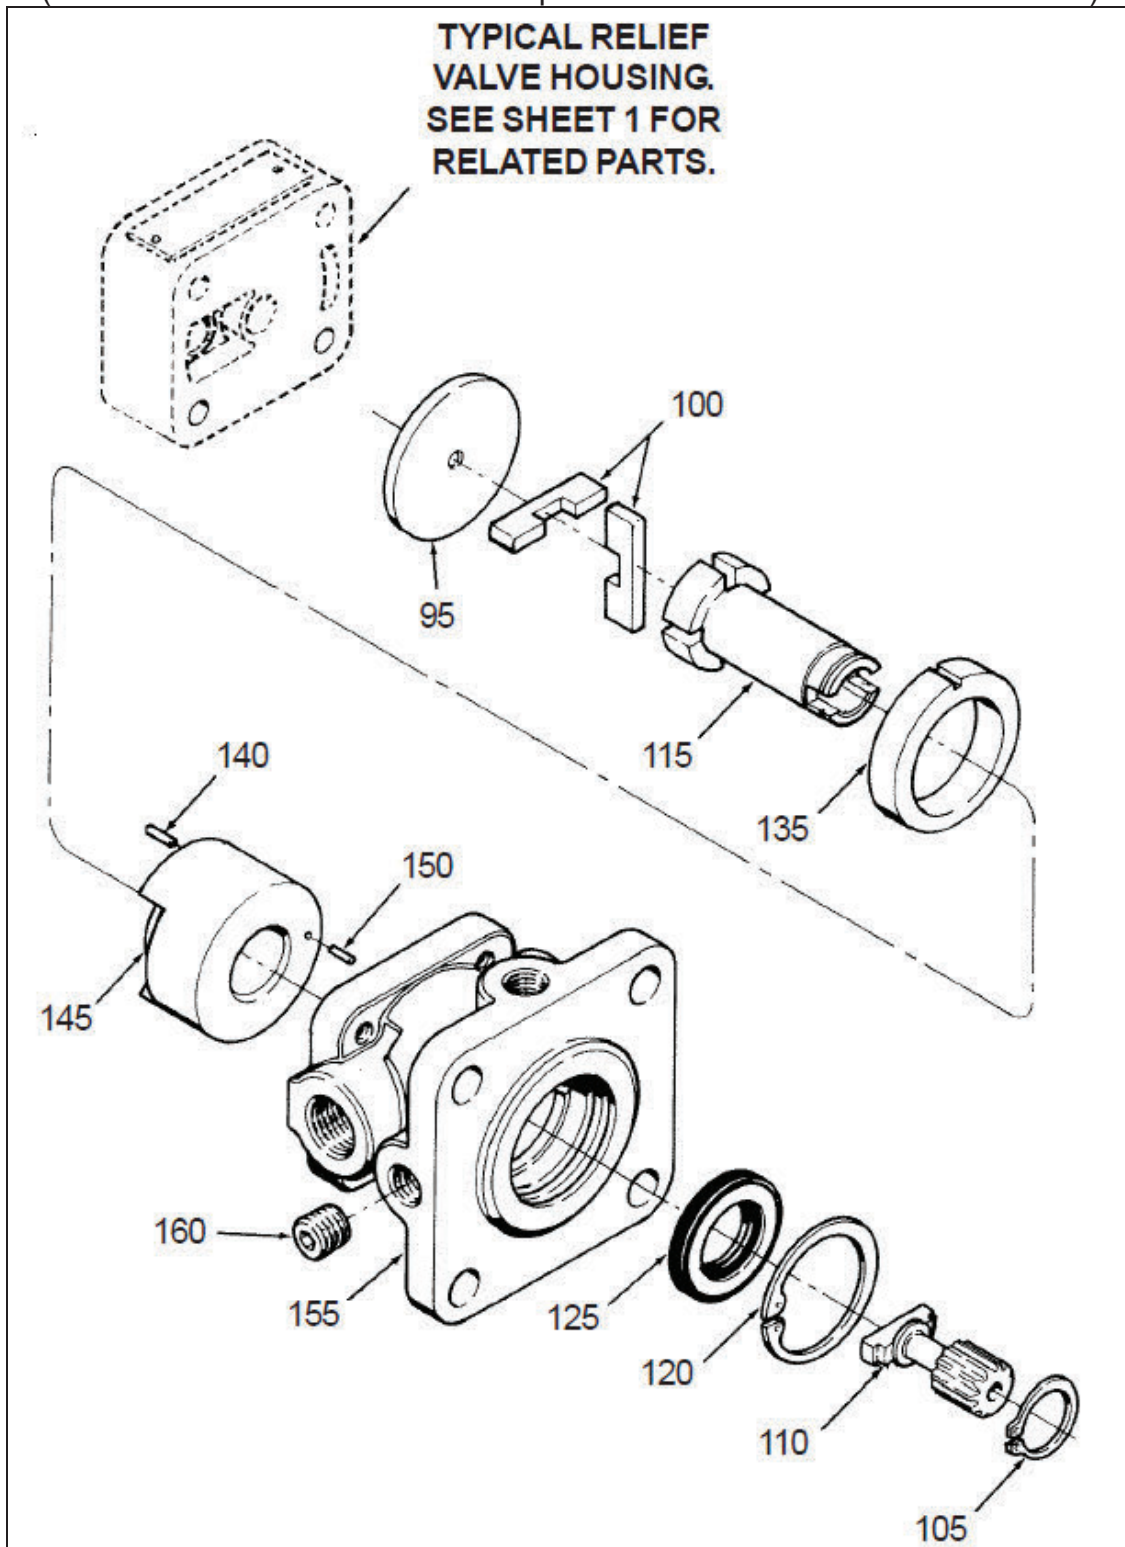
Figure 1: Pump housing and pumping element components  
(Reference Crane/Lear Rome Component Maintenance Manual RG17980)

The pump is an engine driven, vane-type, rotary fuel pump. Two vanes at 90° to each other rotate within an eccentric liner bore to provide pumping action. The fuel pump houses a diaphragm relief valve to maintain pressure (24-28 psig) over the required range of fuel flows (220-230 pph) at 2650 RPM, and an additional bypass valve to allow fuel to flow through the pump in the event of a pump failure. The /M in the model indicates the pump incorporates the modified relief valve housing (Service Bulletin 101SB018). The fuel pump components are illustrated in Figure 1.

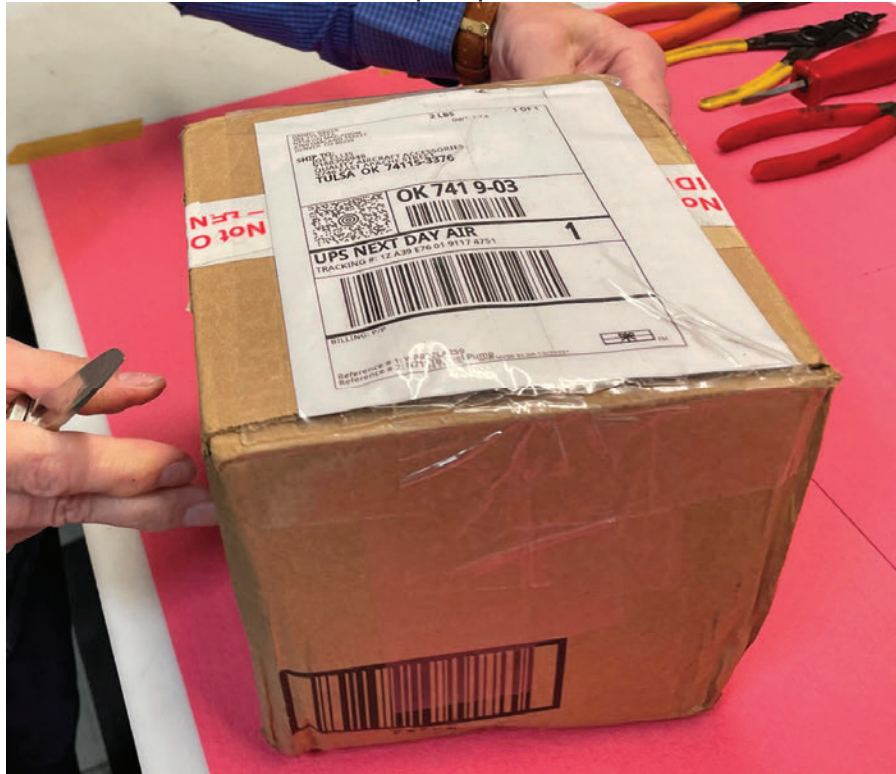
Photo #1 – Fuel pump box as-received

The fuel pump was shipped to QAA in the box shown in Photo #1 by the NTSB Investigator in Charge; UPS Tracking No. 1ZA39E760191174751.

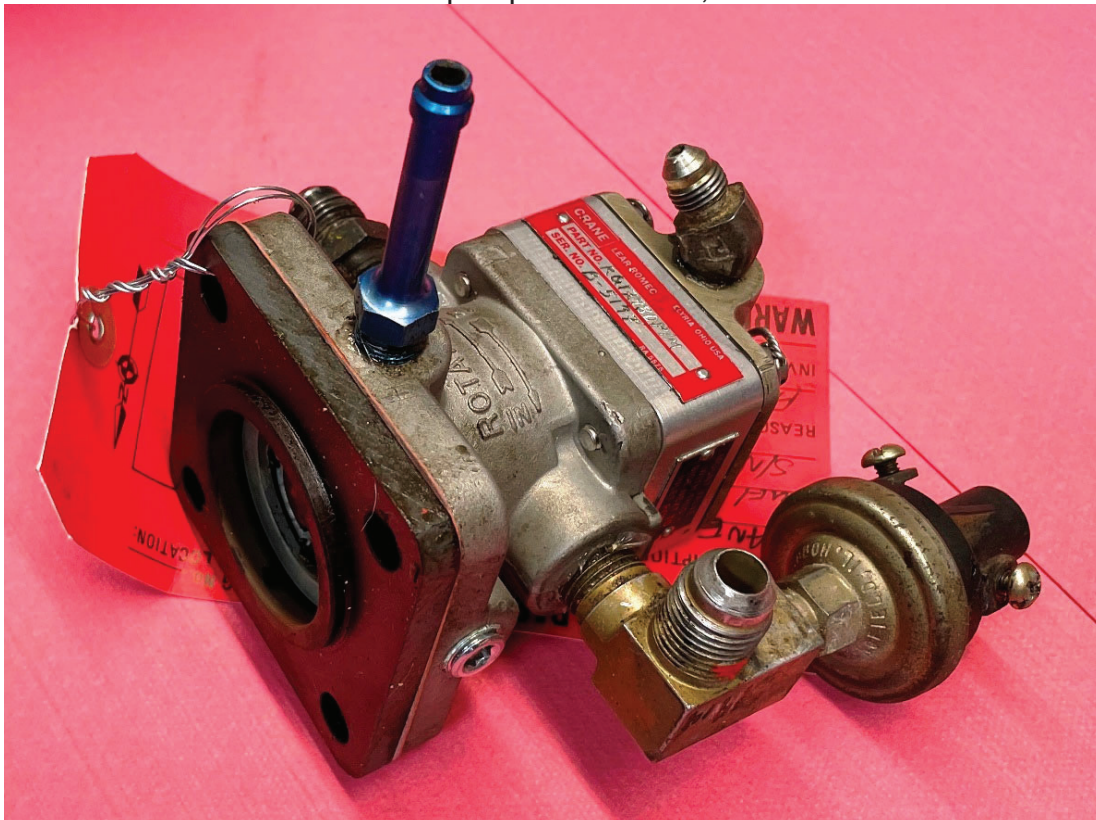
Photo #2 – Fuel pump as-received, before exam

The pump was shipped with the airframe-supplied fittings and fuel pressure sender still attached as shown in Photo #2. There was no exterior surface damage noted. The drive coupling (Item 110) was fractured at the intended safety shear section and the pump-end of the coupling was lodged in the rotor drive end (Item 115) slot as shown in Photo #3. The coupling fragment and drive end of the rotor shaft appeared to have some heat discoloration (Photo #4). The Items 105 and 120 retaining rings remained

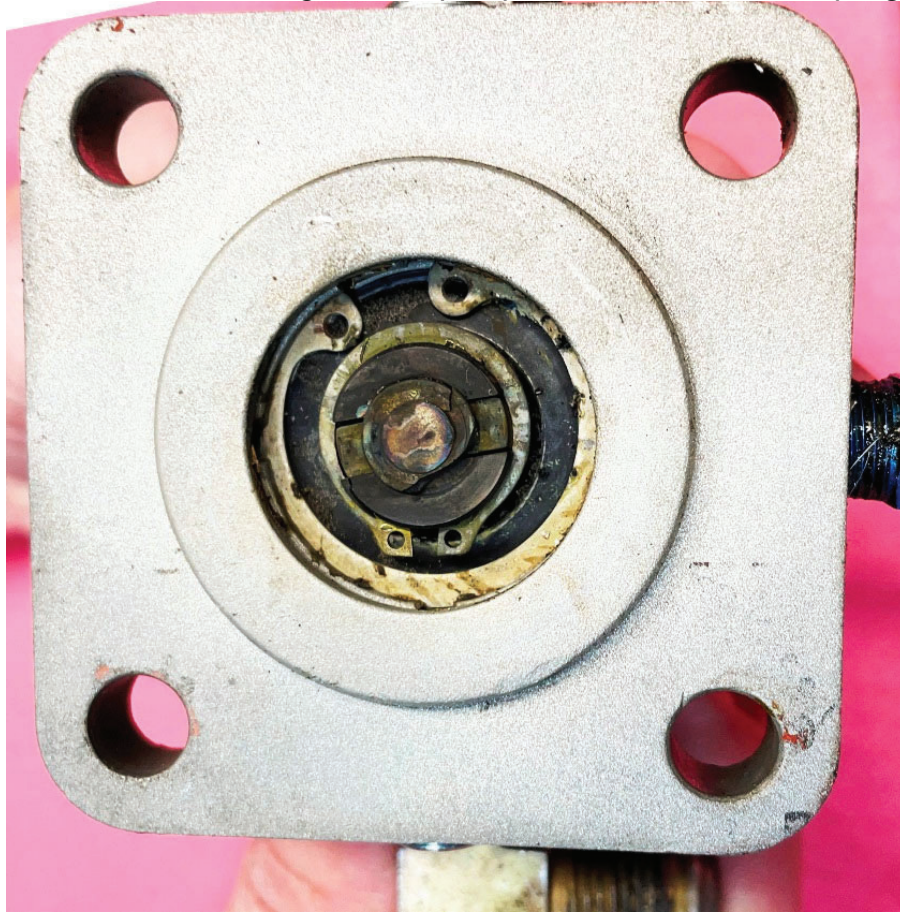
secured in-place. The rotor was seized and could not be rotated by hand force, therefore bench testing of the pump before disassembly was not possible.

Photo # 3 – Mounting base of pump w/ fractured drive coupling

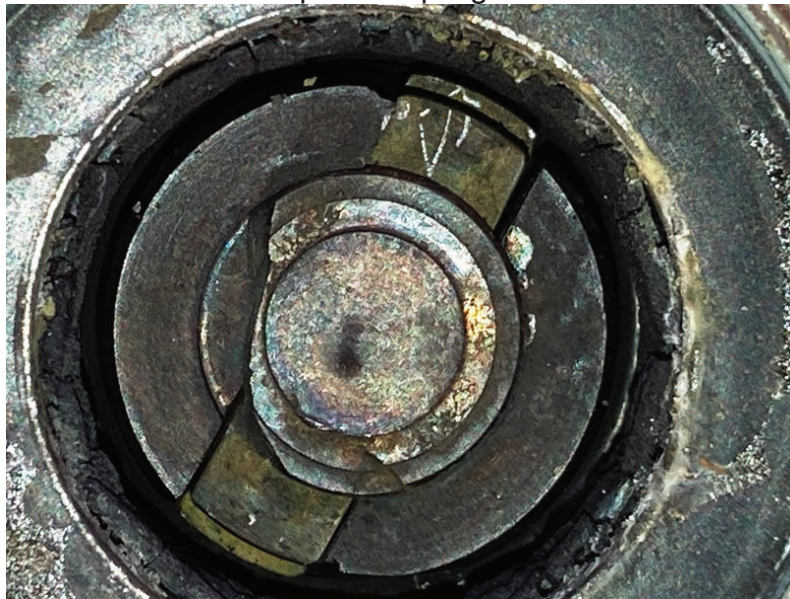
Photo #4 – Close-up of Coupling and Rotor drive end

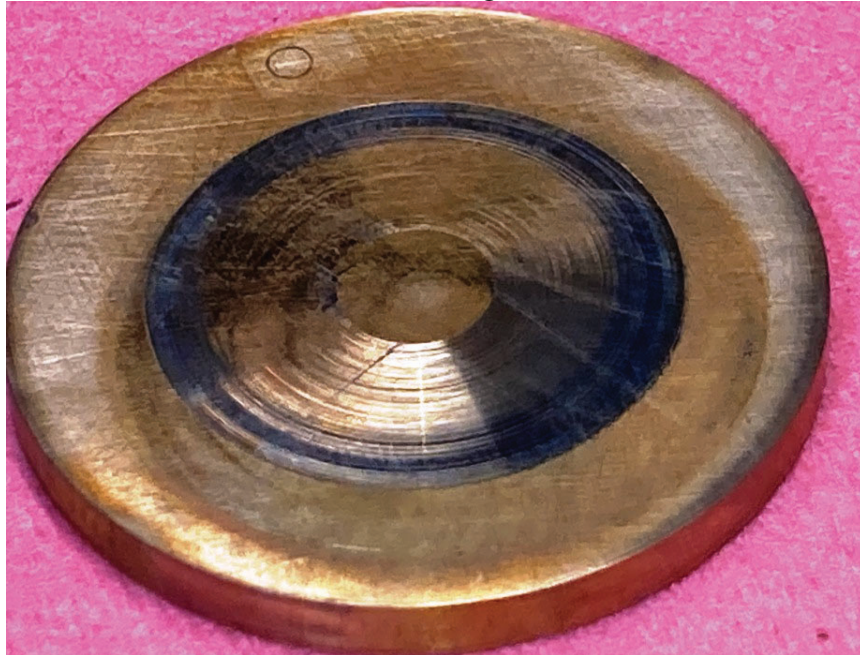
When the Thrust Plate (Item 95) was removed there was remarkable rotational scoring and heat discoloration on the vane-side as shown in Photo #5.

Photo #5 – Rotational coring on the Thrust Plate

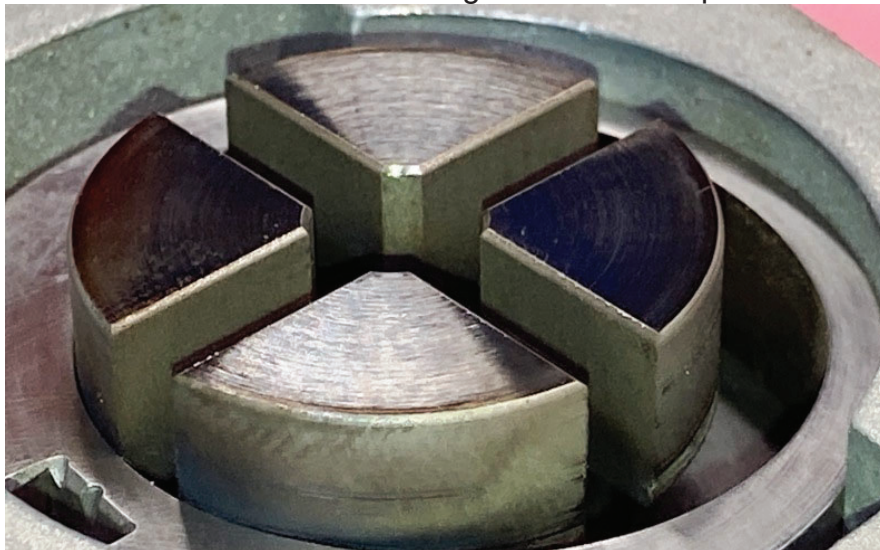
Rotational scoring was also seen on the Rotor top surface (Item 115) that abuts the Thrust Plate as seen in Photo #6. The Blades (Item 100) were intact and were removed easily from the Rotor slots, but had nicks/gouges on lower tip corners.

Photo #6 – Rotational scoring on the Rotor top surface

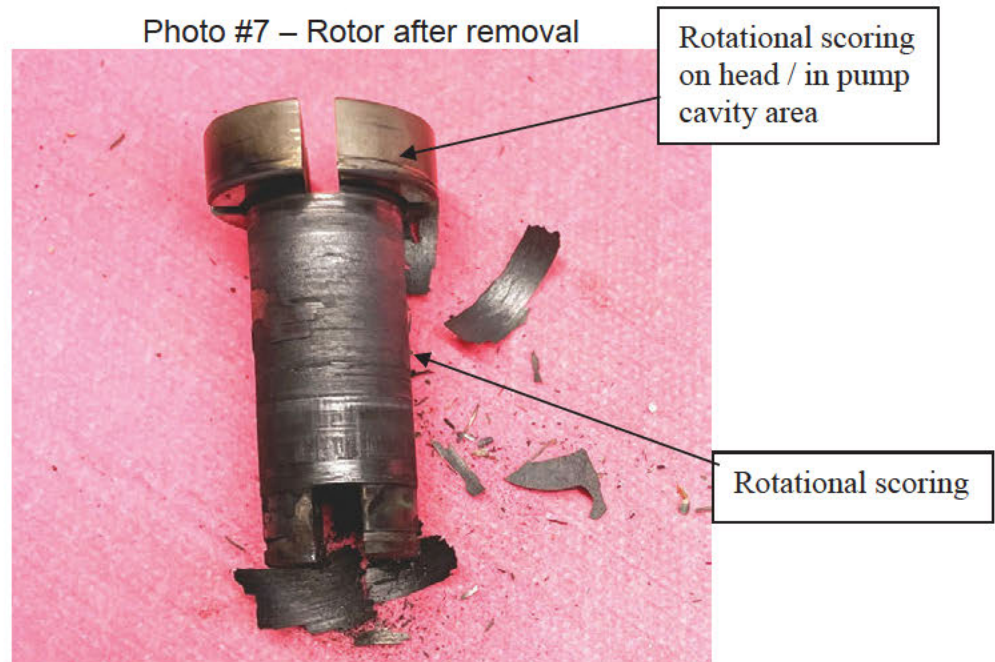
The rotor was bound tight in the Bearing bore (Item 145) and had to be forcefully removed with a hammer and malleable punch. And because the drive coupling fragment was lodged in the rotor slot, it also had to be driven through the Bearing and scored/plowed two channels in the carbo bearing material (seen as the darker, vertical channel in Photo #8). The Rotor shaft had rotational scoring and some fragments of Bearing material adhered to the rotor, and some bearing material flaked off as shown in Photo #7. There were various levels of heat discoloration along the entire length of the Rotor. The Bearing bore had rotational scoring and the Bearing body exhibited radial cracks from ID to OD with some bearing material missing adjacent to the Liner (Item 135) interface. There was also visible rotational scoring on the lower corner of the Rotor blade head and corresponding scoring in the Liner as shown in Photos #7 and #8.

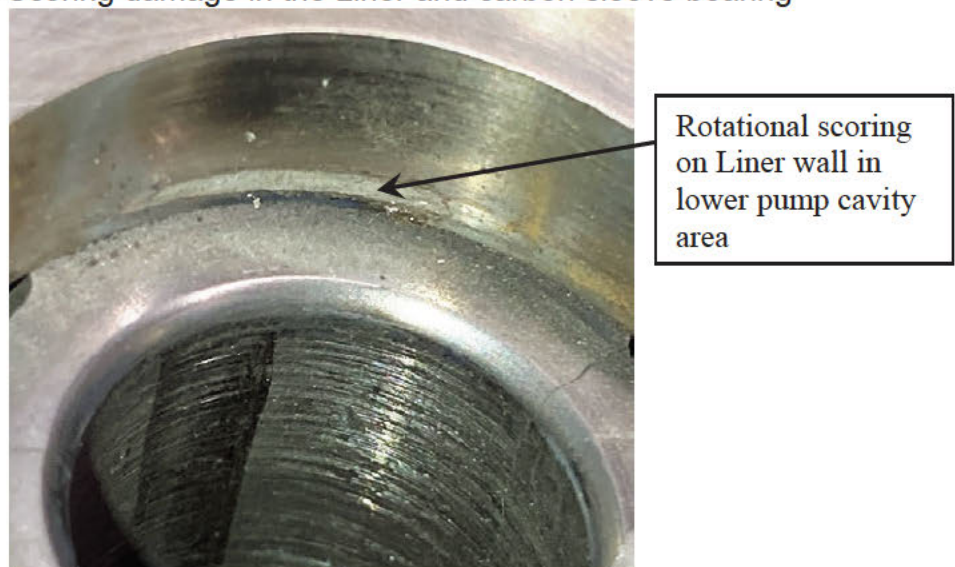
Photo #8 - Scoring damage in the Liner and carbon sleeve bearing

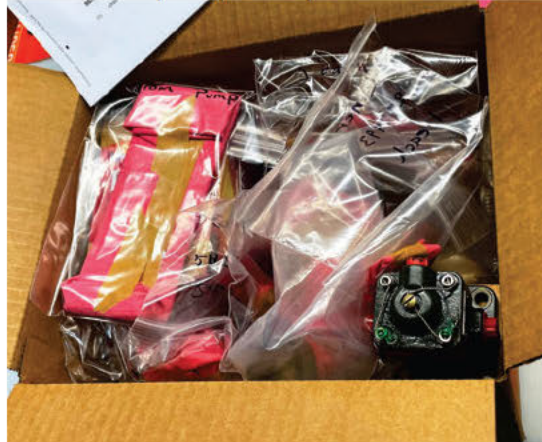
Photo #9 - Fuel pump components before closure

The examined fuel pump components, debris, and an exemplar core pump was boxed and shipped to the NTSB Materials Lab (Attn: Mike Budinski) for further material analysis as shown Photos # and #; UPS Tracking No. 1Z006E9W0162932819.
