# National Transportation Safety Board

WPR22LA262

## **MAGNETO AND IGNITION EXAMINATION**

Location: Three Forks, Montana  
Date: July 20, 2022  
Time: 0820 MDT  
Airplane: N6224M Maule M-5-235C

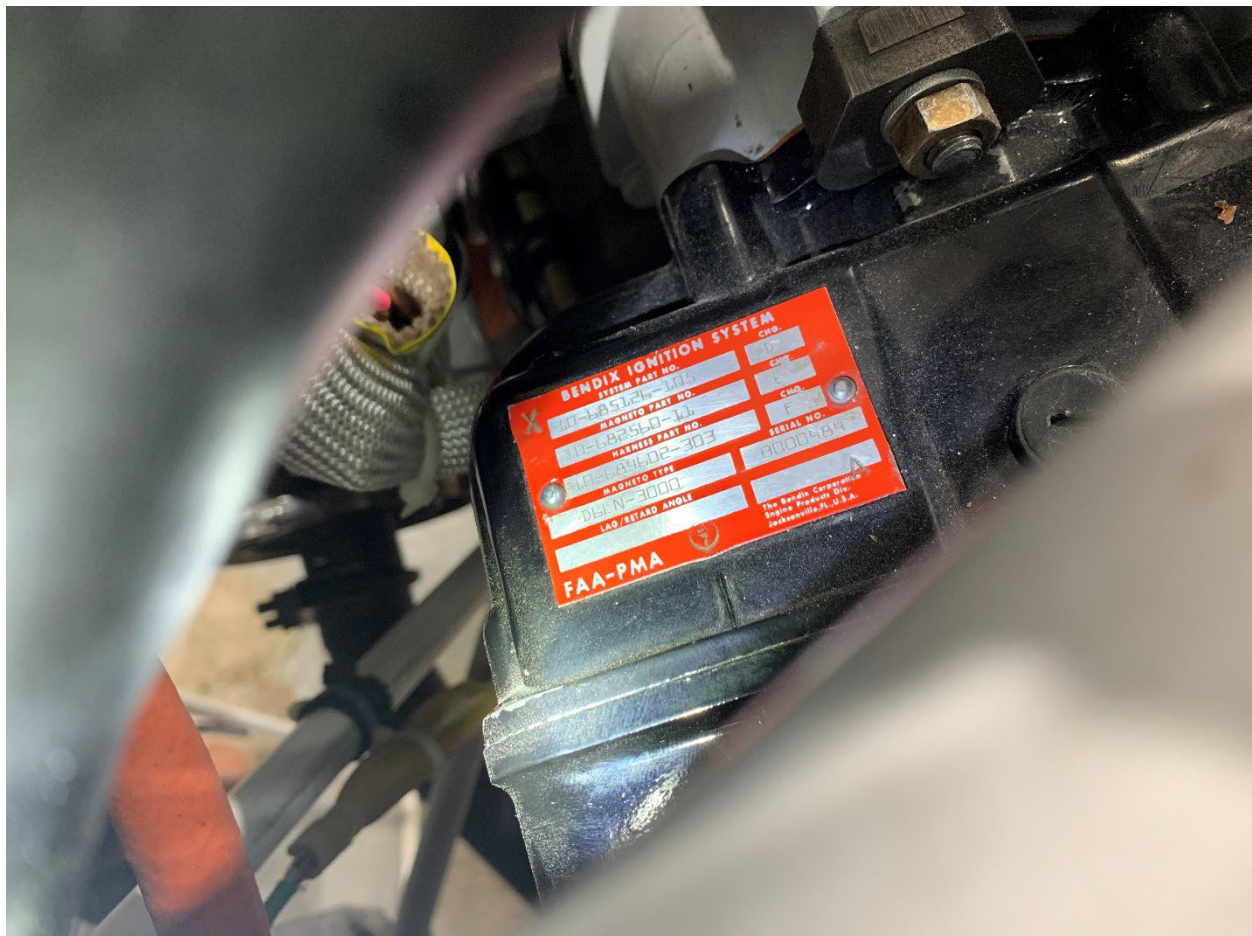
The installed magneto was a Bendix D6LN-3000, serial no. B000484 (Figure 1). This dual magneto system consists of a dual magneto and a harness assembly. The magneto was installed securely onto the mounting pad of a Lycoming O-540-J1A5D, serial no. L-19410-40A, by magneto clamps, lock washers, and nuts. The magneto cover and ignition harness were securely attached and found unremarkable.

**Figure 1. View of installed D3000 magneto**

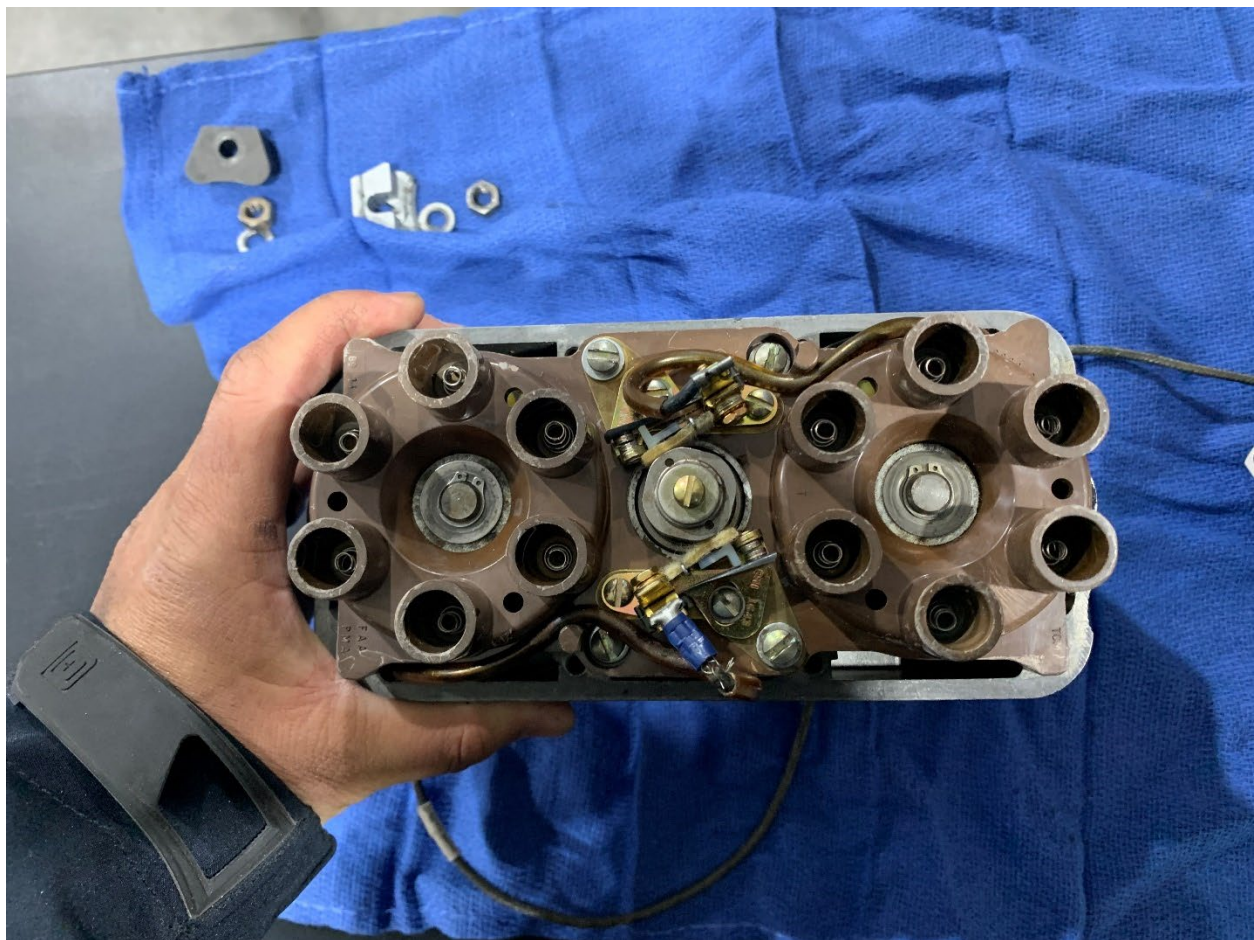
The magneto housing was removed and both keepers were retrieved. Both keepers were found unremarkable. The end of the leads within the magneto cover were unremarkable. The block and bearing assembly was intact and secured (figure 2). When manually rotated, each of the 12 magneto terminals produced a spark. Both left and right capacitor were secured with a corresponding lock ring and its wire was attached to its connector found on the contact assemblies. Upon further examination, the right magneto capacitor wire was improperly secured and separated from its crimp on the connector with minimal movement of the capacitor wire. The 4-lobed breaker cam was secured and found unremarkable.

**Figure 2. View of Magneto block and bearing assembly**

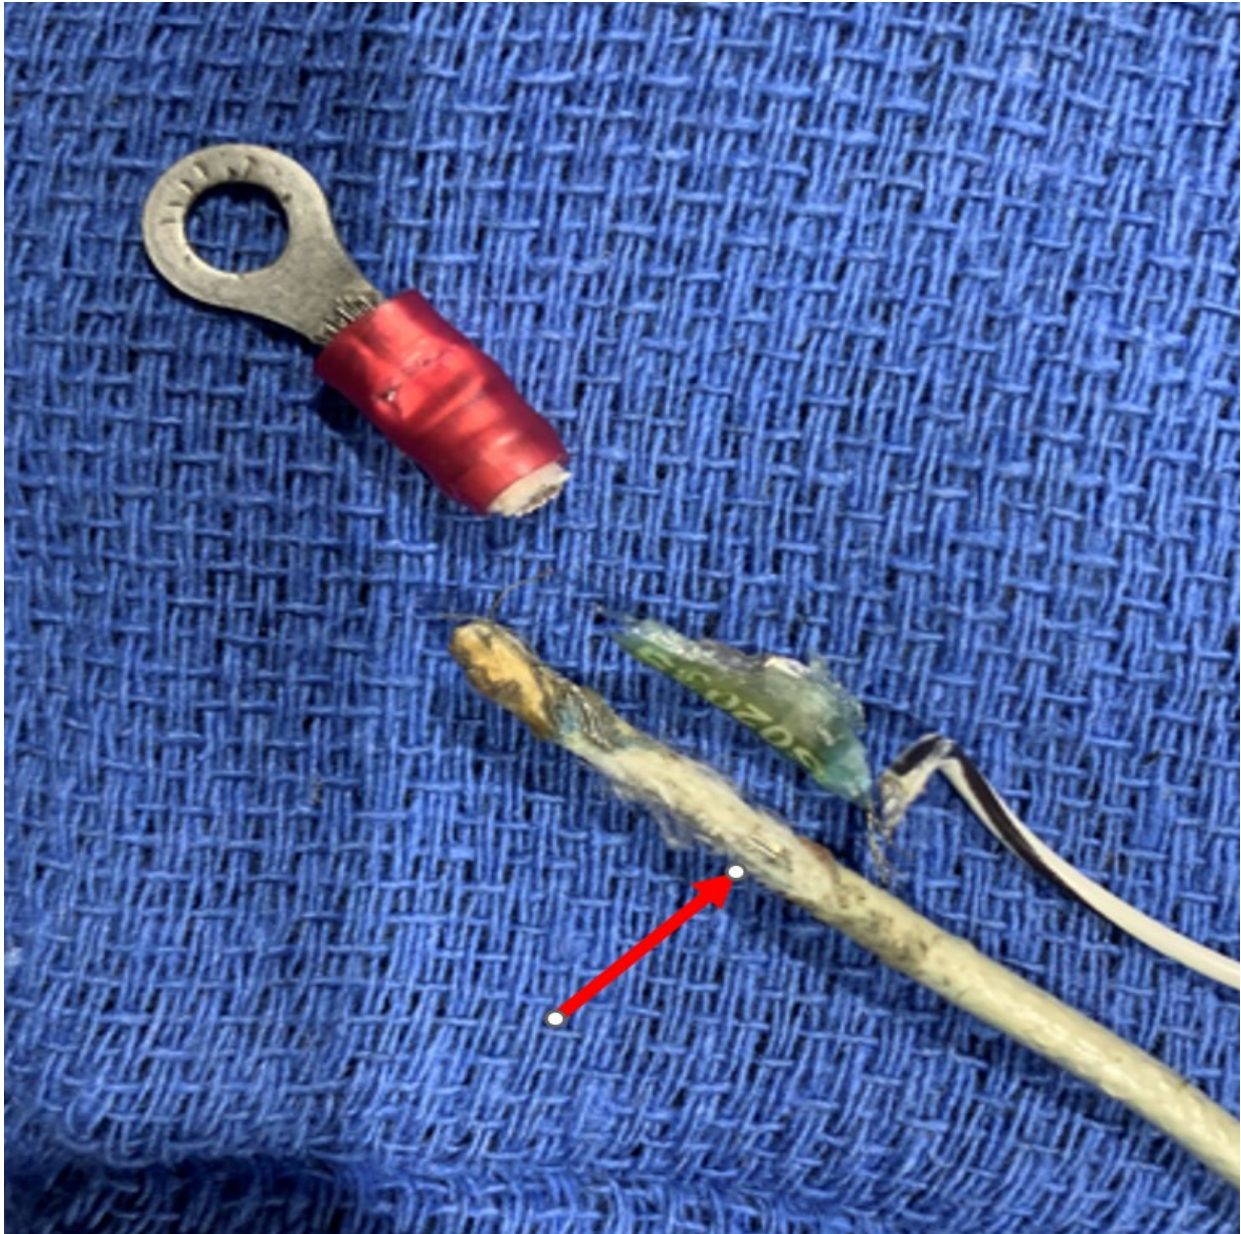
The P-lead terminal and wire was secured to each side of the magneto. Each wire and terminal at the ignition switch were found secured. Examination of the left P-

lead revealed a ground fault, as tested by a multimeter. Further examination revealed that the P-lead had exposed wires where the jumper line mated (figure 3), which in turn caused a ground faulted the dual magneto.

**Figure 3. Closeup view of terminal end of P-lead with exposed wire from its mating surface with the jumper line, indicated by a red arrow.**
