# National Transportation Safety Board

WPR22LA263

## **MATERIALS LABORATORY**

Factual Report 24-020

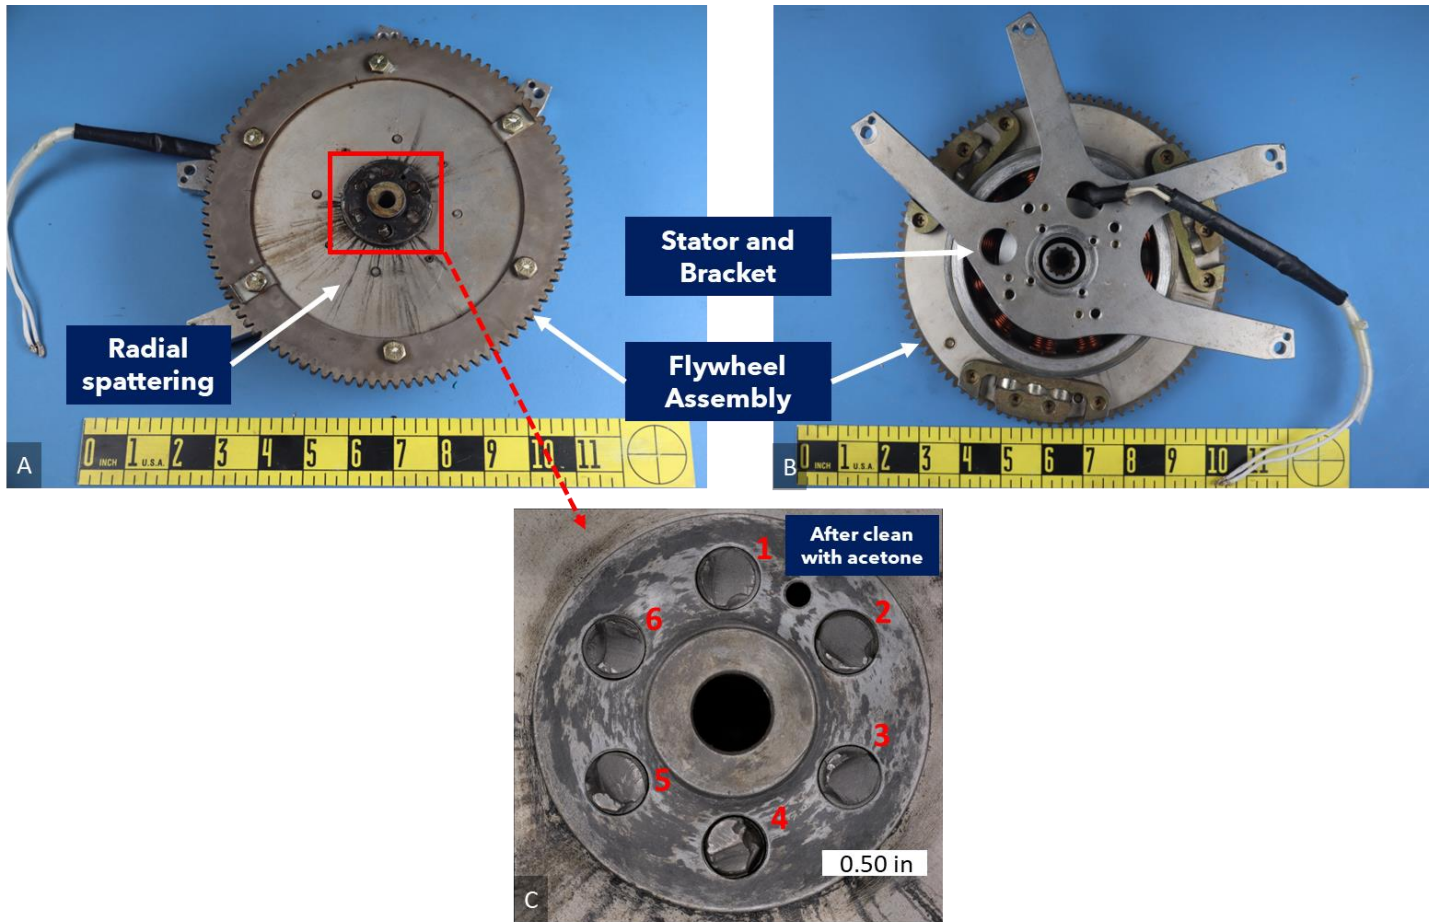
**Figure 1** shows the flywheel and alternator assemblies as received. Radial splattering of a dark substance originating from the center spacer was visible across the face of the flywheel. Six broken bolts were visible on the front face of the flywheel. The planes of the bolt fracture surfaces were located at similar heights, either just above or just below the lip of the mating surface. The bolt fracture surfaces were

**Figure 1.** A) Front and B) rear side of the flywheel, alternator, and bracket as received. C) Fractured bolts in the flywheel assembly after cleaning with acetone.

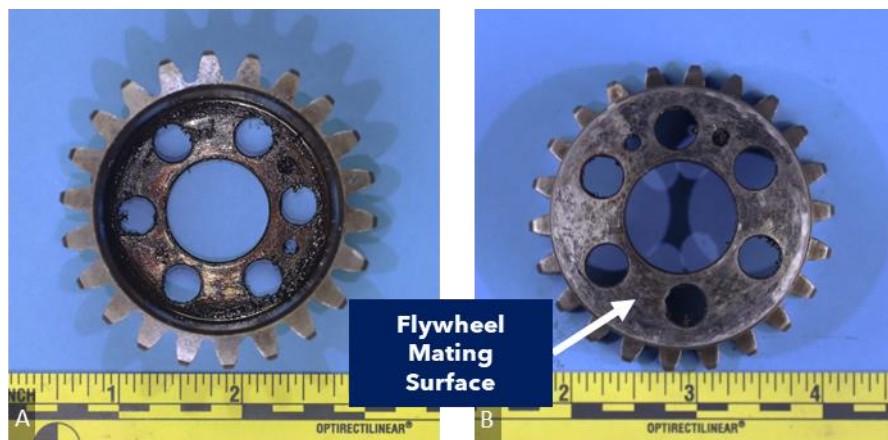
**Figure 2** shows the crankshaft timing gear as received. The bolts would have passed through the six through-holes on the face and then threaded into to the crankshaft, as shown in Jabiru's assembly drawing (**Figure 3**). No significant damage was seen in the timing gear.

**Figure 2.** A) Front and B) rear side of the crankshaft timing gear as received.

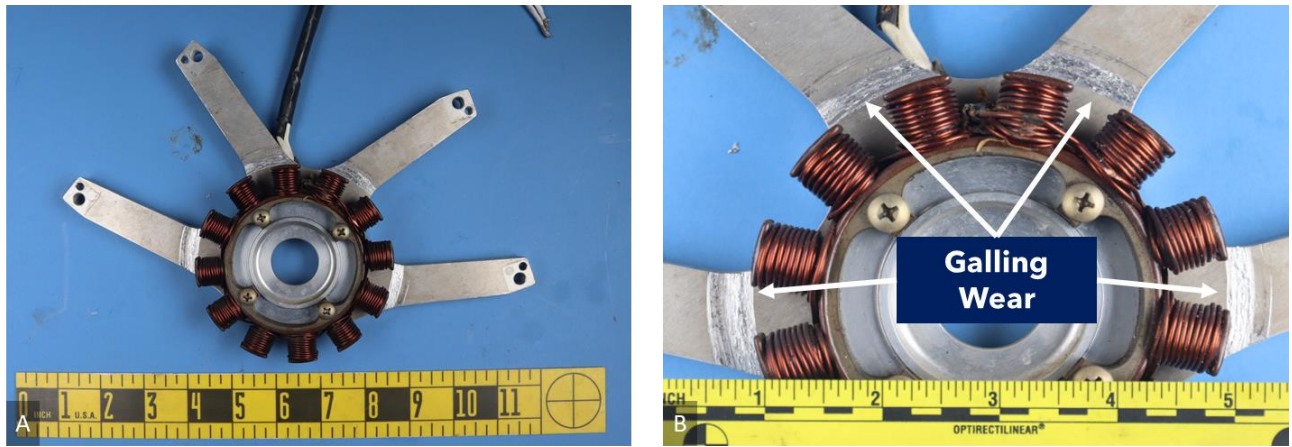
The stator ring and bracket were detached from the flywheel for further examination. The bracket shows galling wear in a circular pattern consistent with the location of the alternator ring when the two pieces were attached, shown in **Figure 4**. This is consistent with repeated contact and rubbing between the spinning flywheel assembly and bracket during engine operation.

**Figure 4.** A) Front side of the stator and bracket after removal. B) Closer view of galling wear on the bracket

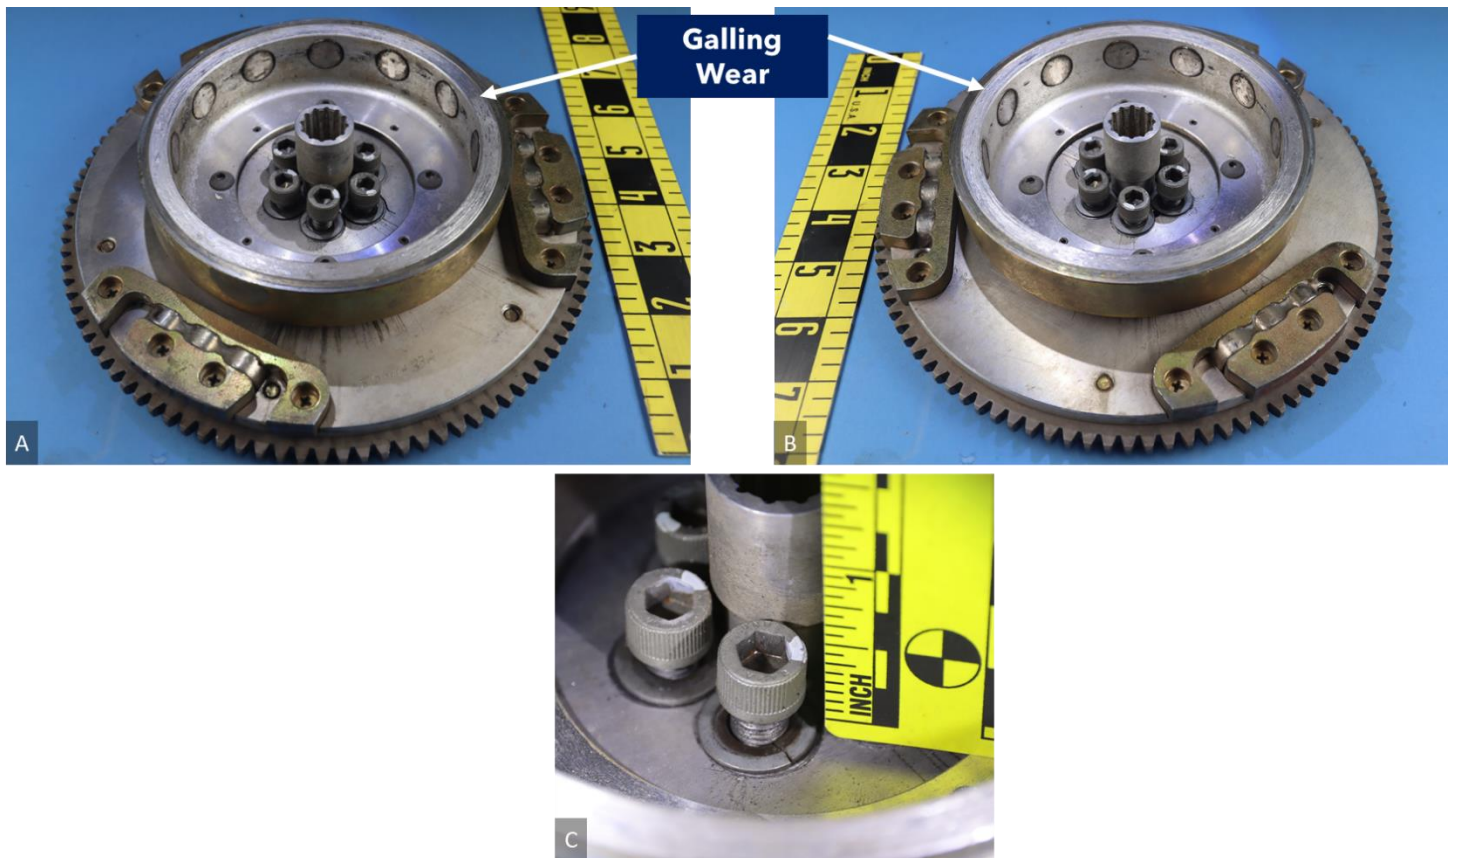
**Figure 5** shows the flywheel assembly after the stator and bracket were removed. The upper surface of the alternator ring shows galling wear where it was in contact with the stator bracket. The six fractured 5/16 inch hex-head bolts were backed out of their fully seated positions by approximately 0.25 inch. The bolts were loosely threaded into the holes, though communication and part drawings from Jabiru indicated that those holes were manufactured with a smooth bore. It is unclear if this was the final position of the bolts at the time of the failure or if they shifted during the subsequent crash or retrieval. Washers under the bolt heads were deformed in a manner consistent with bending forces and a crack was discovered in one washer, shown in **Figure 5C**.

**Figure 5.** A, B) Opposing views of the rear of the flywheel assembly showing the backed-out bolts. C) A closer view of a backed-out bolt (4) with a cracked washer underneath the head.

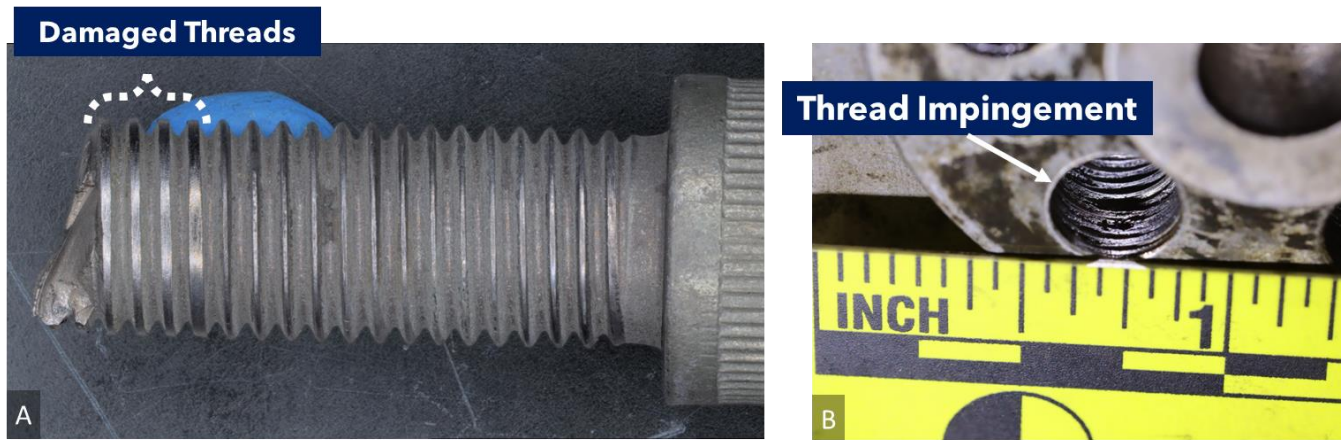
Five of the six bolts were unscrewed from the flywheel for further acetone cleaning and examination; bolt 3 could not be unscrewed by hand. Examination of the bolt threads showed contact damage consistent with impingement on the walls of the through-holes, and complimentary wear resembling screw threading was visible in the through-holes, as pictured in **Figure 6**. It appeared that the contact damage in the through-holes was deep enough to explain why the bolts had to be unscrewed from their positions.

**Figure 6.** A) Thread showing contact damage near the fracture surface on bolt 6. B) Thread impingement on a through-hole in the spacer.

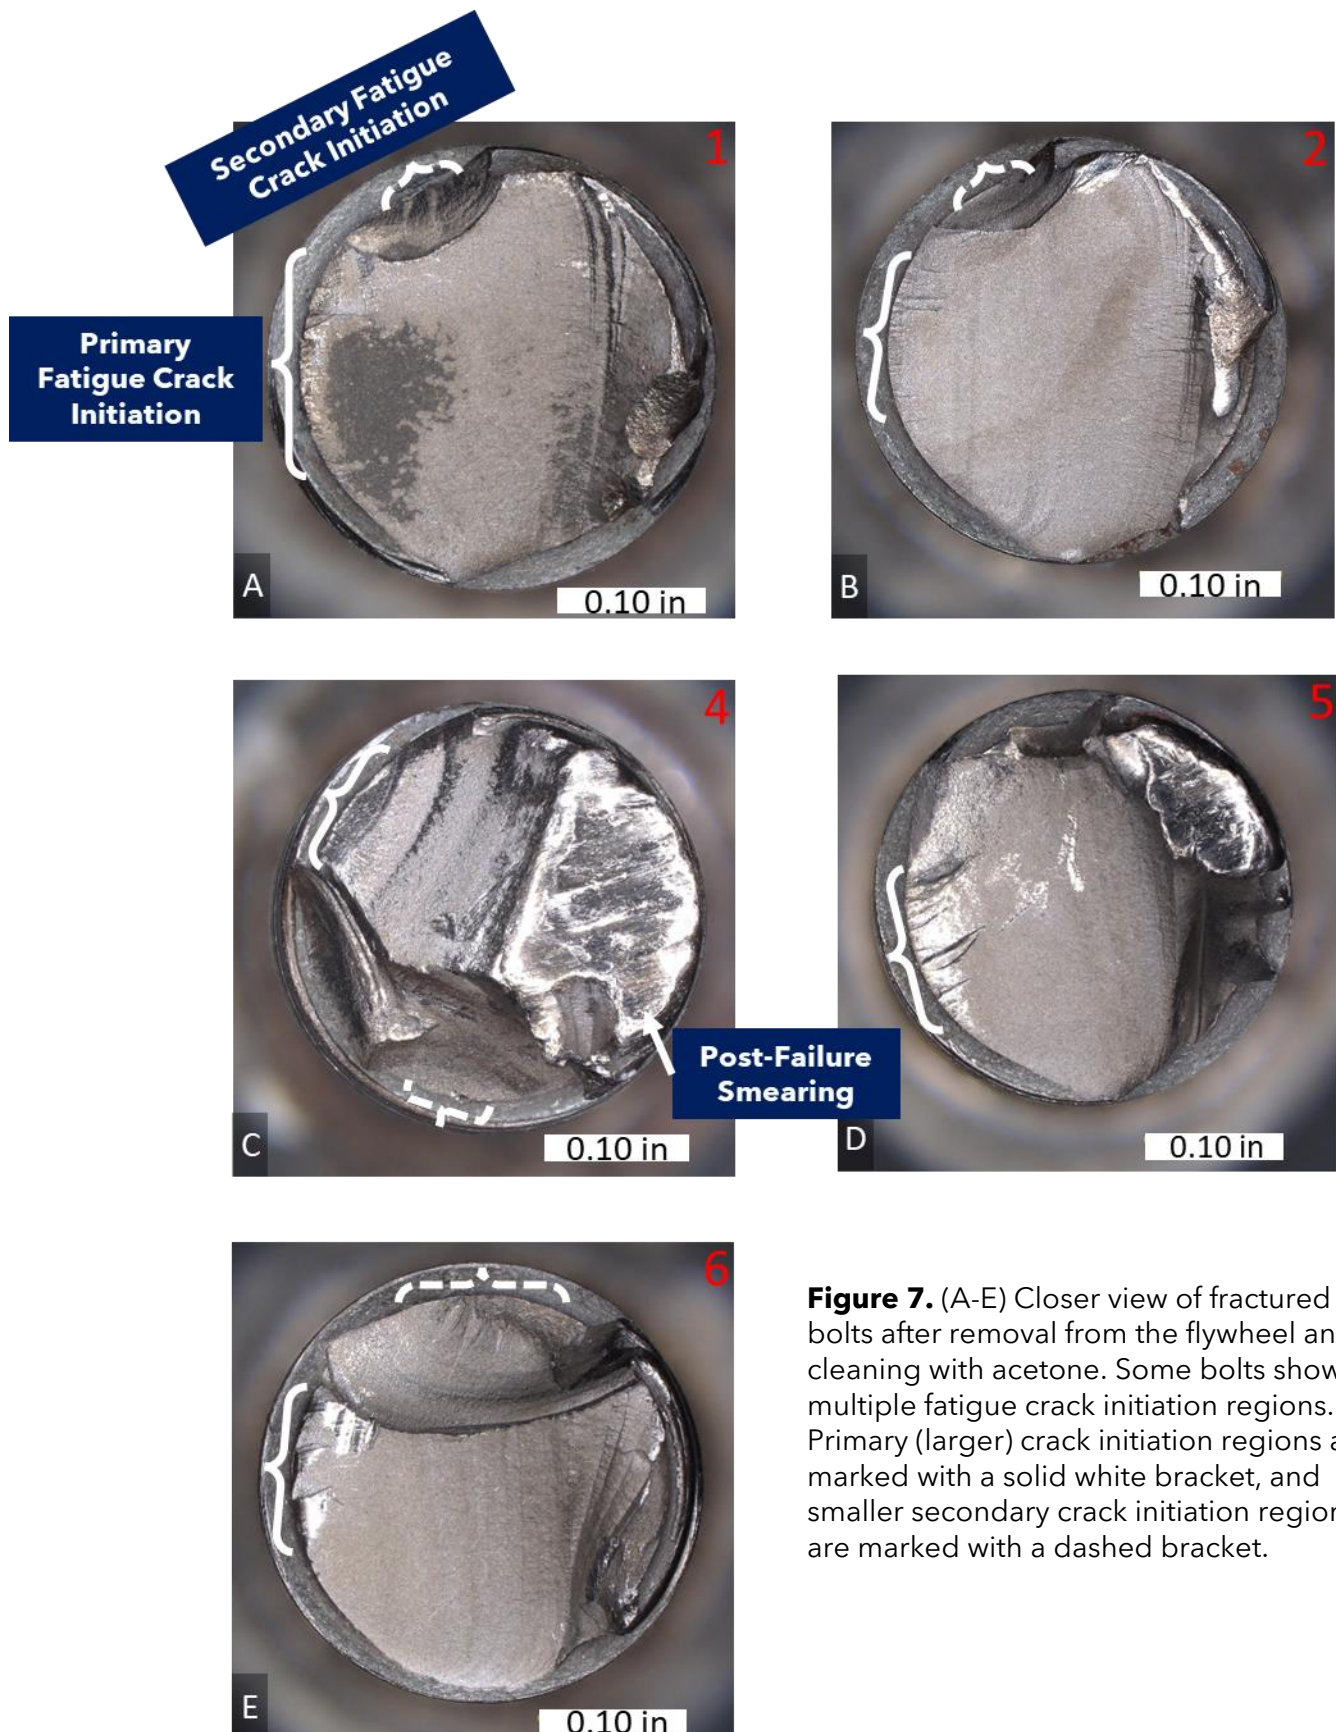
The bolt fracture surfaces were examined using a digital microscope and are shown in **Figure 7**. The surfaces on bolts 1, 2, 5, and 6 show similar characteristics. Ratchet marks (indicative of multiple fatigue initiation points) were seen at the base of the threads, indicated by white brackets. Fatigue crack progression marks were present across most of the face until final failure as indicated by a shear lip. These features are consistent with low stress bending-fatigue. Bolts 1, 2, and 6 also show evidence of secondary fatigue cracks intersecting the primary crack, with origins at the thread roots. Similar features were also observed on bolt 3. Contrasting to the relatively planar faces of the other bolts, bolt 4 (**Figure 7C**) has a pitched fracture surface with significant contact damage at the highest plane. Ratchet marks and crack

progression marks were visible at multiple points around the fracture surfaces, indicating fatigue initiating at the roots of several threads.

**Figure 7.** (A-E) Closer view of fractured bolts after removal from the flywheel and cleaning with acetone. Some bolts show multiple fatigue crack initiation regions. Primary (larger) crack initiation regions are marked with a solid white bracket, and smaller secondary crack initiation regions are marked with a dashed bracket.
