# National Transportation Safety Board

WPR22LA263

## **ENGINE EXAMINATION**

Location: Bothell, Washington  
Date: July 19, 2022  
Time: 22:00 Pacific Daylight Time  
Airplane: N8787G

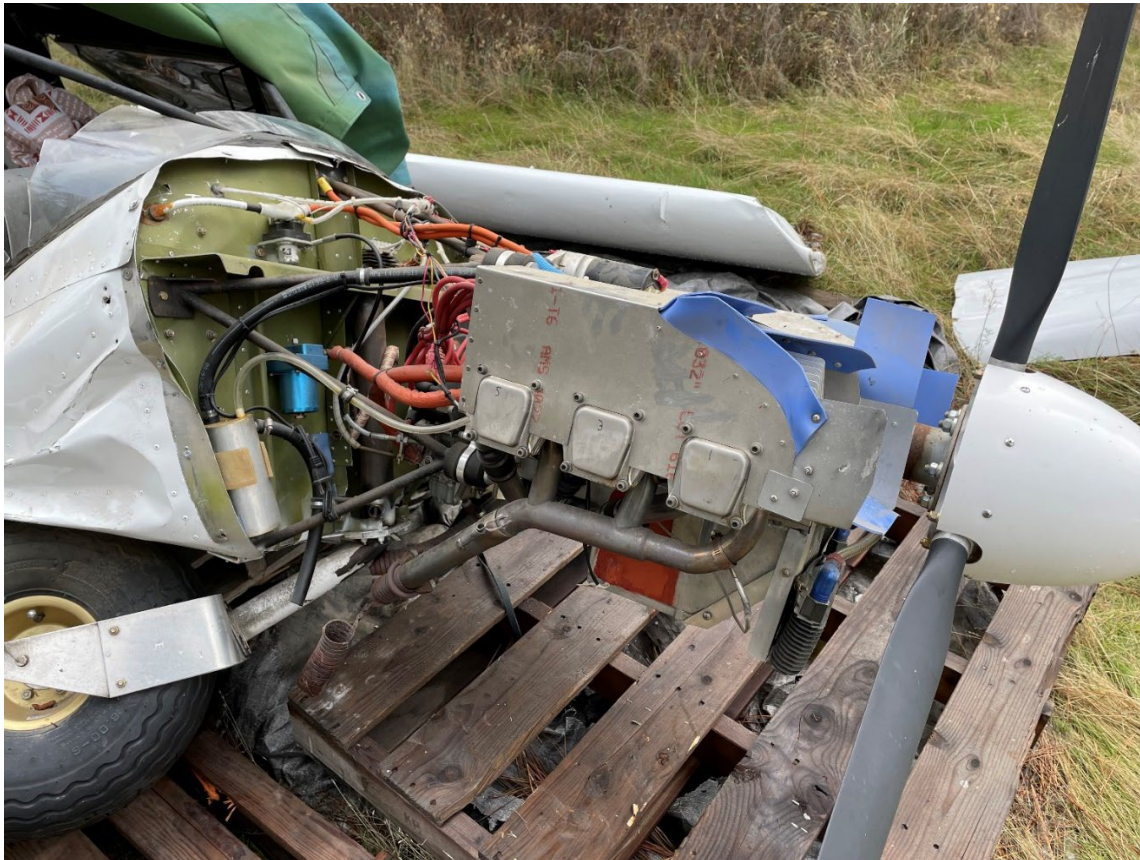
**Figure 1. View of engine**

The engine (figure 1) remained attached to the engine truss, with which remained attached to the firewall. The baffles were found secured to the engine. The starter remained secured and was unremarkable. The distributor caps and wires were secured. The Bing carburetor (figure 2) was secured. The throttle and mixture levers moved freely without binding when manually actuated from the cockpit control levers; the corresponding choke plate moved freely and simultaneously with the throttle mechanics. Both floats were intact and moved freely (figure 3). Traces of fuel was found in the fuel bowl and inlet line from the fuel pump. The fuel pump and its corresponding fuel lines were secured. The induction body and assembly and exhaust pipe set remained secured to the engine and sustained minor damage consistent with impact.

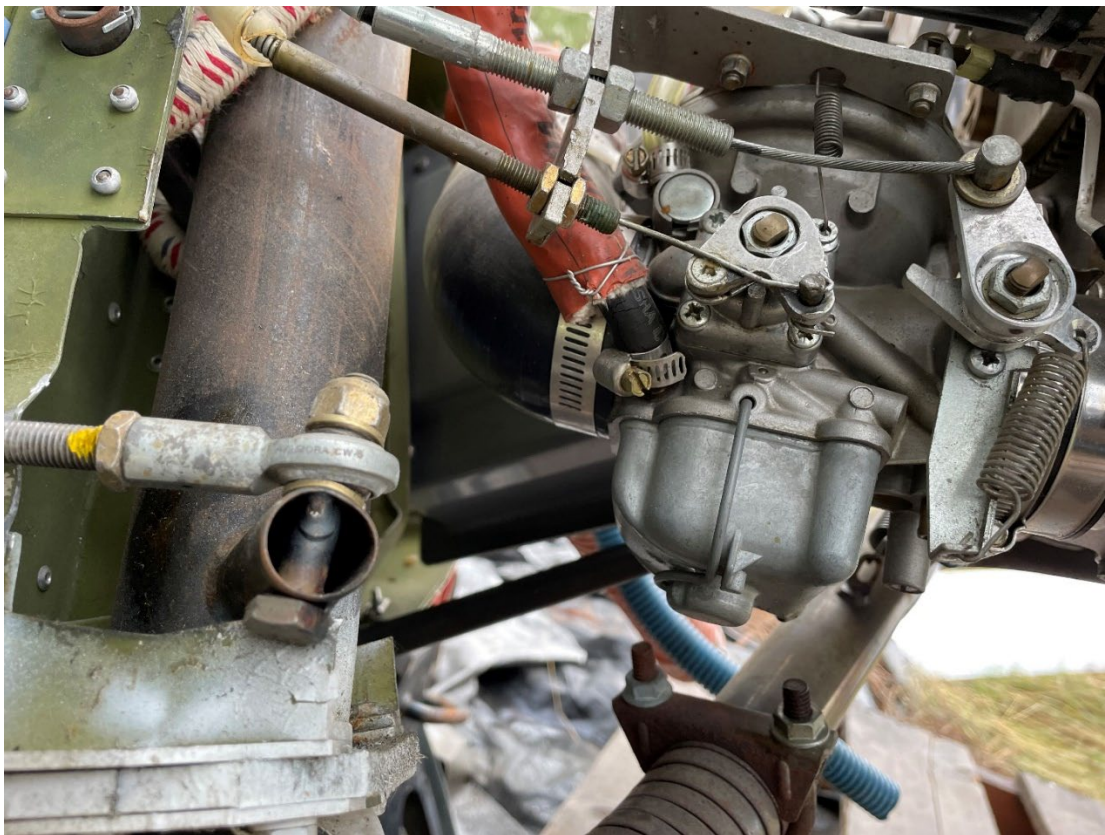
**Figure 2. View of carburetor**

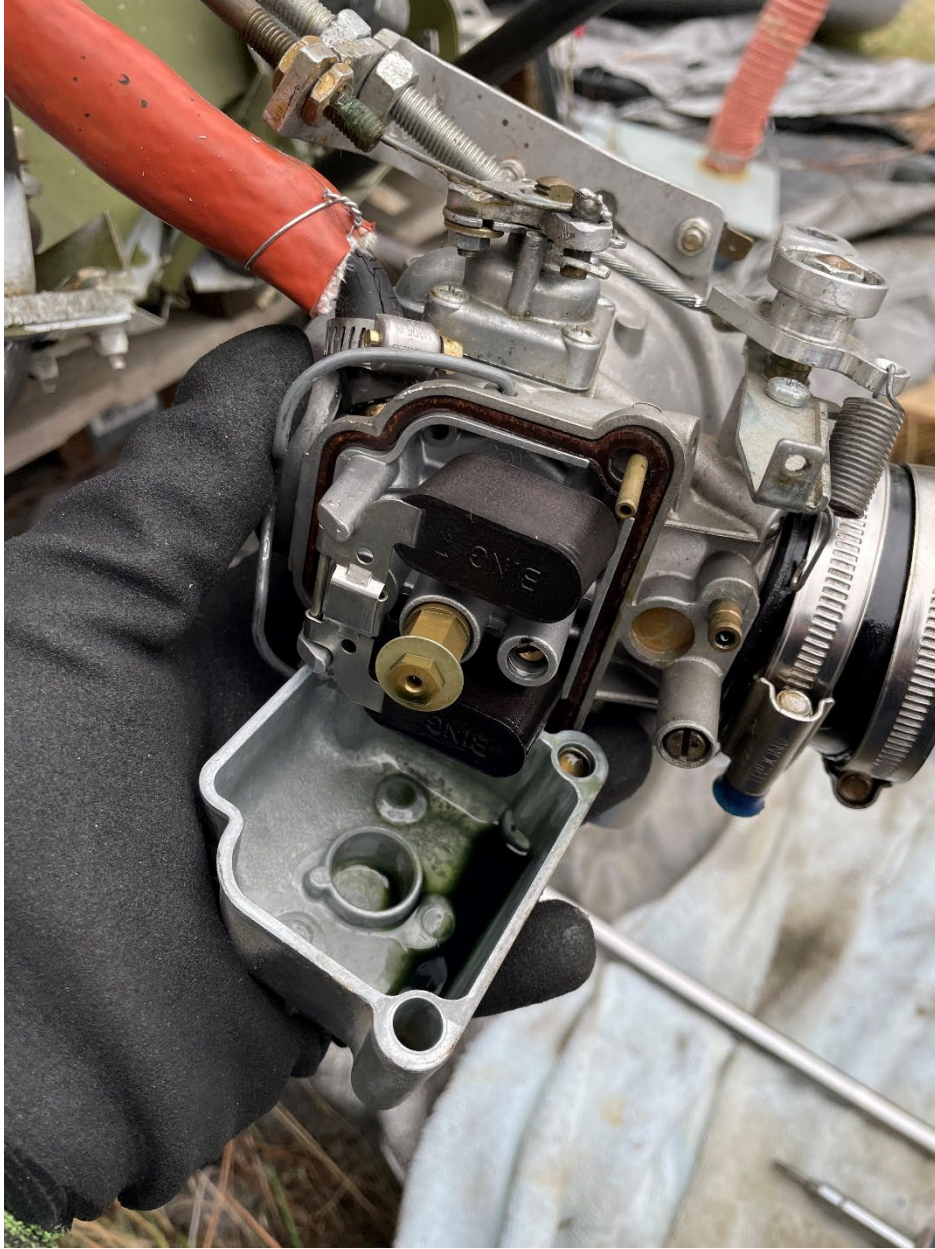
**Figure 3. View of carburetor filter bowl removed revealing floats**

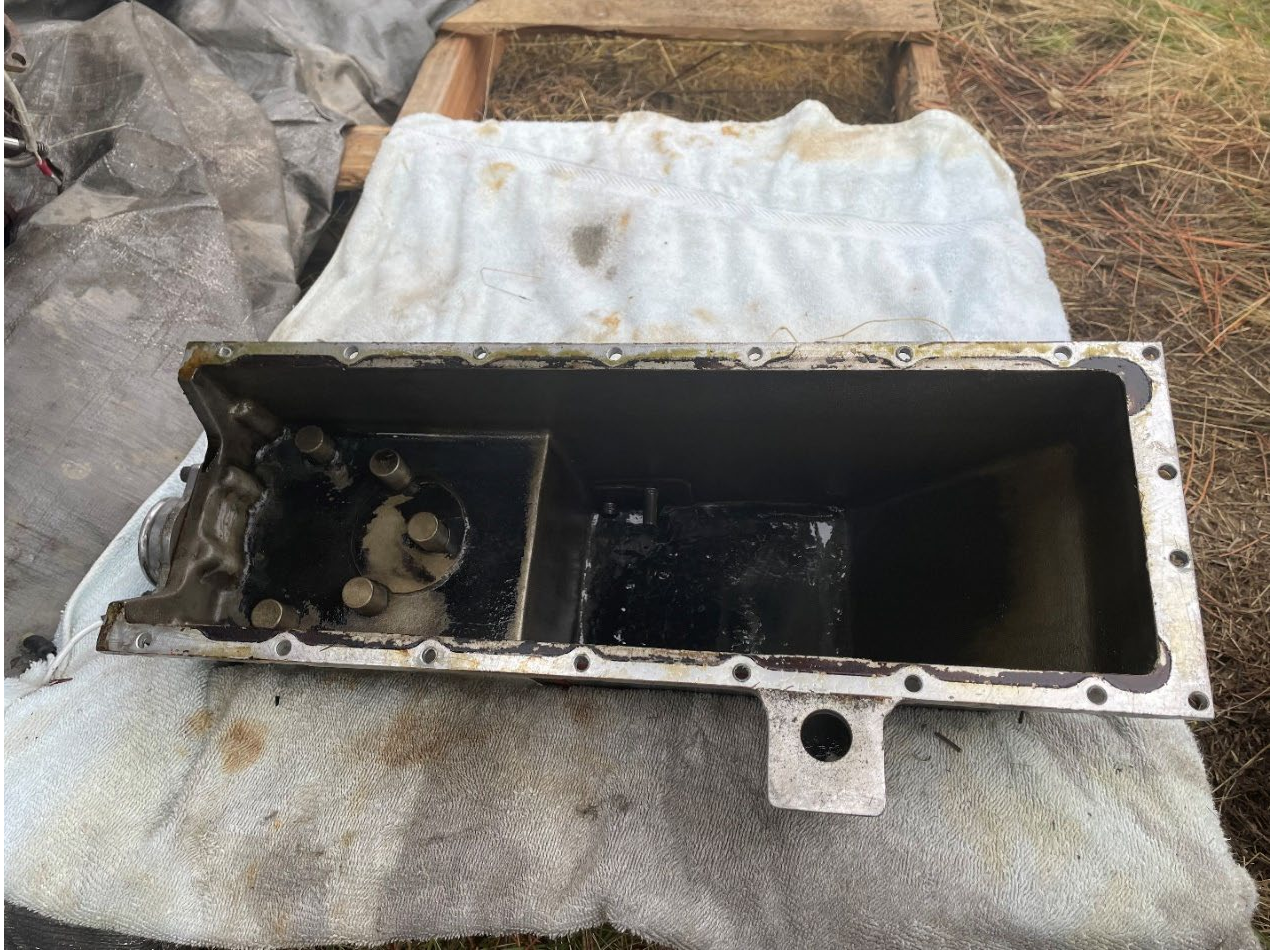
The oil filter was secured and found unremarkable. The oil sump and case (figure 4) sustained damage consistent with impact. Traces of oil was found when the oil case after it was removed from the engine case. The oil cooler remained secured to its mounting pad, while slightly deformed, as it sustained damage consistent with impact.

**Figure 4. View of removed engine oil sump and case**

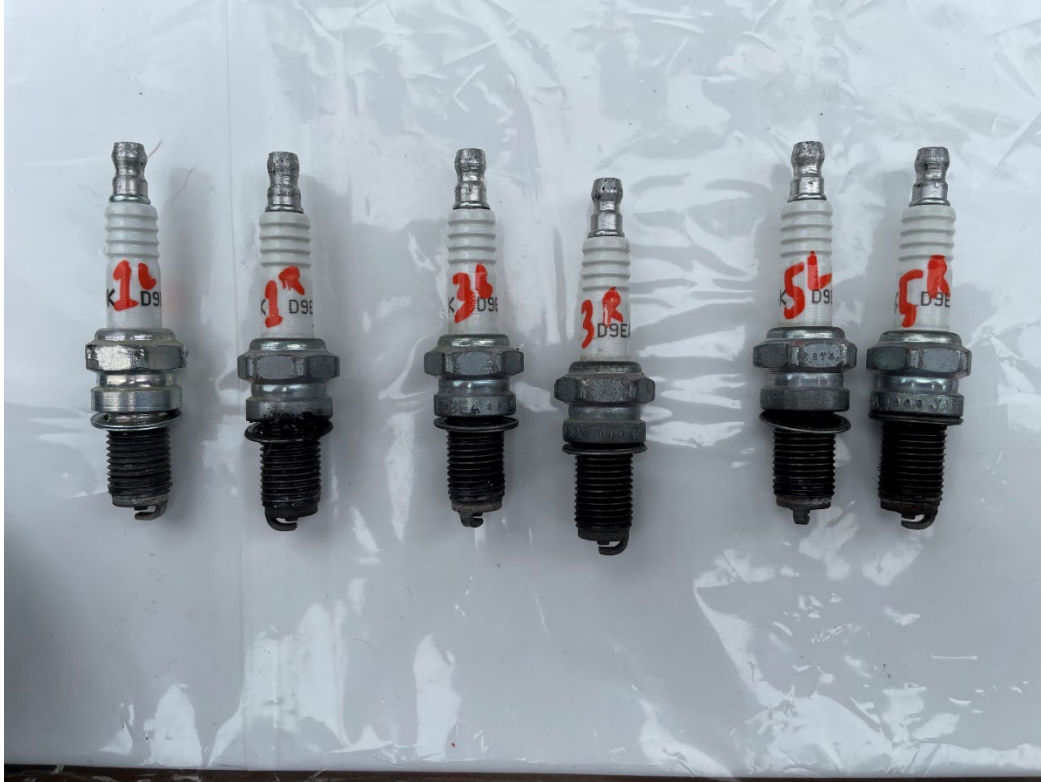
All spark plug wires were secured to its corresponding spark slug. The (6) intake (figure 5) and (6) exhaust spark plugs (figure 6) were removed and found to have carbon on the surfaces of each ground & central electrodes and threads.

**Figure 5. View of removed intake spark plugs**

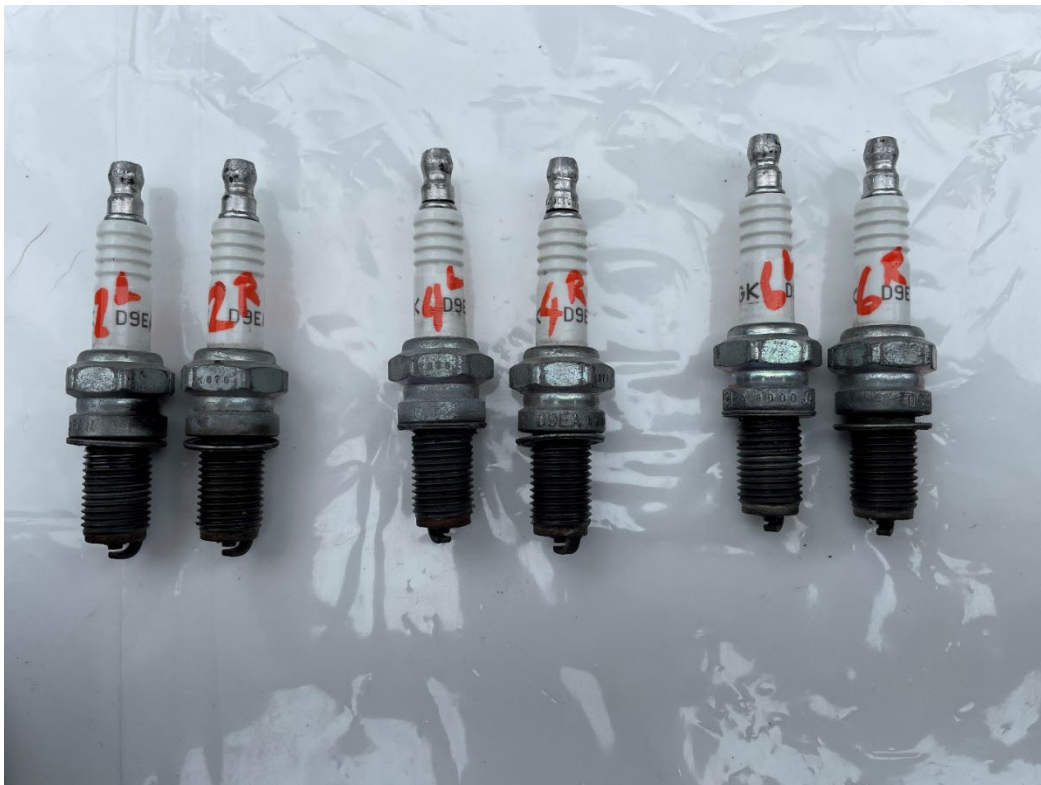
**Figure 6. View of removed exhaust spark plugs**

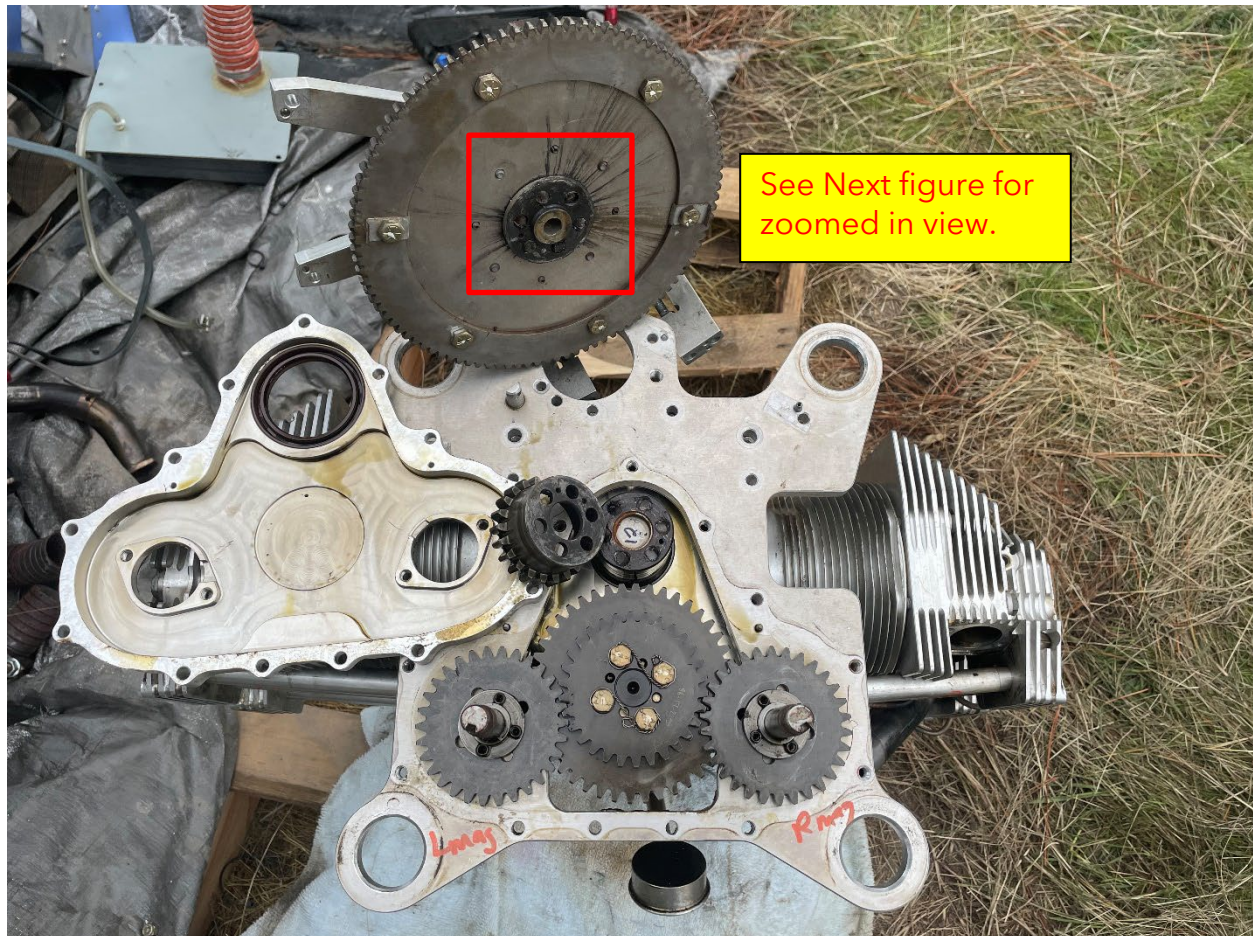
Subsequently, the flywheel and starter ring were removed (figure 7) and it revealed that the cap bolts which secured the flywheel assembly to the crankshaft had separated, consistent with torsional failure (figure 8). The flywheel assembly and the gear crankshaft were removed and secured for further testing.

**Figure 7. View of disassembled flywheel and starter ring assembly**

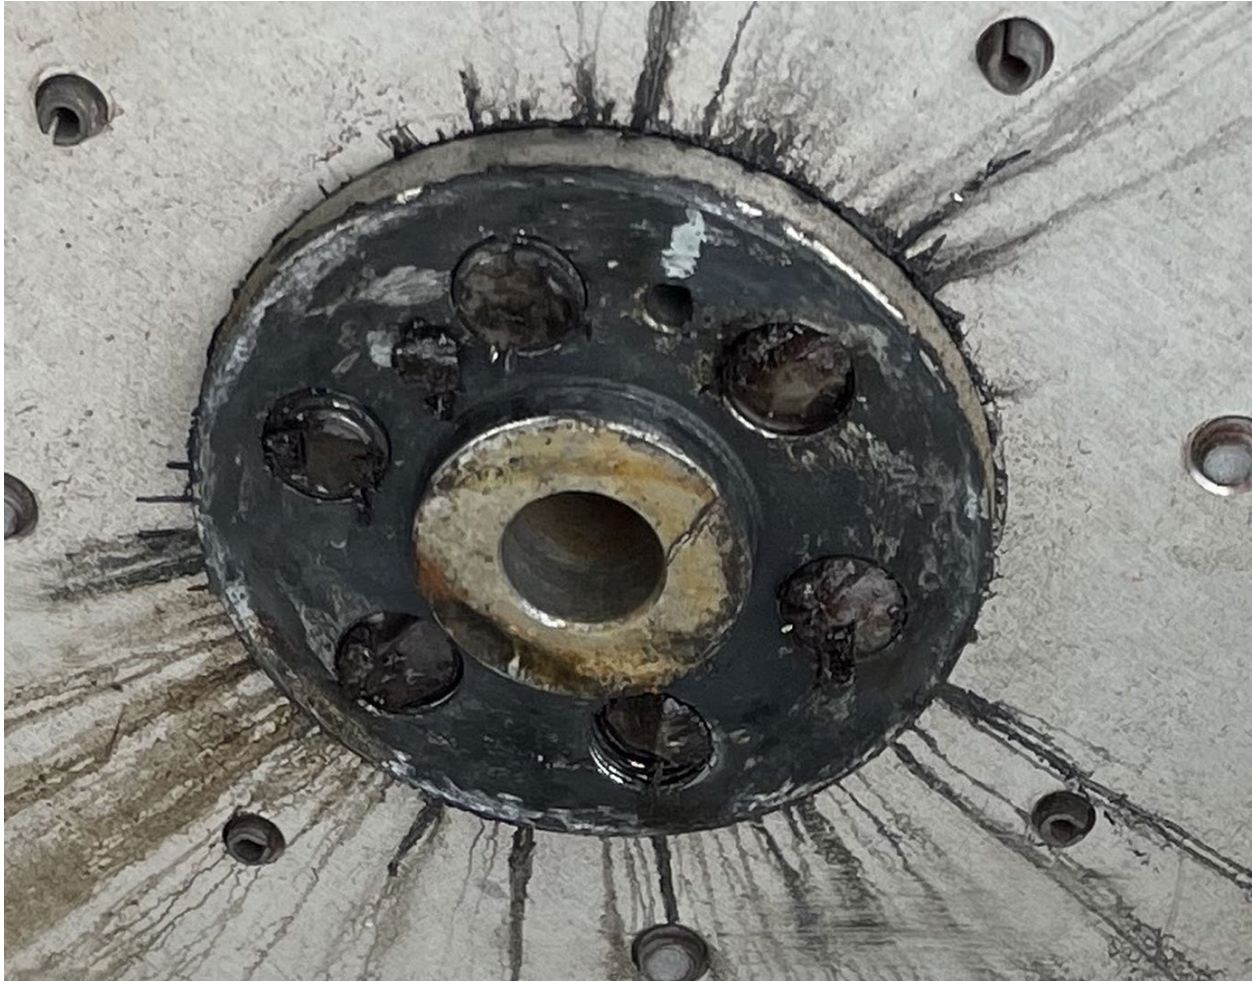
**Figure 8. Close-up view of damaged cap bolts**
