National Transportation Safety Board

WPR22LA263

**INVESTIGATIVE SUPPLEMENTAL MATERIAL**

Location: Bothell, Washington  
Date: July 19, 2022  
Time: 2200 Pacific daylight time  
Airplane: Zenith 701

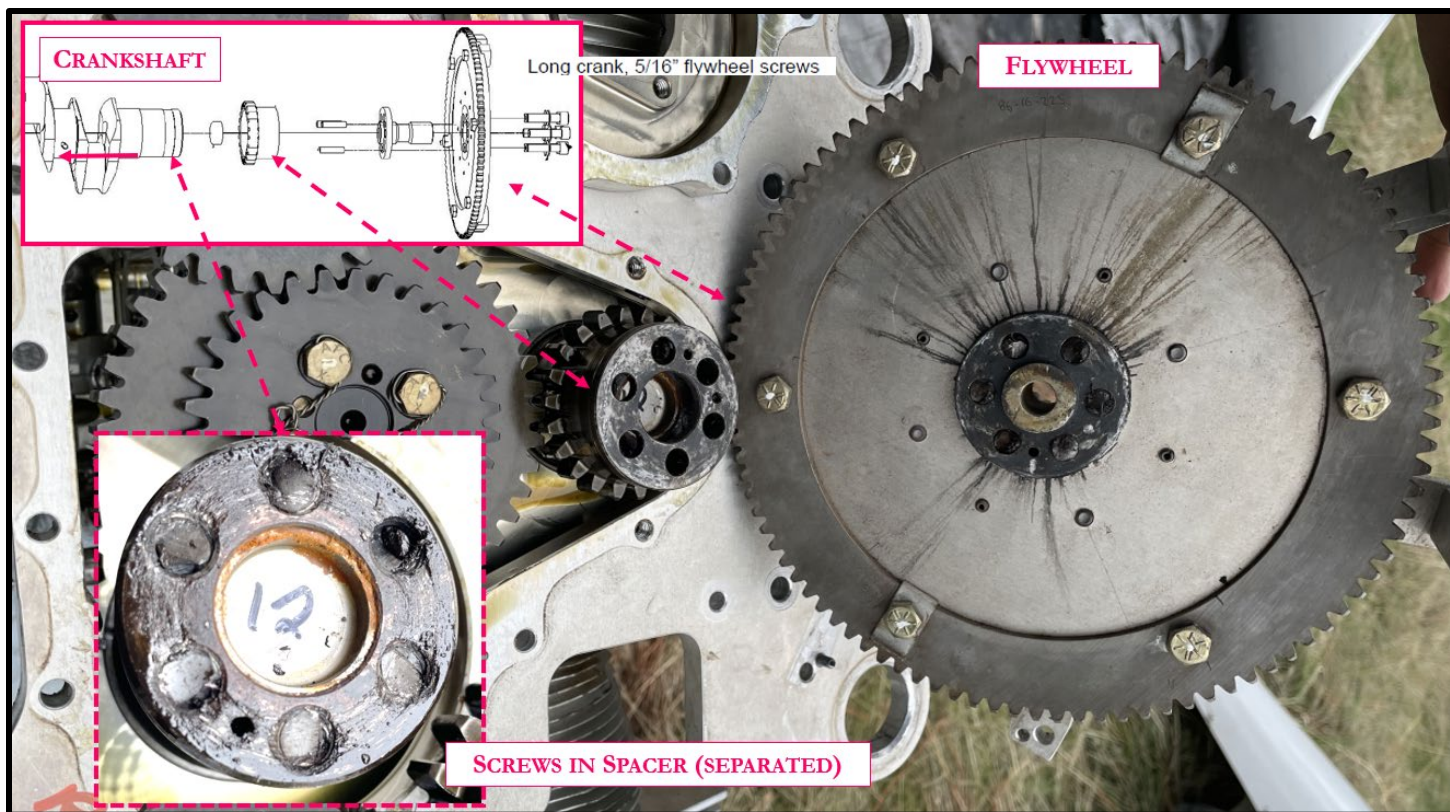
Manual rotation of the propeller did not produce corresponding valve train movement. Disassembly of the engine accessory system revealed the six screws securing the flywheel to the crankshaft were separated, resulting in the separation of the flywheel from the aft end of the crankshaft.

Figure 1: Flywheel and Spacer

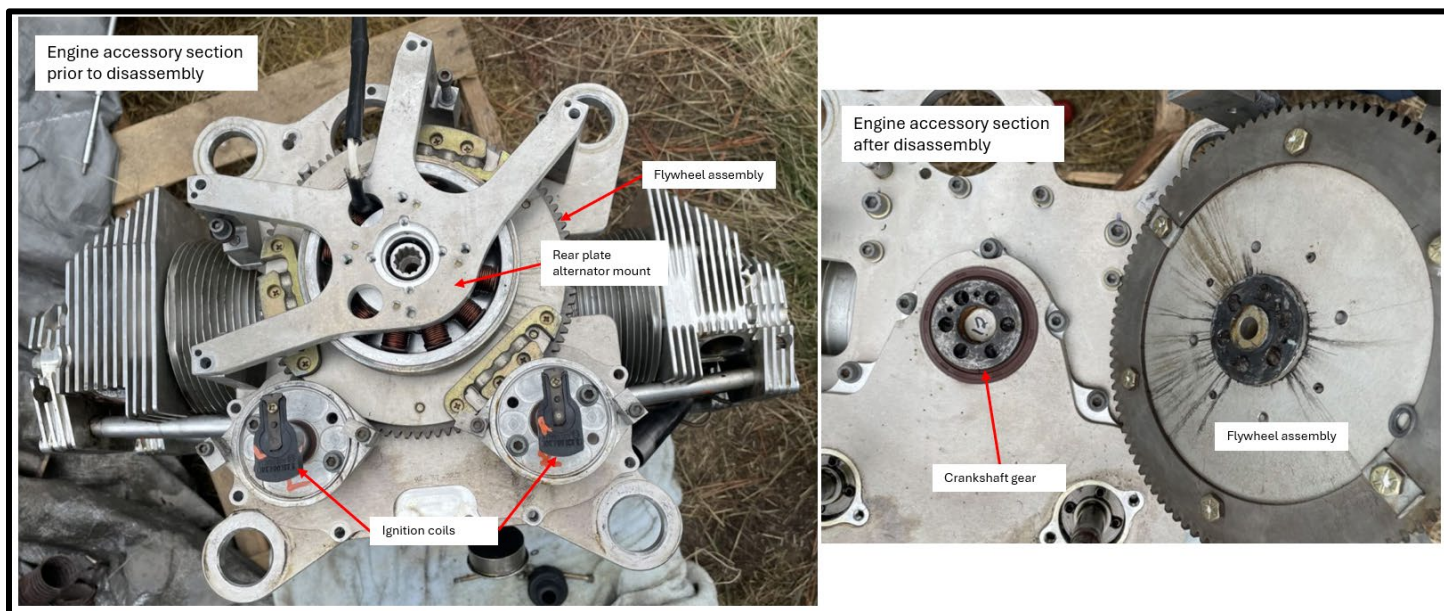
Figure 2: The Accessory Section Including the Separated Flywheel

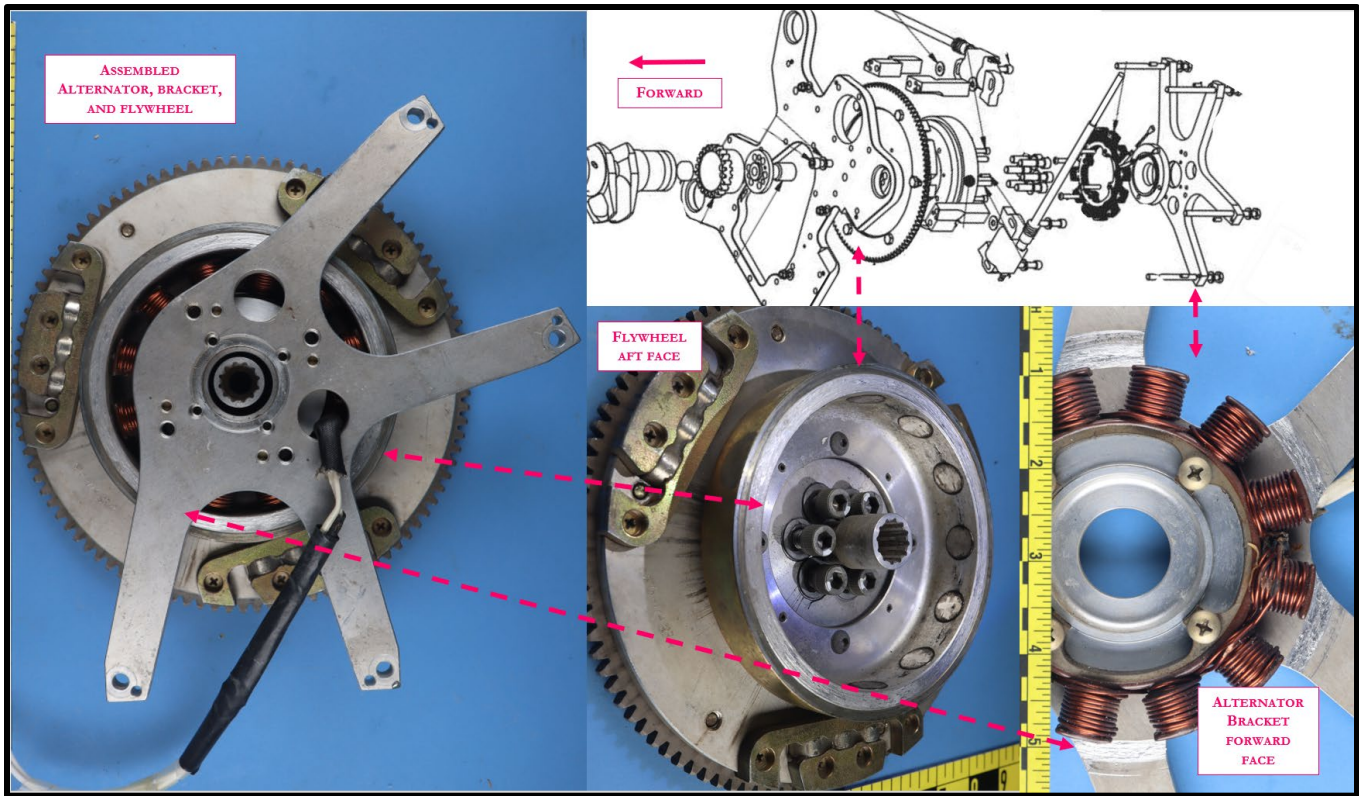
The timing gear appeared undamaged. Removal of the stator ring and bracket revealed galling wear in a circular pattern near the location of the alternator ring when the two pieces were attached. The wear was consistent with repeated contact and rubbing between the spinning flywheel assembly and bracket during engine operation.

Figure 3: Galling wear found between aft face of flywheel and forward face of alternator bracket.

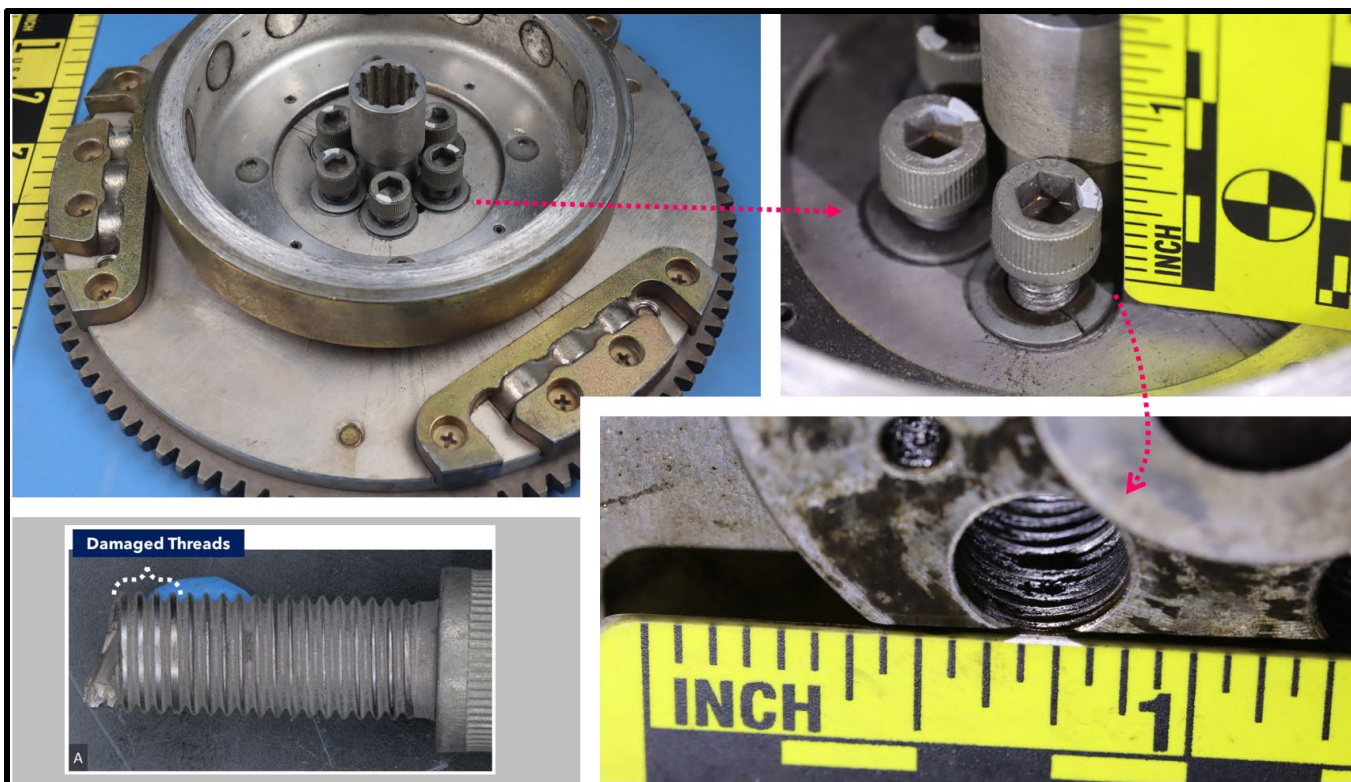
The six fractured flywheel hex-head screws were backed out of their fully seated positions by approximately 0.25 inch. The screws were loosely threaded into the holes; According to the Jabiru parts manual, the holes were manufactured with a smooth bore. It could not be determined if the screw positions represent their position after the failure or if they shifted during the subsequent crash or retrieval. The washers under the screw heads were deformed in a manner consistent with bending forces and a crack was discovered in one washer.

Figure 4: The flywheel with screws installed, and hardware through the hole after removal of the screw.

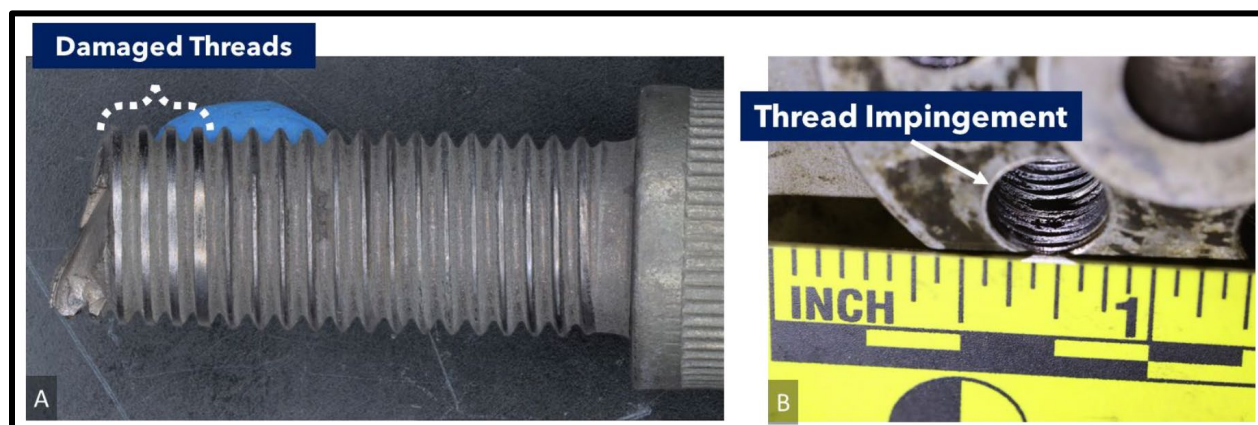
Examination of the screw threads showed contact damage consistent with impingement on the walls of the through-holes, and complimentary wear resembling screw threading was visible in the through-holes. Examination of the screw fracture surfaces revealed that several had ratchet marks (indicative of multiple fatigue initiation points) near the base of the threads. Fatigue crack progression marks were present across most of the face until final failure as indicated by a shear lip, consistent with low stress bending-fatigue. Additionally, three of the screws displayed secondary fatigue cracks originating from the threads. One screw displayed multiple fracture planes with contact damage on the highest plane; it additionally had fatigue progression marks radiating from several points at the roots of the threads.

Galling wear was found between the forward face of the rear plate alternator mount and the aft face of the flywheel. The flywheel attachment screws remained installed in the flywheel, with contact damage noted on the inside of the flywheel hardware holes. Communication with Jabiru revealed that the flywheel hardware hole was manufactured with a smooth bore.

Figure 5: A Flywheel Screw with Damaged Threads, And Thread Imprints In The Corresponding Flywheel Hardware Hole)

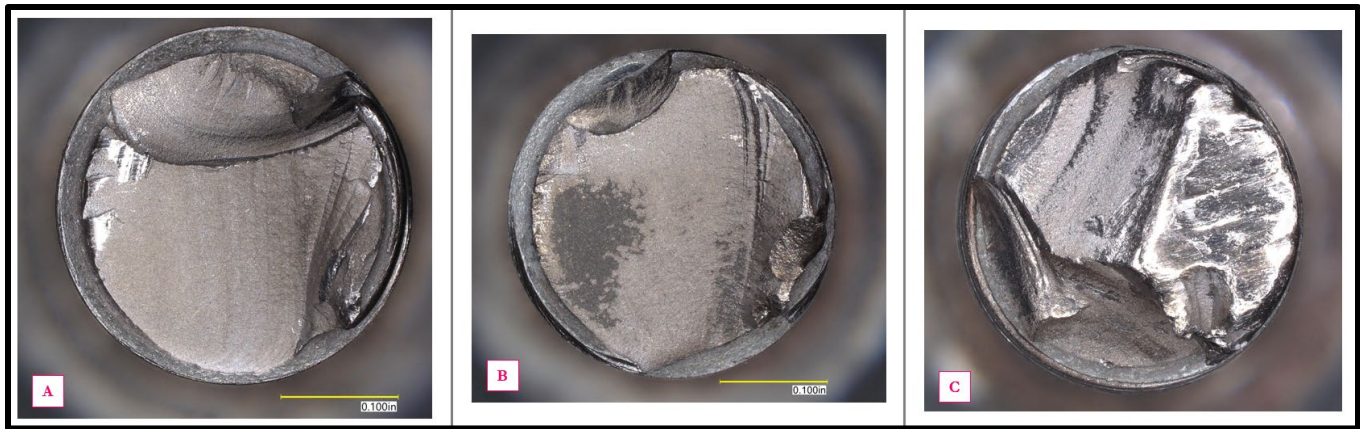
The six flywheel attachment screws were removed from the flywheel, cleaned, and examined using a digital microscope. Four of the screws displayed fatigue crack progression marks across the fracture faces, consistent with low-stress bending fatigue. Additionally, three of the screws displayed secondary fatigue cracks originating from the threads.

Figure 6: Microscope images of flywheel screws; Images A and B show fracture faces with multiple fatigue initiation points, and Image C shows a screw with multiple fatigue planes and contact damage.

One screw displayed multiple fracture planes with contact damage on the highest plane. This screw showed fatigue progression marks radiating from several points at the roots of the threads.
