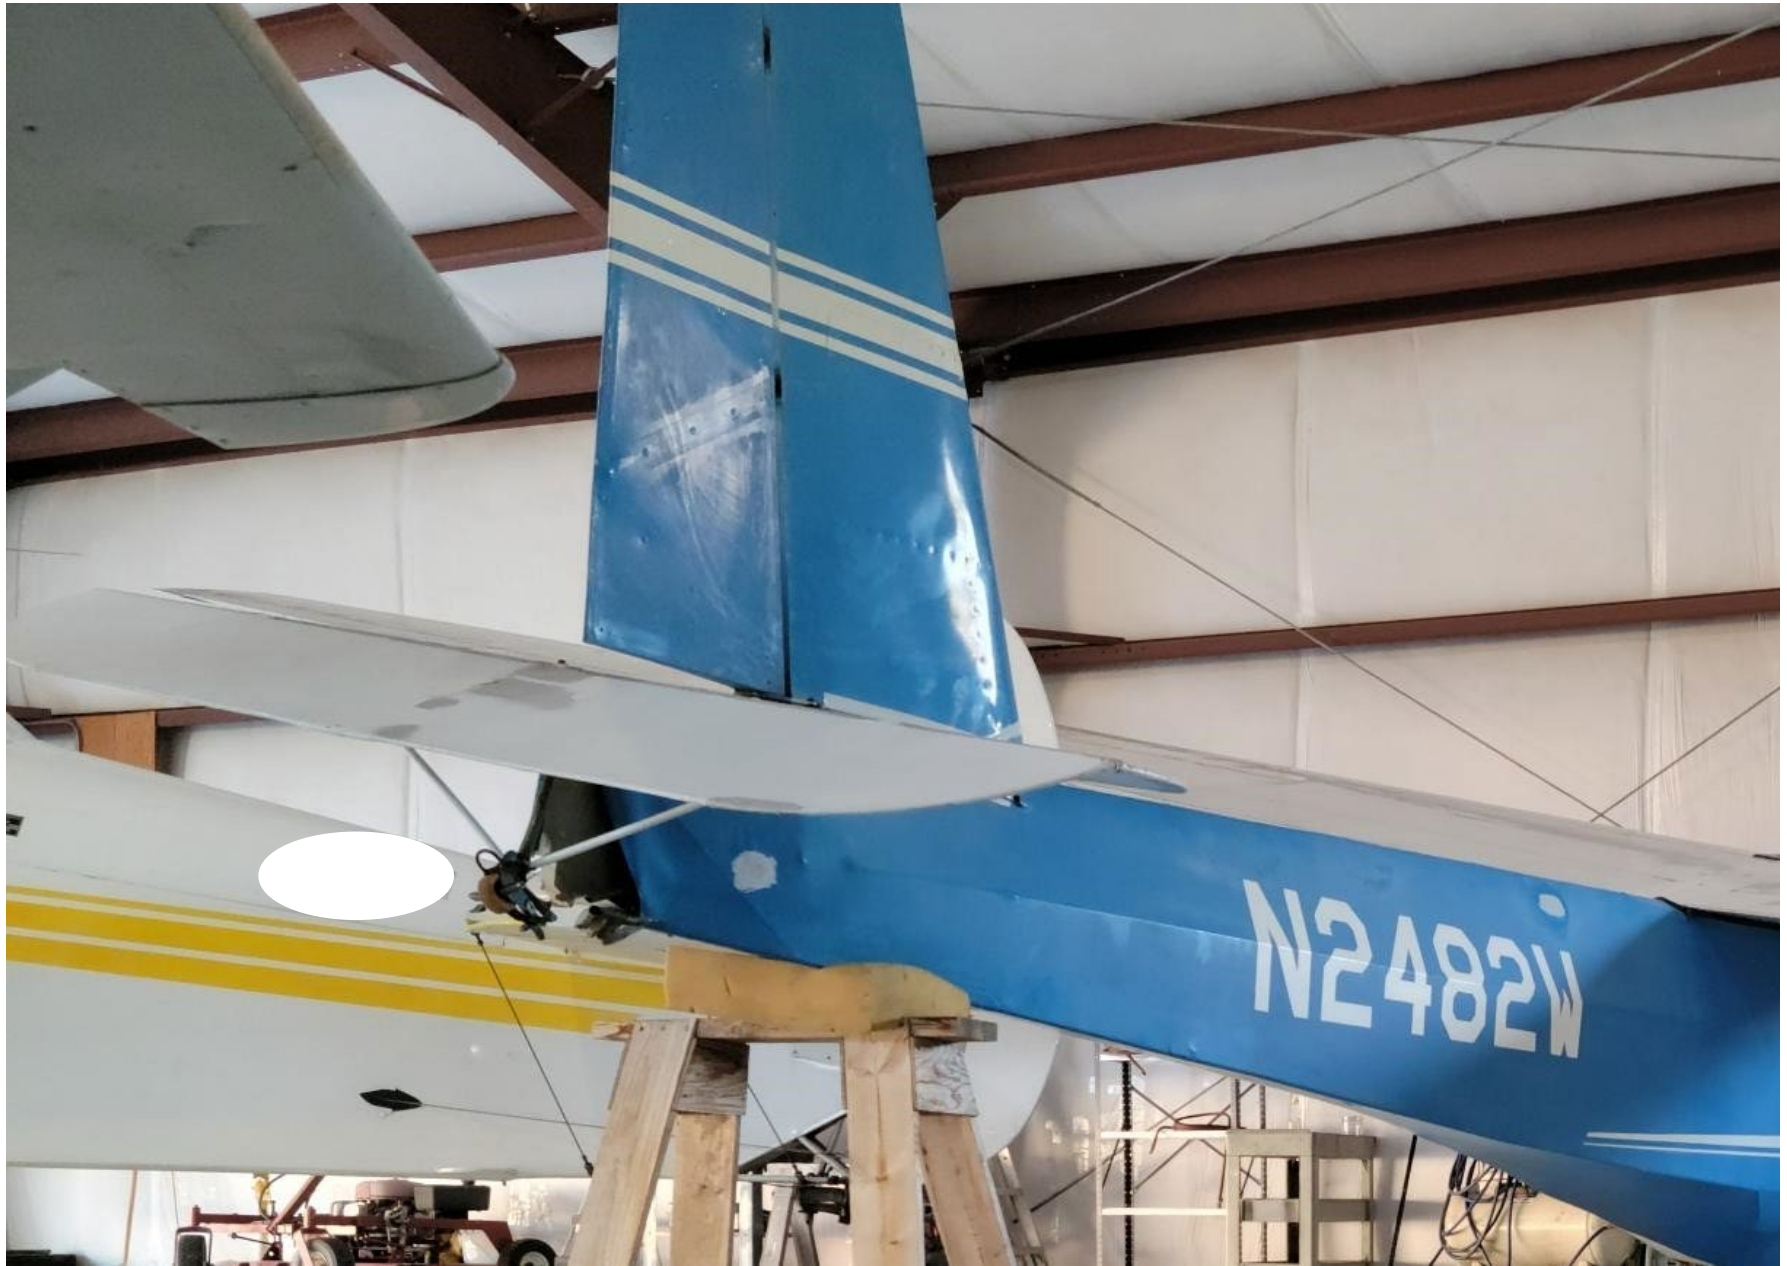
**Photo 1 – View of empennage damage (courtesy of the operator)**

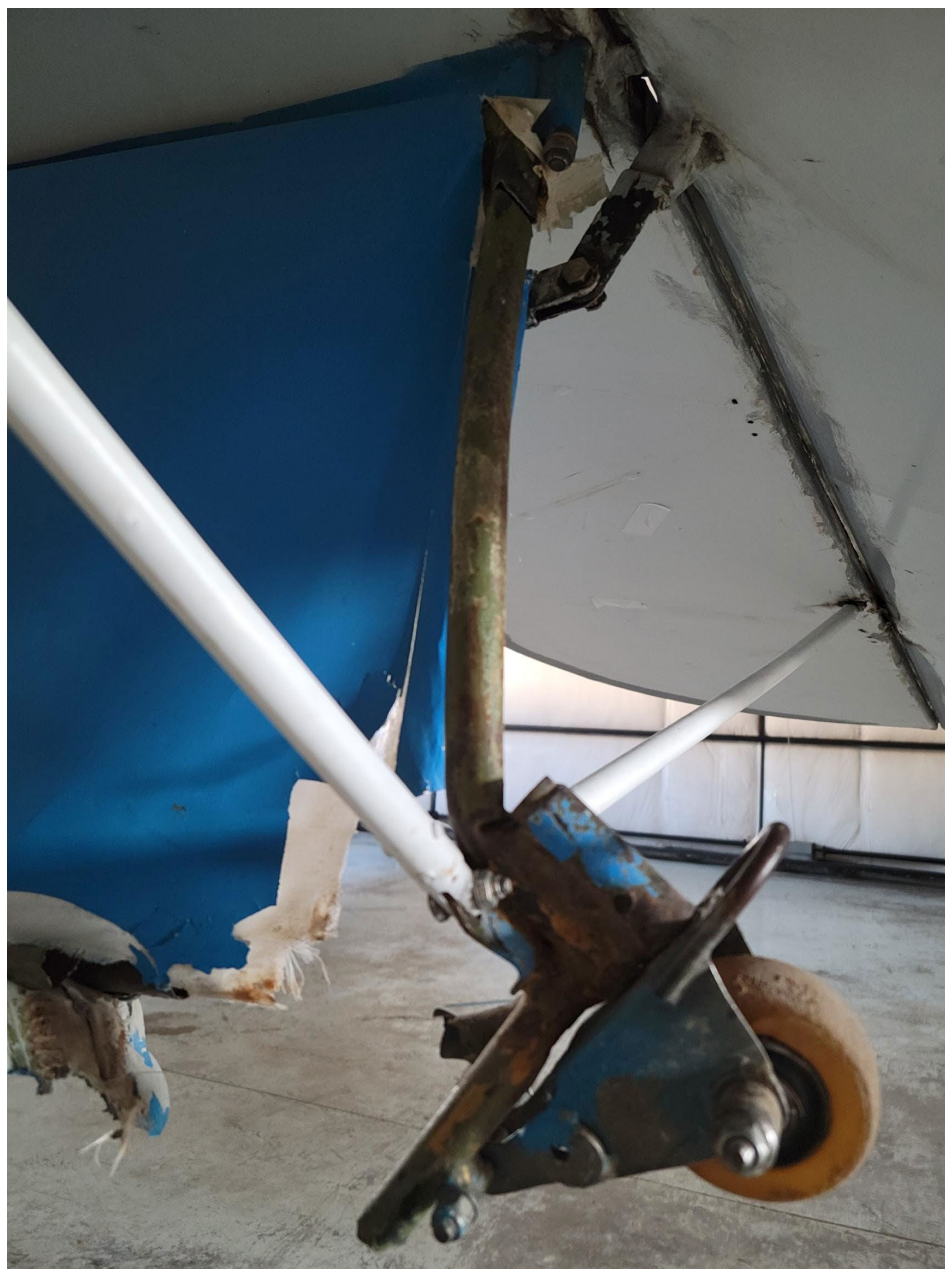
**Photo 2 – Close up view of tailwheel damage (courtesy of the operator)**
