**NATIONAL TRANSPORTATION SAFETY BOARD**  
Office of Aviation Safety

**Wreckage Examination Report**

**A. ACCIDENT      WPR22LA271**

Location:      San Jose, California  
Date:      July 22, 2022  
Time:      1911 PDT  
Operator:      Private  
Aircraft:      Piper PA-32-301  
Registration:      N300BH

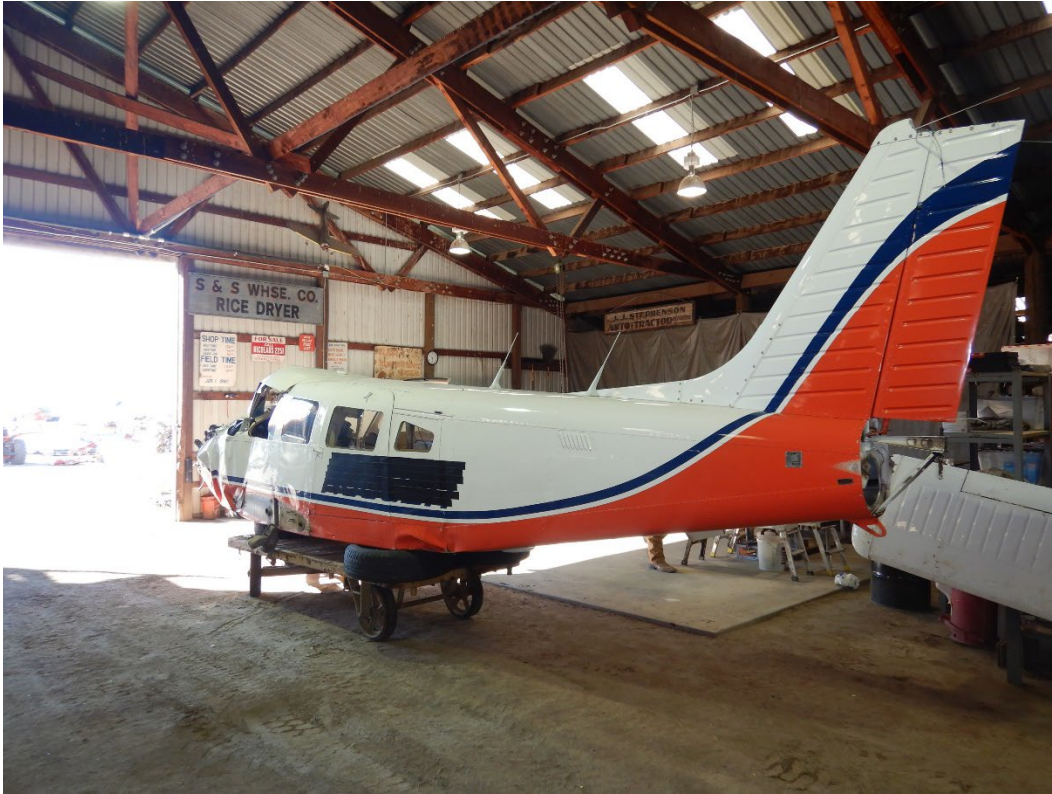
The airplane subsequently impacted the ground and penetrated a fence before it came to rest about 0.3 nm northwest of the departure end of runway 31R. Photographs provided by law enforcement showed that the airplane came to rest upright. The left wing exhibited a steep upward bend about midspan and the right wing outboard leading edge was crushed. The forward fuselage was damaged and the engine was displaced from its normally mounted position.

*Photograph 1: Accident airplane prior to examination*

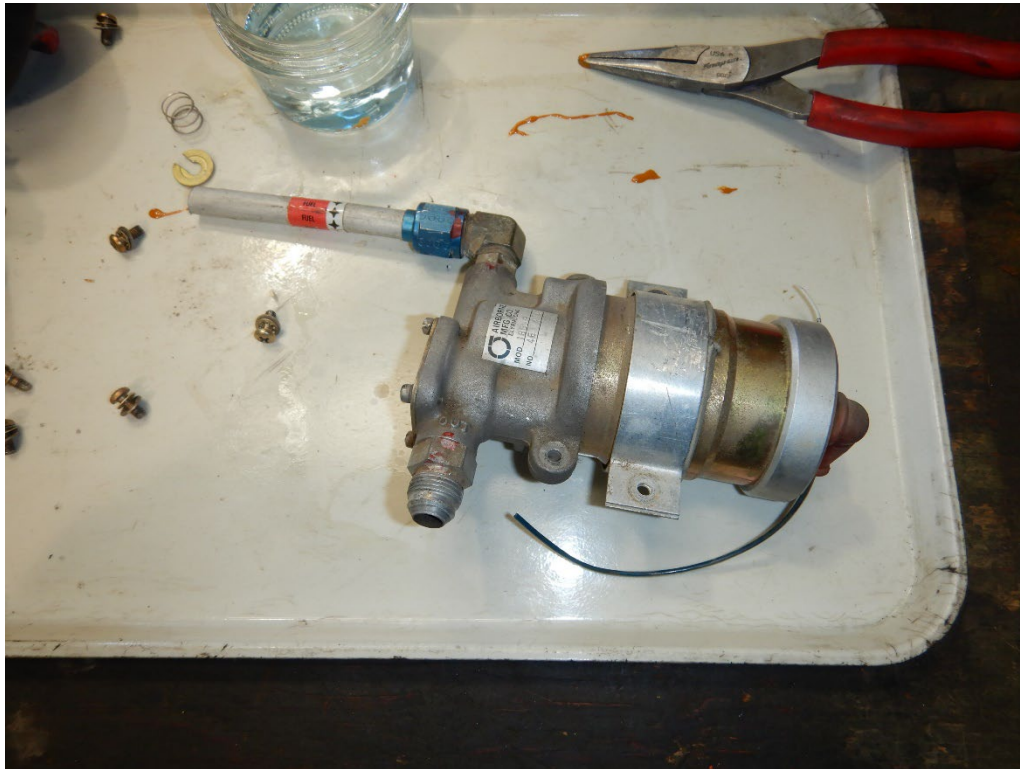
The fuel pump inlet port was submerged in water and the unit was connected to a 24v battery to facilitate a functional test. The pump motor rotated continuously during the test and water was expelled through the outlet port without any evidence of an obstruction.

*Photograph 2: Electric fuel pump and fuel sample*

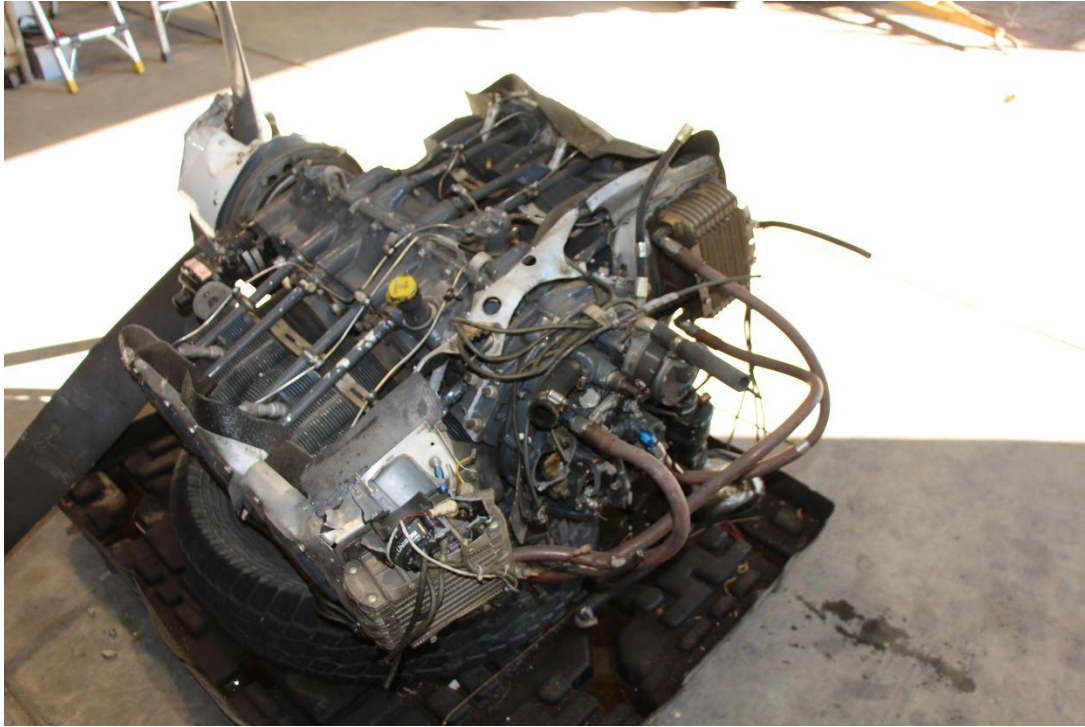
The engine was a Lycoming Engines IO-540-K165, s/n L-19079-48A, an air-cooled, horizontally opposed, 300 hp reciprocating engine. The push rods to the cylinder no. 1 exhaust valve, the cylinder no. 5 intake valve and the cylinder no. 6 exhaust valve were crushed. The left hand engine mount near the top of the accessory case had separated and the right hand mount at the top of the accessory case was partially fractured. Additionally, the propeller spinner was crushed aft.

*Photograph 3: Engine prior to examination*

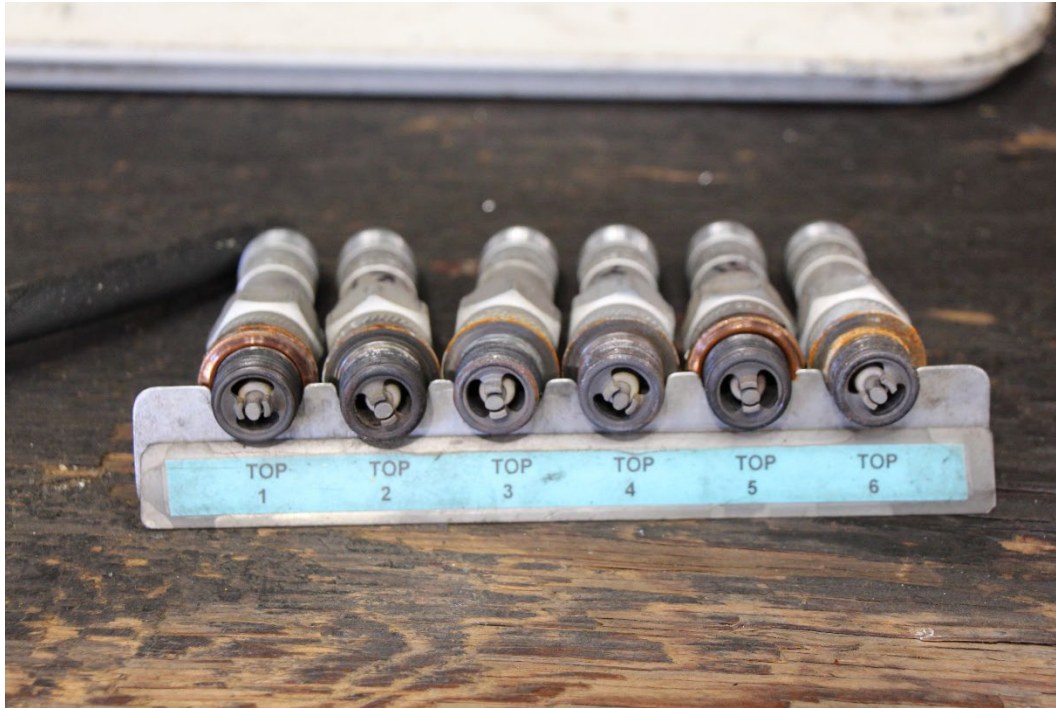
The right magneto was a Slick model no. 6350 and the left magneto was a Slick model no. 6351. Both magnetos were displaced from the accessory case due to overload separation and the magneto flanges remained clamped to their respective mounting pads. All of the ignition harness coils were secured tightly to their respective spark plugs. The right magneto leads were cut and spark was observed at all six of the ignition harness leads as the magneto was rotated by hand at the drive. The left magneto was fragmented due to the absorption of energy sustained during the accident. The top and bottom spark plugs were manufactured by Champion, model RHM 38E massive electrode plugs. Each of the 6 top spark plugs were secure at their respective ports and an inspection of the electrodes revealed they were gray in appearance, consistent with normal wear when compared to the Champion AV27 plug condition chart. The spark plugs were free of mechanical damage.

*Photograph 4: Top spark plugs*

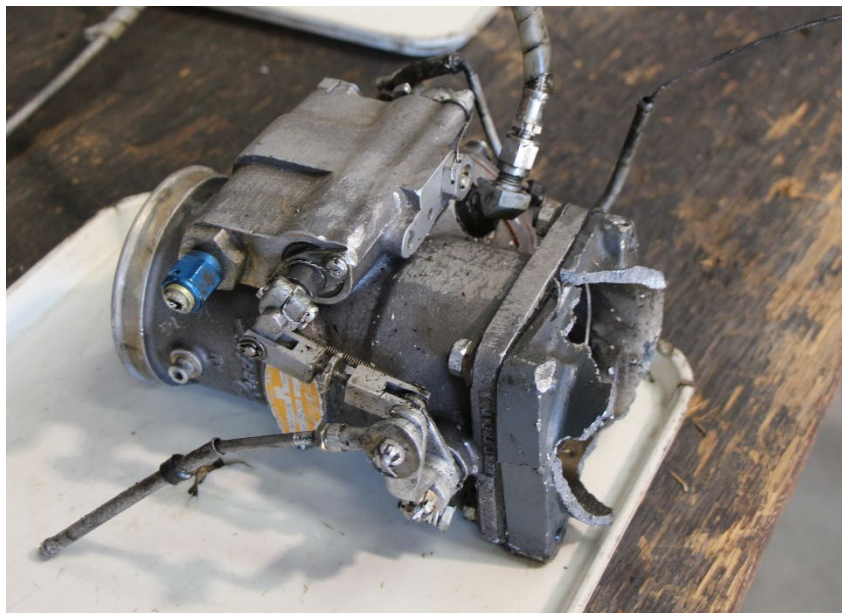
The fuel injection servo was displaced from the engine accessory case due to overload separation. Both the mixture and throttle control arms were secure at the servo and there was no evidence of internal obstructions at the throat of the servo. A trace amount of straw-colored liquid was drained from the fuel servo.

*Photograph 5: Fuel servo*

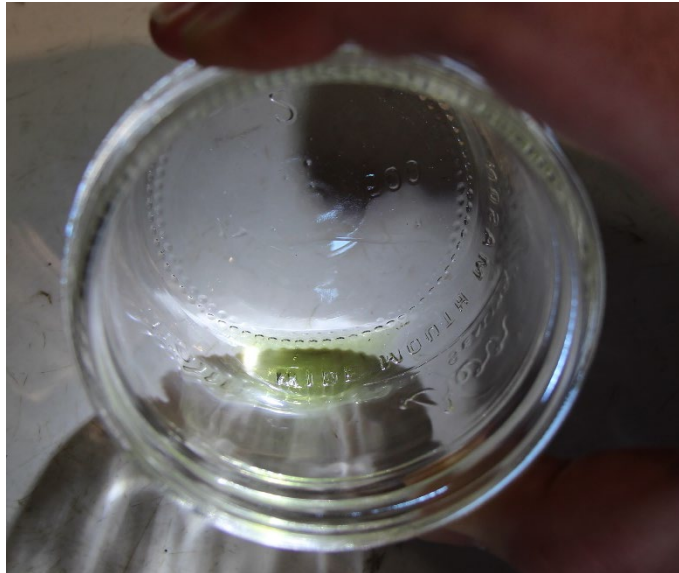
*Photograph 6: Sample from fuel servo*

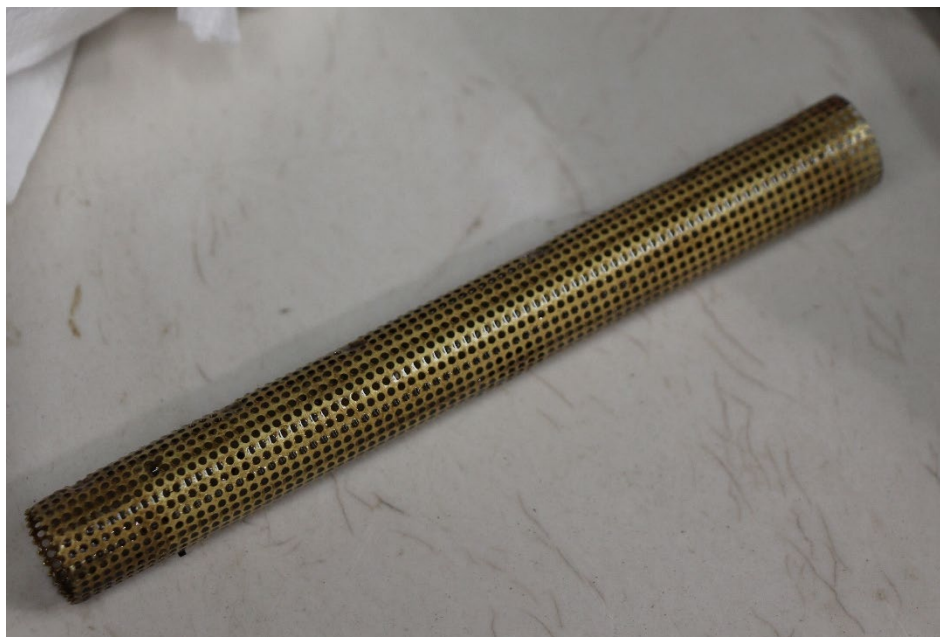
The oil suction screen was free of debris.

*Photograph 7: Oil suction screen*

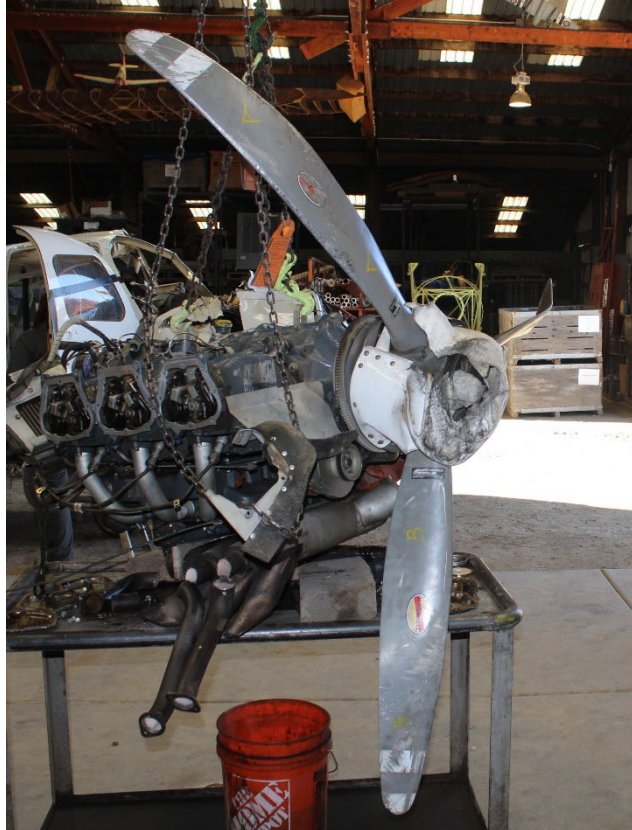
The three bladed constant speed propeller remained attached at the crankshaft flange. All three blades remained attached to the hub. Blades A and B were bent aft about midspan. Blade C was bent aft near the blade tip. The propeller governor was attached at its mounting pad and the pitch control rod was still attached at the control wheel.

*Photograph 8: Propeller*
