## **NATIONAL TRANSPORTATION SAFETY BOARD**

# **AIRFRAME AND ENGINE EXAMINATION**

**WPR22LA287**

Location: Livermore, California  
Date: July 30, 2022  
Aircraft: Cessna 177RG, N2591V, SN: 177RG0627  
NTSB IIC: Elliott Simpson

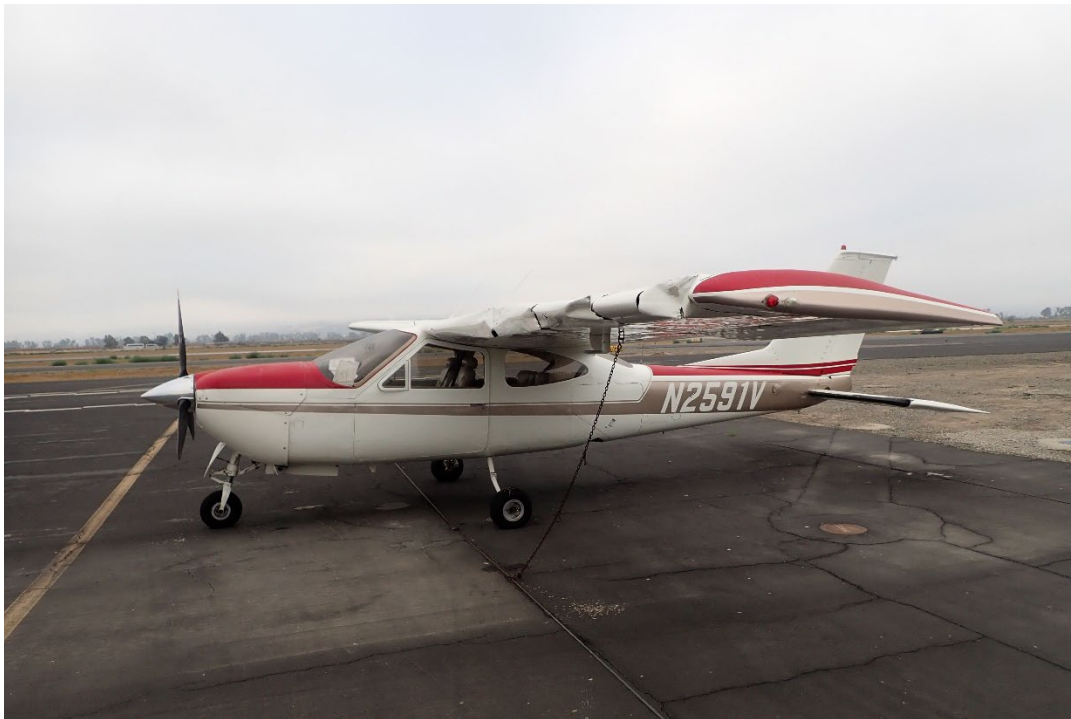
The airplane struck the “T” landing light structures for runway 25R during the accident. The airframe was essentially undamaged, with crush damage noted along almost the entire leading edge of the left wing, consistent with contact with the light structures (figure 1). Similar damage was present on the leading edge of the outboard right and left ends of both the horizontal stabilizer.

Figure 1 – Airplane damage
