## **NATIONAL TRANSPORTATION SAFETY BOARD**

### **FACTUAL EXAMINATION**

**WPR22LA287**

Location: Livermore, California  
Date: July 30, 2022  
Aircraft: Cessna 177RG, N2591V  
NTSB IIC: Elliott Simpson

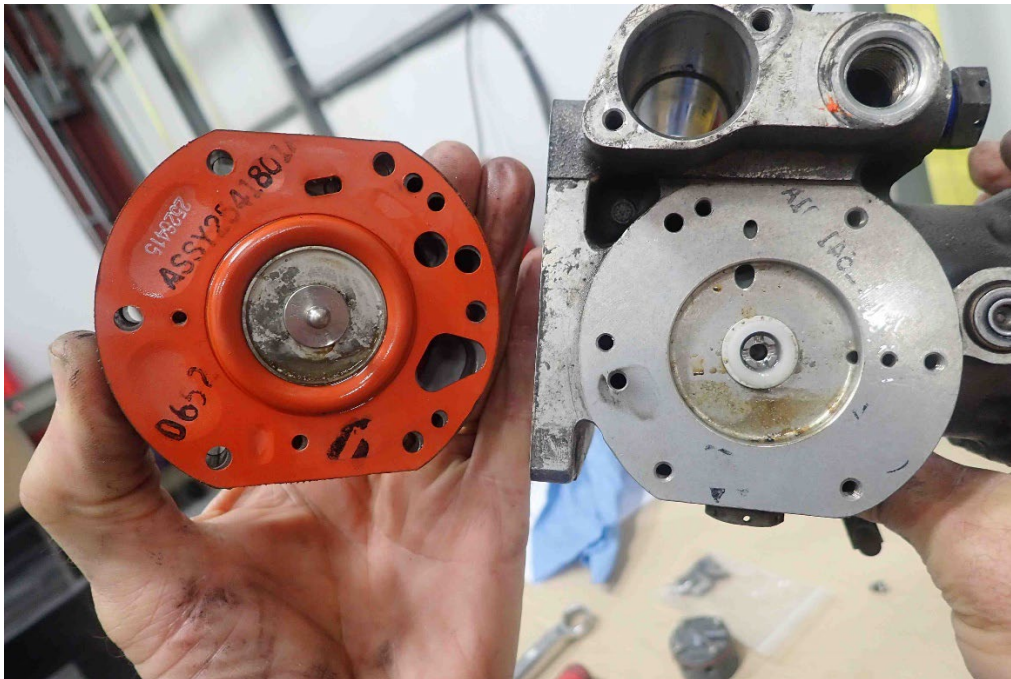
Disassembly of the servo revealed significant internal corrosion and corrosion deposits. The diaphragm cavities revealed “water lines” and corrosion on the metered and unmetered fuel side consistent with water contamination.

The unit was then disassembled, and removal of the mixture and idle valve assemblies required much more force than was appropriate. Disassembly revealed significant internal corrosion and corrosion deposits throughout the unit. Specifically, “water lines” and corrosion and rust deposits were observed within the cavities on the metered (figure 1) and unmetered (figure 2) side of the diaphragm assembly. Corrosion deposits were on the lower side of the mixture control arm spring assembly (figure 3).

Figure 1 - Water line and corrosion on metered side

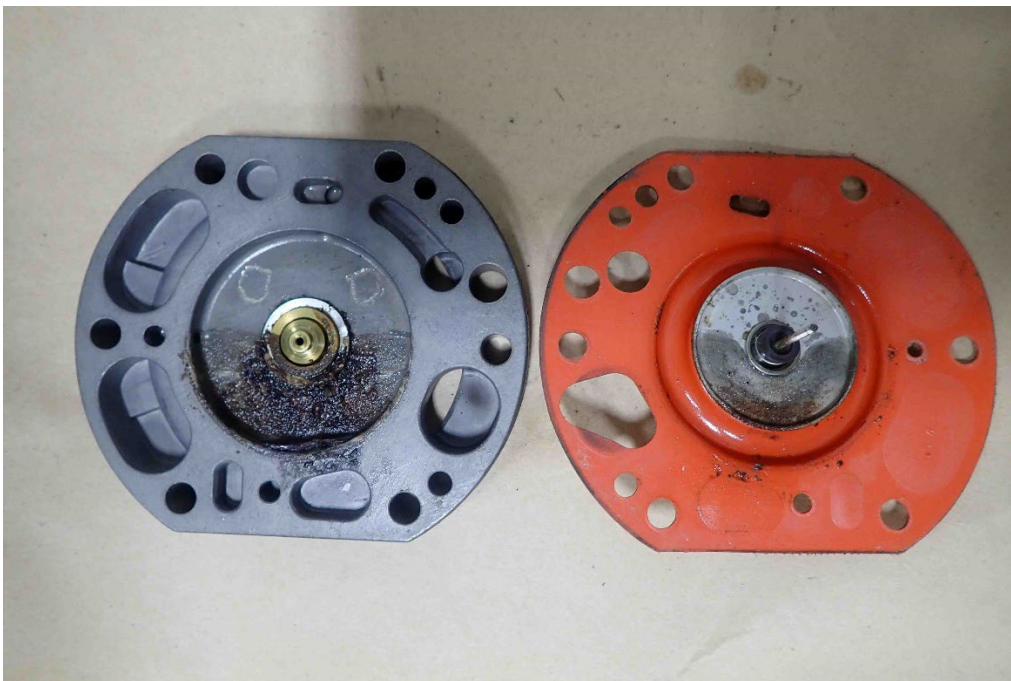
Figure 2 - Water line and corrosion on unmetered side

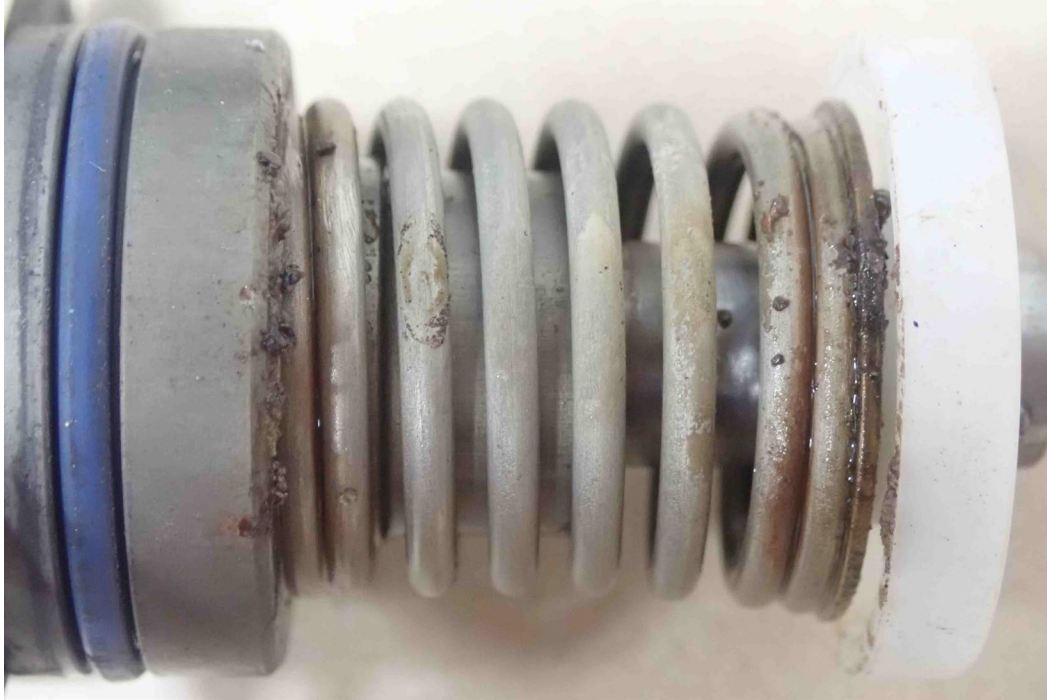
Figure 3 - Corrosion deposits on the lower side of the mixture control spring

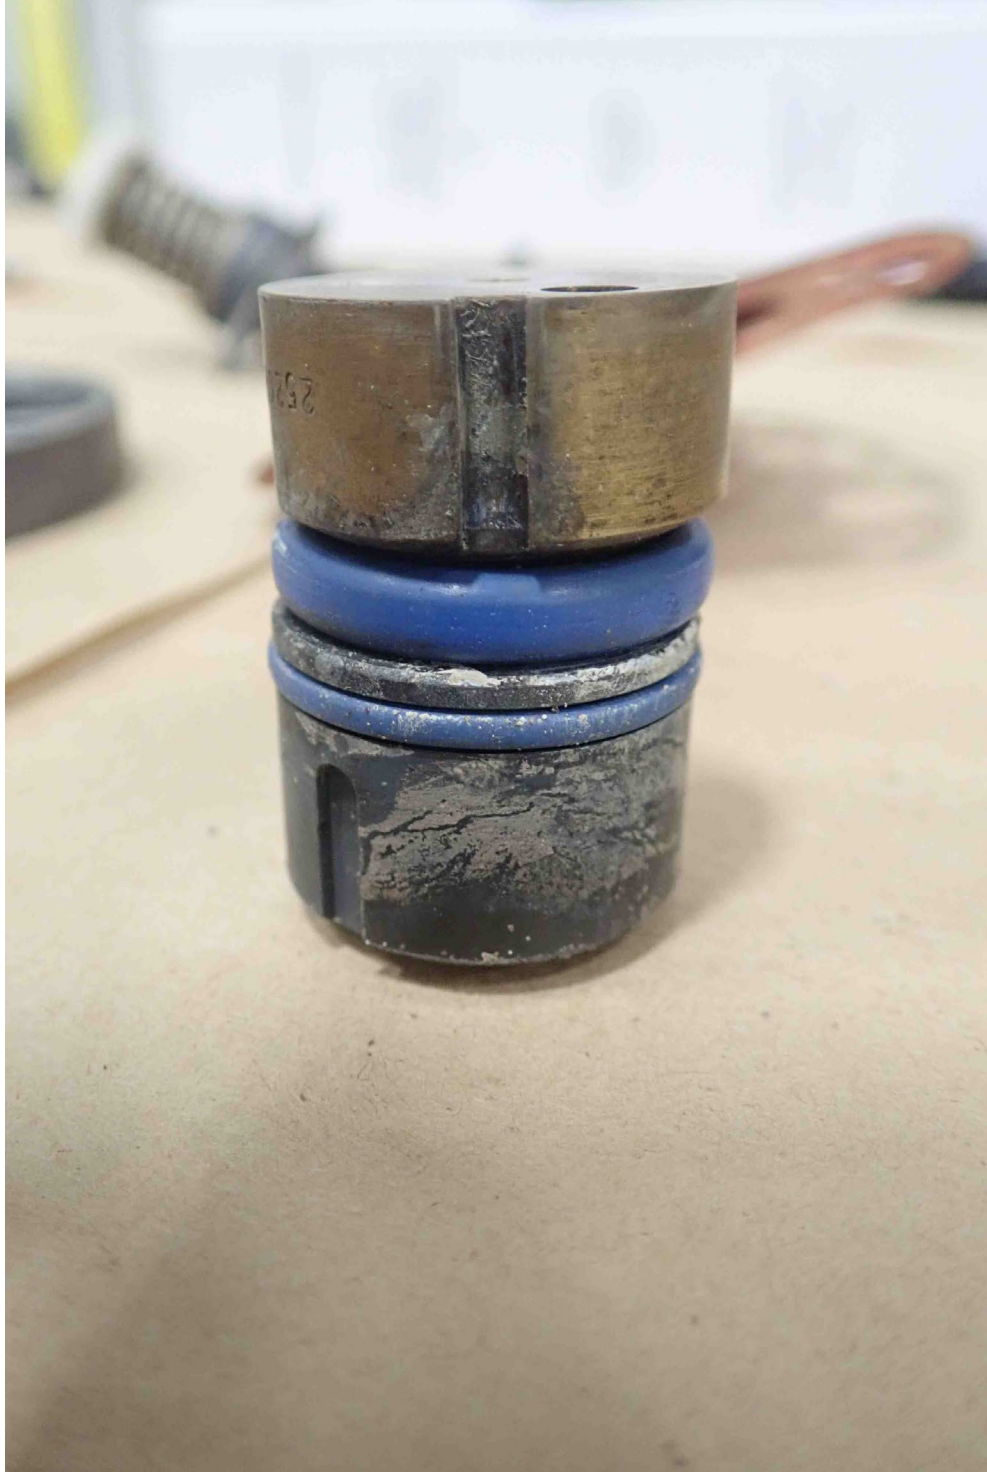
Corrosion was observed on the surfaces of both the idle and mixture valve plugs (figure 4), and their assembly housing bore (figure 5). The alternate fuel outlet plug which was at the lowest point of the system, was removed and corrosion deposits were noted on the plug (figure 6) and its bore (figure 7).

Figure 4 - Corrosion on the surfaces of the idle and mixture valve plugs

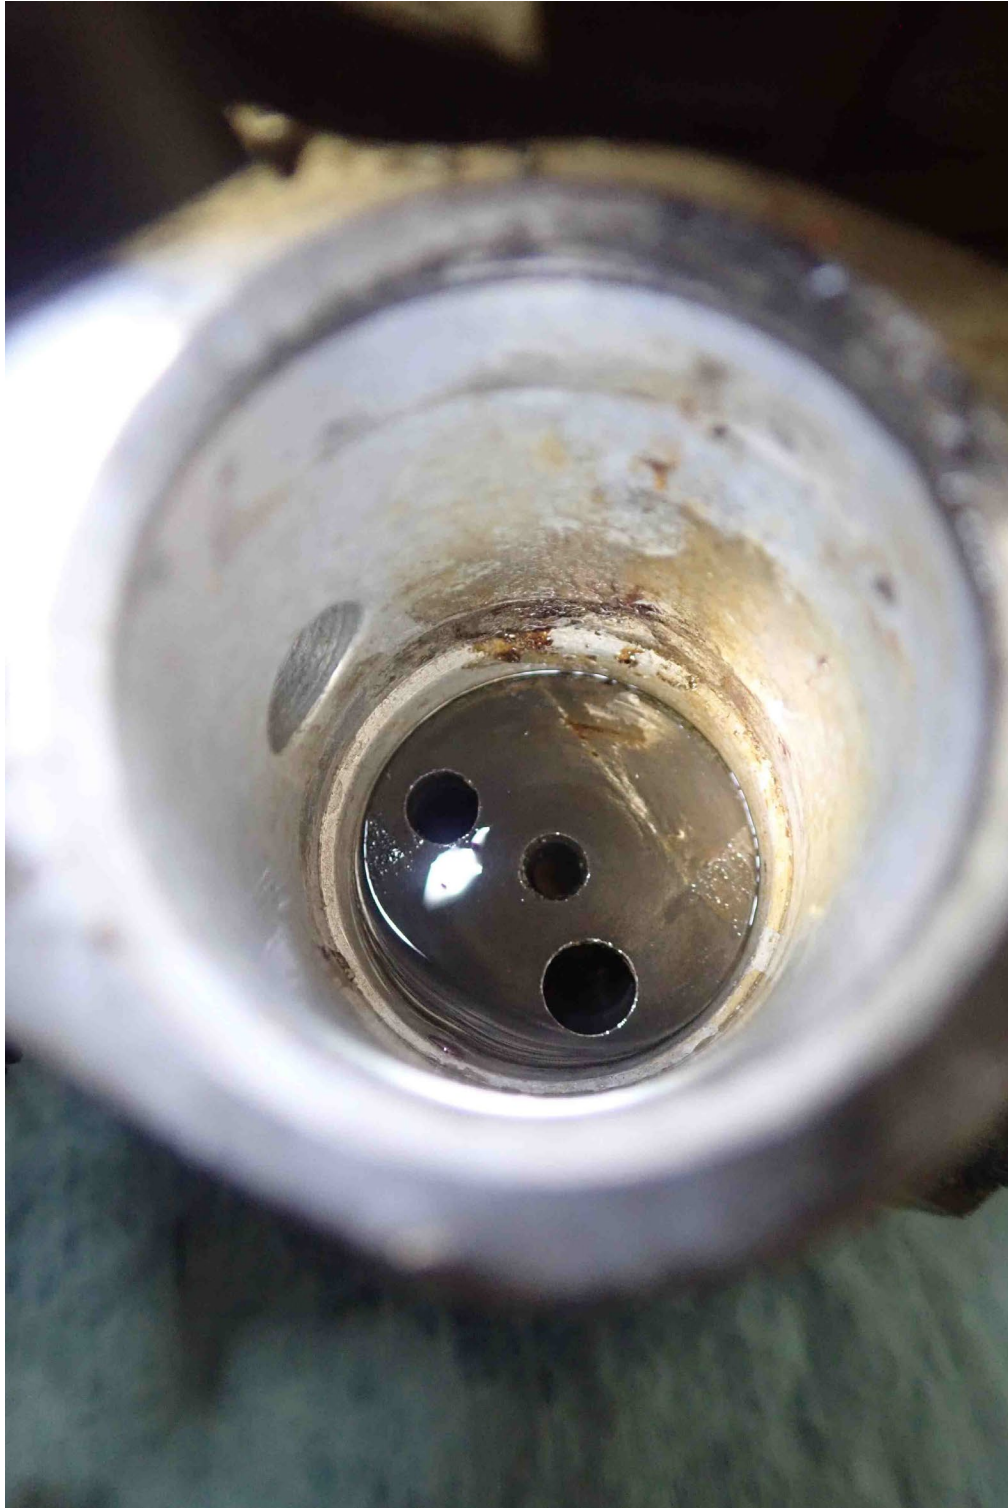
Figure 5 - Corrosion on the surfaces of the idle and mixture valve housing bore

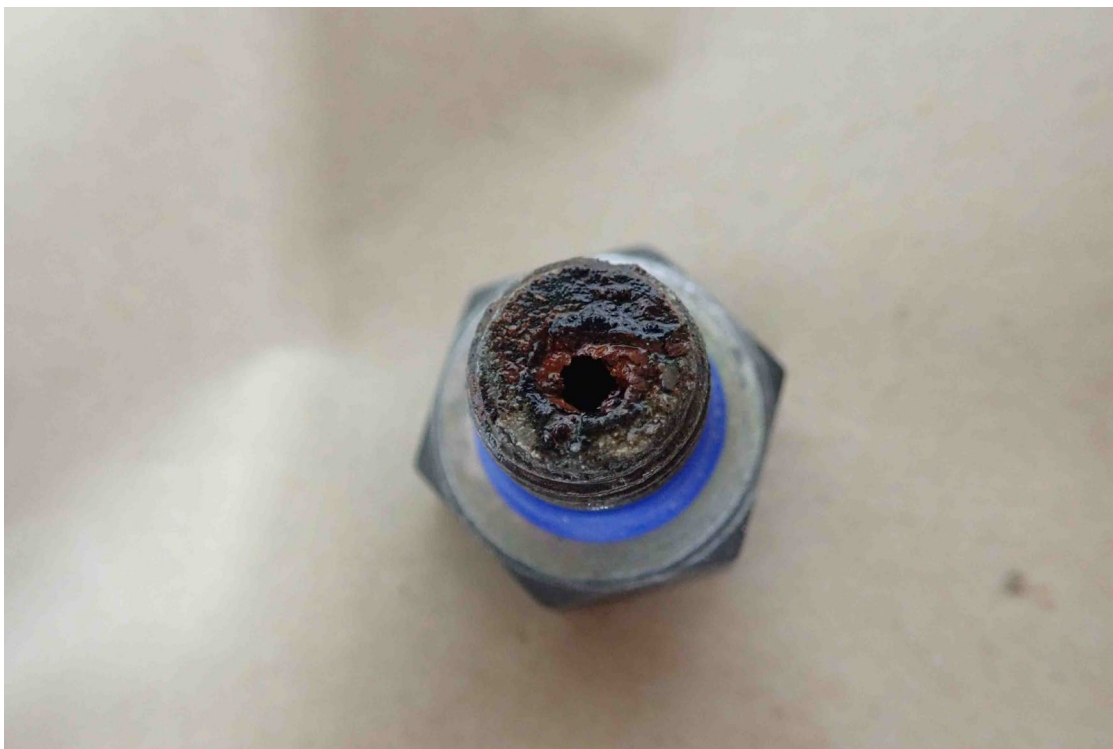
Figure 6 - Corrosion on alternate fuel outlet plug

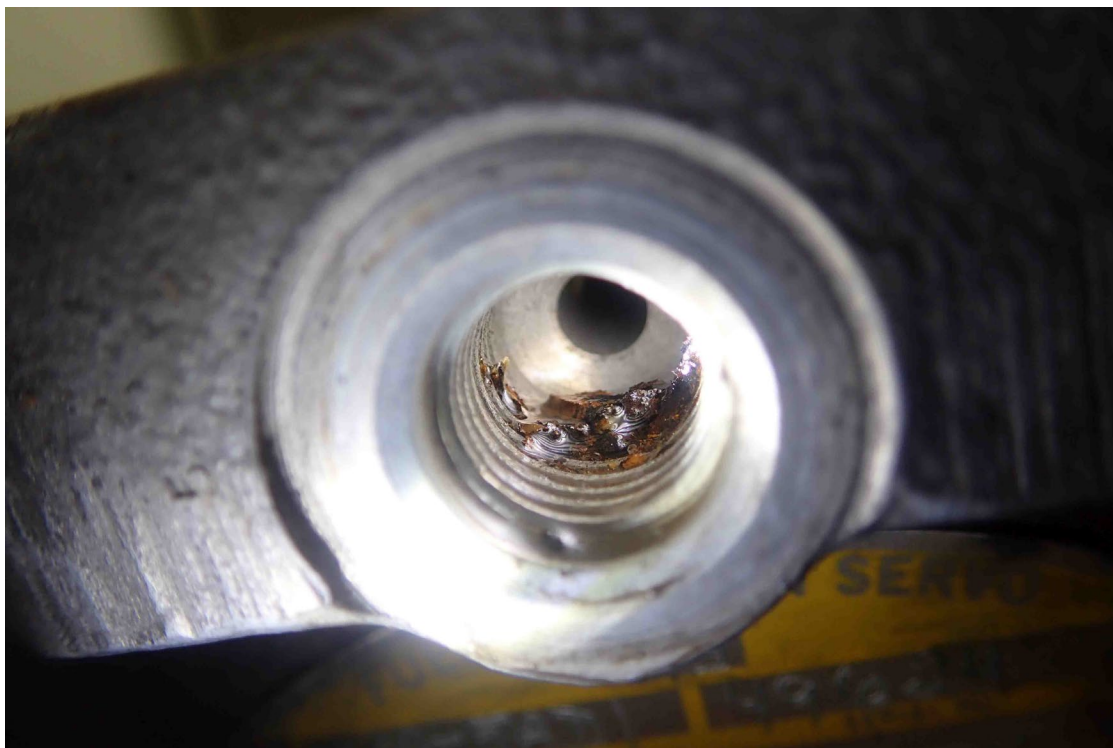
Figure 7 - Corrosion on alternate fuel outlet plug bore

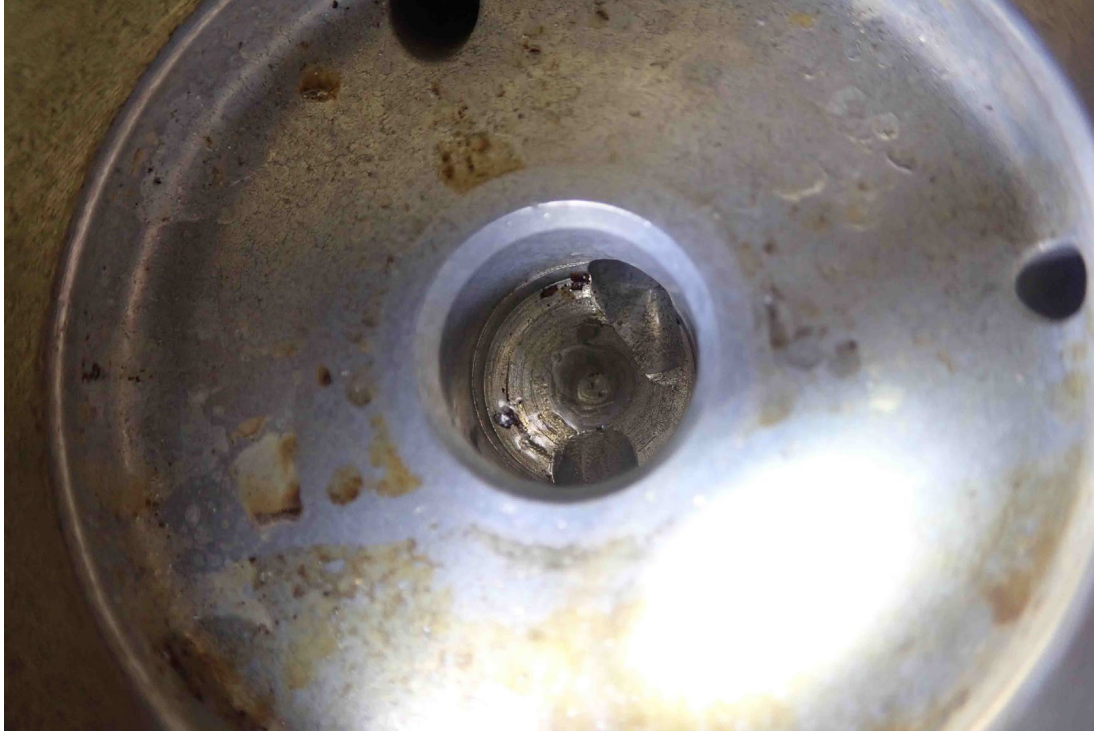
Corrosion deposits were present on the servo valve seat cavity (figure 8).

Figure 8 - Corrosion deposits on the servo valve seat cavity
