# National Transportation Safety Board

WPR22LA296

## **SERVO EXAMINATION**

Location: Corona, California  
Date: August 9, 2022  
Time: 1231 Pacific daylight time  
Airplane: Piper, PA-32-300, N841AD

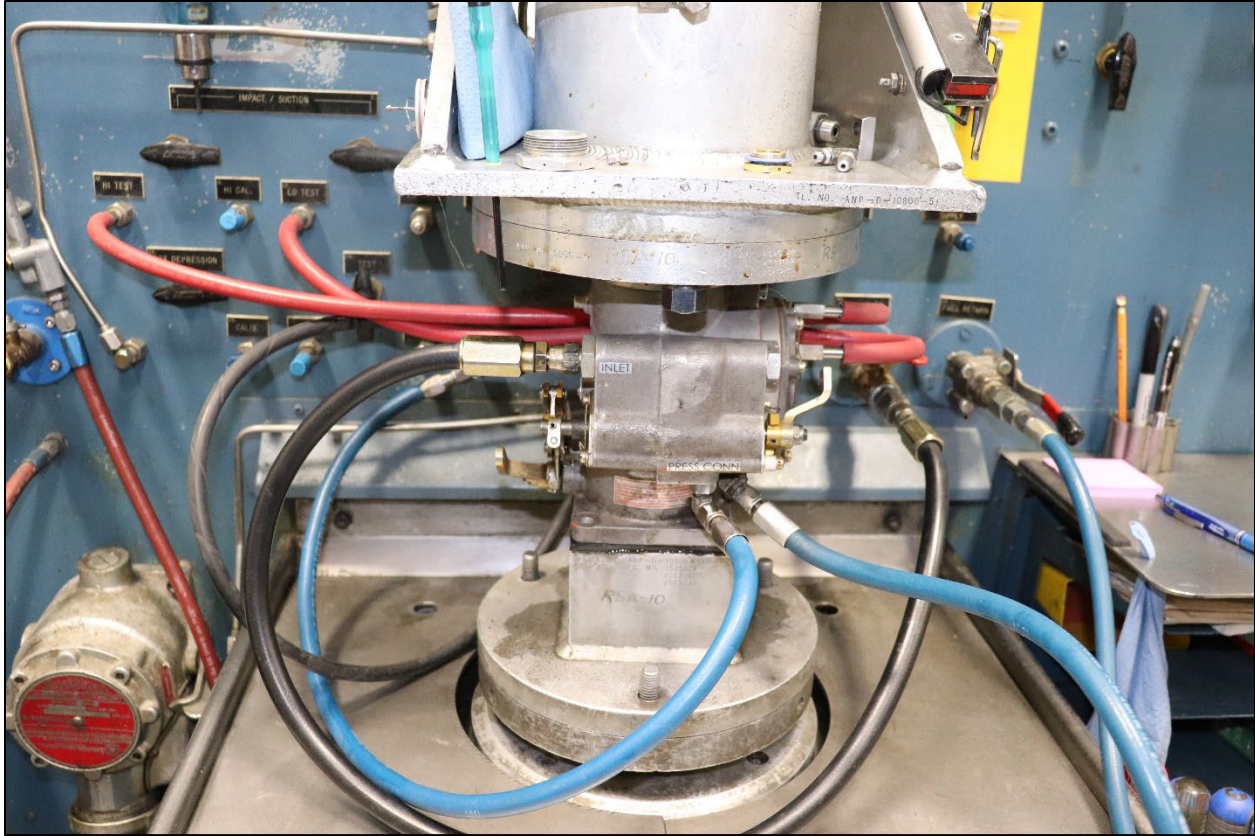
**Figure 1: View of fuel servo connected to test stand.**

The fuel servo was connected to a test stand and performed within manufactures field service limits specifications when tested. The kinked/twisted fuel line was connected to the servo fuel inlet and test at full throttle, a reduced fuel flow of about 3 lbs./hr. was observed.

Test fluid was observed in the venturi and air side of the regulator. The servo was removed from the test stand and disassembled. No anomalies were noted in the idle lever assembly, mixture lever assembly, or regulator. The servo was reassembled, pressure tested, and no leaks were observed. The test fluid previously observed in the venturi and air side of the regulator was consistent with a loose fastener on the regulator housing.
