# National Transportation Safety Board

WPR22LA296

## **FUEL PUMP EXAMINATION**

Location: Corona, California  
Date: August 9, 2022  
Airplane: Piper PA-32-300, N841AD

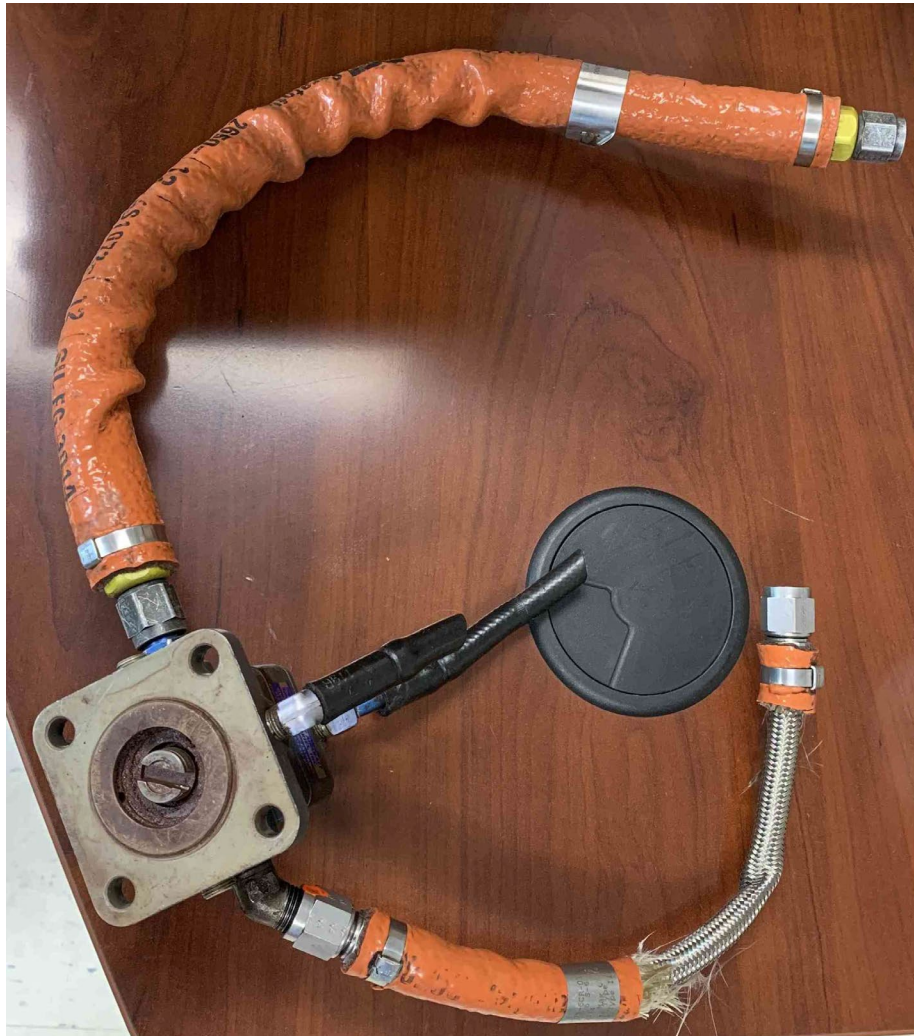
The pump was intact, and its inlet fuel line remained attached by its fitting (figure 1). The outlet line was in place but was loose at its fitting. The fire sleeve at the end of the line had been previously removed, and there was a kink in the braided line (figure 2).

**Figure 1 - Fuel pump assembly**

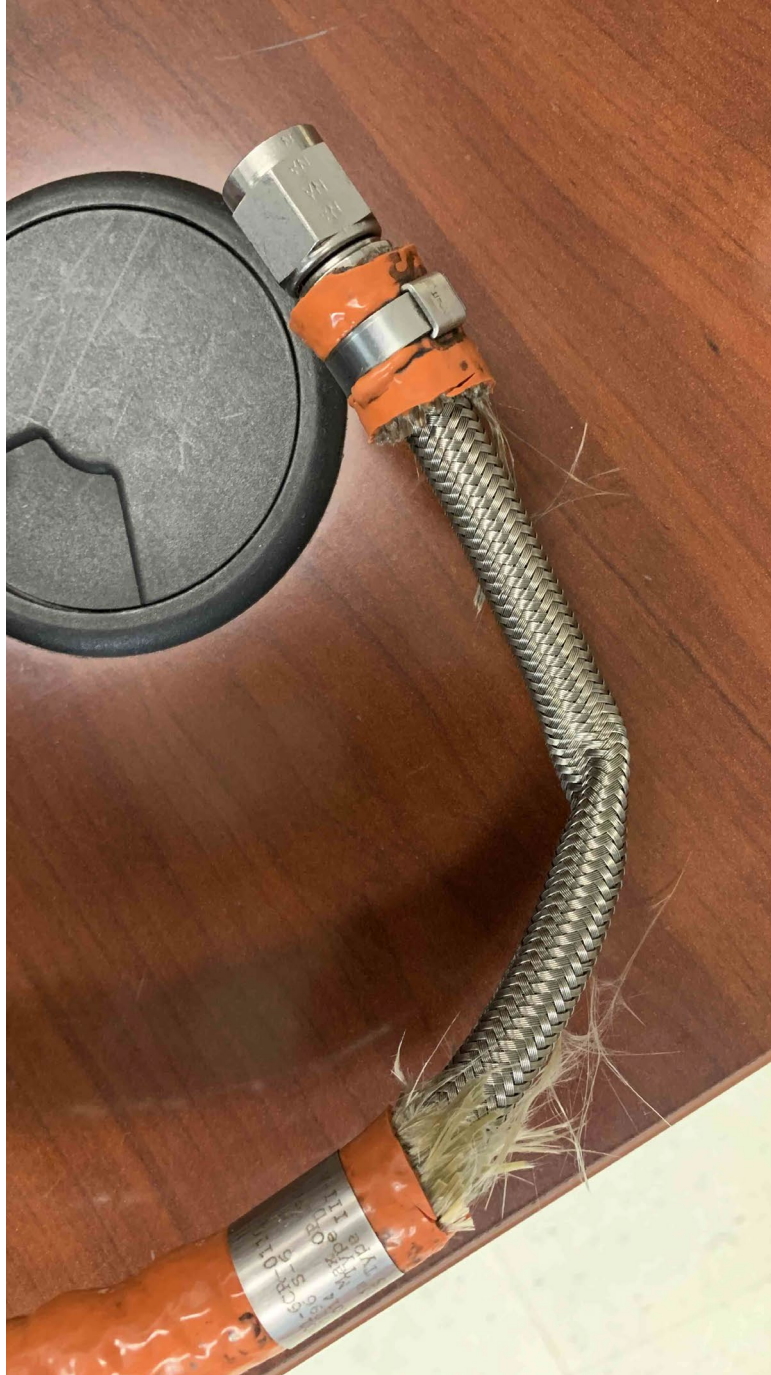
**Figure 2 - Kinked outlet line**

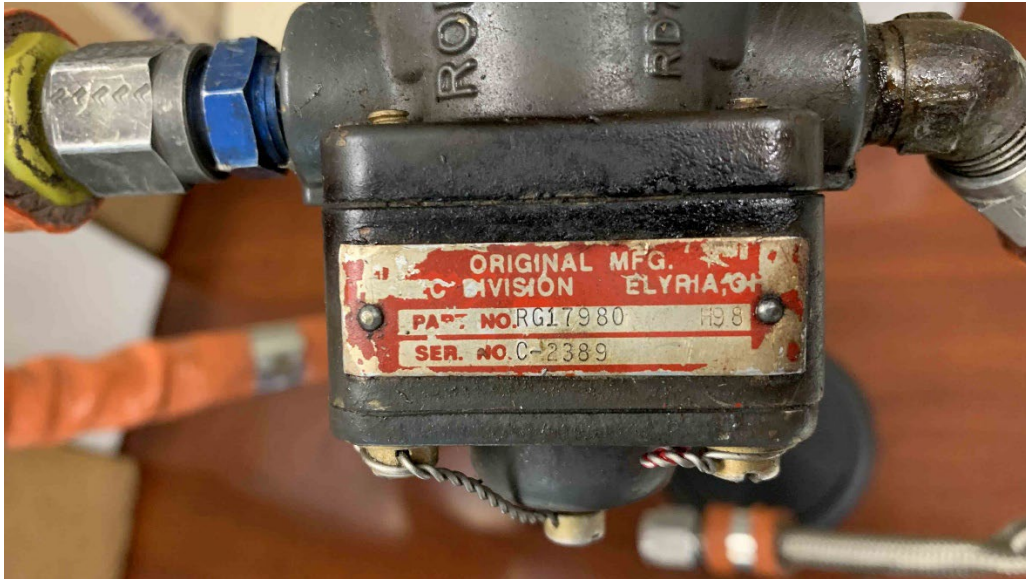
The pump exhibited discoloration and stains consistent with a preexisting leak (figure 3). The input drive shaft seal plate was covered in brown and red colored deposits, consistent with corrosion (figure 4).

**Figure 3 - Fuel pump discoloration**

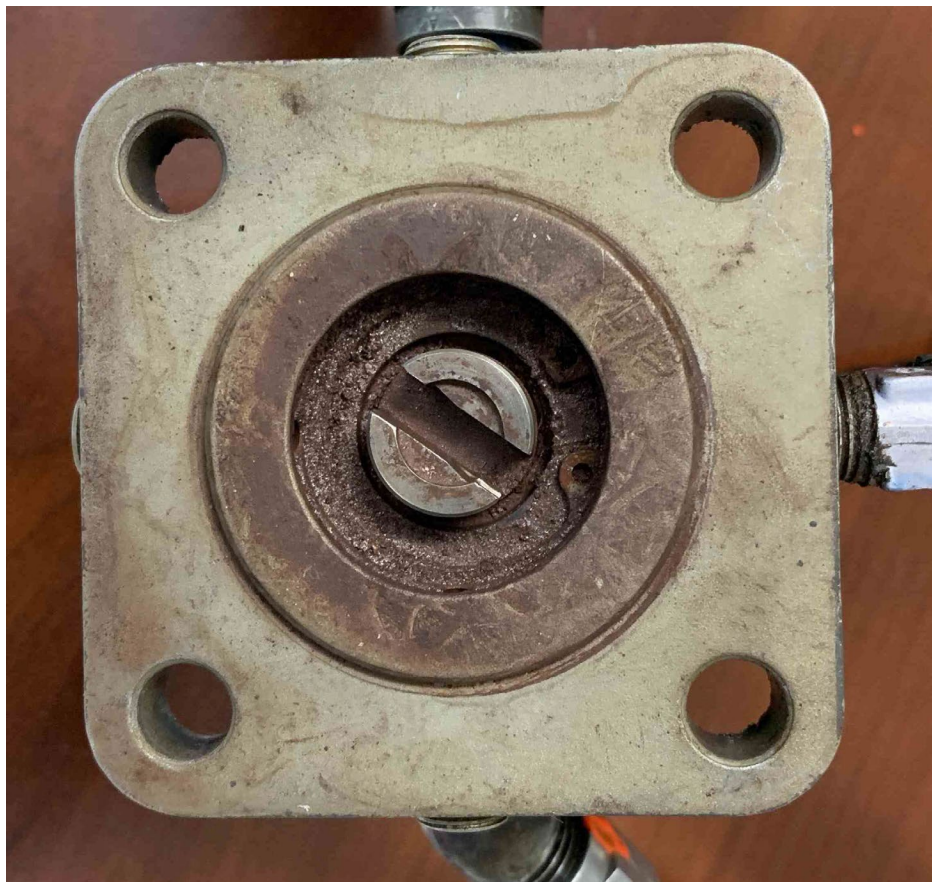
**Figure 4 - Input drive seal plate**

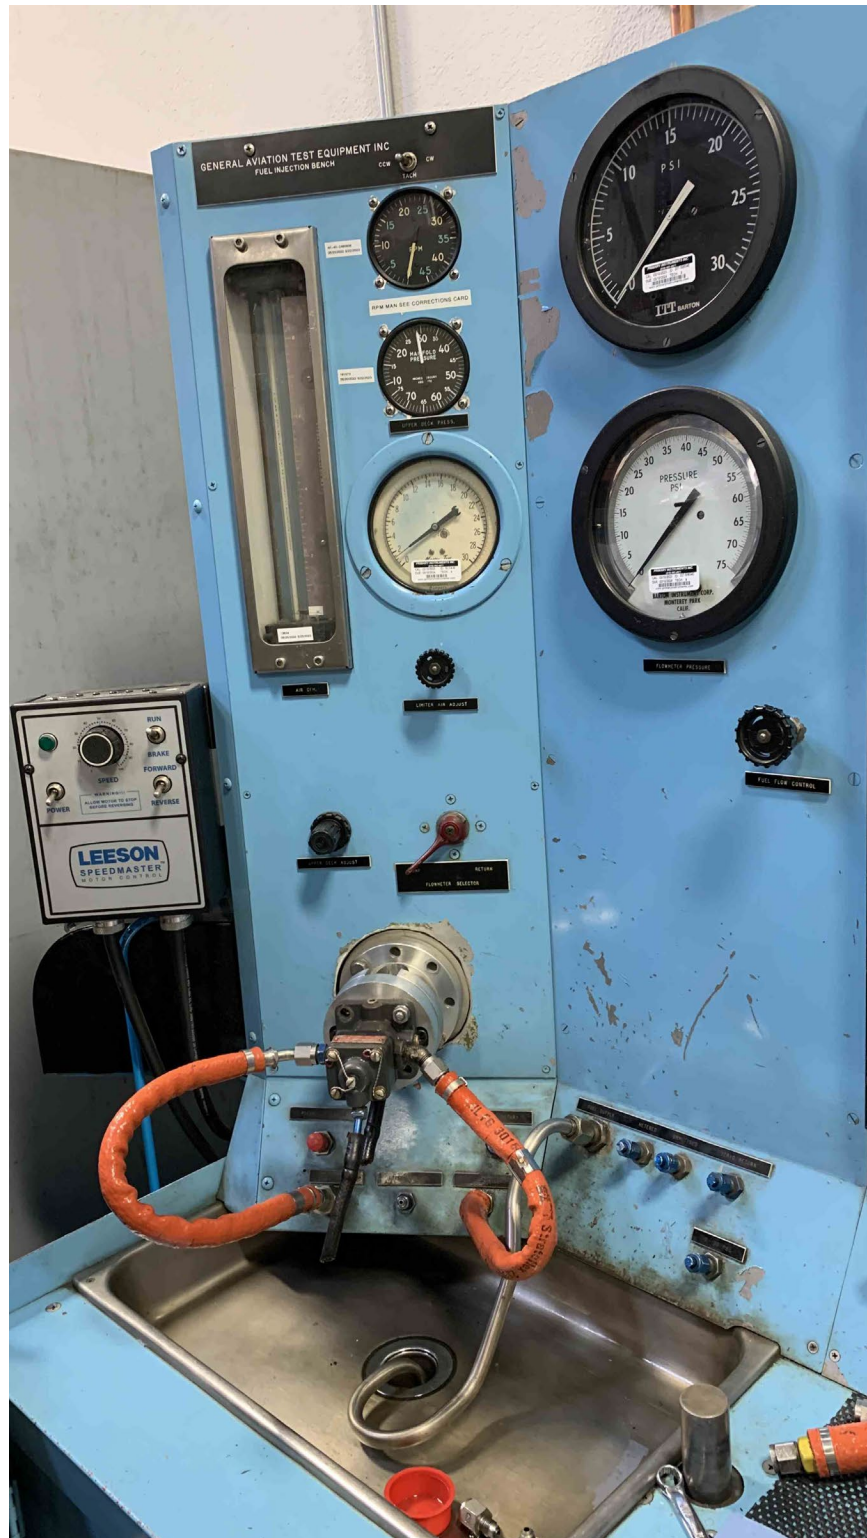
The fuel lines were then removed, and the unit was installed in a fuel injection flow bench and operated at various speeds and fuel flows (figure 5). During the tests, fuel wept from the split case seal (figure 6), and fuel drained continuously from both the input drive seal drain (figure 7), and the seal at the driveshaft. Red and brown corrosion-like deposits were observed in the leaking fluid (figure 8).

**Figure 5 - Fuel Injection Flow Bench**

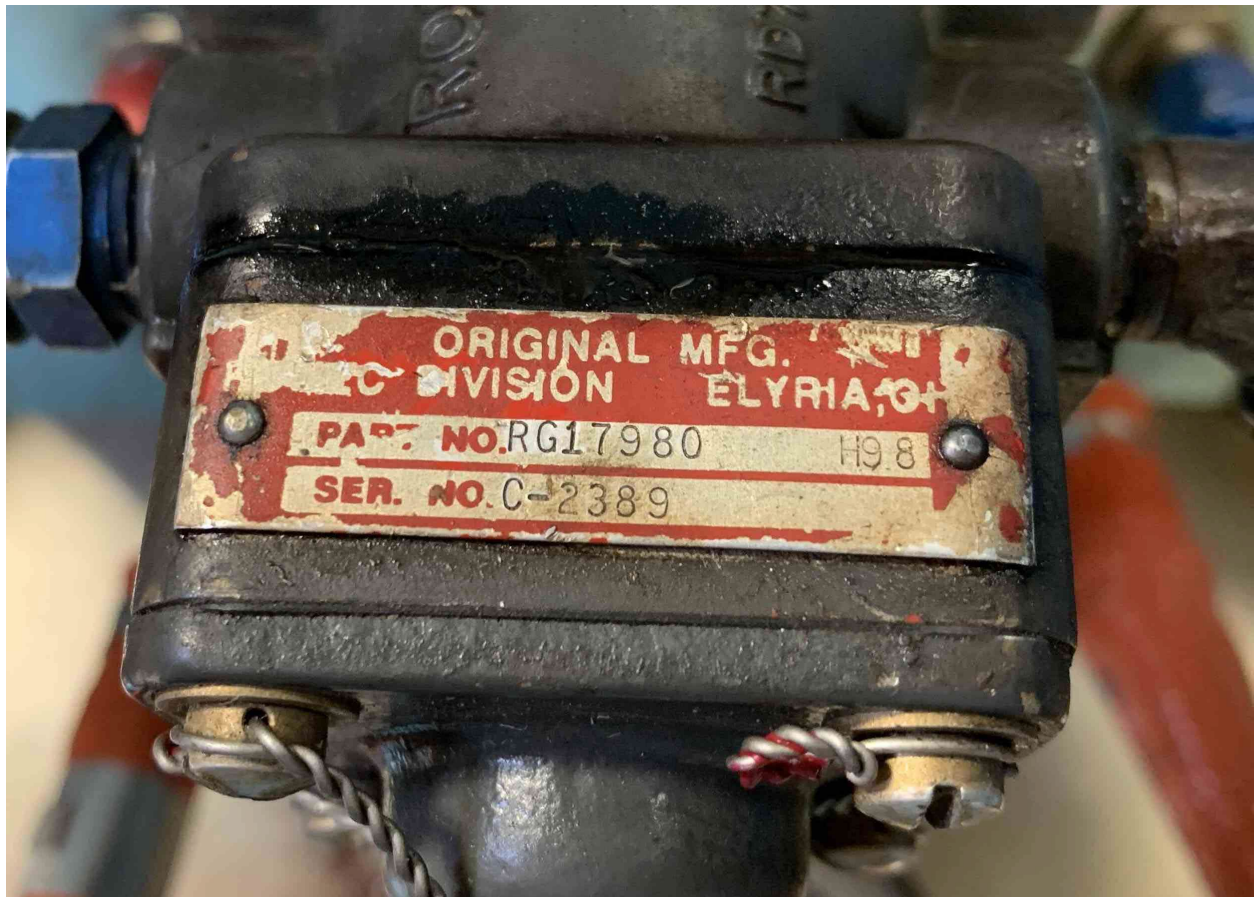
**Figure 6 - Fuel leak from split case seal**

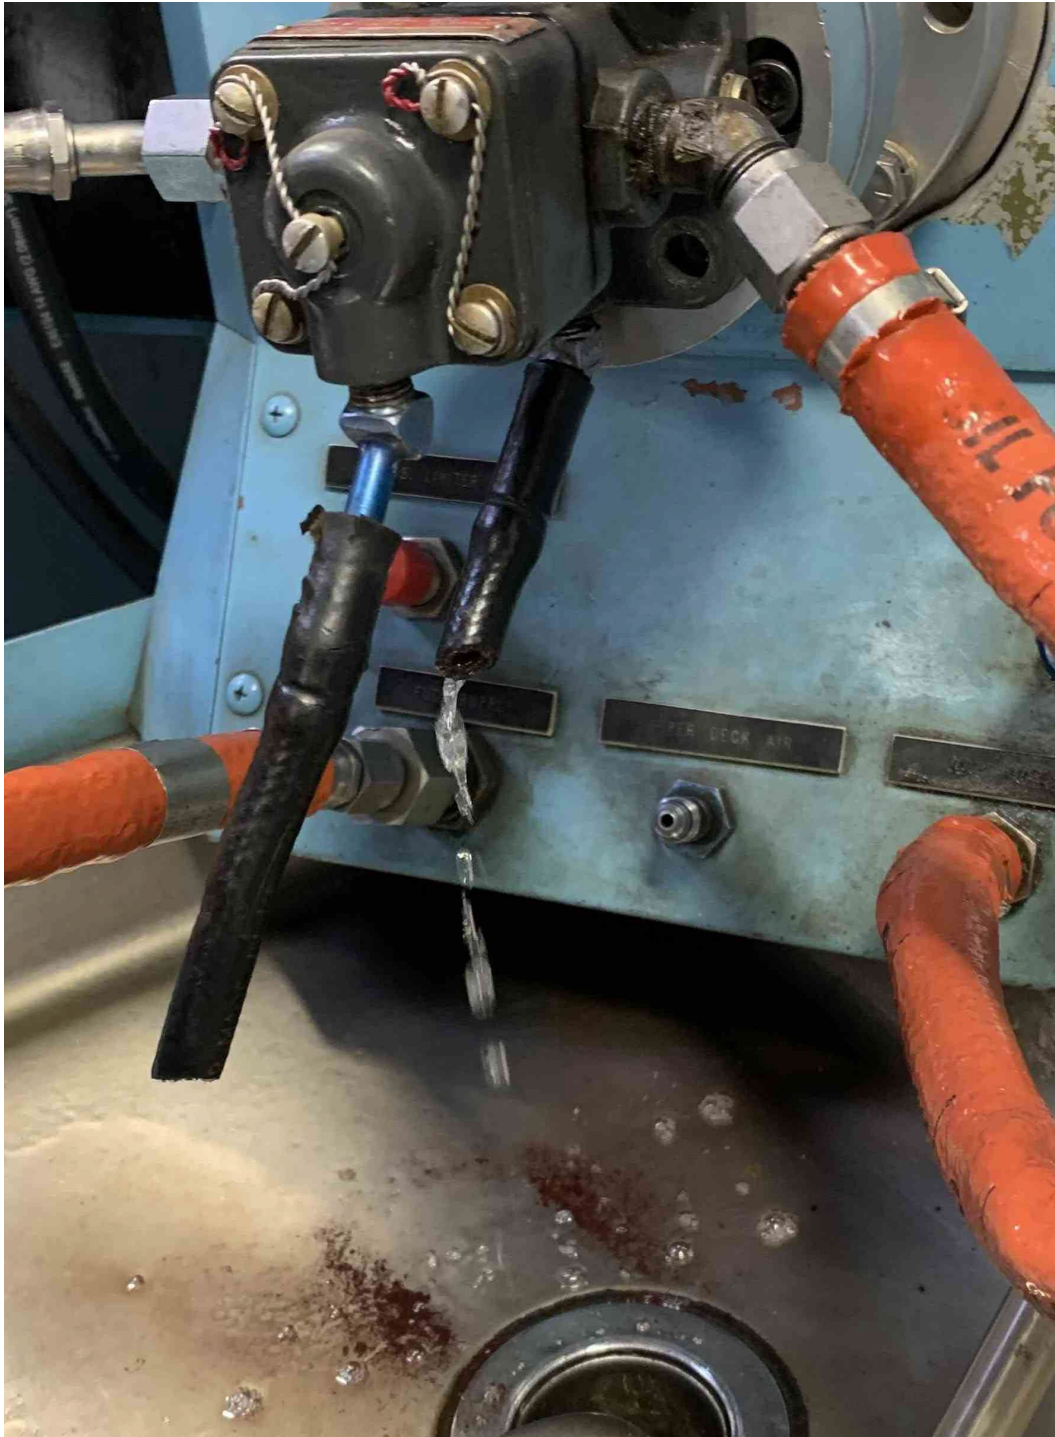
**Figure 7 - Fuel leak from input drive seal drain**

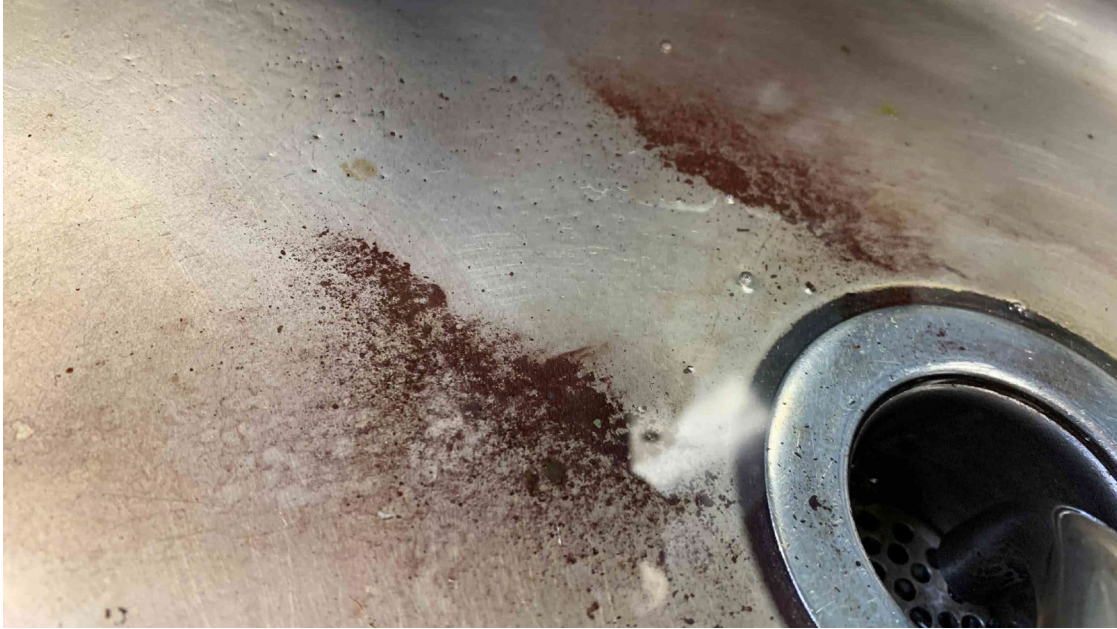
**Figure 8 - Corrosion-like deposit from seal drain**

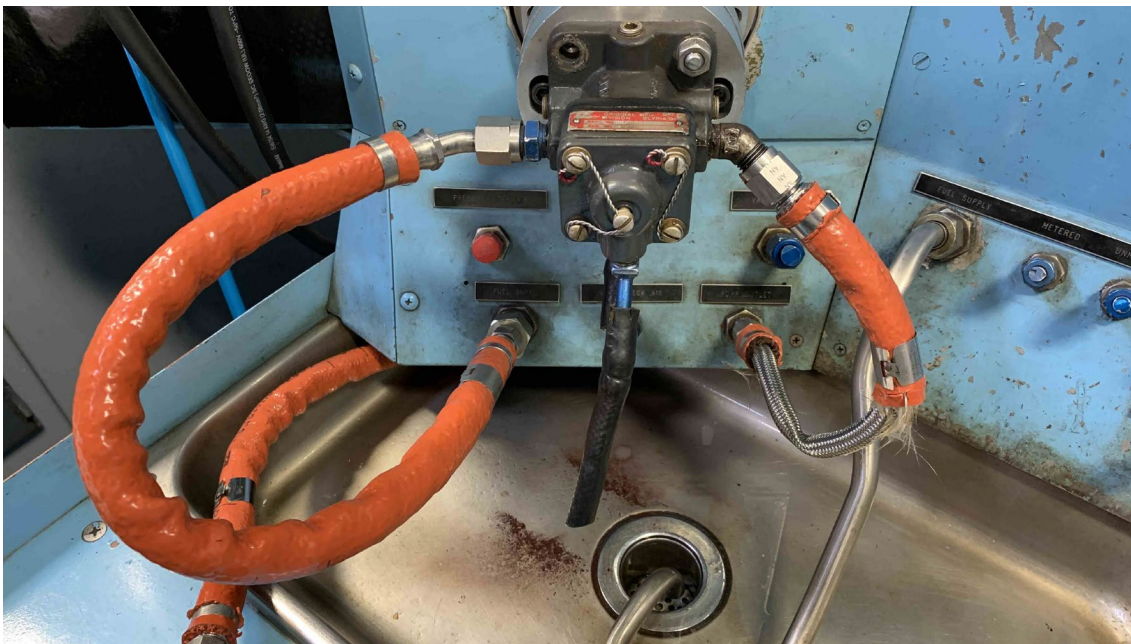
To determine if the kinked outlet line could restrict fuel flow, the line was installed in the flow bench with the pump (figure 9). With the line kinked as-found, the pump output pressures were the same as for previous tests.

The line was then progressively bent by hand at the kink, and fuel pressure remained unchanged until it reached a bend angle of about 100°, when the pressure began to decrease.

**Figure 9 - Kinked output line installed**

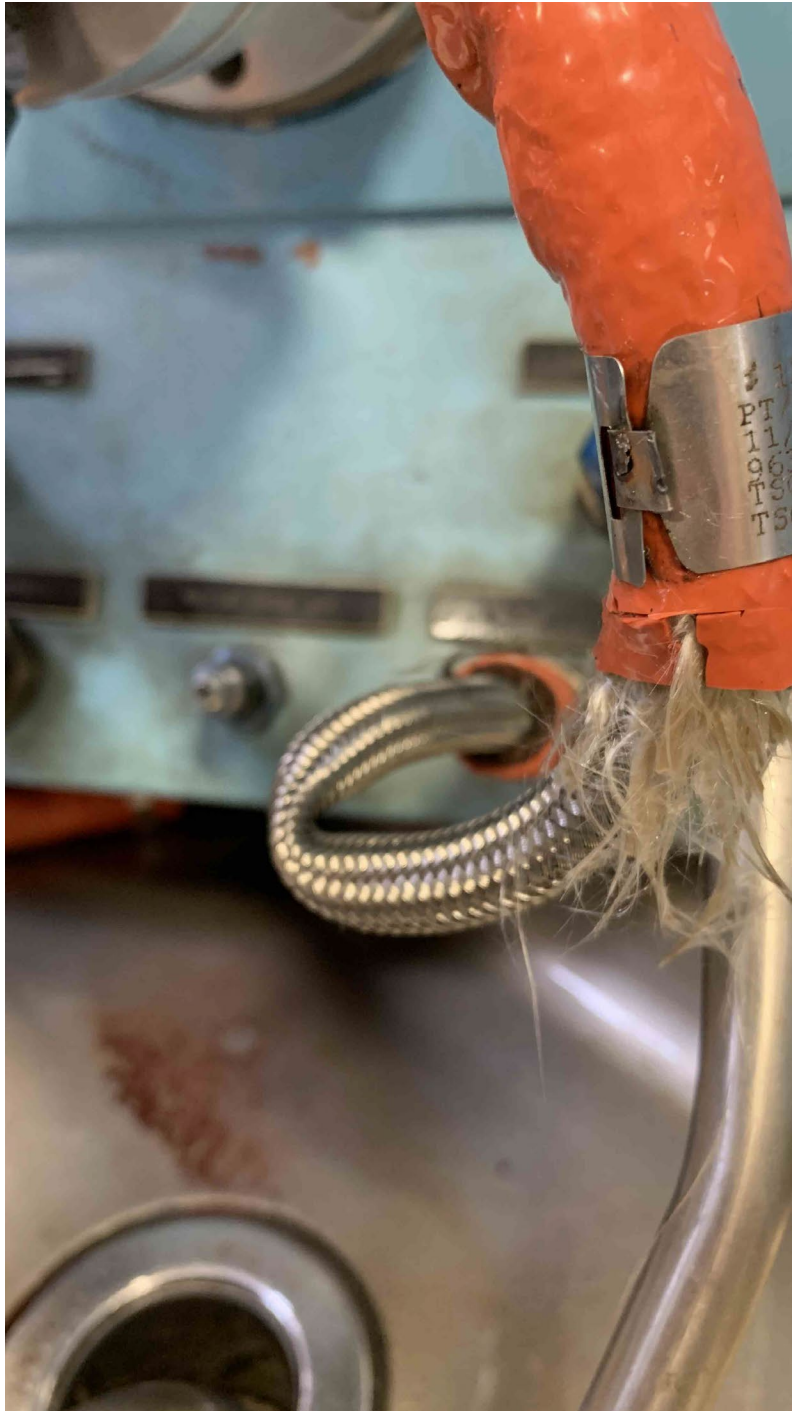
A series of tests were then performed with the fuel outlet line tightened so that it increased the twist in the line (figure 10). It was found that under these conditions, the fuel pressure could be reduced considerably more than when bending by hand, such that at one point fuel pressure reached 5 PSI.

**Figure 10 - Output line twisted until flow limited**
