## **NATIONAL TRANSPORTATION SAFETY BOARD**

# **AIRFRAME AND ENGINE EXAMINATION**

**WPR22LA296**

Location: Corona, California  
Date: August 9, 2022  
Aircraft: Piper, PA-32-300, N841AD  
NTSB Investigator-in-Charge: Eric M. Gutierrez

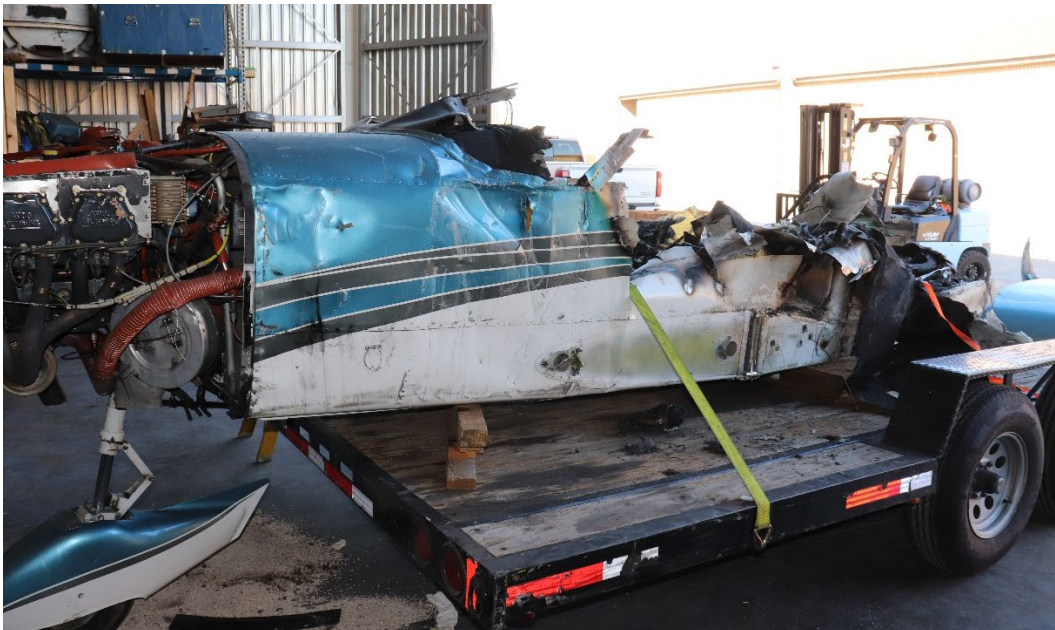
**Figure 1: View of airplane during examination**

Examination of the recovered wreckage revealed that the cockpit, fuselage structure was mostly destroyed by thermal and impact damage. The recovery organization had removed the left wing and the right wing impact separated at the wing root. The engine, engine mount, firewall, nose landing gear, instrument panel and flight controls remained attached. All instruments and instrument panel and exhibited thermal damaged.

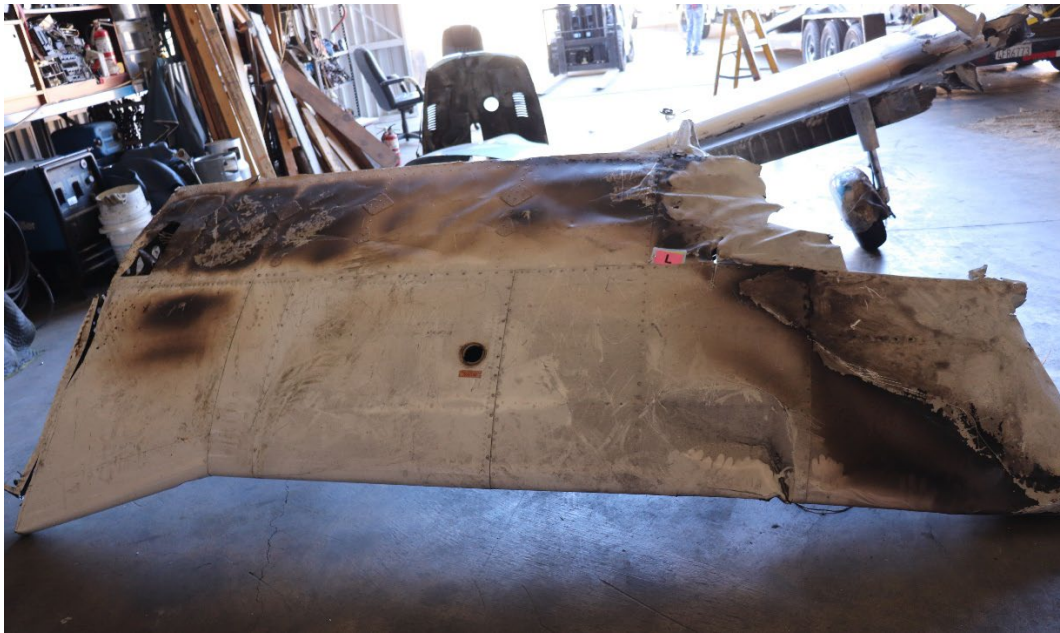
**Figure 2: View of left wing during examination**

The left wing was separated from the fuselage near the wing root. Various degrees of impact and thermal damage was observed throughout the wing. The left wing aileron was separated and not observed with the wreckage. The flap remained attached to its respective attachment points and was impact damaged. The airplane was equipped with aluminum fuel tanks and composite auxiliary tanks. Both main wing tanks were examined internally using a lighted borescope, no obstructions or debris was observed. The left wing auxiliary tank was impact separated and remnants of the fuel tank was observed in the wreckage. The left main fuel cap was separated and not observed with the wreckage. The left main filler port was normal and unremarkable.

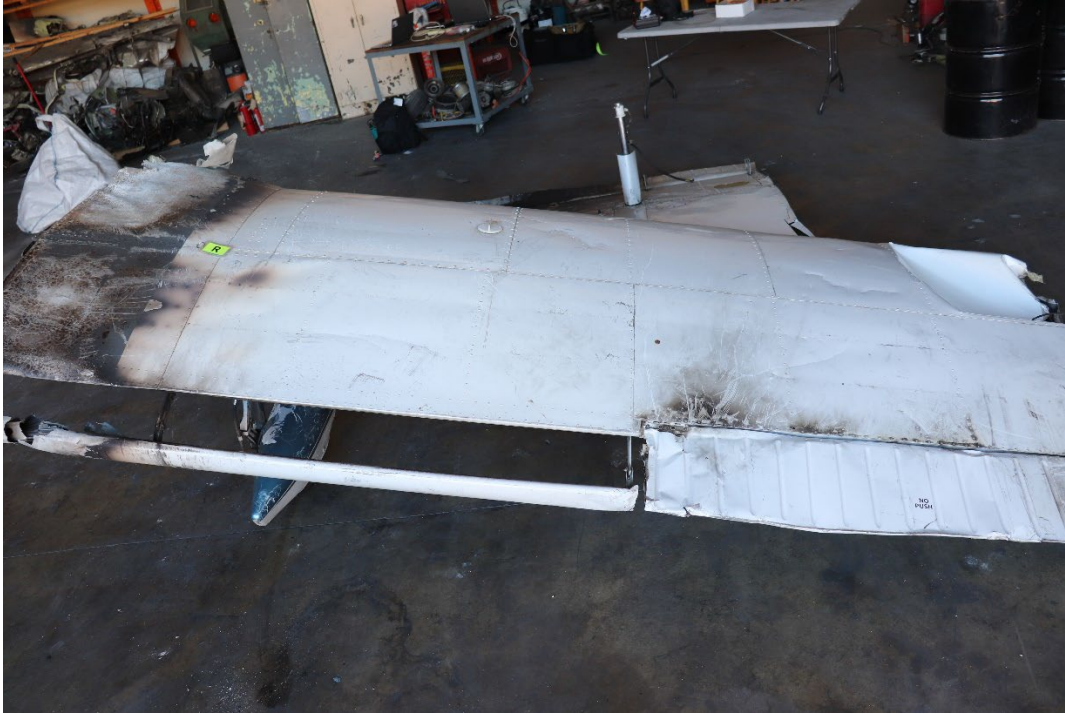
**Figure 3: View of right wing during examination**

The right wing was separated from the fuselage near the wing root. Various degrees of impact and thermal damage was observed throughout the wing. The right wing aileron and flap remained attached to their respective attachment points and was impact and thermal damaged. The right wing auxiliary tank was impact separated and remnants of the fuel tank was observed in the wreckage. Visual inspection of the right fuel cap revealed that the rubber seal appeared normal and unremarkable. The right main filler port was normal and unremarkable.

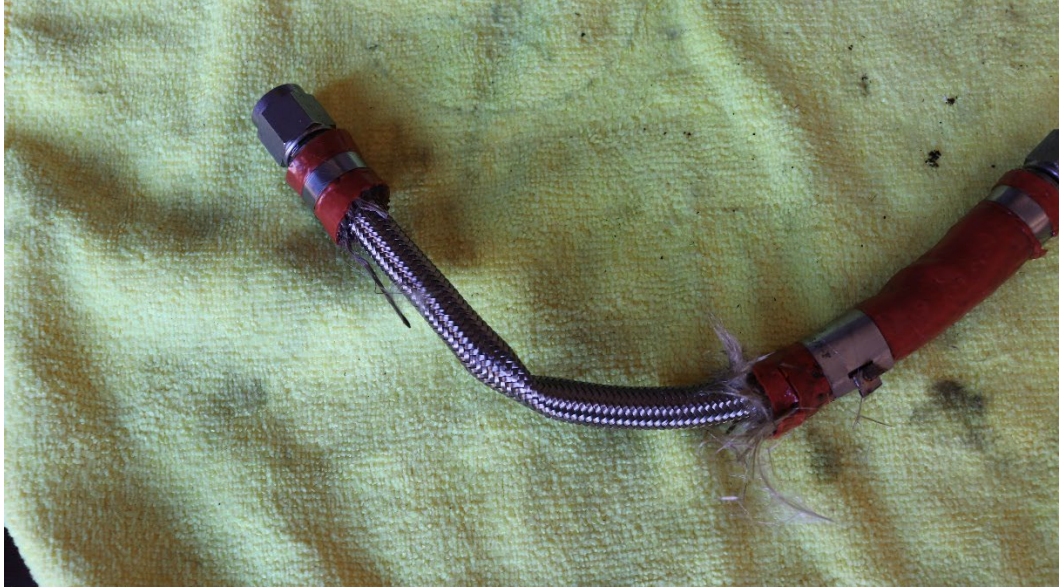
**Figure 4: View of fuel line**

A visual inspection was conducted of the fuel system. Continuity was established from the wing roots to the fuel injectors. Various breaks in the wing fuel lines were observed in both wings, consistent with cuts by recovery personnel and/or impact damage. The fuel selector handle was observed in a position, consistent with OFF. The fuel selector valve was observed in the near off position. A torsional twist (kink) was observed in the fuel line from the engine driven fuel pump to the servo. No visible impact damage was observed to the airframe or engine that would account for the torsional twist in the fuel line.

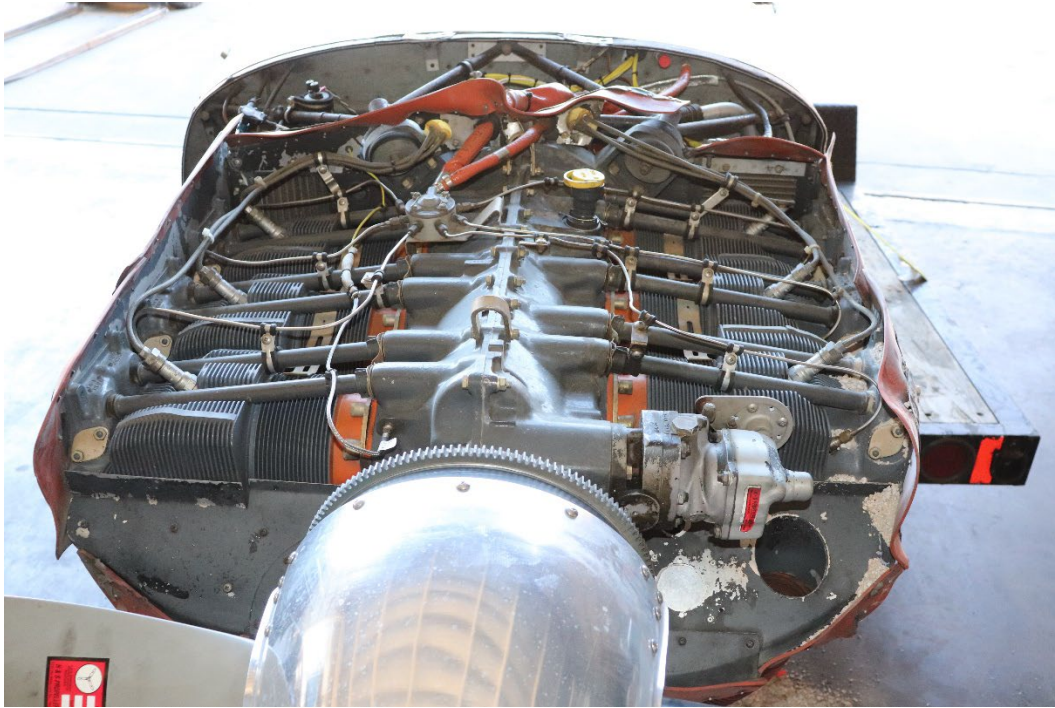
Figure 5: View of engine during examination

Examination of the recovered engine revealed that the engine remained attached to the airframe via the engine mounts. All six cylinders and all engine accessories remained attached. All fuel and oil lines that were removed were tight. No evidence of any mechanical damage was observed to the engine crankcase.

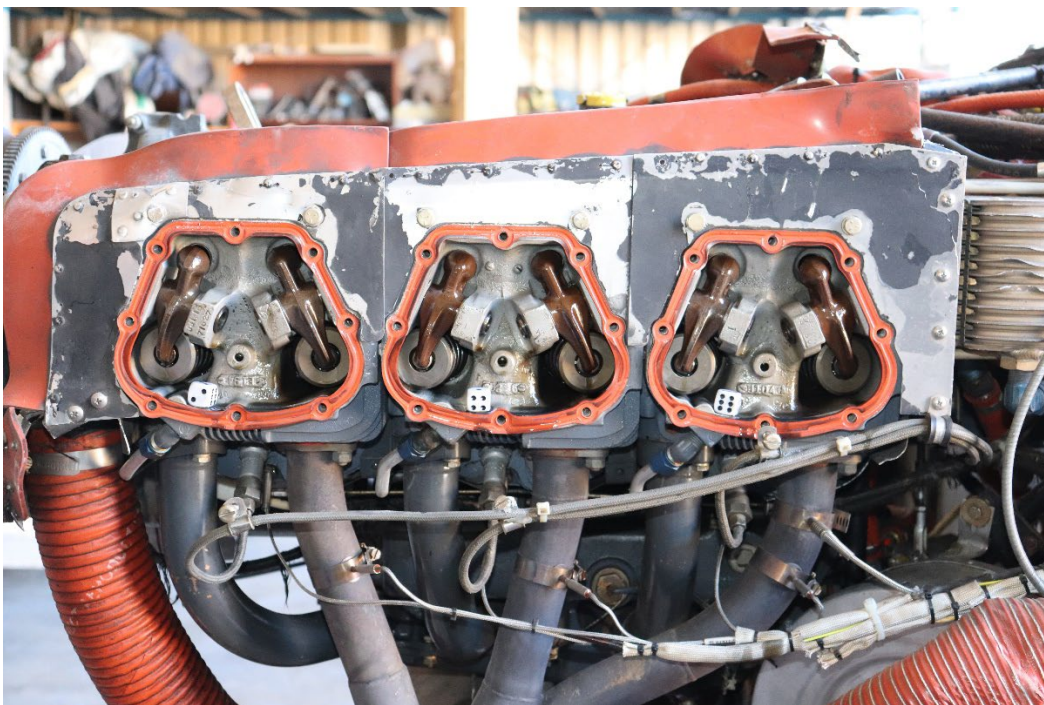
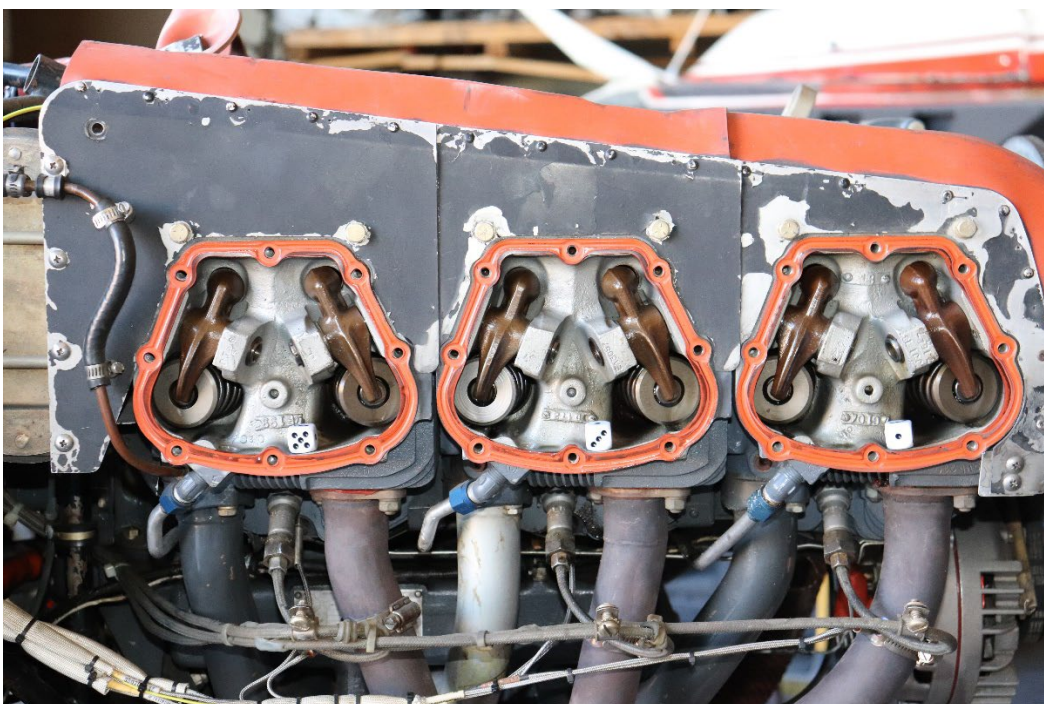
The rocker box covers were removed. The intake and exhaust rocker arms were intact, and oil coated on all cylinders. All intake and exhaust valve springs were in place and visually appeared to be undamaged. The upper spark plugs were removed, and all six cylinders were examined internally using a lighted borescope. A normal amount of combustion deposits was observed within the combustion dome of each cylinder and piston face. All of the intake and exhaust valves were unremarkable. The crankshaft was rotated by hand using the propeller. Rotational continuity was established throughout the engine and valve train. Thumb compression and suction was obtained on all six cylinders.

Figure 6: View of left side of the engine

Figure 7: View of right side of the engine

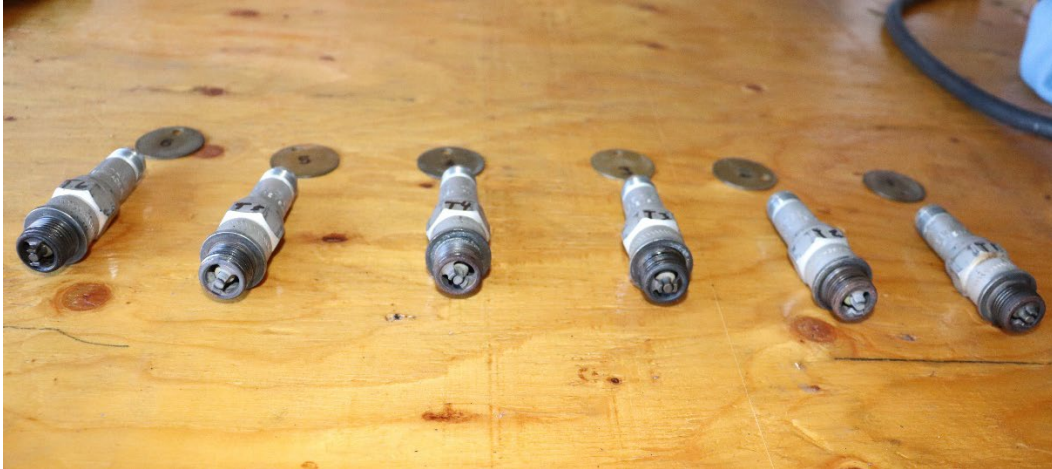
Figure 8: View of top engine spark plugs

The top engine spark plugs were removed from the engine, and they were the massive electrode type. The sparkplugs were light gray in color and exhibited dark deposits within the electrode area. All of spark plugs exhibited signatures consistent with NORMAL when compared to the Champion Check-A-Plug comparison chart.

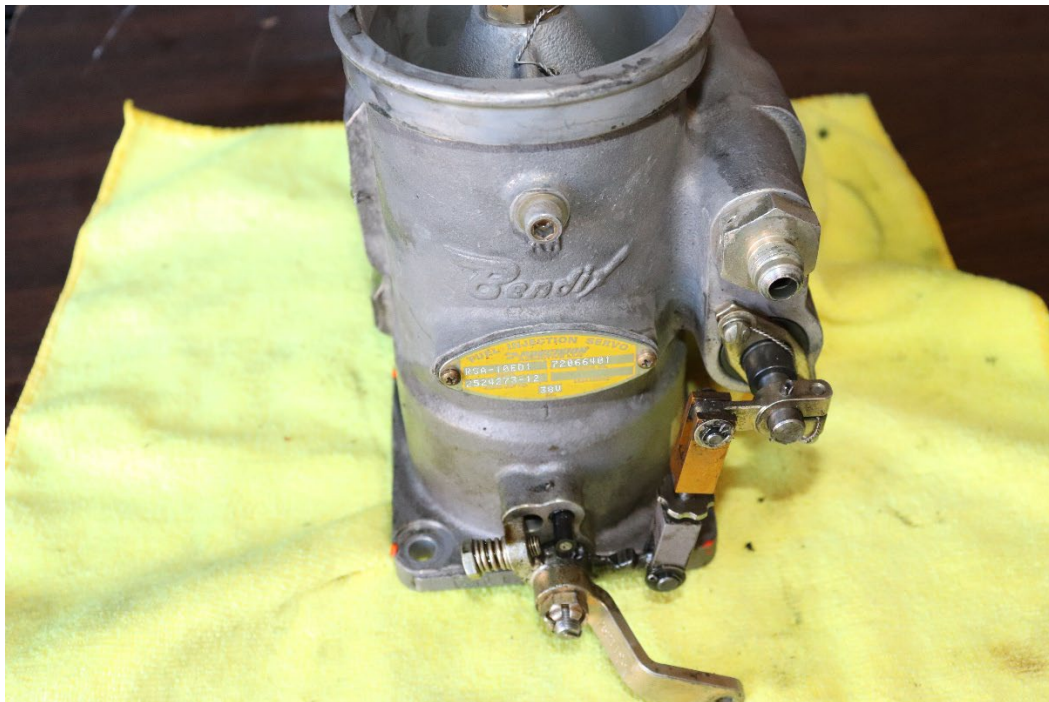
Figure 9: View of fuel servo

The fuel servo remained attached to the engine and was unremarkable. The throttle and mixture control cable remained attached to the servo and unremarkable. The throttle and mixture control moved the available length. The fuel servo inlet screen was removed, and no debris was observed.

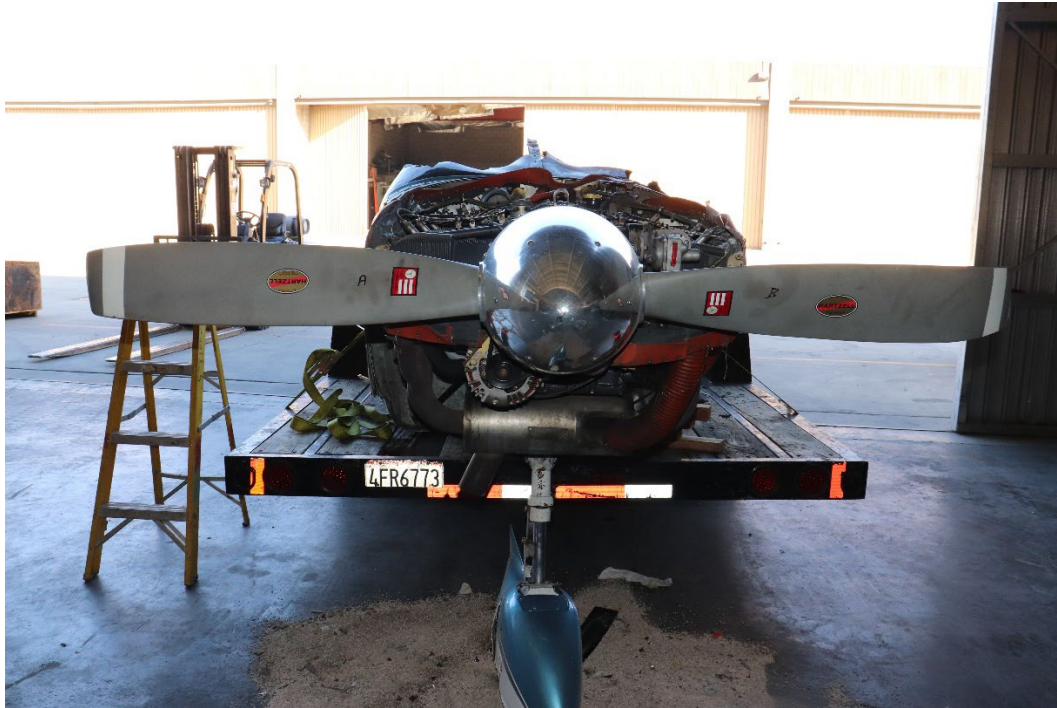
Figure 10: View of propeller

The airplane was equipped with a 2 blade, constant speed Hartzell propeller. The propeller blades remained attached to the propeller hub, with aft bending near the propeller tips. The blades exhibited various striations on the cambered side of the blade near the propeller tips.
