# National Transportation Safety Board

WPR22LA301

## **ENGINE EXAMINATION**

Location: Laurel, Montana  
Date: 08/11/2022  
Time: 1735 MDT  
2335 UTC  
Airplane: N5780F, Piper PA-28-140

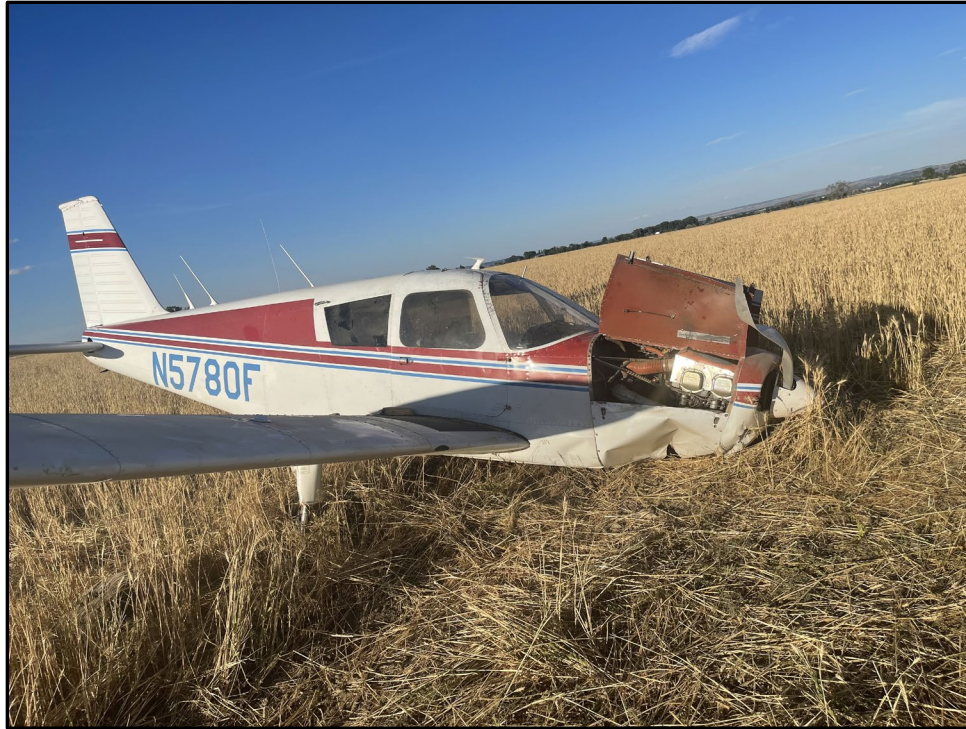
The engine and cowling assembly remained attached to the airframe during the relocation of the wreckage from the accident site. The airplane wreckage had its wings removed from the recovery.

**Figure 1: Airplane in field as viewed from the right side.**

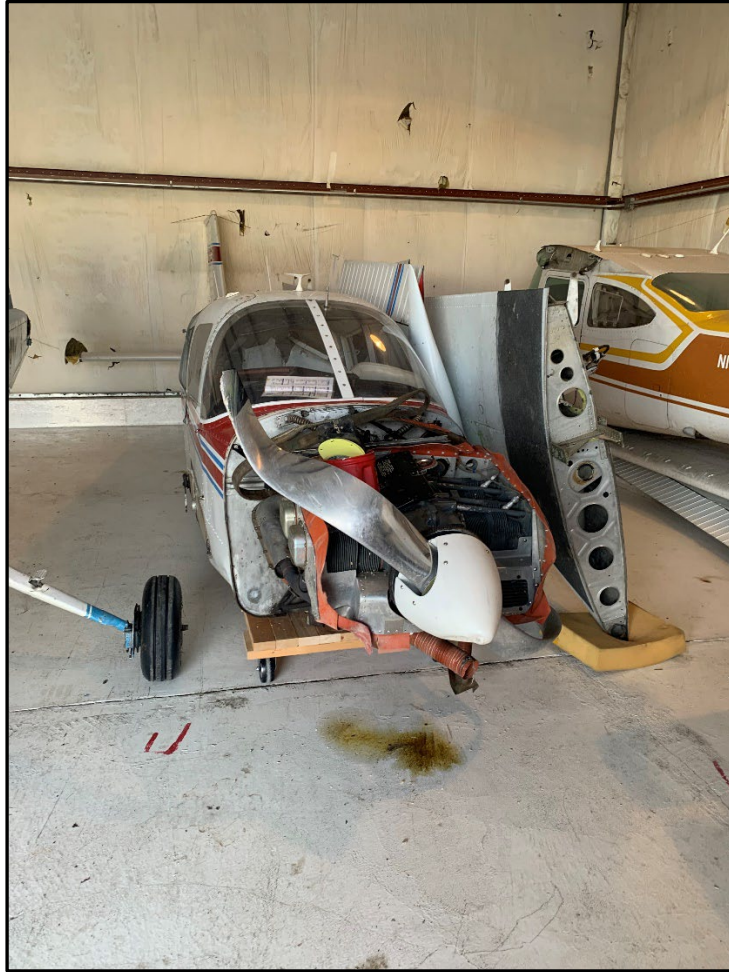
The propeller was attached, and one blade was bent aft and twisted about mid-span and the other blade sustained impact damage.

**Figure 2-Front view of the airplane wreckage.**
