# National Transportation Safety Board

## **MATERIALS LABORATORY**

Factual Report 23-002

Location: Corona, CA  
Date: August 13, 2022  
Vehicle: Goddard Dick SIM BENSEN B-8M, N532KB  
Investigator: Michael Hicks

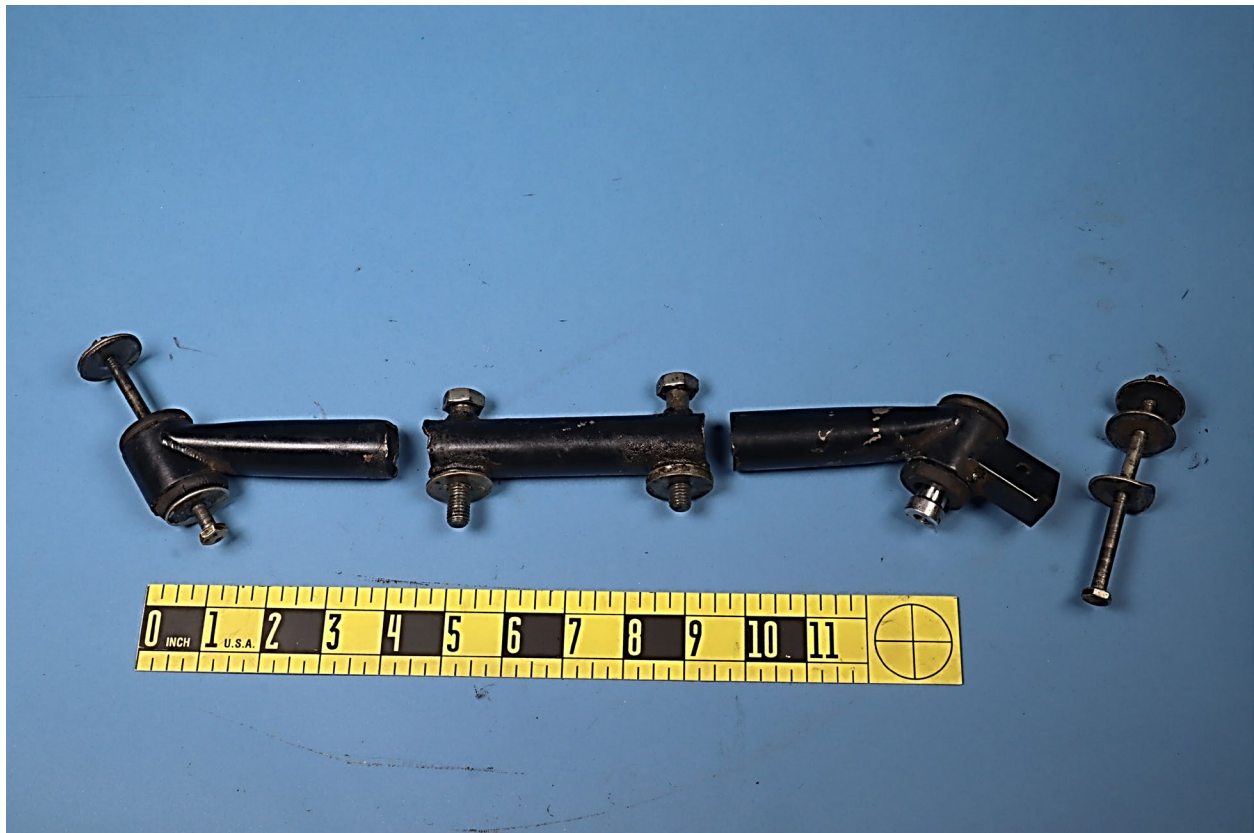
The engine mount submitted for examination consisted of a steel tube weldment exhibiting two fractures (Figure 1). The fractures were perpendicular to the length of the tube and were located near washers that had been welded onto the exterior of the tube. The two fracture surfaces contained in the center section (Figure 2) of the engine mount tube were cleaned using a mild detergent and a soft bristle brush. The fracture surfaces were labeled 1 & 2 as shown in the figure.

**Figure 1.** Engine mount as received.

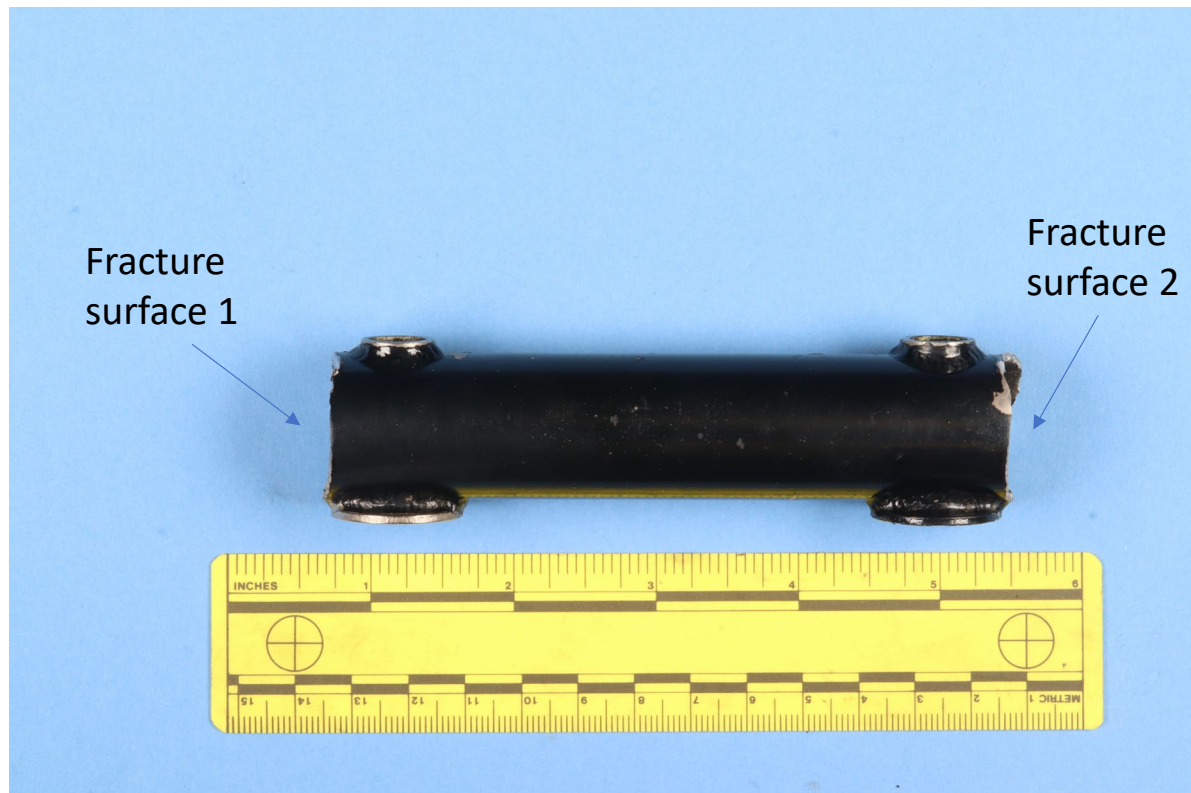
**Figure 2.** Center section of engine mount containing fracture surfaces 1 & 2.

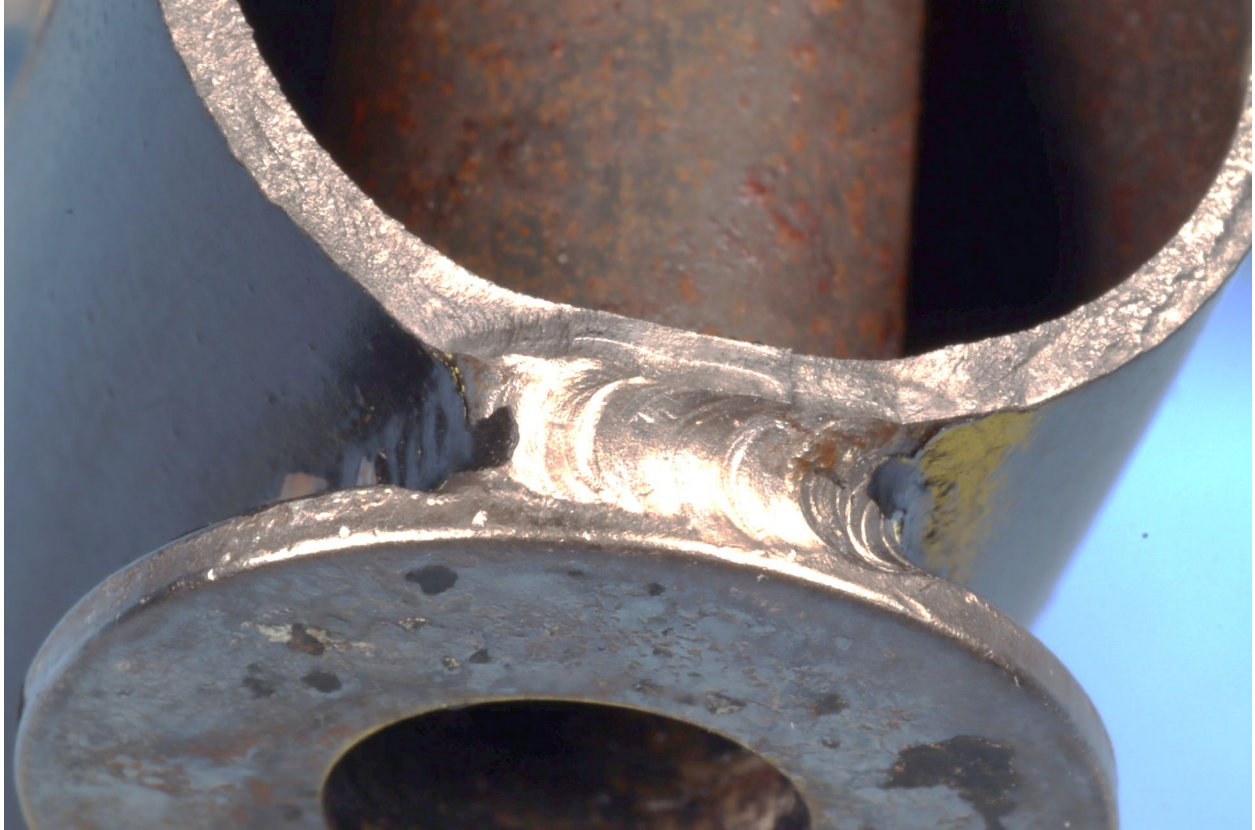
Fracture surface 1 exhibited a thumbnail<sup>1</sup> shaped fatigue crack originating at the toe of the weld fillet that attached the washer to the tube (Figure 3). The fatigue crack exhibited ratchet marks indicating multiple origins. The rest of the fracture surface outside of the fatigue crack exhibited fracture features consistent with overstress.

**Figure 3.** Fracture surface 1 exhibiting a thumbnail shaped fatigue crack and ratchet marks.

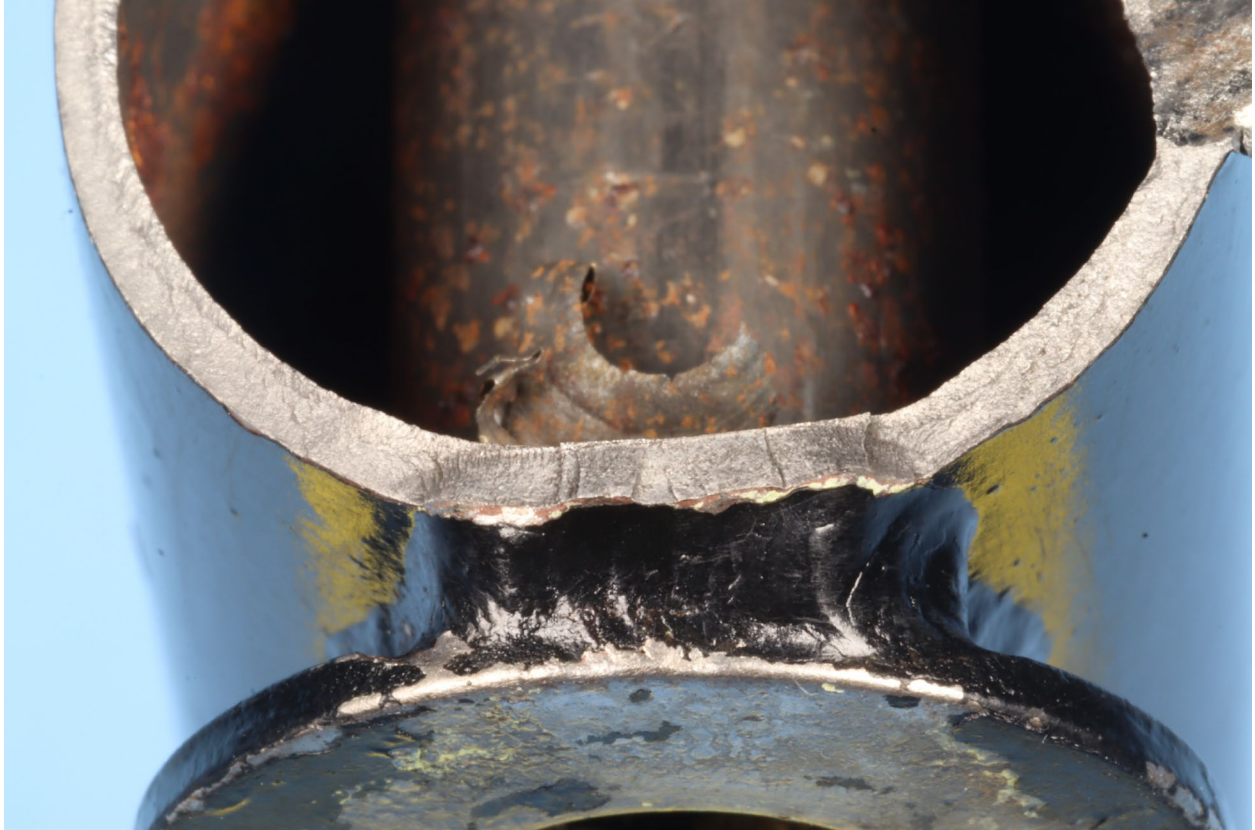
Fracture surface 2 exhibited a thumbnail shaped fatigue crack originating at the toe of the weld fillet that attached the washer to the tube (Figure 4). The fatigue crack exhibited ratchet marks indicating multiple origins. The rest of the fracture surface outside of the fatigue crack exhibited fracture features consistent with overstress.

**Figure 4.** Fracture surface 2 exhibiting a thumbnail shaped fatigue crack and ratchet marks.
