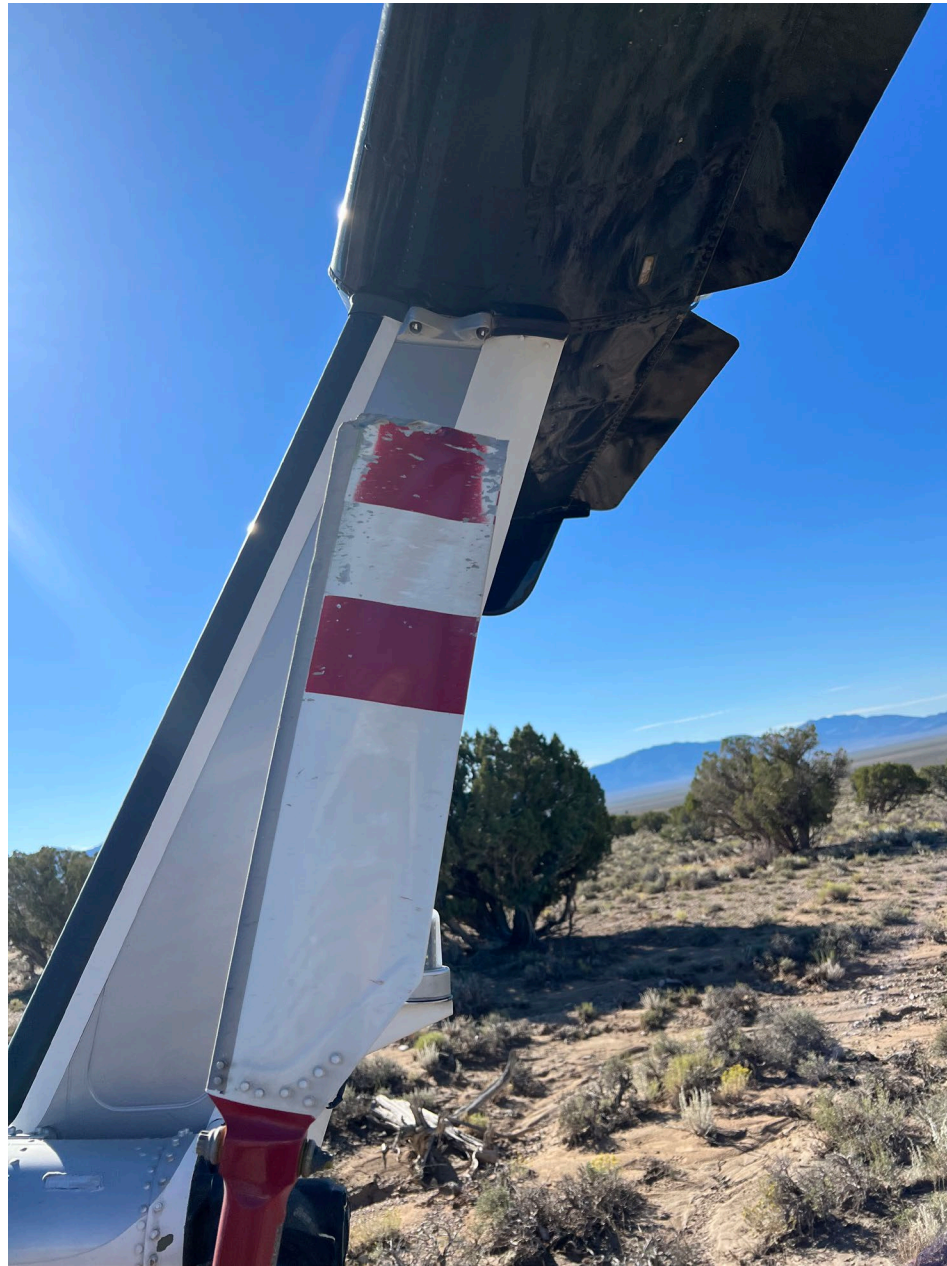
**Photo 1 – Rotor damage of sheared tail rotor shaft**
